**Ex-Post Monitoring Report of Japanese ODA  
Loan Projects 2010  
(The Philippines, India, Argentina, Colombia, Ghana)**

Ex-Post Monitoring of Completed ODA Loan Project  
Republic of the Philippines

Boracay Environmental Infrastructure Project

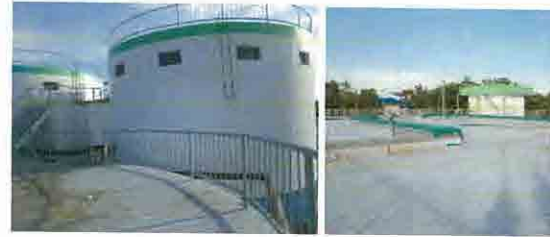
Overview of STP

Indicators for sewage treatment services (e.g. population covered by sewage service, the quantity of sewage treated, and etc.) are shown in Table 2. The average quantity of inflow at the time of the ex-post monitoring was 4,500m<sup>3</sup>/day, and the maximum inflow during the rainy season was 6,500m<sup>3</sup>/day. Through the expansion project, currently being implemented by BIWC, the upgraded STP has its capacity 2.5 times higher, from 2,600m<sup>3</sup>/day (2005) to 6,500m<sup>3</sup>/day (2011). Thus it can be said that the problem of excessive treatment raised at the time of the ex-post evaluation has been resolved. The number of connections to the sewage system has increased from 657 (2005) to 761 (2011). Of these connections, the number of business connections has increased from 359 (2005) to 657 (2011), of which the number of connections for large-scale businesses such as hotels etc. is 426 (2011), an increase of 19% from the 359 connections in 2005<sup>2</sup>. Also, it was confirmed that the increase in the population served by the sewage treatment system has increased about 9 times.

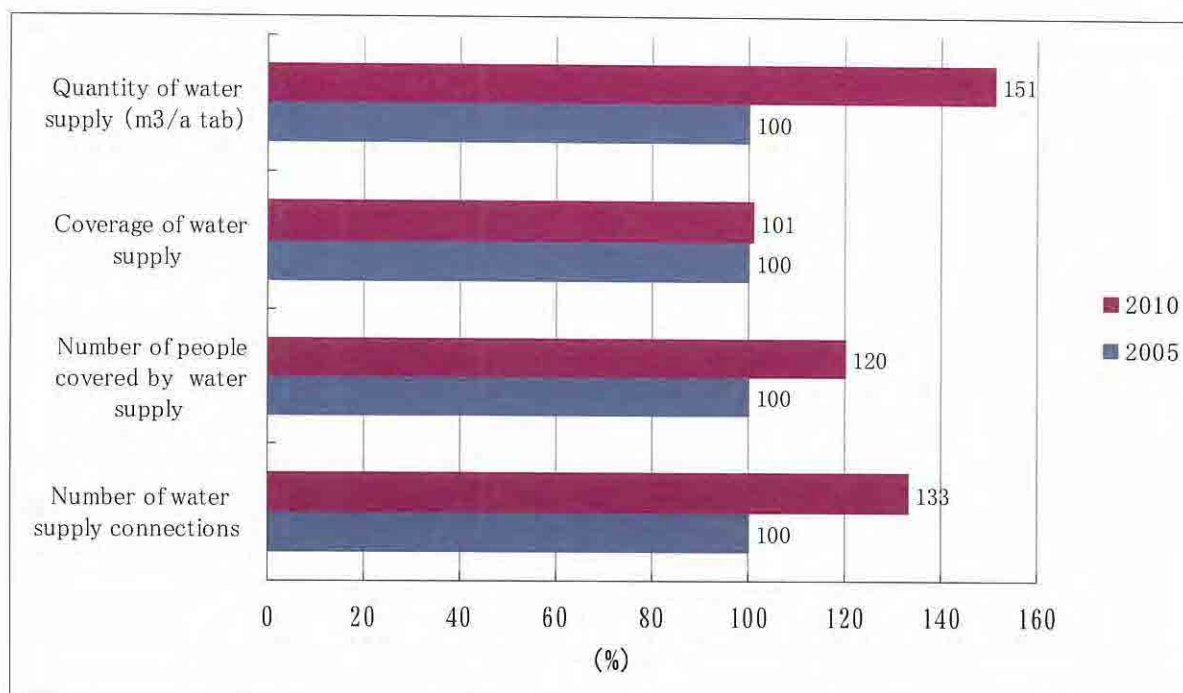
Figure 1: Rate of increase on indicators (average values for 14 water supply projects)

In order to ascertain the effectiveness direction (increase/decrease), the average increase/decrease in the quantity of water supply, coverage of water connections, population of water supply and number of water connections as operation and effect indicators were compared to those of the ex-post evaluation (The base value in 2005 was considered to be 100%).

All the values of the four operation and effect indicators mentioned above exceeded those of the ex-post evaluation, particularly the quantity of water supply and number of water connections.

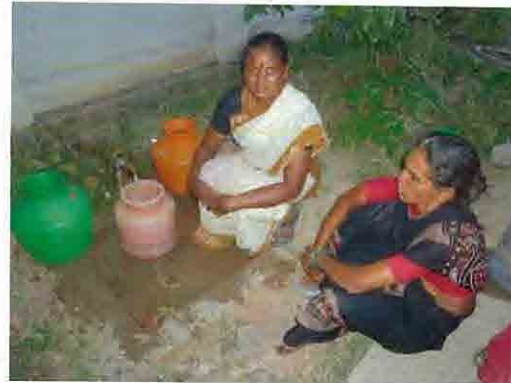
Public water tap in Tirupati

Based on interviews<sup>5</sup> with each entity and beneficiaries during the ex-post monitoring, similar impacts concerning the hygienic environment were noticed throughout the areas by implementing the project in various habitats.

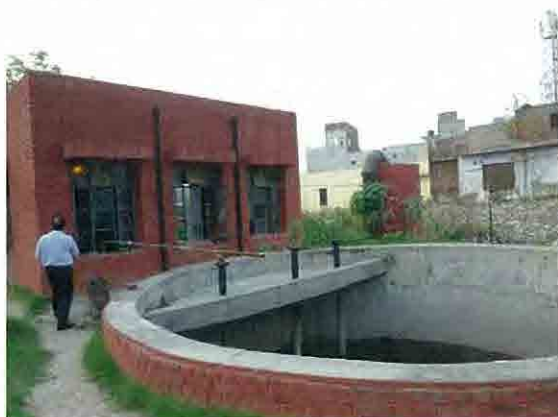
Sewerage facility in Amritsar

During the site visits to Amritsar, Tirupati and Hyderabad, it was observed that operation and maintenance were being reasonably implemented in terms of the availability of requisite staff and fund allocation. Based on responses to the questionnaire, the collection rate for water and sewerage fees was between 75 and 98%, averaging up to 90%. For proper operation and maintenance, however, the collection fees remained insufficient.

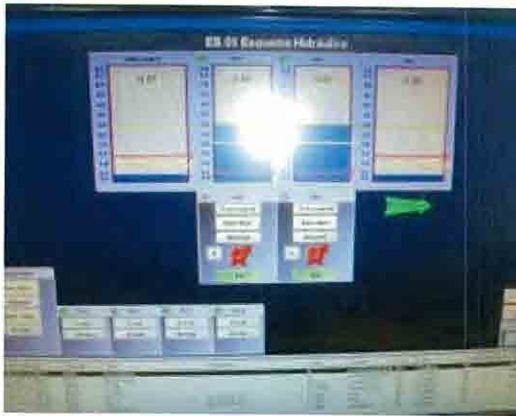
Photo 1 Monitoring the Pump Facilities

Ten pumping stations are currently in operation, and the main control and monitoring center is located at the ninth station. Maintenance activities are performed regularly every three months. The garbage removal machine at each pumping station has also been replaced.

According to the private corporation, Ilubaires S.A, in charge of the stations operations and maintenance, the monitoring system for all ten stations has been improved since 2008. Former provincial government employees are in charge of the training program for plant operators, and an operations manual has also been prepared.

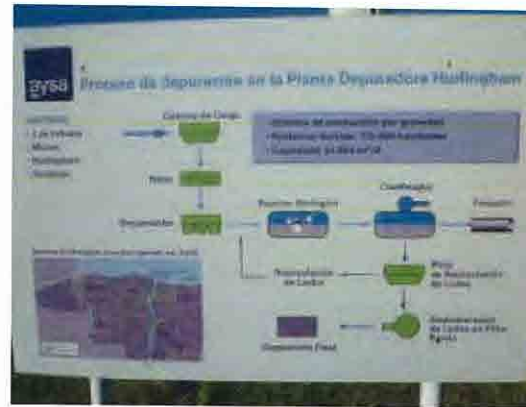
Photo 2 Facility Chart of the Sewage Disposal Plant

Training of staff members at the disposal plants is mainly OJT carried out by AySA and ABSA, the companies that are in charge of the operation and maintenance of the sewage plants. The current chief engineer of the plant has 22 years of experience. The water quality inspection procedures are based on the quality standards of these companies, which are more stringent than provincial government water quality regulations.

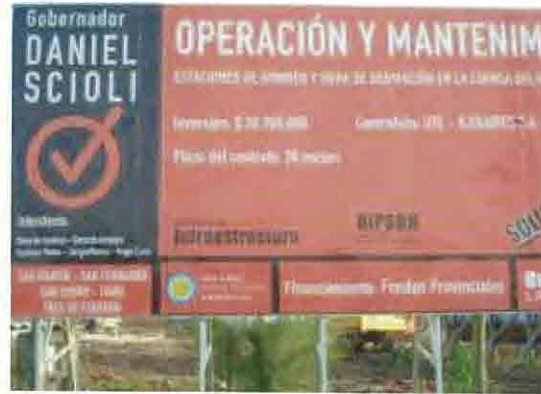
Photo 6 Pumping Station O&M Sign

The operational conditions of the two sewage disposal plants out of the four that are in operation and the maintenance of the pumping stations were confirmed through visual observations (at pumping stations 6 to 10), and the monitoring activity, periodic inspections, garbage removal, etc. were adequately implemented.
