Aguablanca Water Supply and Sewage Project

External Evaluator: Koichi Ishii

Pegasus Engineering Corporation

1. Project Description

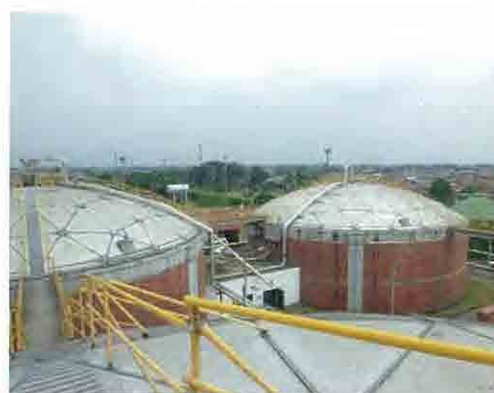
Overview of the sewage treatment plant

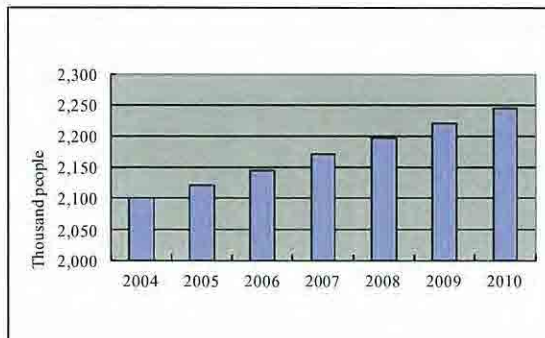
Fig. 1 Population supplied with water

At the time of the ex-post evaluation in 2004, the service coverage was about 96%, and had risen to 100% at the time of the monitoring study in 2010. According to EMCALI, this is because the number of service connections in the poverty area increased. Similarly, the population of Cali needing domestic water connections reached 2.24 million in 2010 as opposed to the planned 1.55 million.

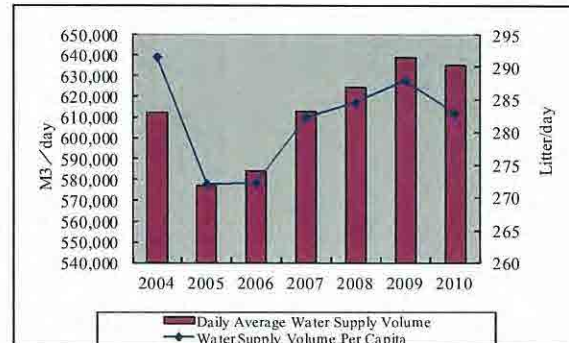
Fig. 2 Water Supply Volume

In the project, the estimated daily average volume of water supply was 600,000 m³, whereas

the actual water supply volume in 2010 was 634,962 m³/day. Notwithstanding major interannual fluctuations in the water supply volume, a 21% growth was recorded in the last 24 years from 1986, when construction commenced, to 2010, when the construction was completed. This is because the facility utilization rate improved as mentioned below.

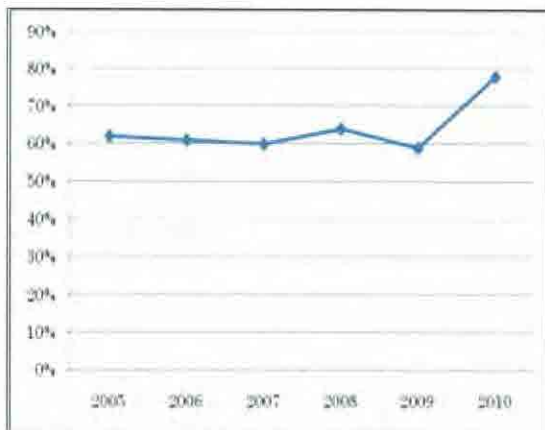
Fig. 3 Facility Utilization Rate of the Puerto Mallarino Purification Plant

At the Puerto Mallarino Purification Plant, the installed capacity prior to the project implementation was 285,000 m³/day and the facility utilization percentage was nearly 100%, namely full capacity. Since the capacity doubled to 570,000 m³/day, the utilization rate accordingly remained at 57%. Recent growth in the population and water demand raised the utilization rate to 78% in 2010.

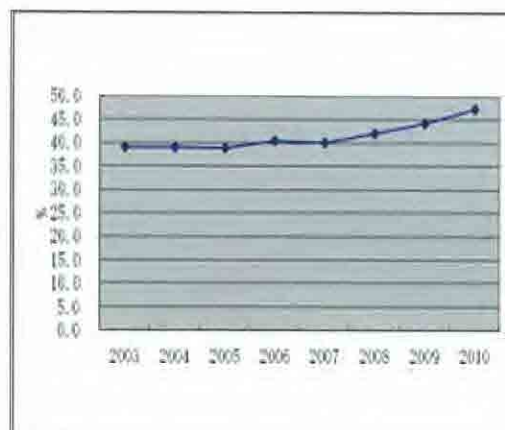
Fig. 4 Unaccounted-for Water Rate

The percentage of unaccounted-for water was 30%, meeting exactly the planned level, in 1997 (when the construction was actually completed). In subsequent years, however, it worsened to 39% in 2004 and 47% in 2010. The factors behind this increase include increased water leakage due to a lack of maintenance work on the deteriorated water supply network and meters, because of EMCALI's financial problems, and more and more illegal connections. In response, EMCALI, the executing agency of the project, has implemented wide-ranging countermeasures: upgrading or installing main pipes and water meters, implementing a management program, controlling illegal connections (the project area is home to many immigrants from the Pacific region), taking measures against water leakage by reducing water pressure, outsourcing water pipe repair and replacement work to the private sector, organizing a local water conservation organization, and water pipe disconnection or compulsory

collection for houses not paying due bills for at least two months. The ultimate goal of the agency is to lower the percentage of unaccounted-for water to below 30%, as initially planned.

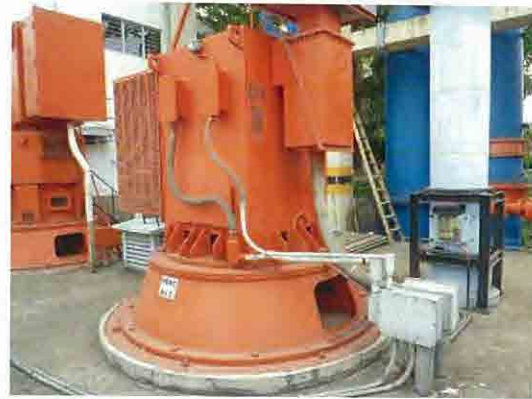
Photograph 2 Water Supply Pump (funded by the yen loan)

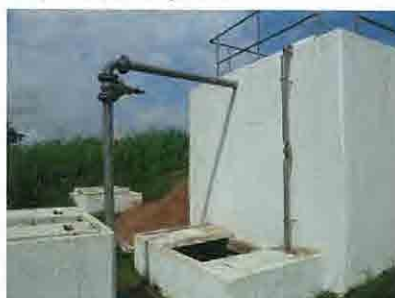
Large-scale facility (Ho)

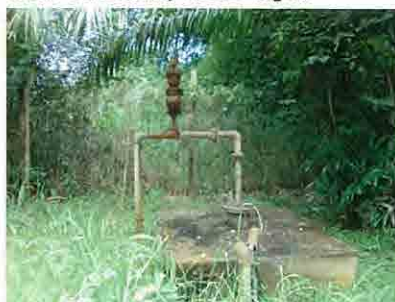
Small-scale facility (Sovie-Digbe)

Nkonya-Ahenkro, Sovie-Digbe, etc.), maintenance is not sufficiently implemented, which affected the status of operation of the facilities. Also, according to the explanation of GWCL, the reason that the quantity of water supplied at Denu-Aflao reduced was because an elevated tank had a breakdown, and another tank in a nearby location was used instead. Although the latest data for Tamale in the North and Wa in the Northwest was not provided, judging from the 2008 data, it is considered that the planned values are being achieved.

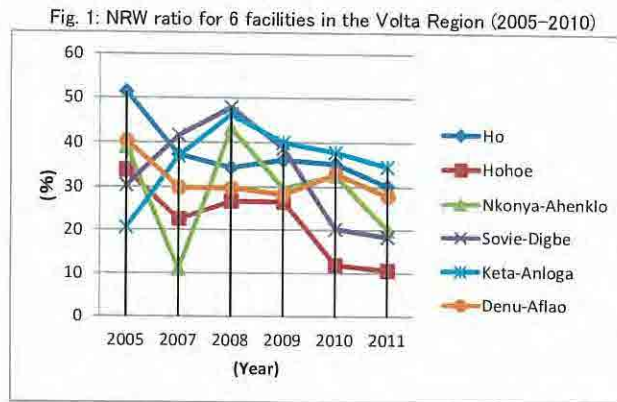
According to hearing surveys with GWCL, the reasons for the improvement in the NRW ratio were (1) implementation of the World Bank's "Urban Water Project"², and (2) establishment of the system of water tariffs by GWCL³.

However, the values of the NRW ratio for all the facilities fluctuate greatly. Time was not allocated to investigate the reasons for this during the period of the field survey, but based on the interviews with GWCL and reports, it was confirmed that there were issues such as (1) the rate for normally-functioning customers' meters is low at about 40%, so the accurate quantity of water used is not known⁴, and (2) at some facilities, the water flow meters that measure the quantity of water supplied are faulty⁵. It was inferred that because the measurement by meters is insufficient, it is not possible to calculate the NRW ratio based on the accurate quantities of water supplied, quantities of water distributed, and quantities of water consumed, etc., which is the reason that the numbers fluctuate significantly. It is necessary that GWCL continues its efforts to grasp the status of water supply and water distribution based on accurate data, and to investigate appropriate

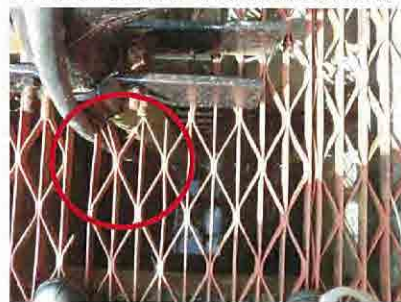
Based on the interviews at the Volta Regional Office, at large-scale water facilities, periodic maintenance (e.g. changing sand in the filters, inspection and repair of equipment) was conducted in accordance with annual maintenance and clean-up plans, prepared by GWCL headquarters. Also, at the facility in Hohoe, it was confirmed that the intake pump was replaced with GWCL's own budget and the water tank was cleaned once a year. It was also confirmed that a water quality test was conducted every 2 hours daily and no particular problems were found in terms of maintenance.

Pump replaced with GWCL budget (Hohoe)

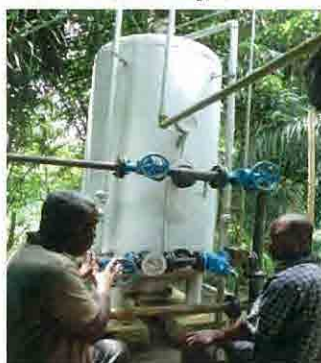
On the other hand, at small-scale facilities the inside of the tank and the sand filter were not cleaned as regularly as at large-scale facilities. According to the Volta Regional Office, regular clean-up was not carried out at any of the facilities for budgetary

Sand filter (Sovie-Digbe)

Of the facilities, it was confirmed that deterioration at some facilities had advanced and the initially targeted water supply volume was not achieved. GWCL should improve the operation and maintenance structure so that these facilities can operate properly to secure the required water supply volume. In order to maintain and inspect the facilities and machinery regularly and to retire old equipment and replace parts without fail, efforts should be made to (1) consolidate the maintenance system centering around the third party contractor (GUWL) and (2) enhance GWCL headquarters' capability to supervise the private company to which maintenance is contracted.
