**Ex-Post Project Evaluation 2010:
Package I-2 (Guatemala, Nicaragua)**

JAPAN INTERNATIONAL COOPERATION AGENCY

**FOUNDATION FOR ADVANCED STUDIES
ON INTERNATIONAL DEVELOPMENT**

“The Project for the Water Supply for the Urban Area of Quetzaltenango City”

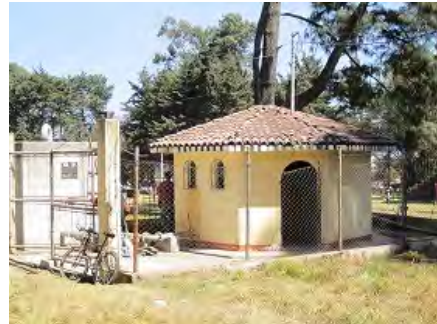
Barehole at Zoologico

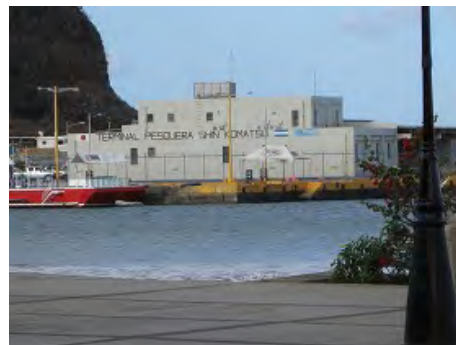
Overview of facility of SJDS port

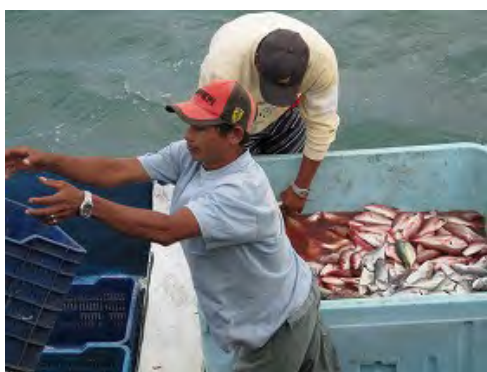
Discharging of the catch is still being performed by the crew members of the fishing boat. They directly transfer the cargo from their fishing boat to the truck carriers parked alongside the deck by brokers and export traders. At the time of the BD, it was planned that the catch would be directly discharged from the deck to the cargo disposal area, using the discharging equipment (i.e. a crane mounted on a truck carrier), with a view to reducing the number of workers involved in the discharging operation and minimizing the time required to complete the discharging operation. However, the same method employed prior to this project is still being used at the moment and at the time of ex-post evaluation. As a consequence, neither the number of workers nor the time required to unload the cargo has been reduced.

Crew member of fish boat to unload the fish caught

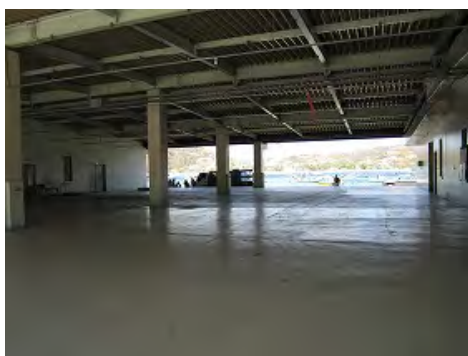
Although offices for brokers had been installed in which to conduct auctions, no broker has moved into the facility. At the moment, these spaces are being used for other purposes, e.g. as an office for HACCP projects;¹⁰ an office housing the fishermen's association; and a kiosk where daily commodities for fishermen are being sold.

Areas for disposal of fish caught

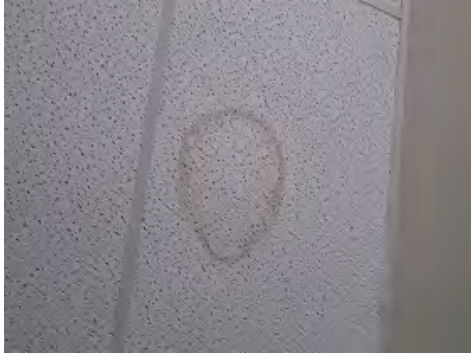
leaks in ceiling

It should be noted that the Nicaraguan side believed that it would be the responsibility of the Japanese side to repair these defects of the facilities at the time of first field survey in January 2011: but in May 2011, at the time of second field survey, having understood that it needs to be done by the Nicaraguan side, they are now reviewing the budgetary measures necessary for such repairs.

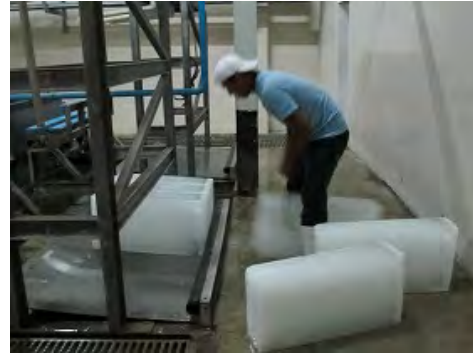
functioning ice machine

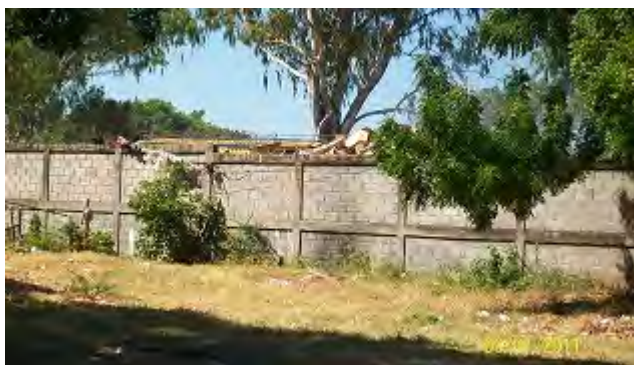
Many schools want to have high walls for security reasons as this (Fernando Gordillo Cervantes School in Managua City).

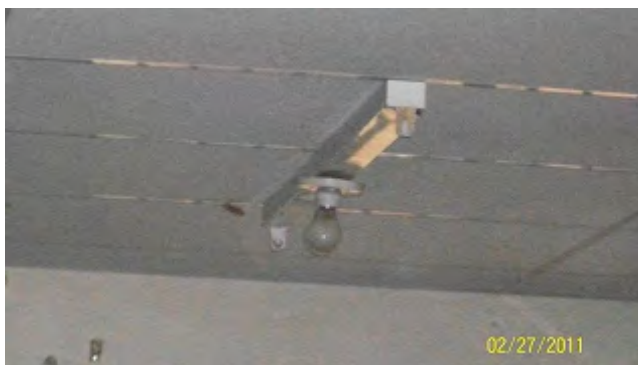
At the 24 schools visited, there are no problems which seriously hinder the class. Small problems common in more than 10 schools include: (i) light bulbs, (ii) broken light switches, (iii) locks (doors and cabinets), (iv) unstable chairs, and (v) loss of teaching materials. Compared to schools in the rural area, more

The fluorescent was gone and it is replaced by a bulb because it is cheaper (Diriangén School). This is observed at other many schools.

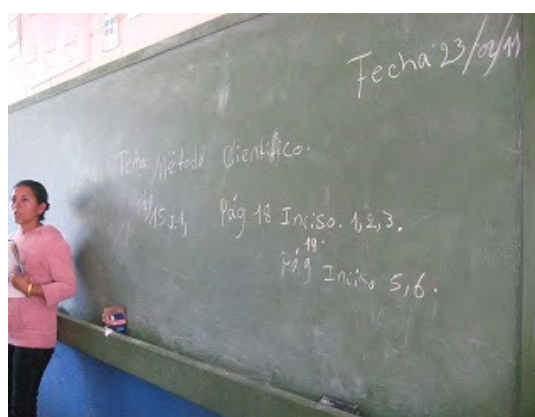
As for the blackboards, in 14 of the 40 schools visited, they are not used. Most of the teachers who did not use the blackboard answered that chalk dust was unhealthy, and now they use the acrylic white board instead of the blackboard. Teachers who use the blackboard evaluate them highly, commenting that “they are sufficient in size and easy to use” and “students easily can look at the blackboard without light reflect.” On the other hand, some say that “if they can purchase the acrylic board and pens, they prefer it¹⁶.” With regard to the toilets, at the five schools visited, all or some are not in use. Reasons cited include: the waste level in the tank rose

Blackboards are used at more rural schools than urban schools.(Concepción de María School in Chontales). Some are well maintained.

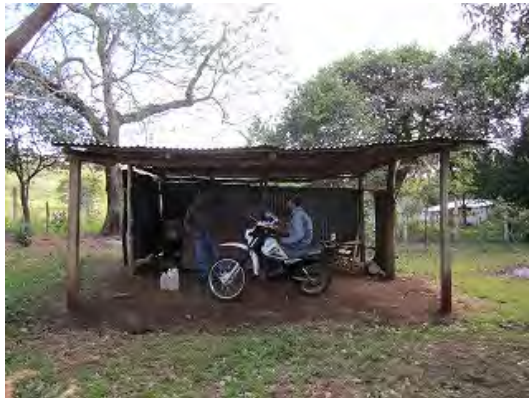
Classroom before the Project. Classes were sometimes canceled because of rain and wind (Puertas Rojas School in Chontales).

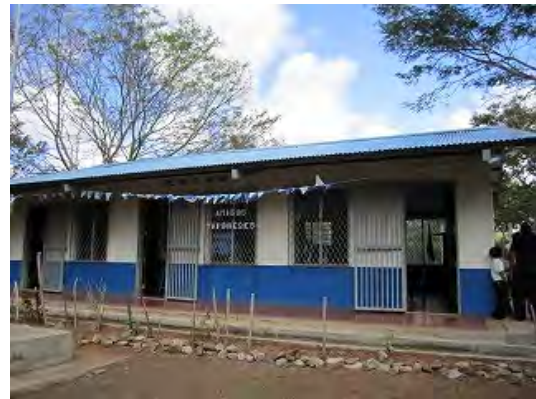
A new school improved by the Project (Puertas Rojas School in Chontales).
