**PREPARATORY SURVEY ON
INTEGRATED BASIN MANAGEMENT
AND FLOOD CONTROL PROJECT FOR
MEJERDA RIVER: DEVELOPMENT OF
FLOOD PREVENTION MEASURES
RESOURCE DOCUMENT**

MARCH 2013

JAPAN INTERNATIONAL COOPERATION AGENCY (JICA)

YACHIYO ENGINEERING CO., LTD

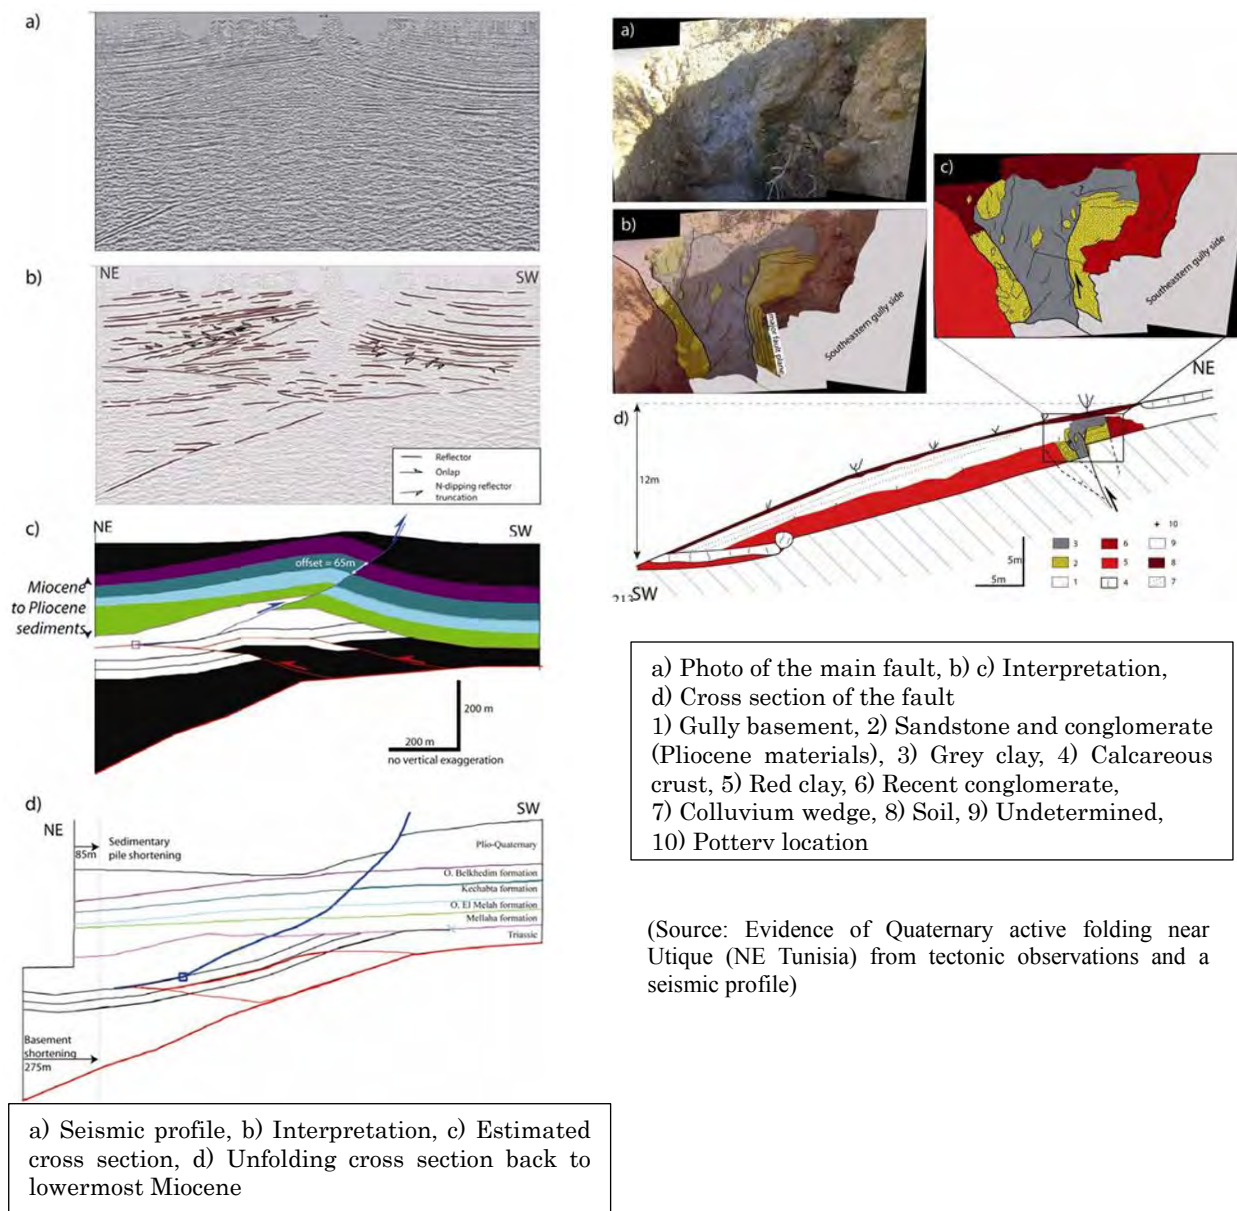
Figure 2-6: Analysis Result of Seismic Survey and Outcrop Observation of Utique Fault

Existence of a thrust fault is presumed by seismic survey in the Menzel Ghoul mountain of the above figure. As shown in **Figure 2-6**, the analysis result shows the activity by early Quaternary, and namely it is a Quaternary fault. It is suggested that the same dislocation structure exists in the highland and the hill around the study area. In the plain area around the Medjerda river where is covered with Quaternary strata, the dislocation is not confirmed. Moreover, it has not appeared in landform feature.

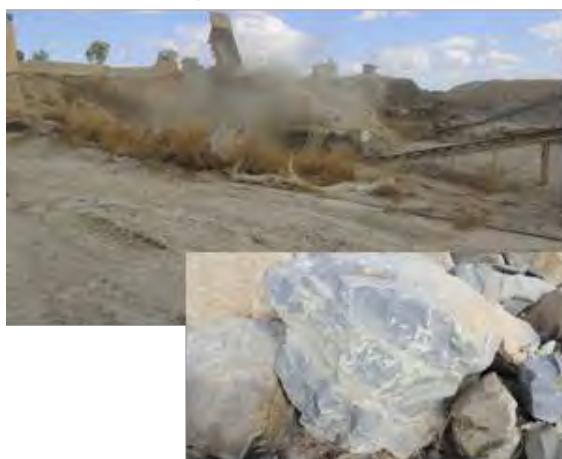
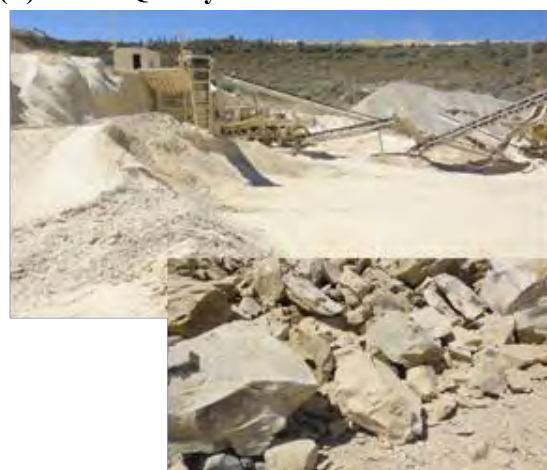
Figure 2-32: Crushing Equipment and Raw Stone of Caza Quarry and Fahdli Quarry

(A) Caza Quarry

(B) Fahdli Quarry

From the aggregate test result of the former preparatory survey and the this preparatory survey results, marl and limestone in part are mainly quarried around the study area, and marl shows slightly large abrasion and has the tendency of slightly soft and easily breaking (Refer to **Figure 2-32**). When some improved structure needs high intensity, it is necessary to receive from the quarry produces more hard limestone or to make severe the quality control such as strict sorting of use aggregates and frequent conducting of concrete strength test. In addition, dolomitic limestone sometimes shows alkali aggregate reaction, and it is necessary to check by alkali aggregate reaction examination and to cope with mixing alkali aggregate.

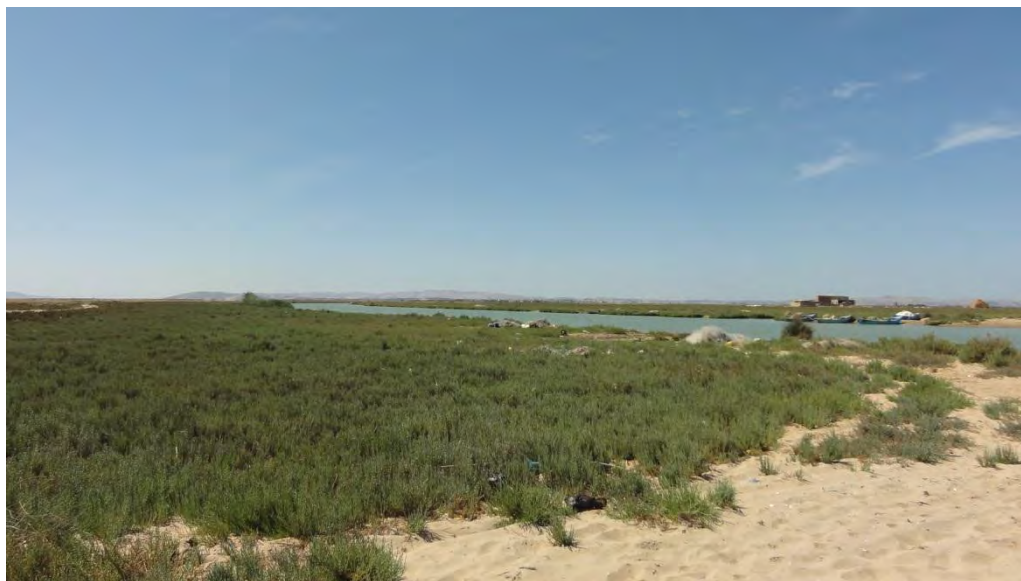
Distance Mark	0 km
Site Name	River Mouth
Photo	Direction: Upstream
Details

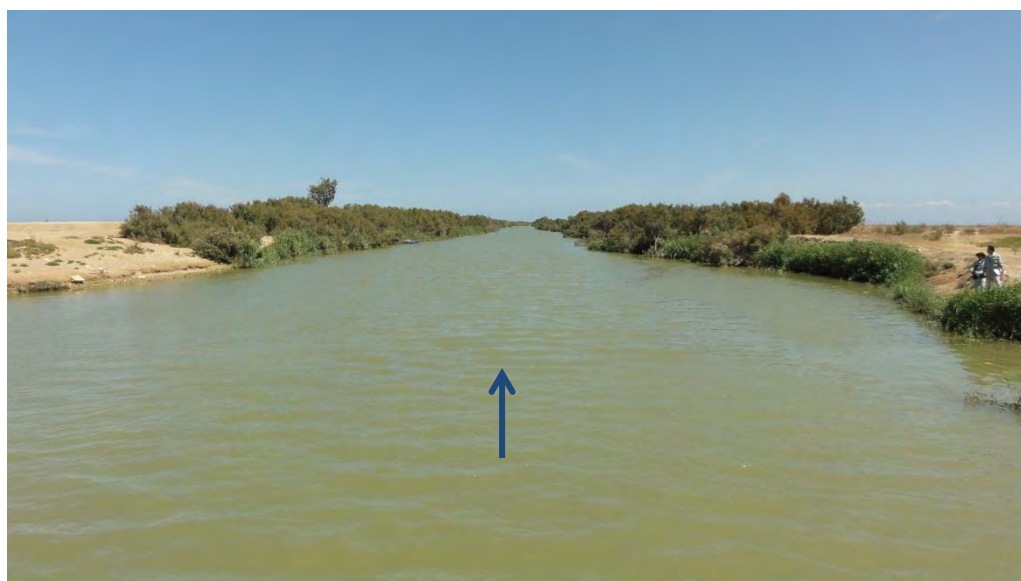
Distance Mark	11 km
Site Name	Tobias Barrage
Photo	Direction: Downstream
Details	River condition after overflowing the Tobias Barrage

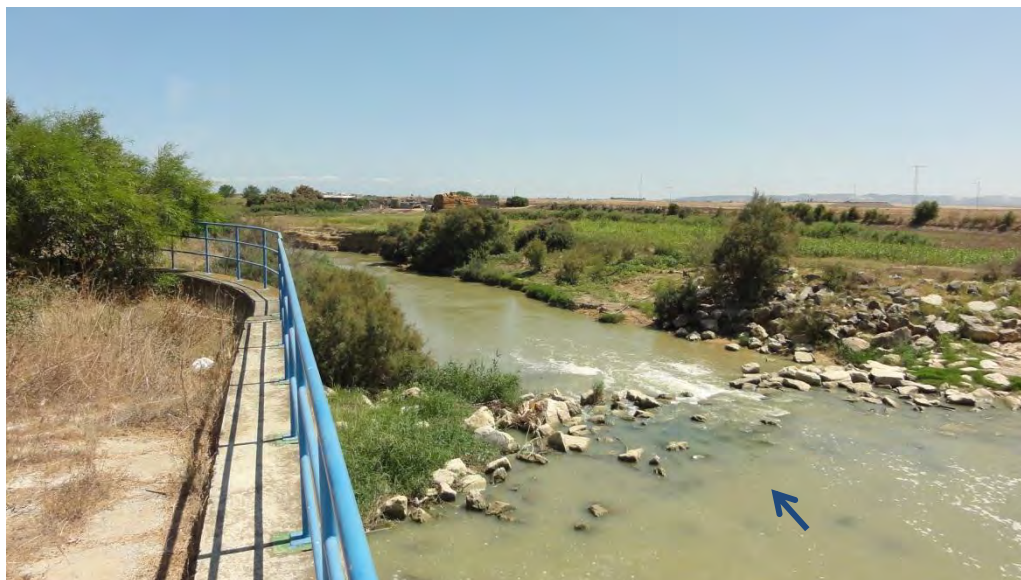
Distance Mark	14 km
Site Name	GP8 Bridge Area
Photo	Direction: Downstream
Details	View is downstream from the bridge

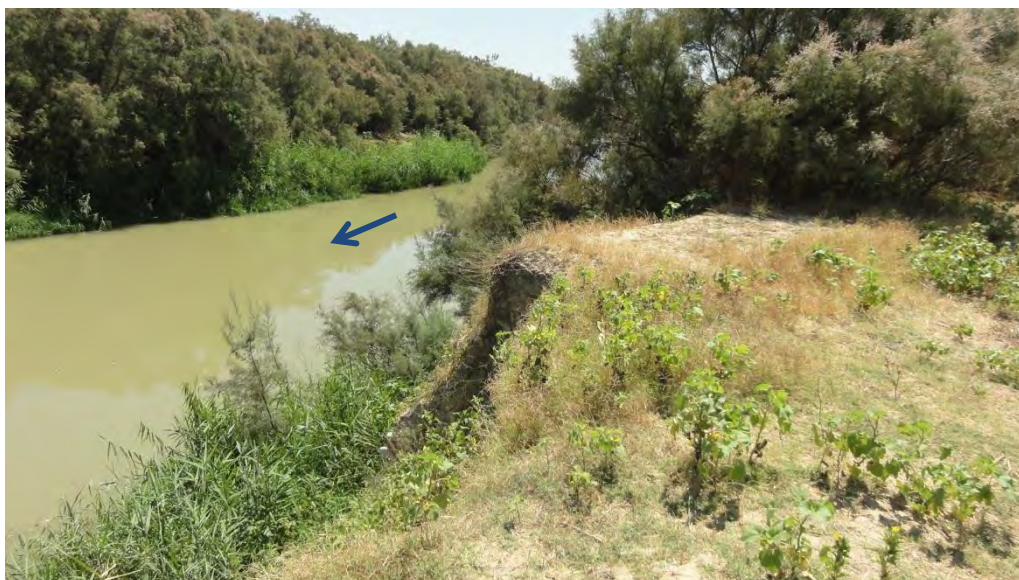
Distance Mark	17 km
Site Name	Left bank at 17k
Photo	Direction: Upstream
Details	View is upstream from the left bank

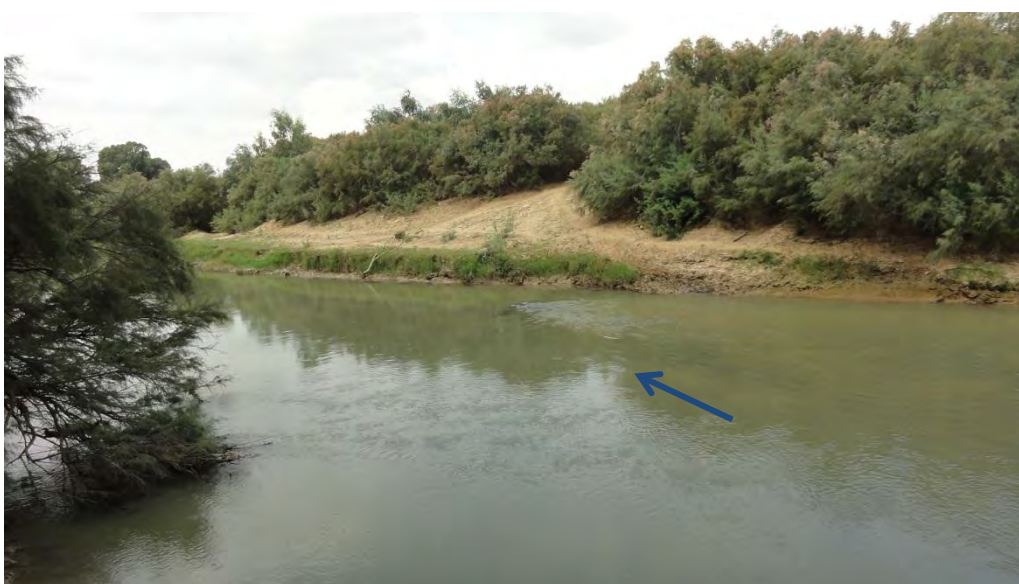
Distance Mark	32 km
Site Name	Left bank at 32k
Photo	Direction: Downstream
Details	Near diversion facility project

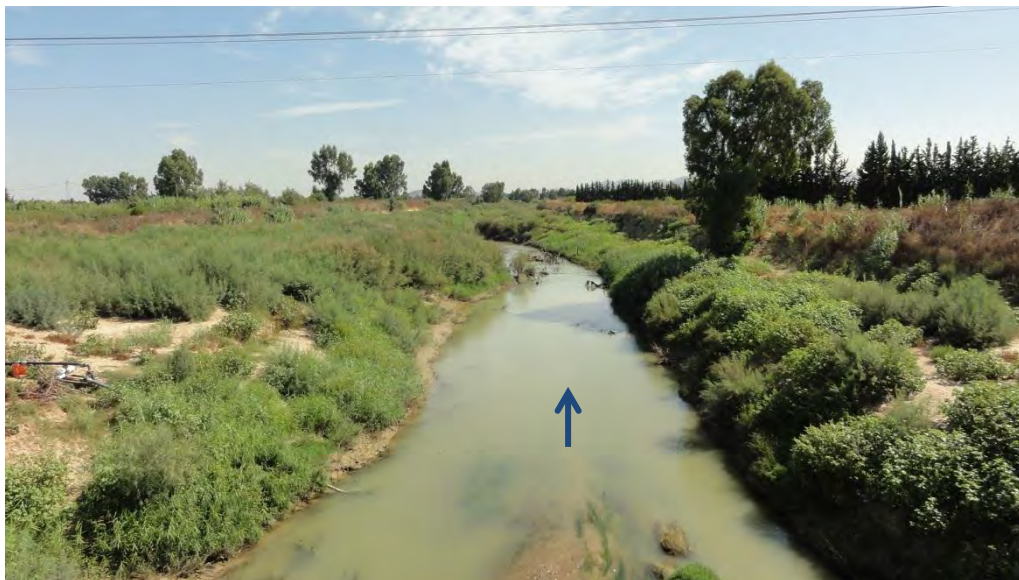
Distance Mark	38 km
Site Name	Jedeida Railroad Bridge area
Photo	Direction: Downstream
Details	View is downstream from the bridge

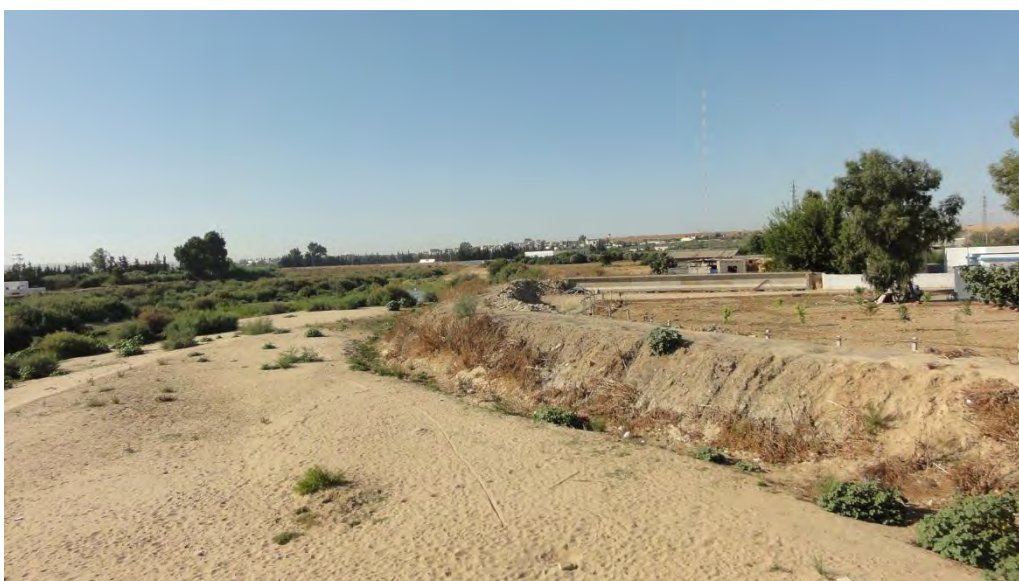
Distance Mark	41 km
Site Name	Jedeida Road Bridge area
Photo	Direction: Downstream
Details

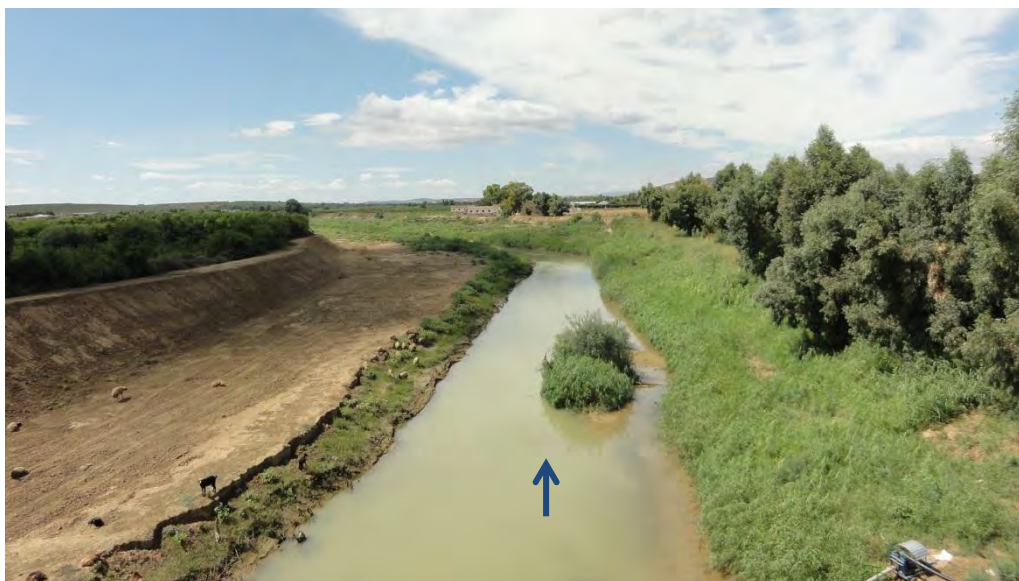
Distance Mark	42 km
Site Name	Jedeida GP7 Road Bridge area
Photo	Direction: Downstream
Details	View is downstream from the bridge

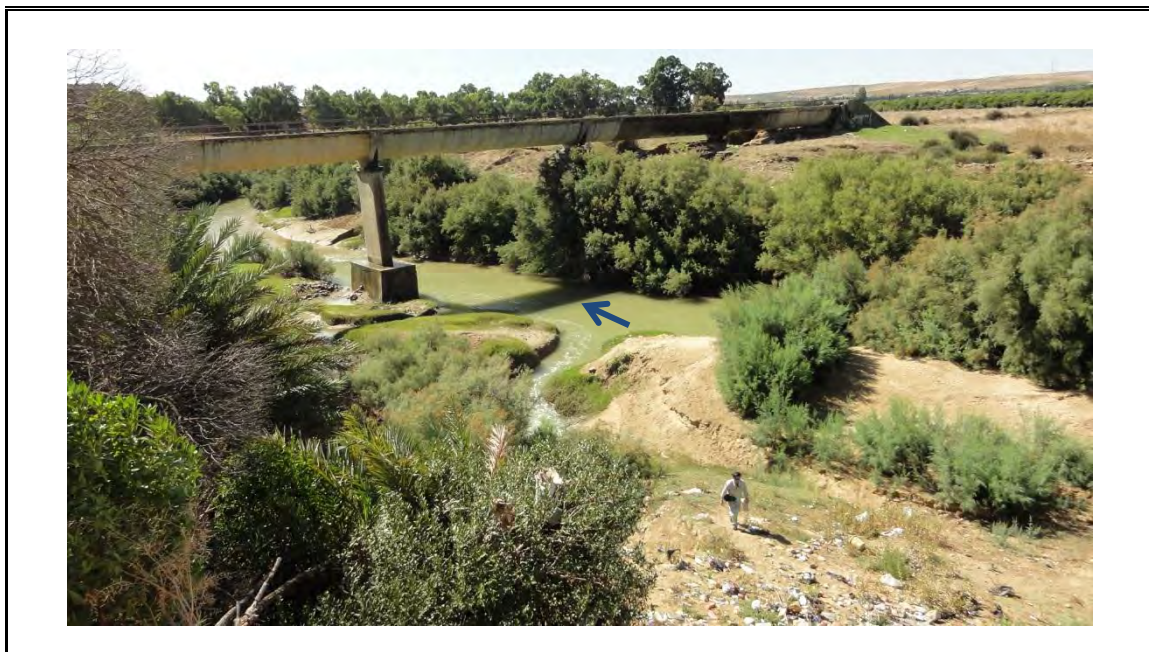
Distance Mark	57 km
Site Name	Waterway Bridge area
Photo	Direction: Downstream
Details	Relative height of left bank is high, the right bank is low

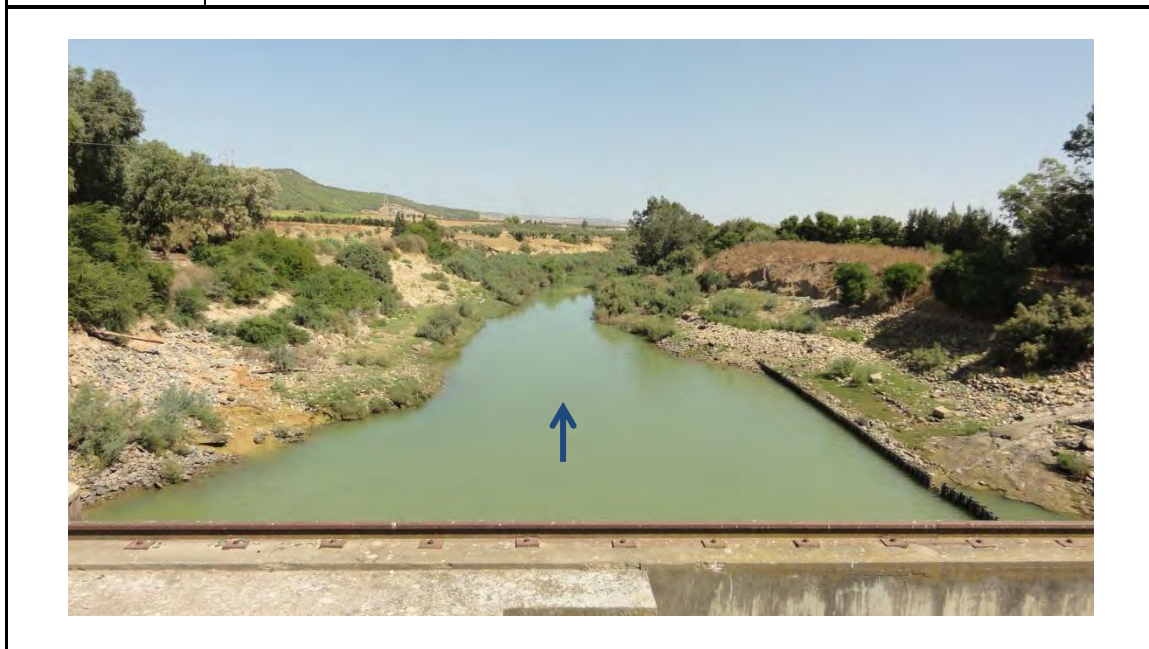
Distance Mark	65 km
Site Name	Laroussia Dam
Photo	Direction: Downstream
Details	View is downstream from the crown of dam

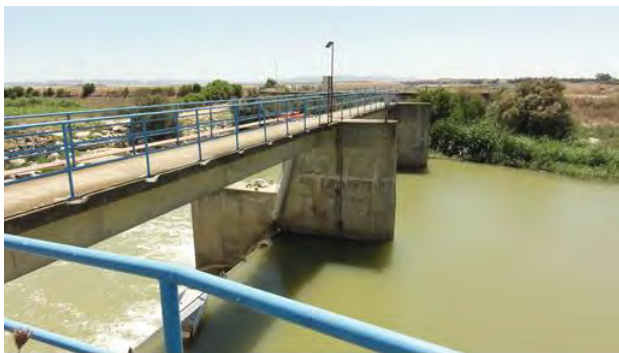
Facility Name	Tobias Dam	MD416 (10.836km)

<ul style="list-style-type: none"> • 2 tumble gates for left bank • Fixed weir installed on right bank

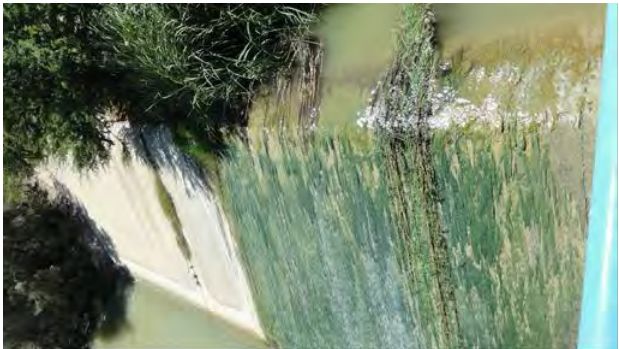
<ul style="list-style-type: none"> • Current condition of tumble weir

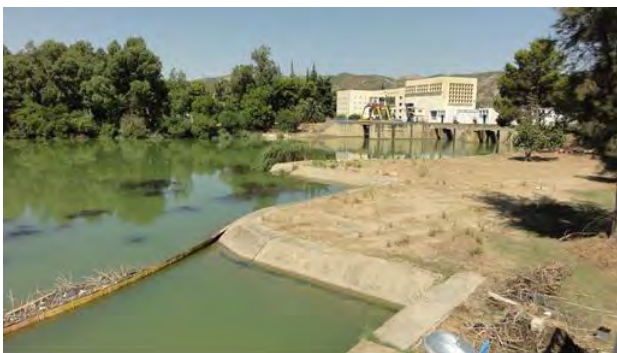
<ul style="list-style-type: none"> • Current flood condition of the upstream region • Channel installed in upstream region to reuse water for irrigation.

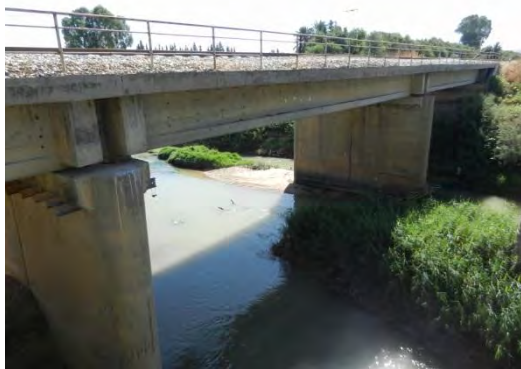
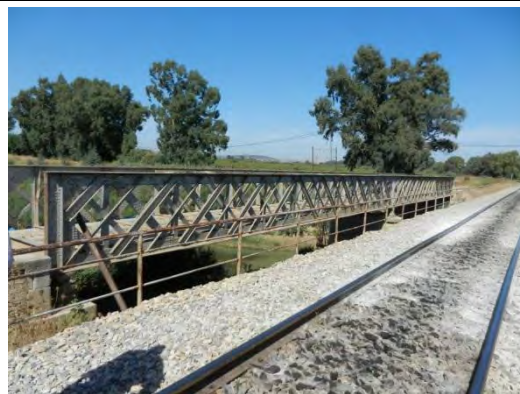
No.9 JEDEIDA RAILWAY BRIDGE

- The old bridge (right) is still intact, but because the new bridge and pier are not aligned, it obstructs the cross sectional area
- Vestiges of the afflux during floods on the girder suggest the clearance for the river is insufficient
- Constructed in 1982, blueprints available (attached to Appendix)

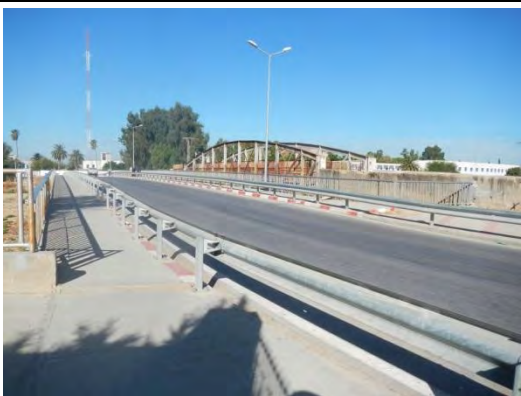
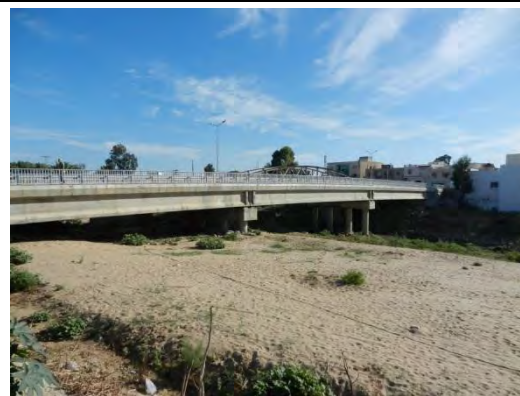
No.10 JEDEIDA BRIDGE

- Along with the narrow river channel, there are private houses and schools.
- Constructed in 2011, condition is good, blueprint available (attached to Appendix)

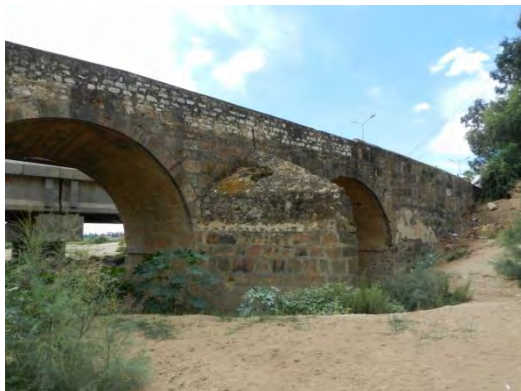
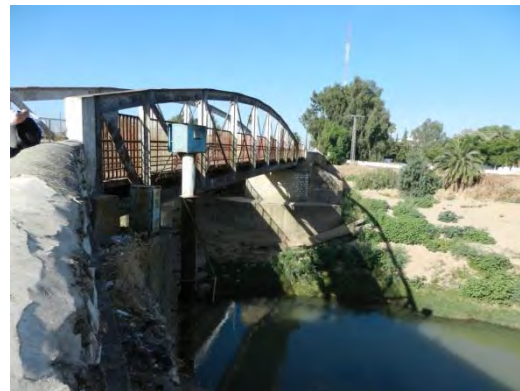
No.11 JEDEIDA OLD BRIDGE

- Constructed of a stone arch and steel railway arch, the stone part is a historically significant structure.
- The stone part located on the narrow river channel particularly obstructs the cross sectional area, remarkably

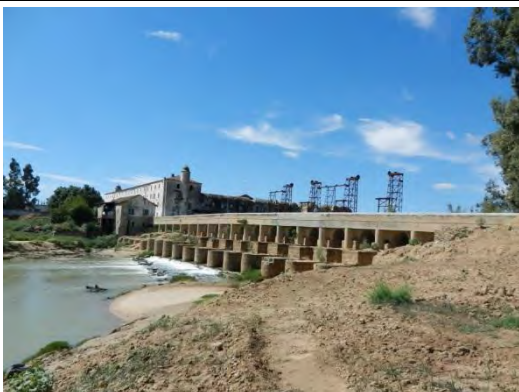
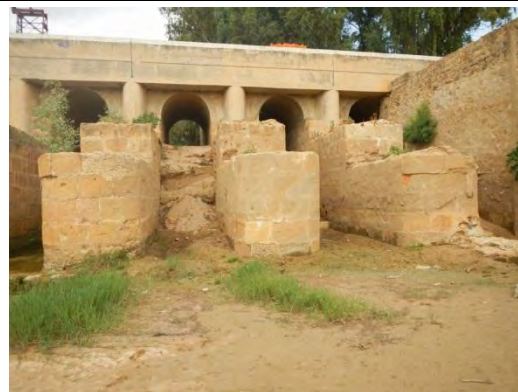
No.13 EL BATTAN BRIDGE

- Historically significant structure
- Largely obstructs the cross sectional area and remarkably accumulates earth and sand

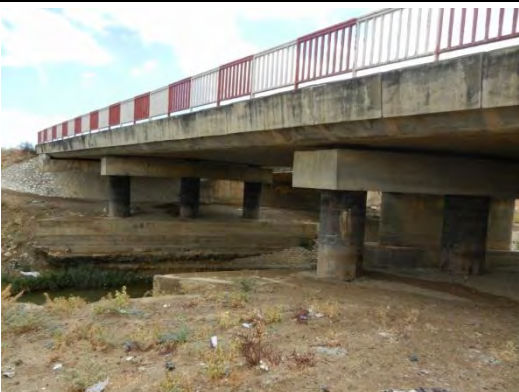
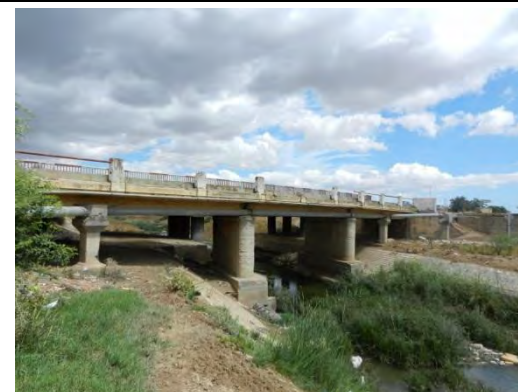
No.15 GP7 BRIDGE ON CHAFUROU

- The old bridge (right) is still intact, but because the new bridge and pier are not aligned, it obstructs the cross sectional area
- The abutment and dike are not aligned, so they obstruct the cross sectional area.

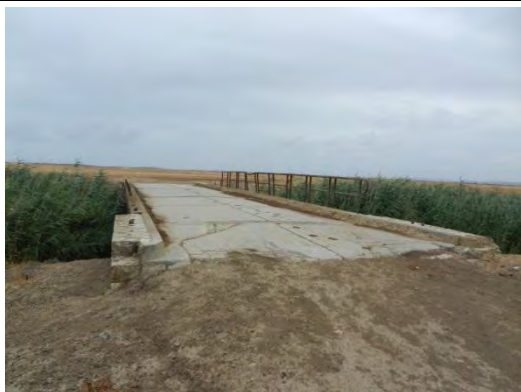
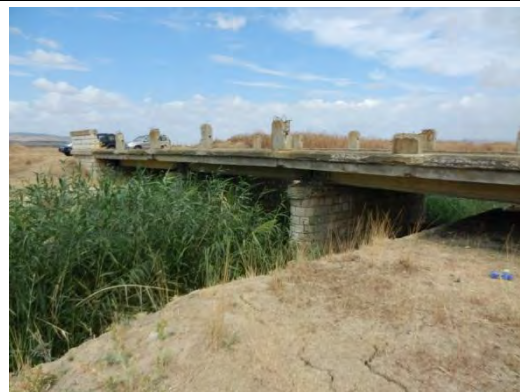
FARM BRIDGE

- This small-scale farm bridge located in El Mabtouh appears old
- There are many similar bridges

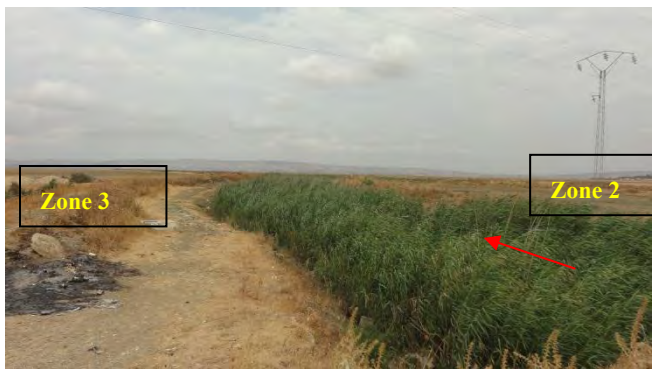
Facility Name	Inlet channel

<ul style="list-style-type: none"> • An inlet channel established to receive the outflow from the mountainous district of the west bank. • The water channel is an unsupported excavation.

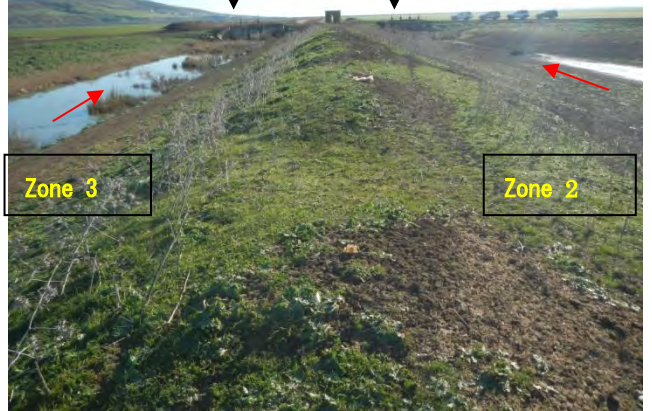
<p>Control gates, Inlet channel (Left, Zone 3) and Control gates, Inner channel (Right, Zone 2)</p>
<div style="display: flex; justify-content: space-around;"> <div style="border: 1px solid black; padding: 2px;">Control gates, Inlet channel</div> <div style="border: 1px solid black; padding: 2px;">Zone 2</div> </div>

<ul style="list-style-type: none"> • Control gates, Inlet Channel • It is used to adjust the flow rate of flood effluent retained in Zone 3 • The three installed gates are currently nonfunctional and not being used. • There are Control gates, Inner Channel on the other side. It is used to adjust the flow rate of effluent retained in Zone 2 to the drainage.

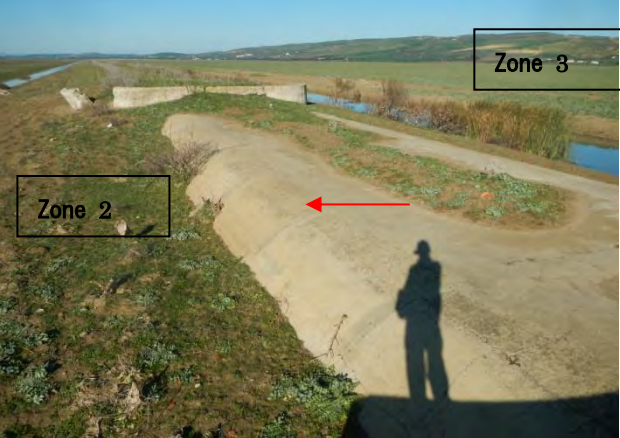
<p>Overflow weir</p>

<p>Same as above</p>
<p>Facility Overflow dike facilities Name</p>	
 	<p>Overflow weir and overflow weir with control gates</p>

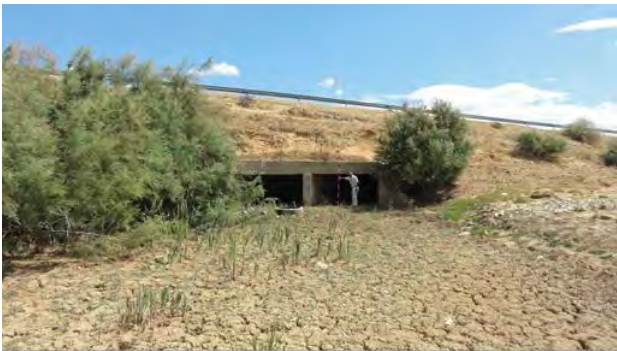
<p>Facility Box culvert crossing the highway Name:</p>

<ul style="list-style-type: none"> • The motorway has become an embankment, and a box culvert and bridge are installed where the water channel crosses.

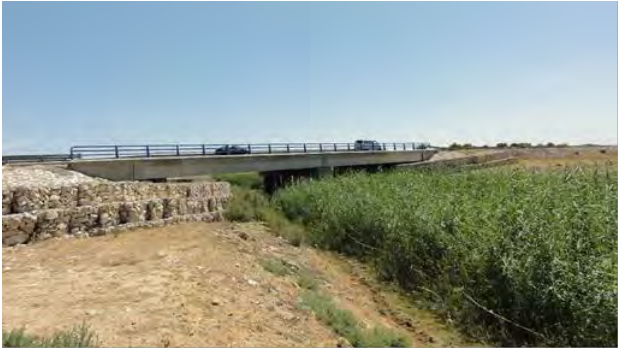
Facility Name	Outlet channel (crossing the highway)

<ul style="list-style-type: none">• The outlet channel crosses the highway at the bridge.

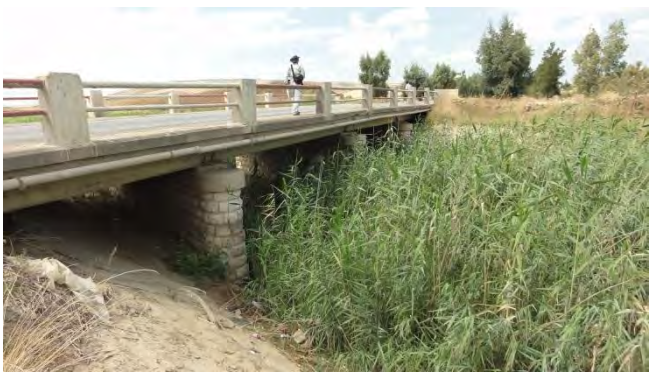
Facility Name	Outlet channel (crossing the road)

<ul style="list-style-type: none">• The outlet channel cross the road at the bridge.

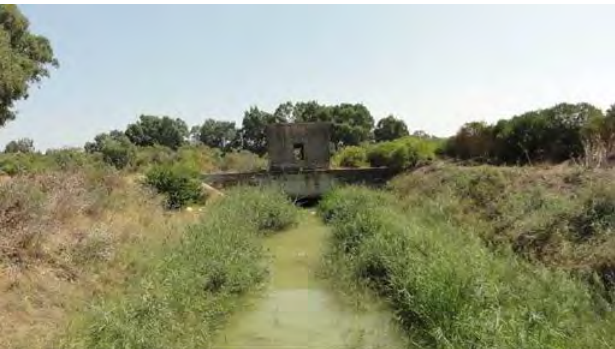
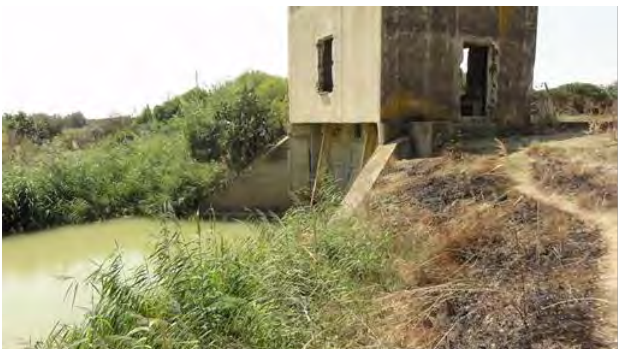
Facility Name	Confluence facilities to Mejerda river

<ul style="list-style-type: none">• Backflow prevention gates are installed at confluence points to the main river.

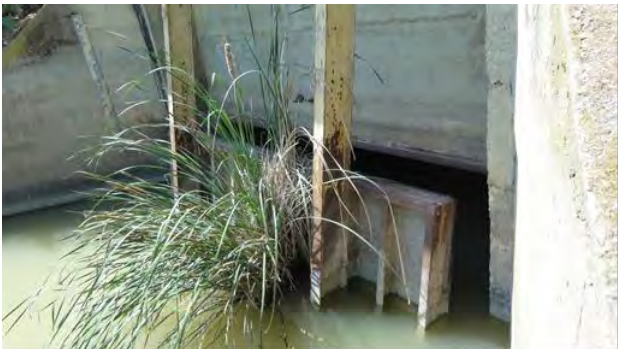
<ul style="list-style-type: none">• Gates are nonfunctional and are currently not being opened and closed.• The gates are slightly open.

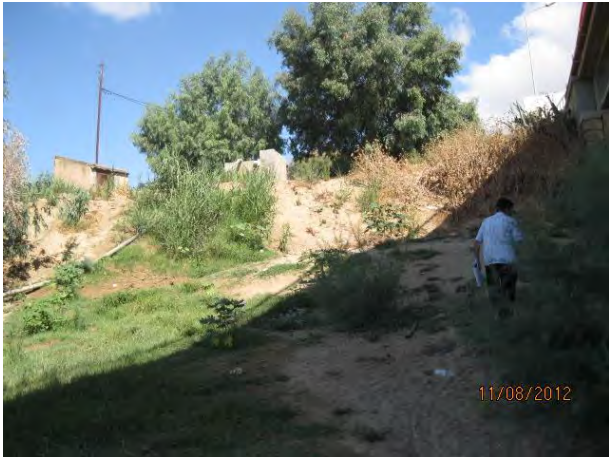
Record of Sluiceway Survey			
No.: 3		Name	
Coordinate	N: 4077827.03	E: 582562.24	Altitude
Photos

Description			
Sluiceway which is not used now

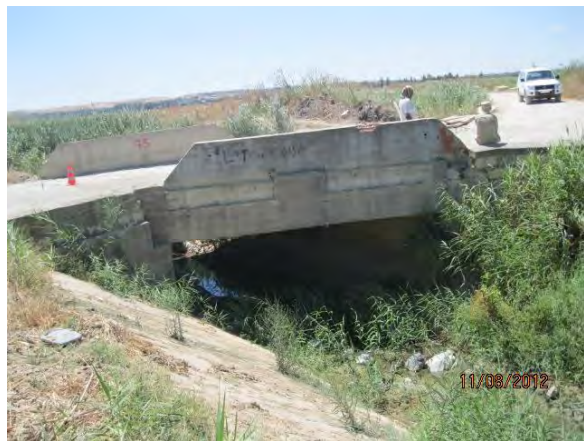
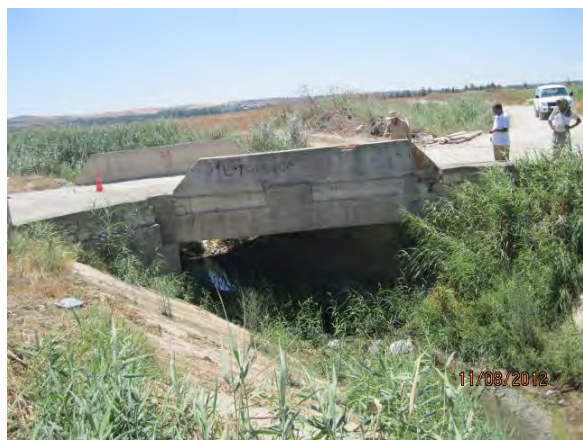
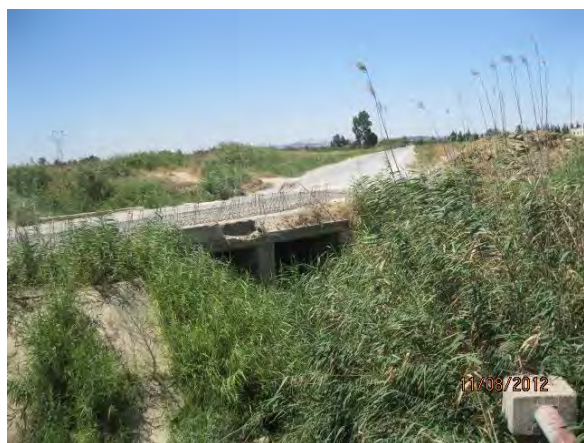
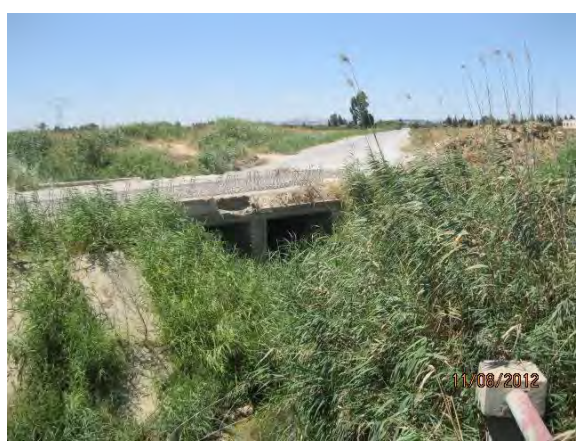
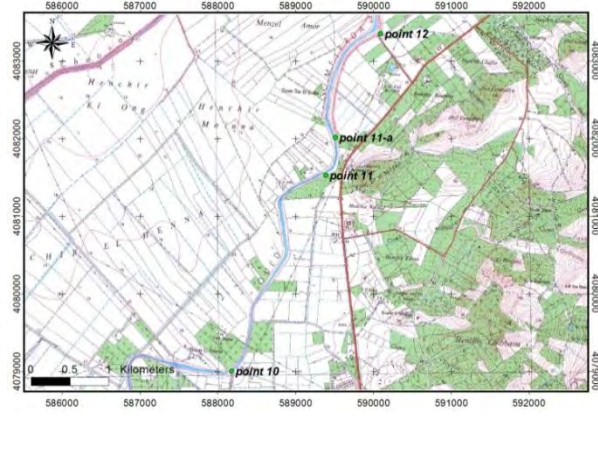
No.: 10		Name	
Coordinate	N: 4079015.530	E: 588177.85	Altitude

Bridge with two passes
Dimensions: 3.20×1.20

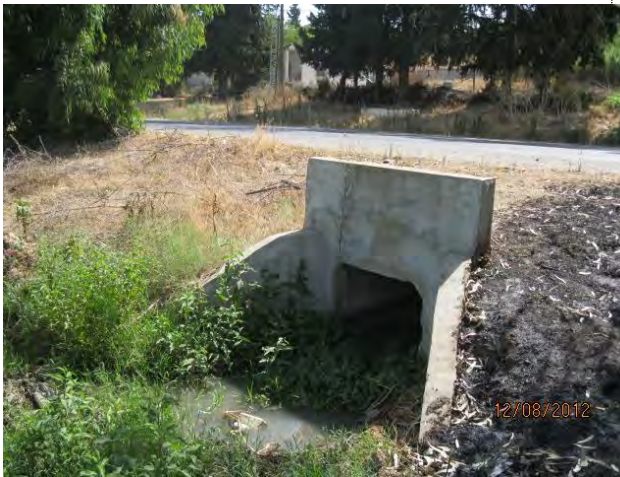
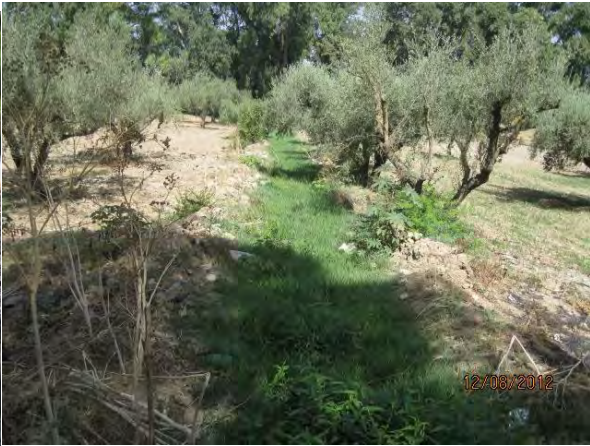
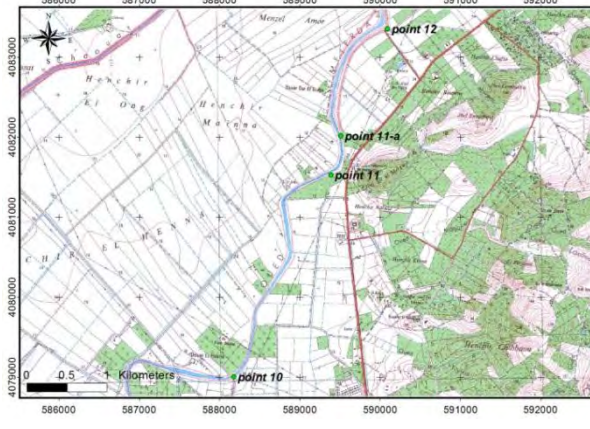
Record of Sluiceway Survey			
No.: 11		Name	
Coordinate	N: 4081537.00	E: 589381.55	Altitude
Photos

Description			
Drainage of water. Dimension: 1.04*0.8

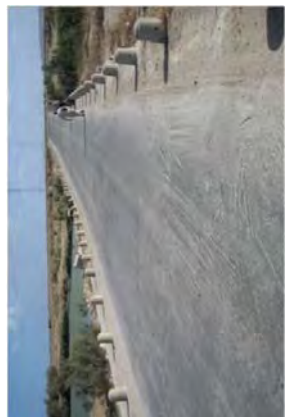
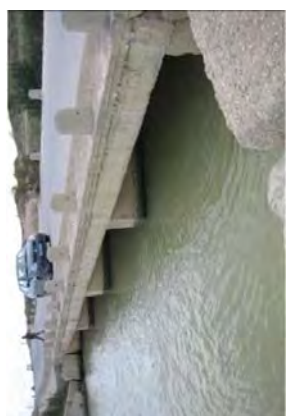
無し	Good
Construction Overview		I. Widening channel & Reconstruction	
Other important issues		冠水橋のため架け替え	
Pictures of Site		Picture-1 Deck surface	Picture-2 Side

Width of Pillar (m)	0.37	Transverse	unknown
Height (m)	Pier	beam	-
Material	<input checked="" type="checkbox"/> RC <input type="checkbox"/> Stone <input type="checkbox"/> Other		
Form	<input type="checkbox"/> Inverted T type <input type="checkbox"/> Gravity type <input checked="" type="checkbox"/> Other		
Height (m)	Parapet	Wall	-
Width of abutment (m)		unknown	
Location map		Deterioration & damage	Condition

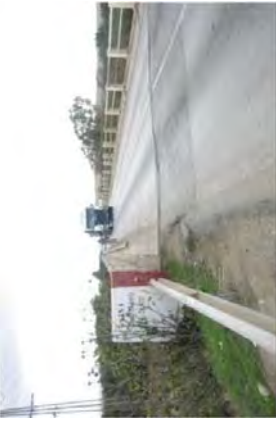
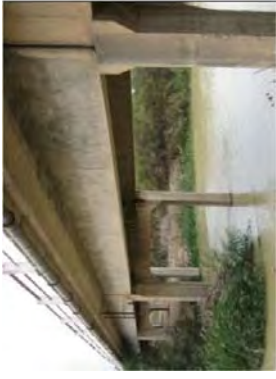
Picture-1 Deck surface		Picture-2 Side

Width of Pillar (m)	0.60		
Height (m)	unknown		
Material	<input checked="" type="checkbox"/> RC <input type="checkbox"/> Stone <input type="checkbox"/> Other		
Form	<input type="checkbox"/> Inverted I type <input type="checkbox"/> Gravity type <input checked="" type="checkbox"/> Wall <input type="checkbox"/> unknown		
Height (m)	unknown		
Width of abutment (m)	8.20		
Location map			
Deterioration & damage		Condition	Not good
Main		支間中央の曲げひびわれ、支点付近のせん断ひびわれ、コンクリート剥離、鉄筋露出、鋼材腐食	
Deterioration			
Construction Overview

1. Excavation			
2. Reconstruction (1. のみでは困難の場合)			
Other important issues			
①劣化・損傷程度が大きい。			
②交通量が多く、架け替え時は仮橋が必要。			
Pictures of Site		Pictures of Site

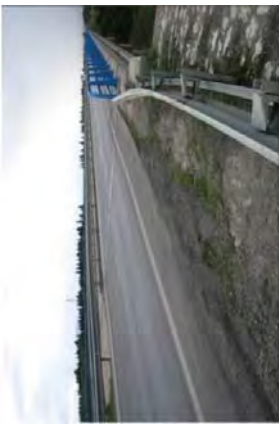
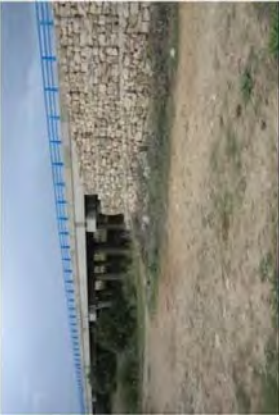
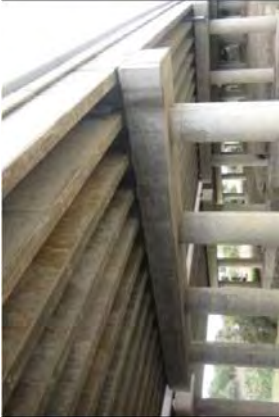
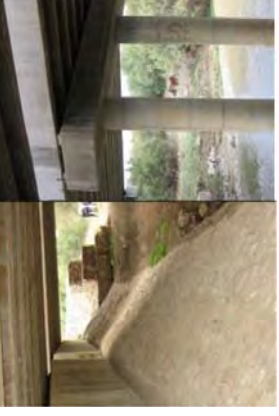
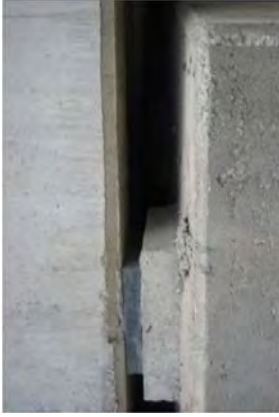
Width of Pillar (m)	φ2.0	Transverse	φ2.0 x 4
Height (m)	Pier unknown	beam	unknown
Material	<input checked="" type="checkbox"/> RC <input type="checkbox"/> Stone <input type="checkbox"/> Other		
Form	<input checked="" type="checkbox"/> Inverted T type <input type="checkbox"/> Gravity type <input type="checkbox"/> Other		
Height (m)	Parapet 2.10	Wall	unknown
Width of abutment (m)			12.00
Location map			
Deterioration & damage		Condition	Good
1999-2002架設の新橋のため、損傷なし。			
Deterioration			
Main			
Construction Overview

1. Excavation			
Other important issues			
①1999-2002架設			
②上下線分離の橋梁である。			
Pictures of Site		Decision

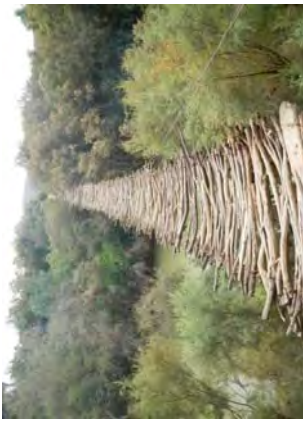
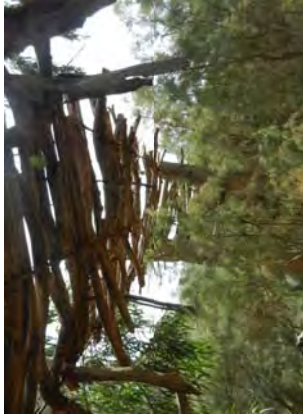
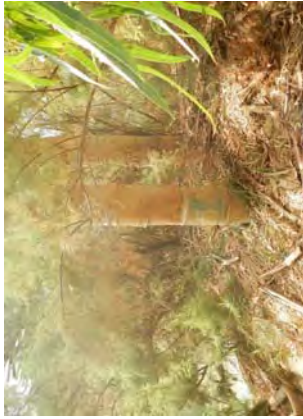
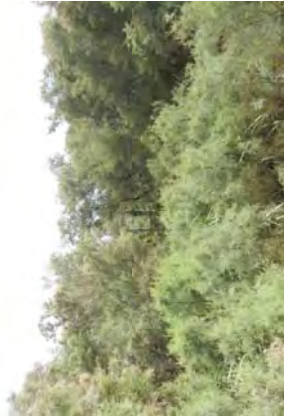
Condition	
		Good	
Construction Overview			
No measures			
Other Important Issues			
おそらく単純桁で再利用不可のため、詳細調査は不要、橋長、幅員の計測のみ			
Picture-1 Deck surface		Picture-2 Side

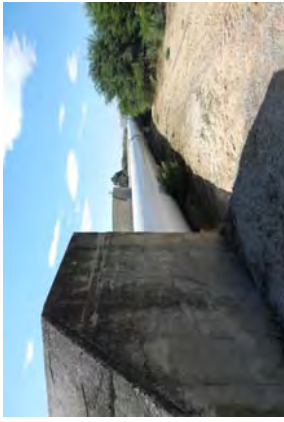
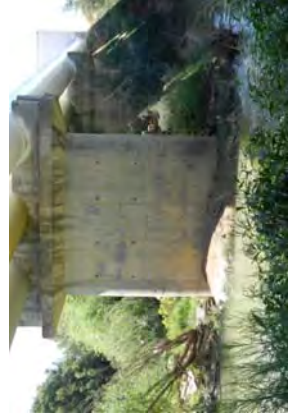
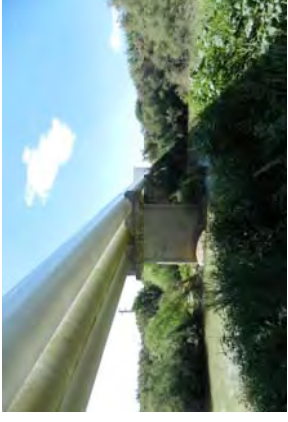
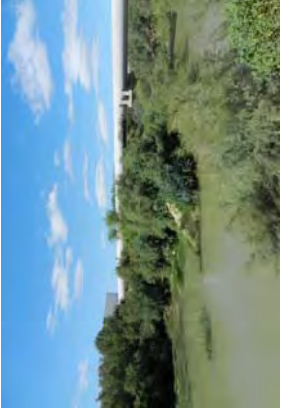
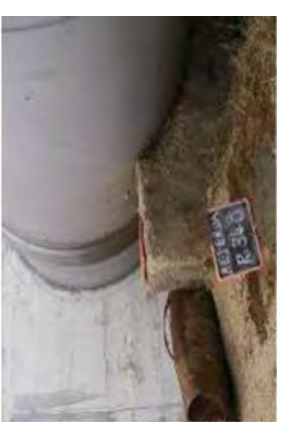
Deterioration & damage Condition	
Main Deterioration		特になし	
Construction Overview			
Excavation			
Other important issues			
3連の水管橋である。左岸側橋台位置は各々異なる。			
Picture-1 Deck surface		Picture-2 Side

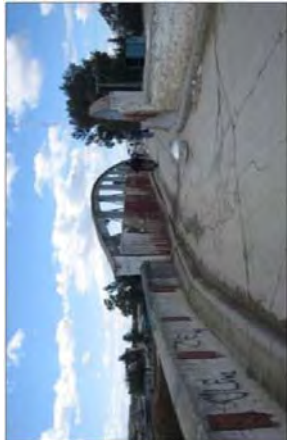
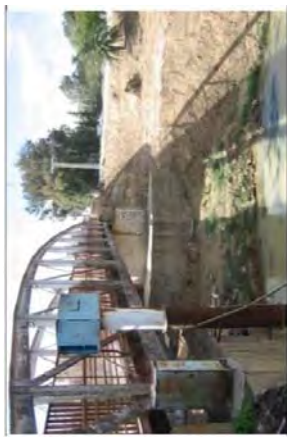
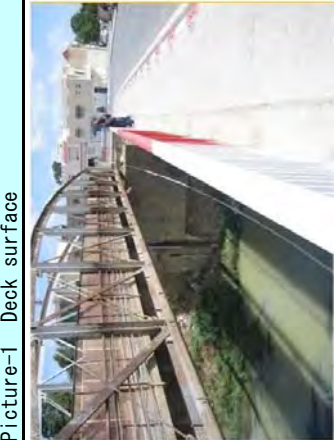
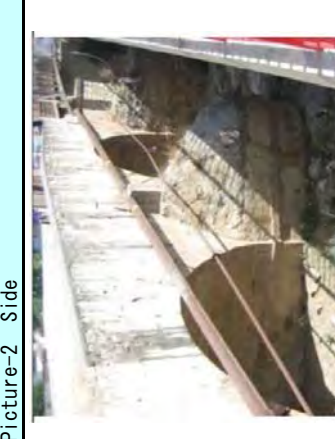
Deterioration & damage	Condition			
		① 鋼製のひび割れ、滲水	Not good			
		② 主径間の深刻な損傷				
		③ 土砂堆積による部分的な河道閉塞				
Construction Overview

1. removing of sediment						
2. constructing of by-pass						
Other important issues						
Because of historical bridge, removing bridge is difficult.						
		Picture-1 Deck surface		Picture-2 Side		
		Picture-3 The underside of the beam		Picture-4 Substructure		
		Picture-5 Bearing or Attachment		Picture-6 Environment

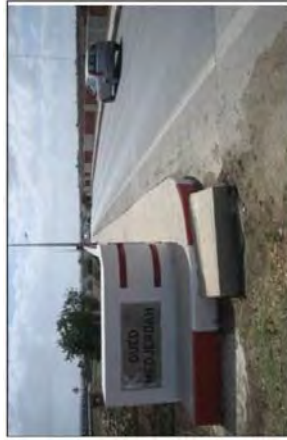
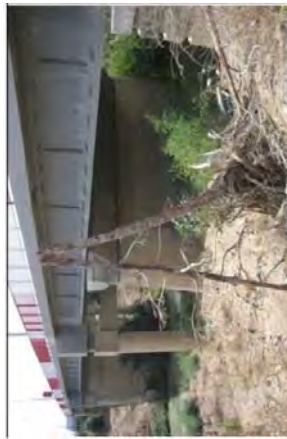
Picture-1 Deck surface		Picture-2 Side

Deterioration & damage Condition Good ①橋梁本体に損傷は確認できない。 ②側径間の橋脚～橋台間に土砂堆積がある。	
Construction Overview

I. Excavation			
Other important issues			
①中央径間の橋脚はハイルベント式橋脚である。 ②近接橋として、水管橋がある (Picture-6)。

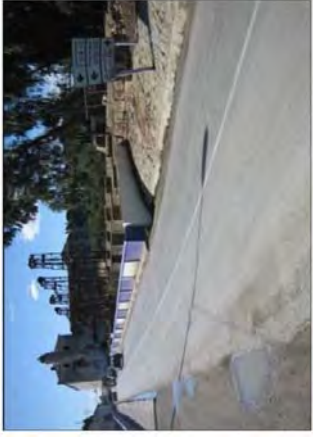
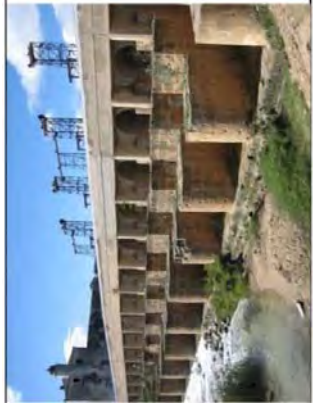
Condition	
		Good	
		Main	
		Deterioration

1. water stagnation of surface	
		2. Preventing water flow brought Tamarix vegetation	
		3. Narrowness of gates call for jamming of debris	
		Construction Overview

1. Removing of sediment	
		2. Constructing of by-pass	
		Other important issues	
		Because of historical bridge, removing bridge is difficult.	
Pictures of Site

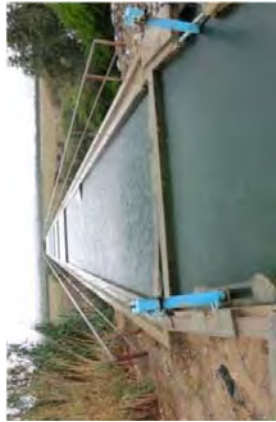
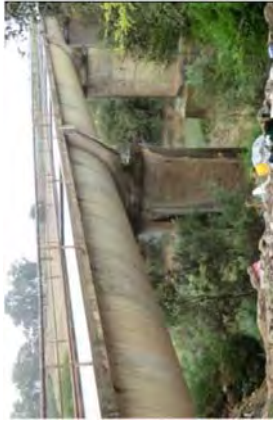
①水漏れ				
		Deterioration				
		Excavation				
		Construction Overview				
		Excavation				
		Other important issues				
		①水漏れ対策が必要。				
		②左岸側は市街地、右岸側は農地				
		③谷がやや深い				
		Picture-1 Deck surface		Picture-2 Side

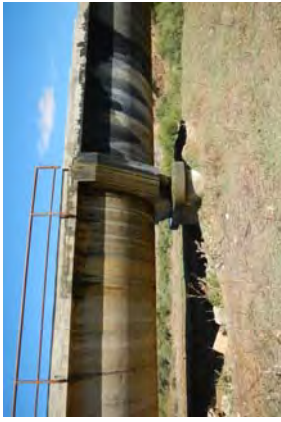
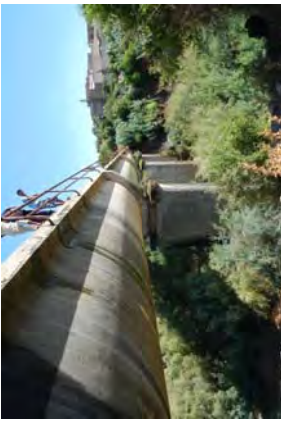
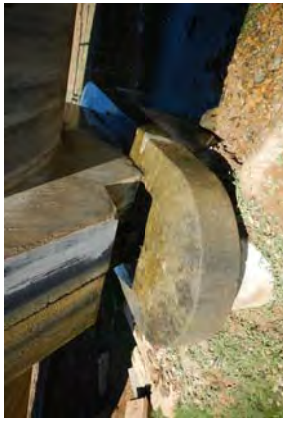
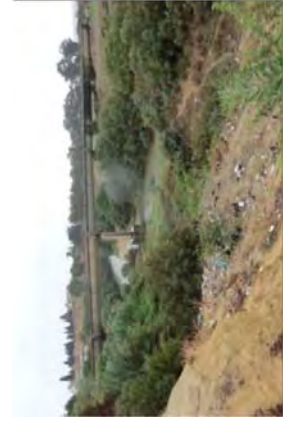
Main girder	The number of girder	Height (m)	unknown			
Angle	Skew(deg.)	Crossing(deg.)	-			
Material	<input checked="" type="checkbox"/> RC <input type="checkbox"/> Metal <input type="checkbox"/> Composite <input type="checkbox"/> Stone <input type="checkbox"/> Other					
Form	<input type="checkbox"/> Single column <input type="checkbox"/> Bearing wall <input type="checkbox"/> Pile bent <input type="checkbox"/> Rahmen <input type="checkbox"/> Other					
Width of Pillar (m)	unknown	Transverse	unknown			
Height (m)	Pier	beam	unknown			
Material	<input checked="" type="checkbox"/> RC <input type="checkbox"/> Stone <input type="checkbox"/> Other					
Form	<input checked="" type="checkbox"/> Inverted I type <input type="checkbox"/> Gravity type <input type="checkbox"/> Other					
Height (m)	Parapet	Wall	unknown			
Width of abutment (m)			unknown			
Location map		Deterioration & damage		Condition	Not good
