**PREPARATORY SURVEY ON
INTEGRATED BASIN MANAGEMENT
AND FLOOD CONTROL PROJECT FOR
MEJERDA RIVER: DEVELOPMENT OF
FLOOD PREVENTION MEASURES
RESOURCE DOCUMENT**

MARCH 2013

JAPAN INTERNATIONAL COOPERATION AGENCY (JICA)

YACHIYO ENGINEERING CO., LTD

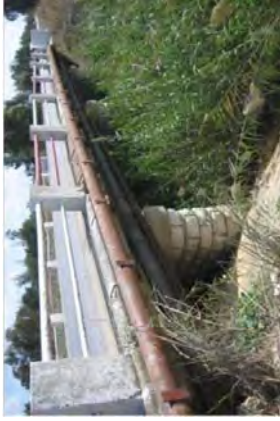
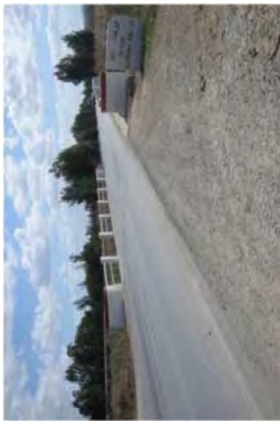
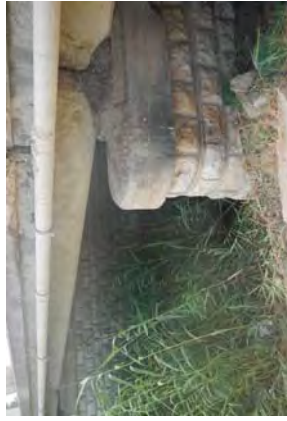
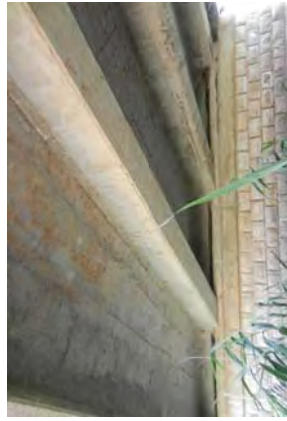
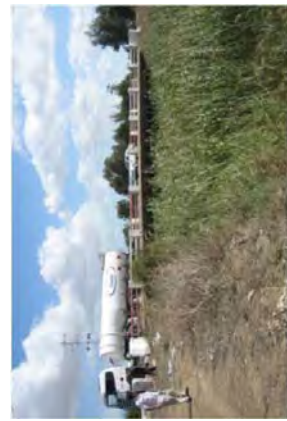
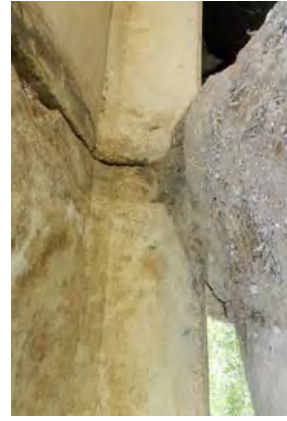
No measures			
Other important issues			
①河床を掘削する場合は掛け替えとなる。 ②側面に添架管有り。			
Picture-1 Deck surface		Picture-2 Side	
Picture-3 The underside of the beam		Picture-4 Substructure	
Picture-5 Bearing or Attachment		Picture-6 Environment

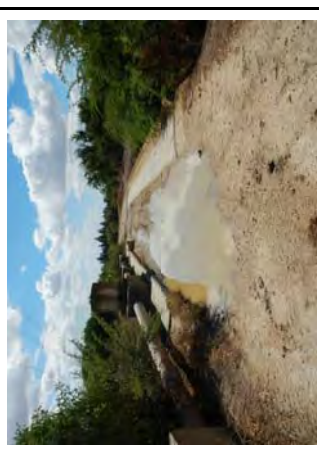
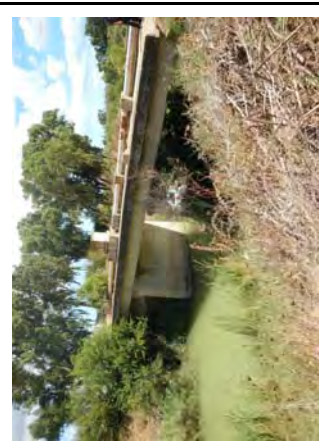
Picture-3 The underside of the beam		Picture-4 Substructure

Main		Good
		Deterioration		
		Construction Overview		
Other important issues		未調査		
Picture-1 Deck surface		Picture-2 Side

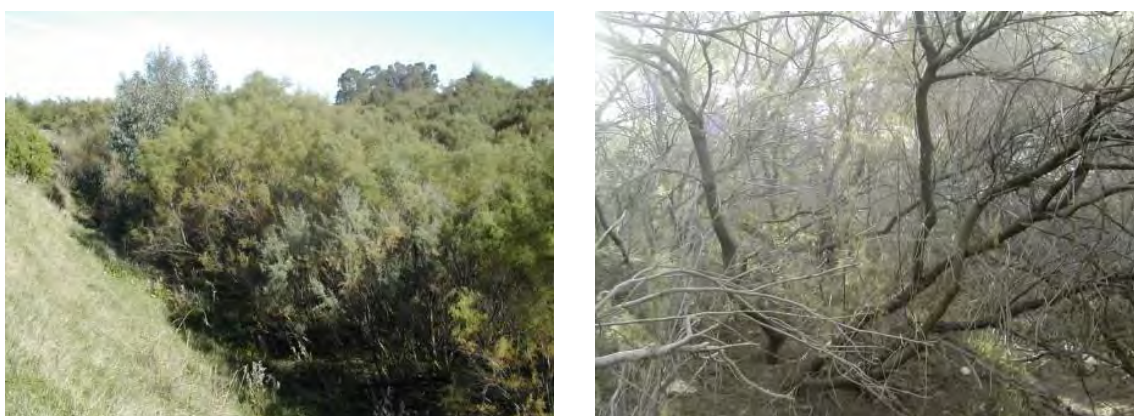
Figure 17: Tamarisks (Farash) in the flood plains of the Mejerda River

In the flood plain of the Mejerda River, there is a dense population of tamarisk, also known as farash (*Tamarix articulata*; see figure below), which is a natural species to central Tunisia, thought to be introduced as a result of tree-planting to affix the riverbank. The tamarisk is a shrub to medium-tall tree with a height of two to 10 meters. Along the Mejerda River, they branch magnificently to become medium-height trees. The tamarisk germinates from its seeds, roots, and branches, allowing it to multiply quickly.
