**Ex-Post Project Evaluation 2011: Package II-1
(Vietnam, Laos, East Timor, Nepal, Ecuador,
Egypt, Jordan, Serbia)**

JAPAN INTERNATIONAL COOPERATION AGENCY

EV
JR
12-20

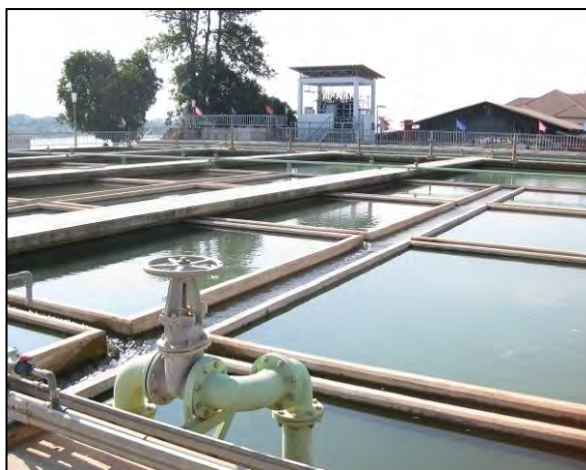
Water receiving well at the Kaolieo Water
Purification Plant

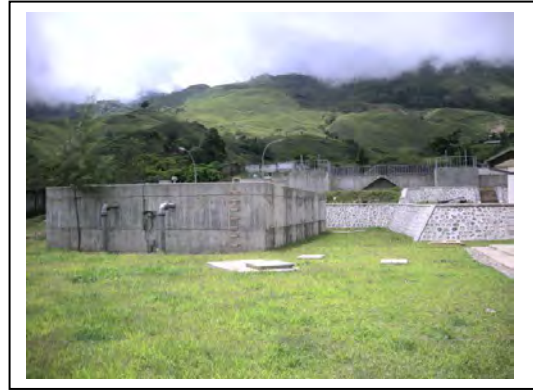
Nugupo Water Purification Plant, Ainaro

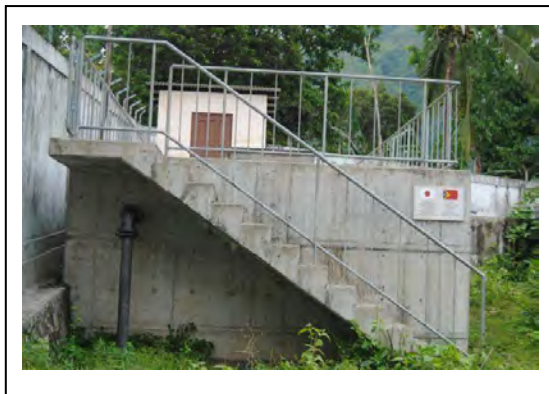
Hoalula Reservoir, Same

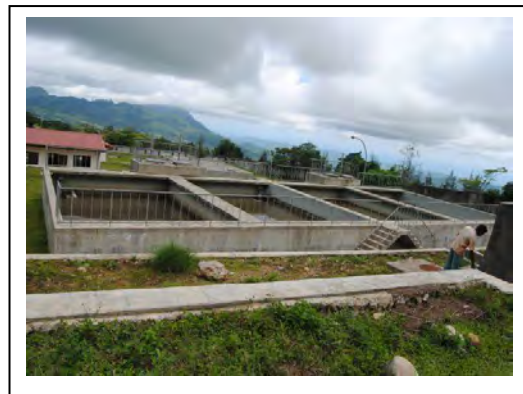
Nugupo Water Purification Plant, Ainaro

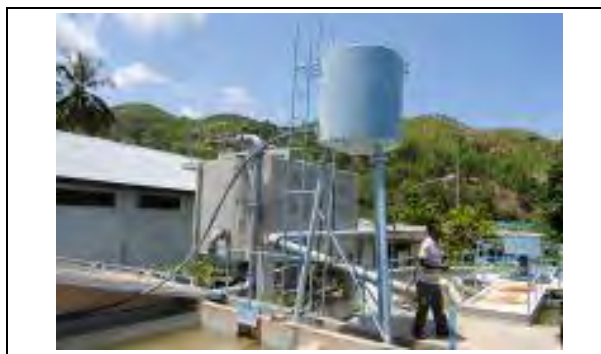
Overall view of Lahane Water Purification Plant

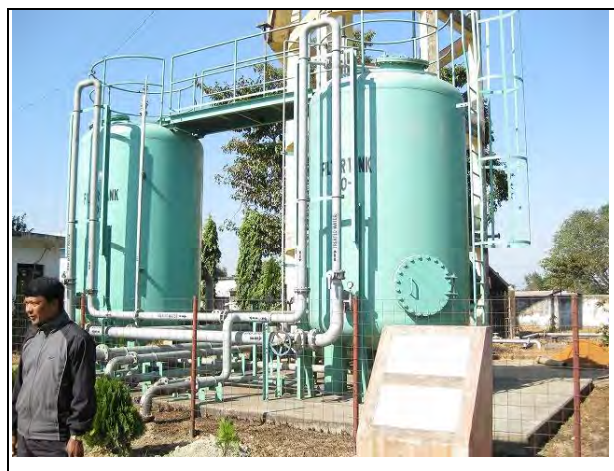
Clear water tank at the Gauradaha Water Purification Plant

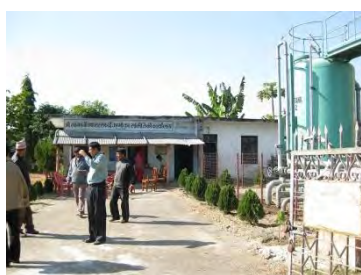
Gauradaha Water Purification Plant (building and facilities)

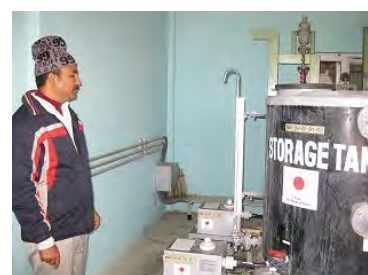
Mangadh Water Purification Plant (sterilizer)

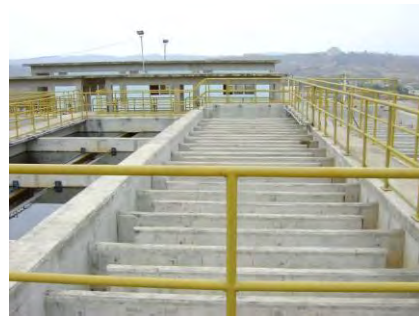
Water treatment plant built by the project

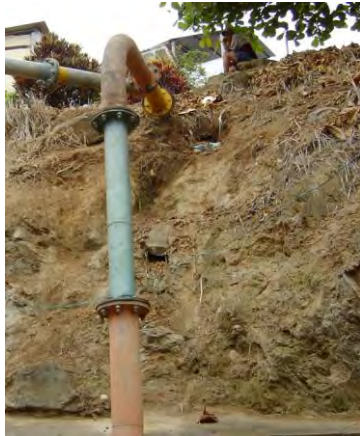
- There is a risk of collapse of the slope behind the intake pump house due to improper protection of the slope.
- The water channel leading from Arenillas River's reservoir to the intake is not well maintained. In some cases, places in which the structure has collapsed and those in which large amounts of sediment, such as sand from the slope, has collected in the channels have been left unattended. EMRAPAH is aware of this problem and estimates that it would cost 100,000 dollars to fix, but there are no prospects for raising this money.

Gradient of backside of intake

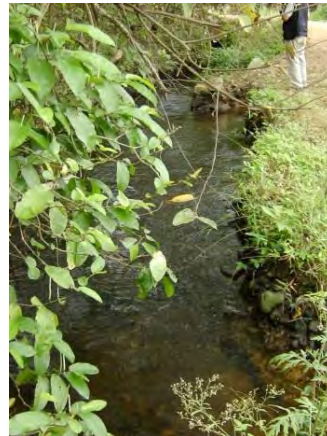
Conduit to intake

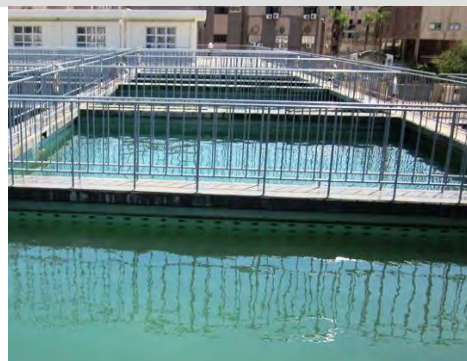
Coagulation Sedimentation Basins

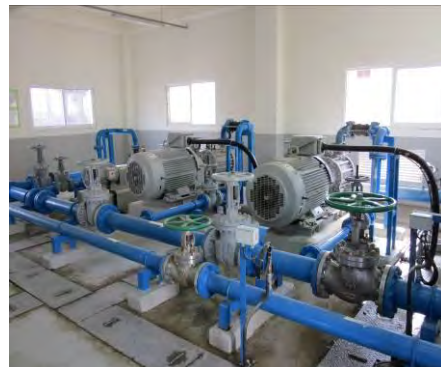
Adasiya Pumping Station

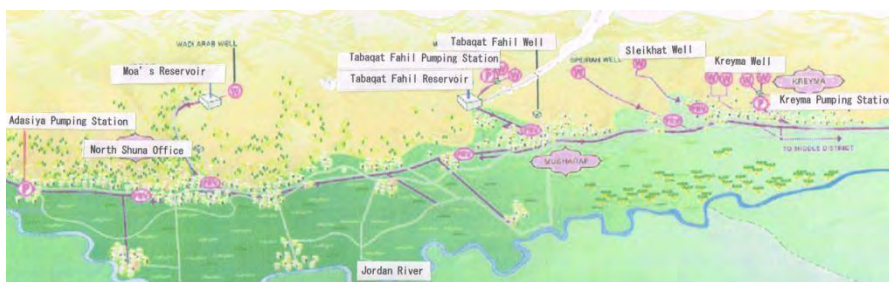
²⁷ According to a CAD drawing provided by YWC, 60,250 meters of pipes have been laid.

Figure 2: Image of the Water Supply Facilities in the Northern Jordan Valley

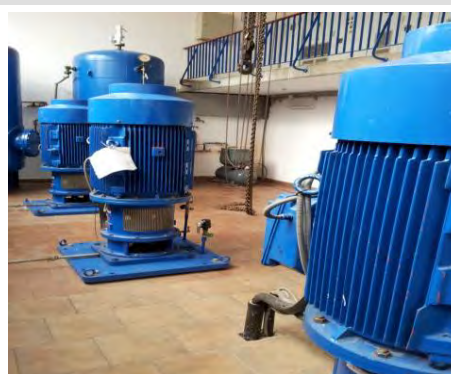
The pump installed in PS 15 by the project

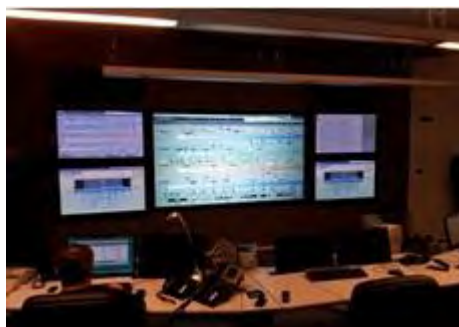
Monitor of SCADA System

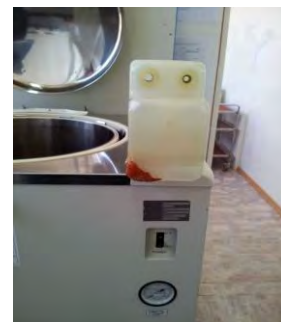
(3) The only piece of equipment that could pose problems with maintenance is the autoclave for water quality inspection equipment. Although the manufacturer has a local distributor, spare parts are quite difficult to obtain. This is because this distributor takes a plenty of time to deliver even a small part. At the time of ex-post evaluation, some parts were seen failing, but stuck together with bond as an emergency measure. Administrators said there were no maintenance problems with other equipment as other local distributors can easily deliver any spare parts to BVK.

Autoclave with a tentative treatment
