Ex-Post Project Evaluation 2011:
Package III-7
(Laos, Sri Lanka, Bhutan, Ethiopia, Tanzania)

JAPAN INTERNATIONAL COOPERATION AGENCY

Ex-Post Evaluation of Japanese ODA Grant Aid Project
“The Project for the Improvement of the Vientiane No.1 Road”

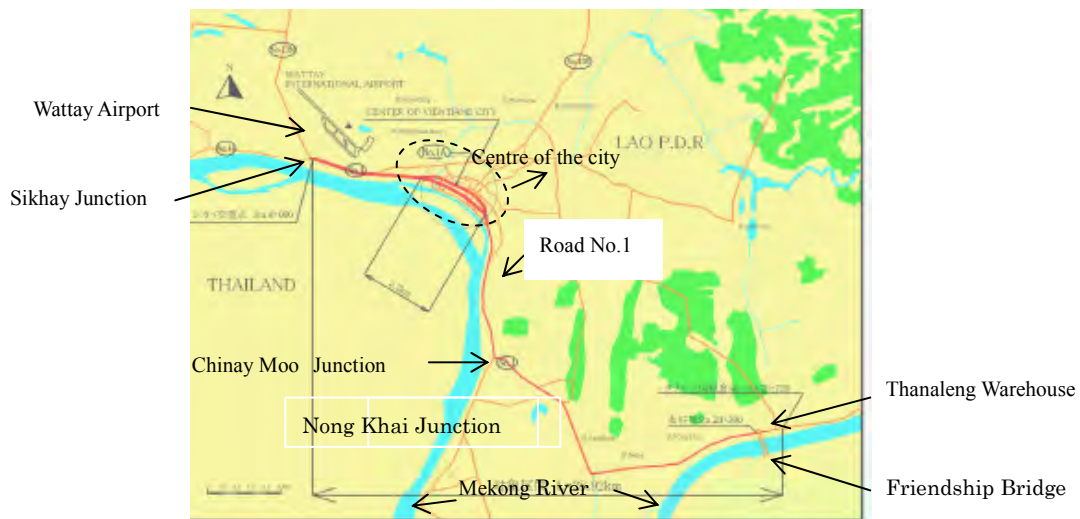
Figure 1 Vientiane Road No.1 (based on B/D)

The objective of this project is to restore function and capacity to Road No.1 between Sikhay Junction and Thanaleng Warehouse, by improving the deteriorated pavement and poor drainage system and thereby ensure the recovery of the smooth flow of goods and people to affected regions.

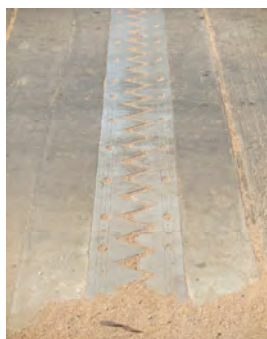
The regular inspection of the superstructure, such as cleaning of sand clogging the joints between the Prestressed concrete (PC) girders, checking and repairing potholes, cleaning drainage systems, pulling out weeds, repainting railings and other tasks, is done every three months as instructed by the RDA and reported to the RDA headquarters based on the designated

Sand clogging joints due to lack of cleaning

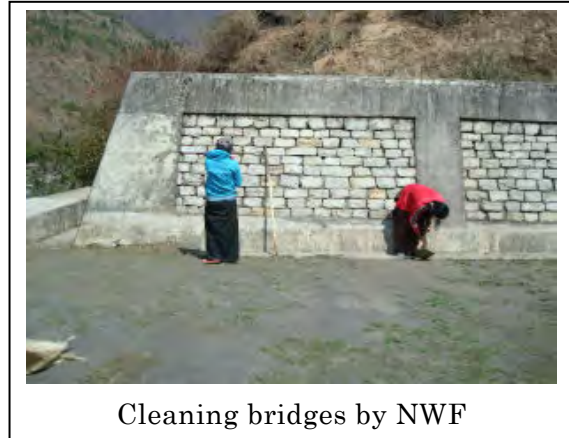
Simple checking is being done by each Field Division Office every week for the Wakleytar Bridge and the Tangmachu Bridge. Since the Sunkosh Bridge is far from the Lingmethang Field Office, it was found that checking is done when necessary. The HQs have undertaken monitoring once or twice every year.

Cleaning bridges by NWF

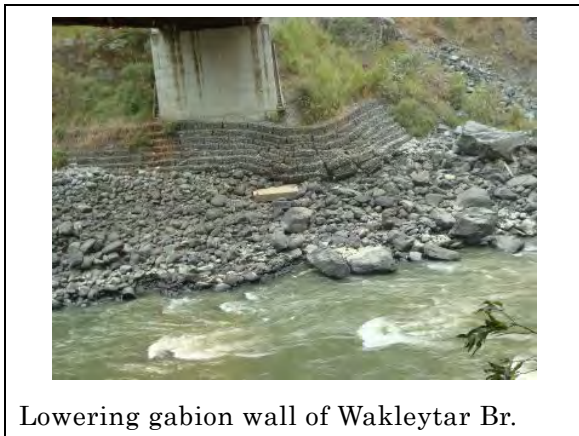
For instance, the ex-post evaluation study found that the left side of gabion wall of the Wakleytar Bridge (lowered by the flood in 2009) has not been repaired yet. Since it was considered not urgently affecting the effectiveness and safety of the bridge, the wall remained un-repaired and the time of repair was not specifically planned. If a maintenance mechanism was established including a practice of periodical checking, such matter could have been responded promptly. Following the ex-post evaluation, DOR will undertake

Lowering gabion wall of Wakleytar Br.

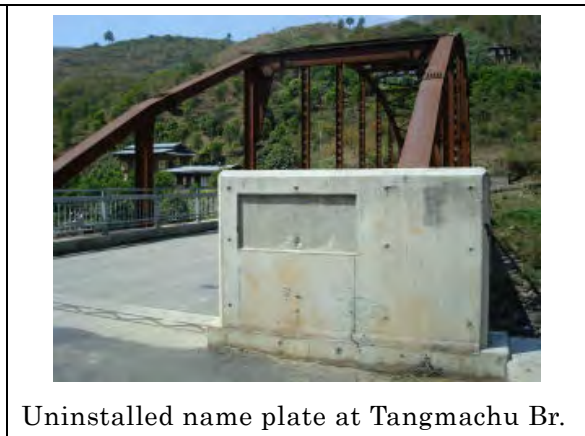
Uninstalled name plate at Tangmachu Br.
