**Ex-Post Project Evaluation 2012: Package IV-5  
(Vanuatu, Solomons, Kiribati, Palau)**

Ex-Post Evaluation of Japanese ODA Grant Aid Project  
“The Project for Improvement of Power Generation  
in Sarakata River Hydroelectric Power Station”

External Evaluator: Keisuke Nishikawa  
Ernst & Young Sustainability Co., Ltd.

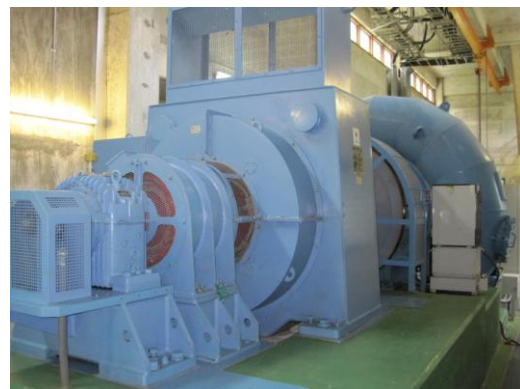
Generator Unit Provided in the Project

With respect to the qualitative effect (2) above, the 600 kW power generation unit<sup>7</sup> under this project was granted at a time when one (Generator No.1) of the two generators (each with a 300 kW capacity) provided under the previous project more than 10 years before and the diesel power generation unit in Luganville had been experiencing various aging troubles. The project has made a major contribution to enhancing the excess supply capacity and ensuring stable operation of the hydroelectric power plant.

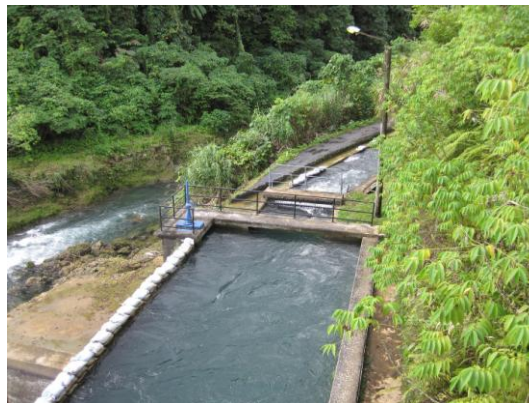
Photo 1: Current Condition of the Intake Water Canal

With respect to the qualitative effect (1) above, the foundation improvement work under this project was completed successfully in the intake water canal zone. There have been no major ground collapses, and water is constantly available in the volume required to generate electricity. The ground surface of the worked area has been covered by natural vegetation over the course of several years since project completion. The risk of soil erosion has thus been reduced.

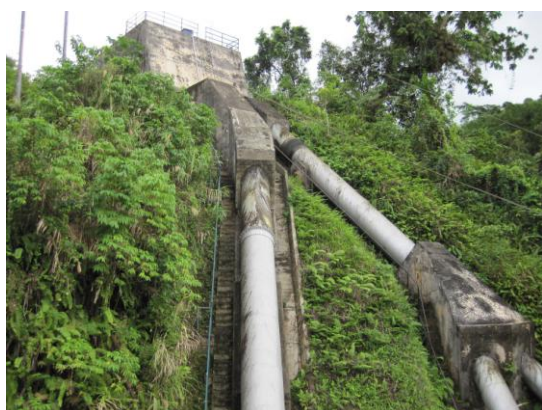
Photo 2: Steel Pipe Installed (Left)

In this ex-post evaluation, various documents related to the project were reviewed and representatives of the project executing agency and of the consultants were interviewed. The review and the interviews confirmed that the repair work of the intake water canal and the capacity expansion of the hydroelectric power station were both executed mostly as planned, as summarised in the above Tables 4 and 5. It was also learned that the construction work for which Vanuatu was responsible was all executed as planned, such as the repair of the interior of the intake water canal, repair of the surface of the access road to the power station (cobble stone pavement, etc.) and the installation of a mudslide prevention fence for the intake water canal.

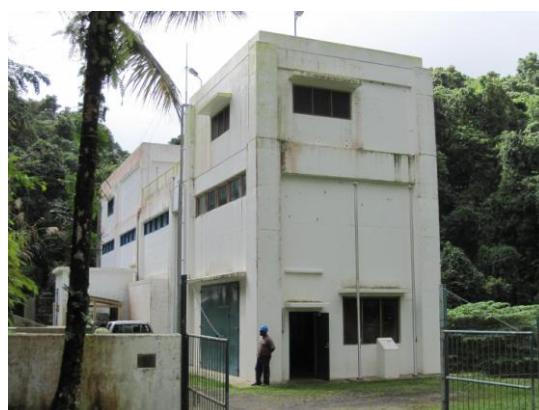
Photo 3: Hydroelectric Power Station Overview

The power generators of the Sarakata River Hydroelectric Power Station were being operated efficiently without any problems at the time of the visit for the ex-post evaluation. The Defect Inspection that was made one year after the project completion found that the governor for the No.1 and No.2 Generators provided under the previous project was made inoperable automatically. The visit in this ex-post evaluation confirmed that the defect had been corrected. It was learned that water was leaking from the No.1 Generator when the new concessionaire took over in 2011 and a substantial repair was made. This ex-post evaluation found no problems in the intake water canal or the access road and other civil engineering work. The power station building was in generally good condition as well.

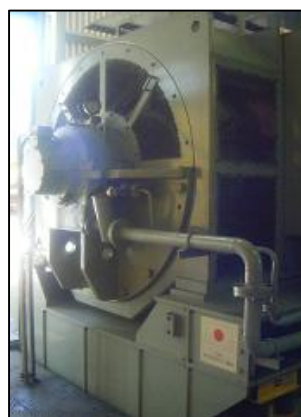
Installed Diesel Engine Generator

The maximum output of the No. 11 generating unit has ranged between 3.8 and 3.9 MW in recent years while the rated power output is 4.2 MW. According to the SIEA technical staff, the reason is mainly due to climate conditions and age-related deterioration. Normally the function of the generating unit is weakened due to high temperature and the maximum output of the No. 11 generator was confirmed as exceeding 4.0 MW on a rainy or relatively cool day. This means the maximum output of the No. 11 generating unit also functions well in terms of maximum output.

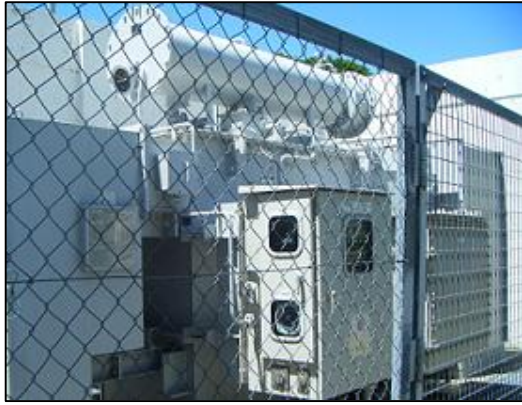
Procurement and installation of the following equipment	Planned	Actual
1) Construction of the 33kV Ranadi Substation (S/S) – 33kV and 11kV outdoor type switchgears and low voltage outdoor type panels – Step-down transformer, station transformer and other related facilities and foundations for the above equipment	1 set 1 set	As planned except 5)

Transformer in Ranadi S/S

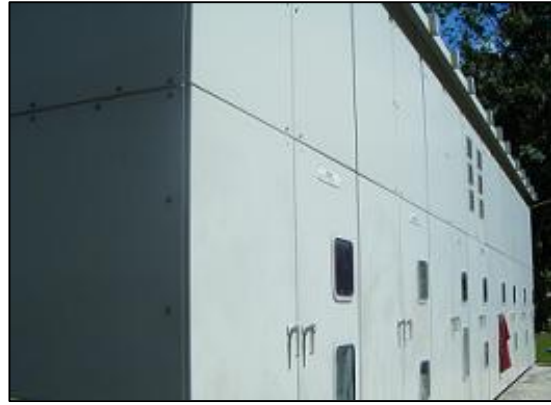
3) Construction of the 33kV Honiara East S/S – 33kV and 11kV outdoor type switchgears and low voltage outdoor type panels – Step-down transformer and station transformer, – Other related facilities and foundations for the above equipment	1 set 1set 1set

Switchgear in Honiara East S/S

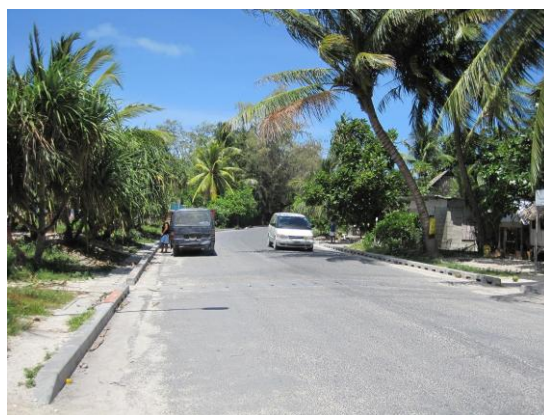
Road Section Improved in the Project

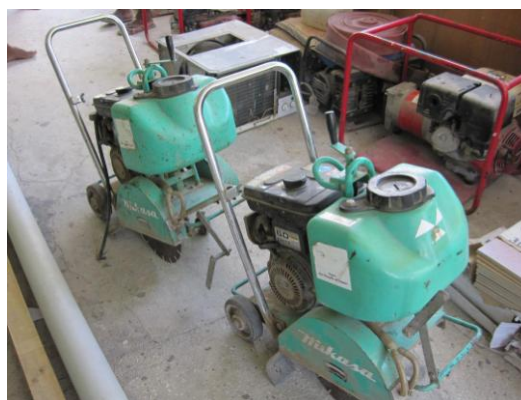
Photo 1: Two Concrete Cutters Provided in the Project

problems were seen in this respect. The concrete cutter, provided under this project, was used only when relatively large repair works were conducted.

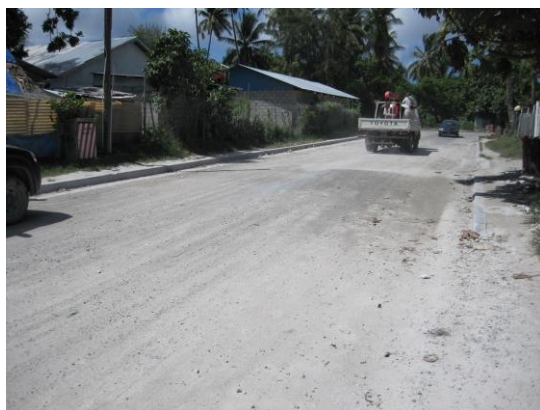
While CES lacks a systematic road maintenance plan, annual work plans are usually prepared, based on which the budget is secured every year. However, in the sections of South Tarawa Road excluded from this project, maintenance activities are reactive as the road is old, has problems with drainage, and requires a series of emergency repairs.

Photo 2: Project Road with the Surface Broken Away (Taatirerei Road)

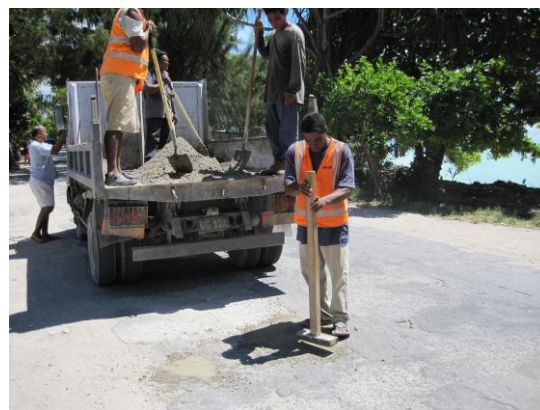
With regard to road maintenance equipment, the site office in Betio was responsible for repairs, showing that the repair work had not been delegated to PVU (Plant and Vehicle Unit), though this was considered at the time of project planning. Some of the repairs of larger equipment have been outsourced to the private sector since 2012. It is assumed that there are no issues from the structural aspect relating to repair work as all the equipment provided in this project and the subsequent follow-up cooperation remain in working order.

Photo 3: Road Maintenance Work (Non-Project Section)

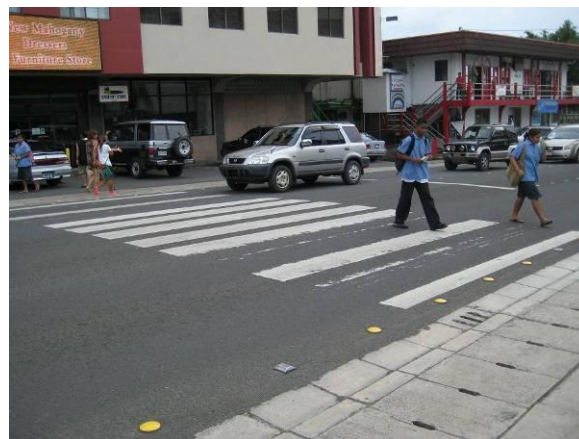
The Arterial Road after its rehabilitation  
(Section A: Downtown Koror)

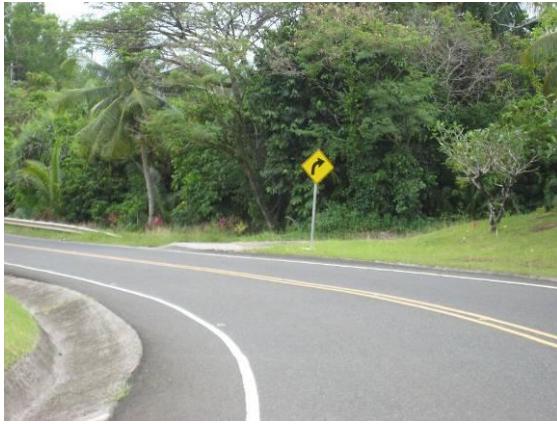
It is believed that the clear separation of the street and the sidewalk by road markings and the installation of lids covering U-shaped concrete ditches also contributed to the effects described above.

Left: Renovated Pavement and Road Markings (Section F-1)

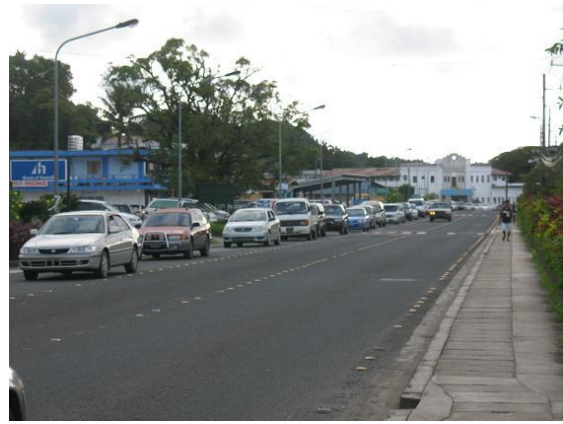
Right: Traffic Congestion during the Rush Hour (Section A, Shell Intersection<sup>14</sup>)
