**Ex-Post Project Evaluation 2012: Package I-7
(Ethiopia, Tanzania, Guinea)**

JAPAN INTERNATIONAL COOPERATION AGENCY

“The Project for Water Supply in Southern Nations, Nationalities and Peoples’ Regional State”

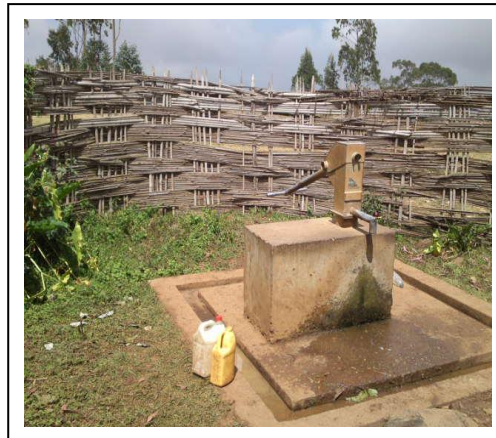
A water facility provided by the project

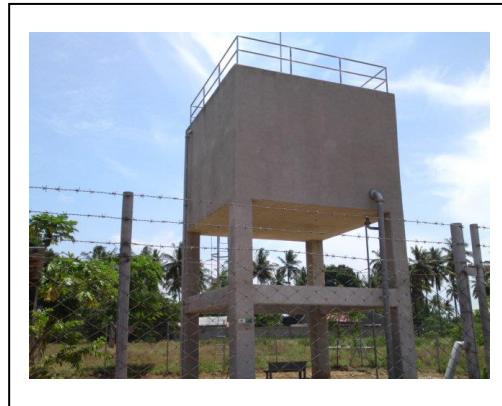
A piped water facility provided by the project

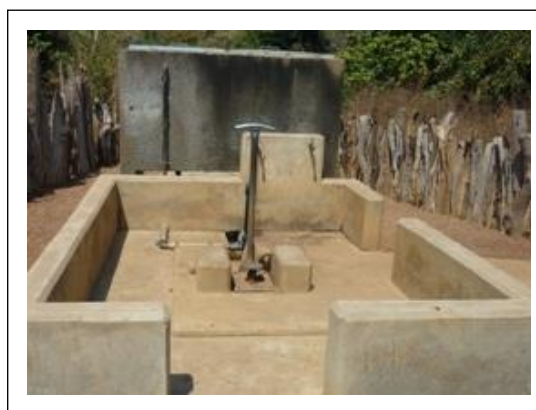
Foot-pump water facility with iron remover provided by the project
