# **Ex-Post Project Evaluation 2012: Package III-6 (Madagascar)**

**October 2013**

**JAPAN INTERNATIONAL COOPERATION AGENCY**

The Project of Classroom Construction of Primary Schools in Antsiranana and Toliara Provinces  
(Le projet de construction de salles de classe d' écoles primaires dans les provinces d'Antsiranana et de Toliara)

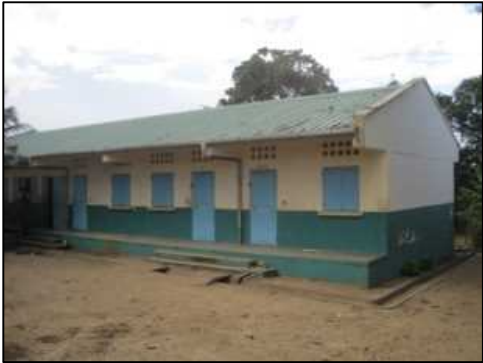
School Building Supported by the Project (Antsiranana)

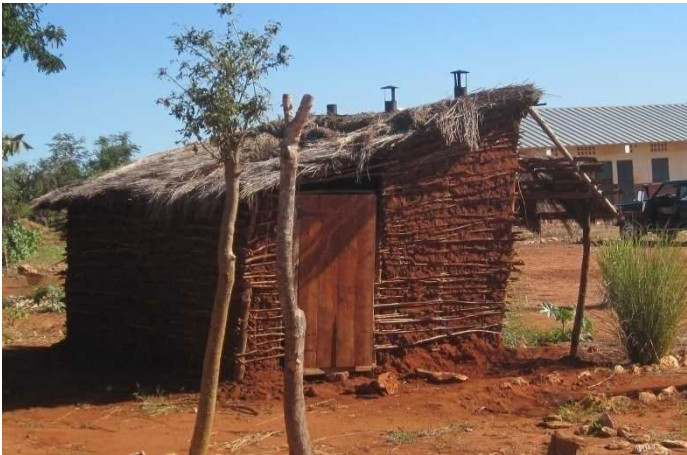
Classroom with Clay Wall Constructed by the Community

Across the country, 13.5% of primary school classrooms are makeshift structures that were built in 2012 with the support of the community. Low-standard materials were used, such as wood or mortared adobe bricks, and galvanised iron for the roofs. Therefore, regular building maintenance and the repair of roofs, doors, and windows damaged by cyclones were a burden on the school staff and community members. The results of the interviews show that the construction of classrooms by the Project—using high-quality materials, mortar, etc.—did away with roof leaks and ensured proper ventilation, thereby reducing the schools' maintenance expenses.

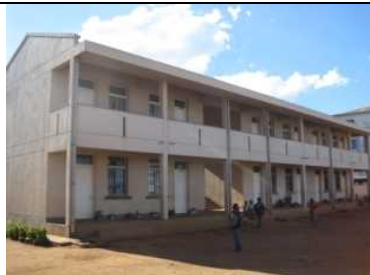
Grant Aid for General Projects Primary School Construction Project Phase II	Grant Aid for Community Empowerment Project for the Construction of Primary School Classrooms in Antsiranana and Toliara Provinces

Advantages	- High durability - High-quality finish - Reliable term of works	- A large number of classrooms due to the low unit cost
Disadvantages	- Fewer classrooms due to higher cost	- Finishing quality is lower than that of the Grant Aid for General Projects - Risks in low quality, delay of the project period

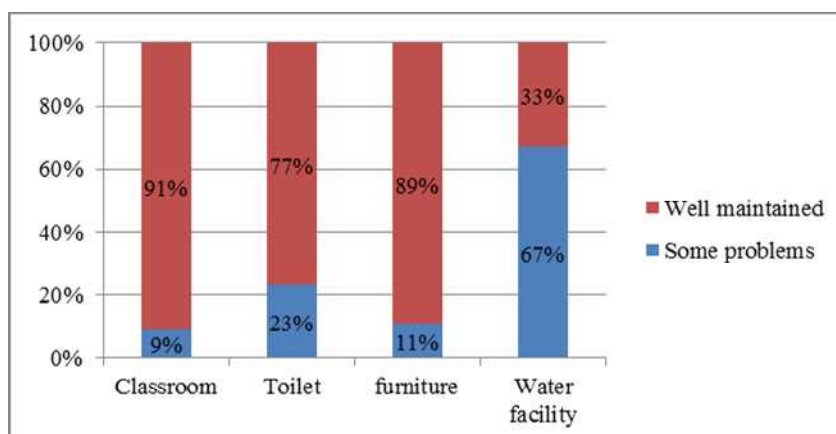
Figure 4: Operation and Maintenance Conditions of School Facilities

On the other hand, cracks in the floor of the classroom building, the lack of window glass panes, leaks in the rainwater tank, theft of water taps and rain gutters, damage to the toilet doors, and damage to furniture by pests has been confirmed in some schools. The beneficiary survey revealed some problems<sup>19</sup> in the maintenance of toilets and water supply facilities (Figure 4). The main cause of the damaged toilets and water supply facilities are the neighbouring residents, who have free access to the facilities due to the absence of a perimeter wall or fence.

<sup>19</sup> Certain water supply facilities cannot be used because they were damaged or the water taps were stolen.

In terms of the operation and maintenance of school facilities in the Project, the damage to toilets and theft of water taps are remarkable. This was attributed to the unauthorised use of school toilets by local residents. Gates and fences need to be installed to restrict unauthorised access—a responsibility of the Malagasy side which has not been carried out because of the lack of budget. Therefore, the installation of the gates and fences in the target schools by the recipient countries should be considered for inclusion in outputs of the Japanese side.

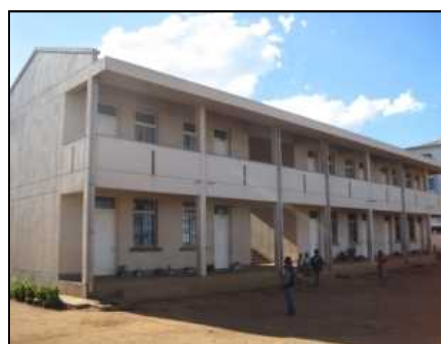
School Building Supported by the Project  
(Mahajanga)

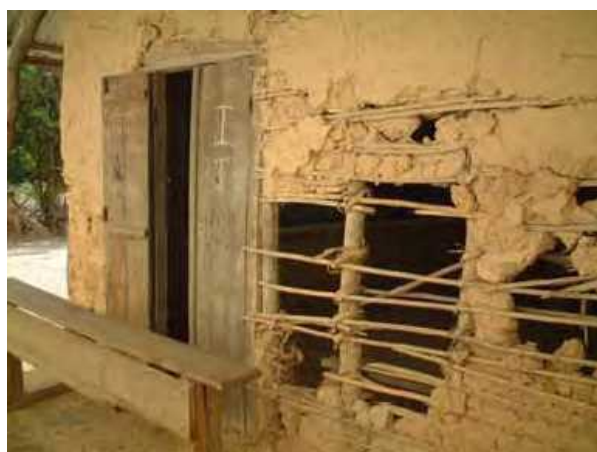
Classroom with Clay Wall Constructed by the Community

Across the country, 13.5% of primary school classrooms are makeshift structures built in 2012 with the support of the community. Low-standard materials were used, such as wood or mortared adobe bricks and galvanised iron for the roofs. Therefore, regular building maintenance and the repair of roofs, doors, and windows damaged by cyclones were a burden on the school staff and community members. The results of the interviews show that the construction of classrooms by the Project—using high quality materials, mortar, etc.—did away with roof leaks and ensured proper ventilation, thereby reducing the schools' maintenance expenses.

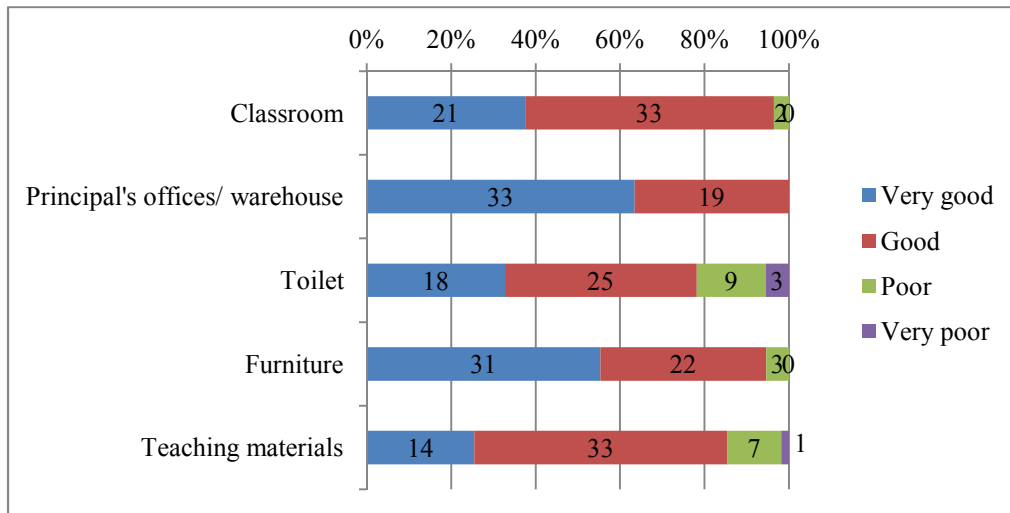
Figure 5: Operation and Maintenance Conditions of the School Facility

On the other hand, cracks in the floor of the classroom building, the lack of window glass panes, leaks in the rainwater tank, theft of water taps and rain gutters, damage to toilet doors, and damage to furniture by pests has been confirmed in some schools.

The beneficiary survey revealed problems<sup>16</sup> with unused teaching materials because of insufficient maintenance, unclean toilets due to improper use by pupils, the undesired free access to toilets by neighbouring residents, and the lack of water for cleaning (see Figure 5).

<sup>16</sup> Certain water supply facilities cannot be used because they were damaged or the water taps were stolen.

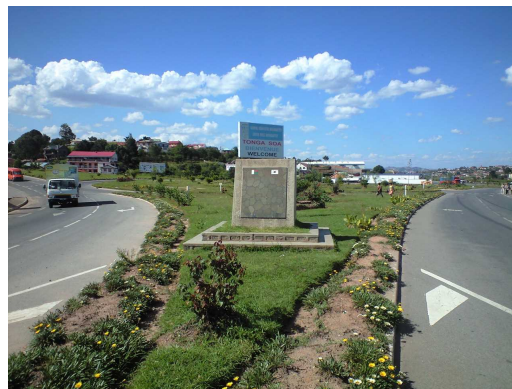
Starting Point of the By-pass of the National Road 7

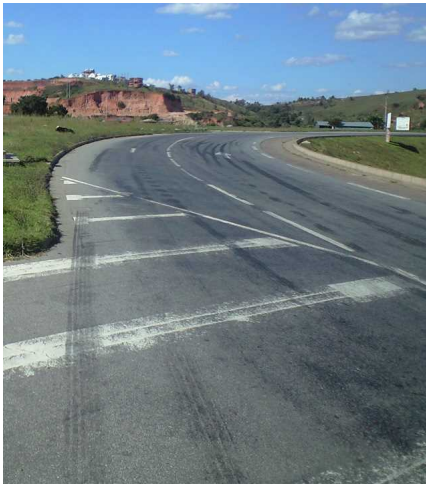
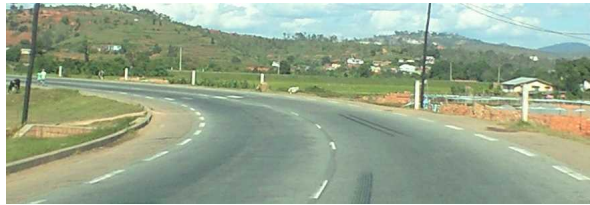
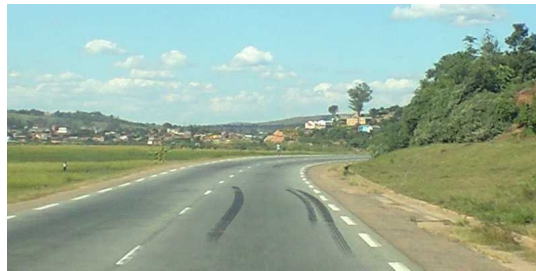
Photo 1: Brake tracks on the By-pass

② The Evaluator actually ran over the By-pass and found many brake tracks as shown in Photo 1. According to MTPM and CUA, these are caused by reckless driving and grazed animals rushing out to it.

Near 10k000, inside Alasora Commune

Near 9k600, inside Alasora Commune

Near 10k600, Amolonakony area inside Ambohimangakely Commune

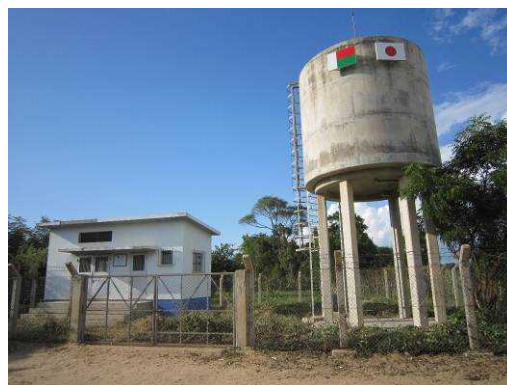
Public fountain type water supply facility

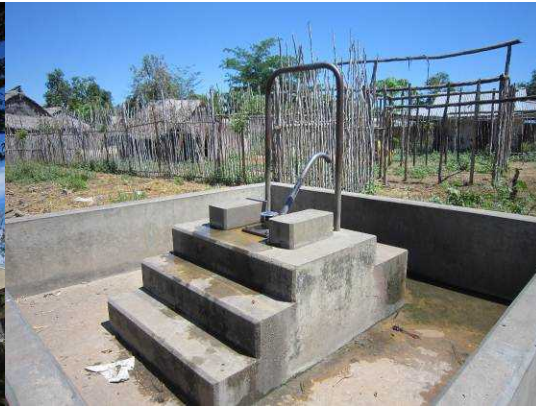
Photo 2: Foot pump type  
Water supply facility

For foot pump type water supply facilities, even though the part of the excavation site was changed because of unsuccessful exploratory drilling and high salinity, etc, the planned number of the water supply facilities was eventually constructed. On public fountain type water supply facilities, the number of actual excavations was two below of the planned number. This was due to the unsuccessful exploratory drilling in Ankirizato and it was also found that the possibility of new underwater development there was extremely low; and the plan was changed through the proper procedures. According to the consultant who was in charge of designing the Project, even after conducting a detailed study and several exploratory drillings in advance at the cancelled site, it was difficult to find good water source. Therefore it was an unavoidable cancellation. For public fountain type water supply facilities, it seems that it was difficult to change the site to neighbouring villages because the scale of the facility was big and they couldn't find good water source; and it was hard to find an alternative site.
