**Ex-Post Project Evaluation 2013: Package III-8**  
**(Tajikistan, Mongolia, Samoa)**

**November 2013**

Ex-Post Evaluation of Japanese Grant Aid Project  
“The Project for Improvement of Dusty – Nijiny Pyandzh Road”

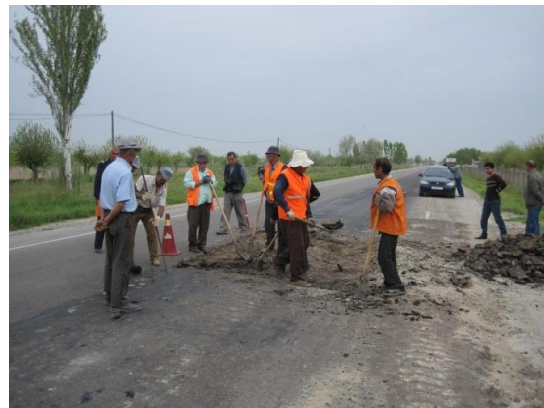
During the ex-post evaluation survey, the Executing Agency commented that the technical level of the maintenance personnel was sufficient. However, even with some knowledge, the quality of the repaired road surface was insufficient, and further repair work was always required. The main factor in the poor quality of patching work is the difficulty in producing and/or obtaining good quality asphalt and a lack of equipment. During the site visit, repair work was being conducted for the second time on a spot that was already repaired once after the project.

Photo 3: Subsequent repair work on a spot once repaired by SEHM (Phase II section)

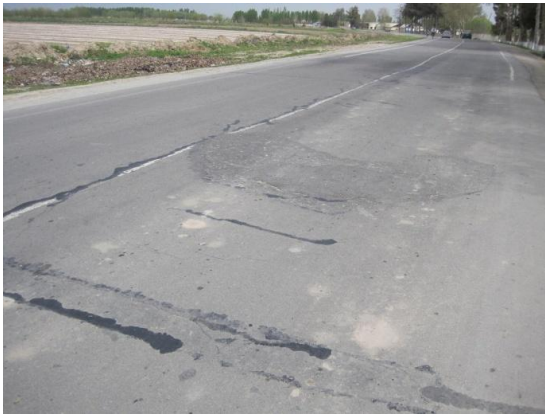
- With regard to the major highway section, a number of repairs were made by the contractor around the warranty inspection period, especially in the Phase II section. While the level of damages was not so severe as to disturb smooth traffic flow, several damages to the road surface were spotted even after repairs were done during the warranty inspection. SEHM Kumsangir has been repairing such damages continuously.
- In the Phase I section, several undulating points were observed on the road surface

of the main highway on the Dusty town side.

Photo 4: Road surface repaired after damages (Phase I section: surfaces are undulating and the median line is winding.)

A maintenance plan is formulated and inspections are regularly conducted by SEHM Kumsangir, but it is difficult to implement repair work in accordance with the schedule due to insufficient budget allocations. With a lack of asphalt plants, road surface repairs are done with cold asphalt, which is less durable and coarser. As demonstrated, there are difficulties in procuring materials and road maintenance equipment such as compactors. It is therefore difficult to say that sufficient repair work has been conducted.

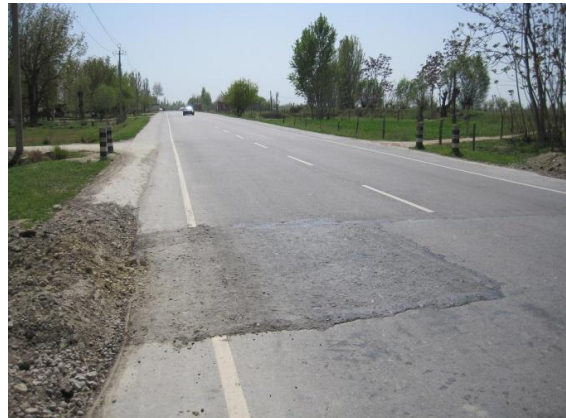
Various damages started occurring soon after the completion of construction work on the project road, and a number of repairs have been made thus far. With this additional repair work, the one-year warranty inspection surveys normally conducted once after the completion of each phase were actually conducted twice.

Photo 5: Road surface repaired again after damages (Phase II section: insufficient strength of asphalt)

Considering the short period of time that passed after project completion, damages to road surfaces of the project road were relatively severe. While the contractor repaired the damaged sections more than required in its warranty, further damages have kept occurring even after that. On the other hand, the surfaces improved in the subsequent project ‘The Project for Rehabilitation of Kurgan Tyube - Dusty Road’ have been far better than those of this project after the same period. With the increasing traffic volume, it is desirable that the conditions of the road surfaces covered in this project be monitored, and discussions with the Tajikistan government held as needed.

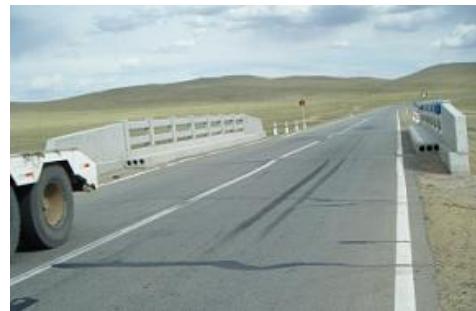
As two<sup>6</sup> of the target four bridges were wooden bridges before the project, only small trucks were able to pass on them. On another two bridges<sup>7</sup>, only heavy vehicles with a loading capacity less than 14 tons were allowed to pass as they were also heavily dilapidated. According to the project documents prepared at the planning period, it was expected that 20 ton trucks as well as trailers with loading capacities of 43 tons would be able to pass on all of the bridges. By upgrading bridges through this project, all four bridges increased their strength and now there are no weight restrictions except on Kherlen Bridge<sup>8</sup>, thus it can be judged that the target has been achieved.

(Photo) Rehabilitated Bridge  
(Khutsaa Narin Bridge)

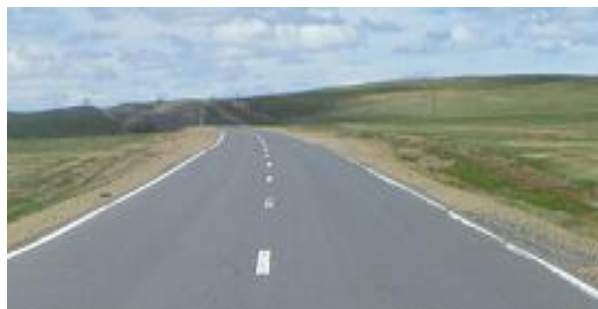
(Photo) The target road where some new grass has started growing on the road side.

started to re-grow. This situation shows that the adverse impact to grassland has been mitigated. When driving along the road at the ex-post evaluation, new grass was confirmed to have started growing at some parts of the target road side.

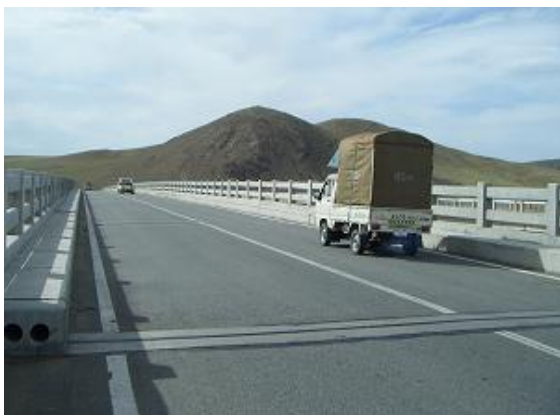
(Photo) Kherlen bridge constructed in Section II

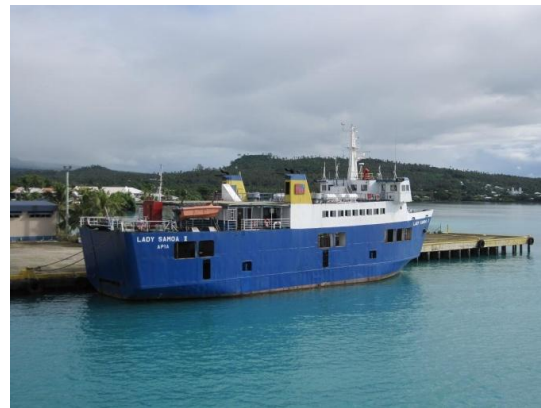
leading to the achievement of breakdown-free operations. Having noted that, certain measures were considered necessary to determine how stable operation could be continued in the same way, even after the retirement of LS2, given the limited remaining service period.

Photo 5: LS2, utilised as a backup vessel  
(anchored at the Salelologa Port)

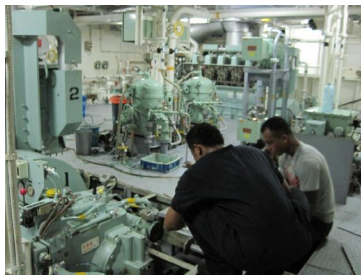
The Executing Agency, with its own workshop within the premises of the headquarters, has been conducting all internal maintenance of vessels, apart from dry-docking of the ship bottom. Upon implementing this project, a preventive maintenance programme specifying regular inspections and replacement of parts was formulated in addition to the provision of the ferry. During the site survey of the ex-post evaluation study, it was confirmed that weekly maintenance every Tuesday, quarterly maintenance, and the first dry-docking in American Samoa in 2012 had all been implemented as scheduled. Inside, the ferry was generally kept clean and no problems potentially hindering its operation were identified in the engines.

Photo 7: Inspection of the main engine
