Isiolo River Basin Integrated Flood Management Plan

**REPUBLIC OF KENYA
PROJECT ON CAPACITY DEVELOPMENT
FOR
EFFECTIVE FLOOD MANAGEMENT IN FLOOD PRONE AREA**

**ISIOLO RIVER BASIN
INTEGRATED FLOOD MANAGEMENT PLAN
- DRAFT -**

August 2013

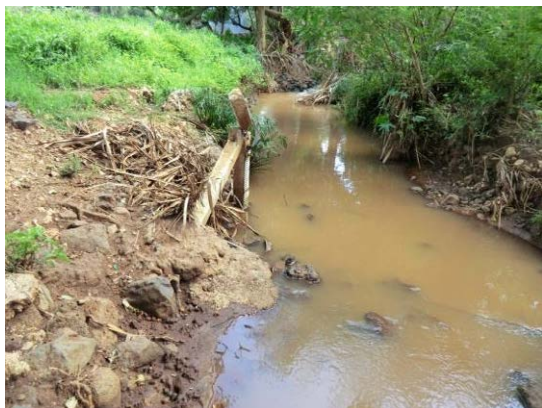
Water Level Gauging Station No.:5DA04
Observation River : Eastern Marania River
Special Note : Water level gauge is broken off
and damaged.

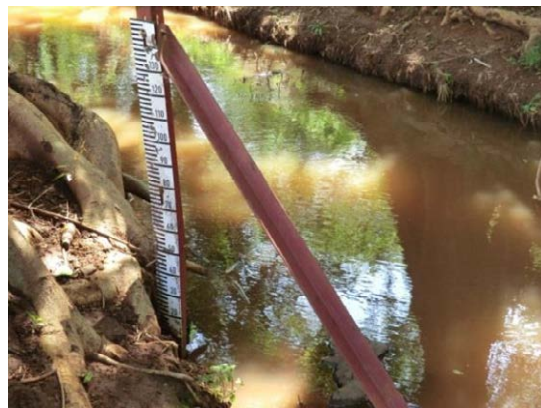
Water Level Gauging Station No.:5DA03
Observation River : Eastern Marania River

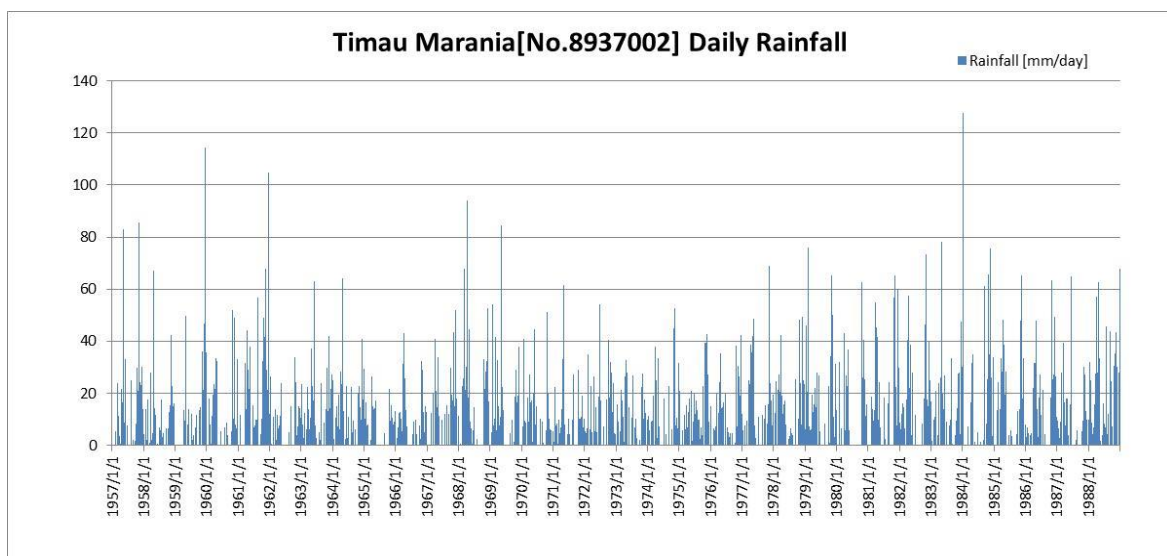
Variability of daily rainfall and maximum daily rainfall per year during the observation period of 1957 to 1989 at Timau Marania Station is shown on Figure 2.1.11

Source : Prepared by JICA Project Team based on the observation period of 1957 to 1989 at the KMD Timau Marania Rainfall Gauging Station that is offered by WRMA

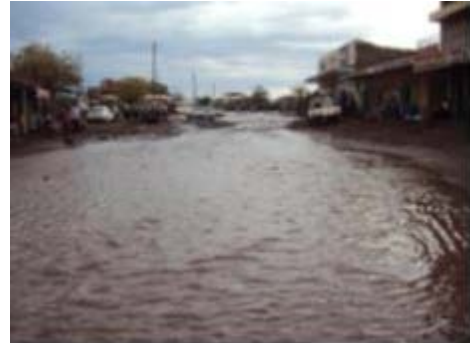
Condition of inundation in the urban area of Isiolo town

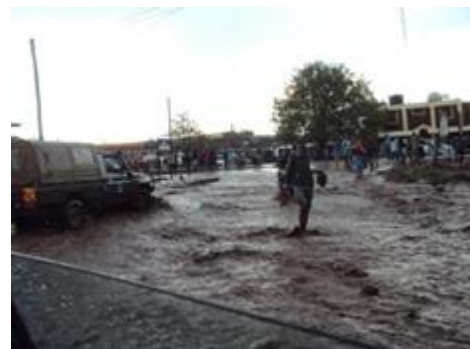
Condition of inundation in the urban area of Isiolo town

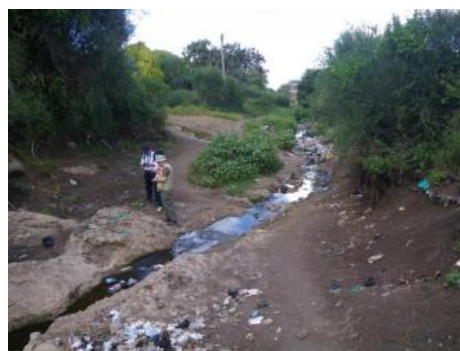
The Merire River runs in the Isiolo town

Regarding the problems of natural conditions, the Merire River doesn't have enough width and cross-sectional area.

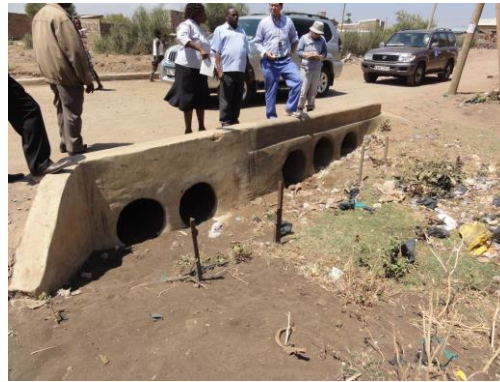
Main riverbed material is sand. Height of river channel is approximately 0.5~1m. Sediment accumulates in the culvert. Sediment and disposed garbage are some of causes of culvert clogging.

Culvert along the Merire River in Isiolo town

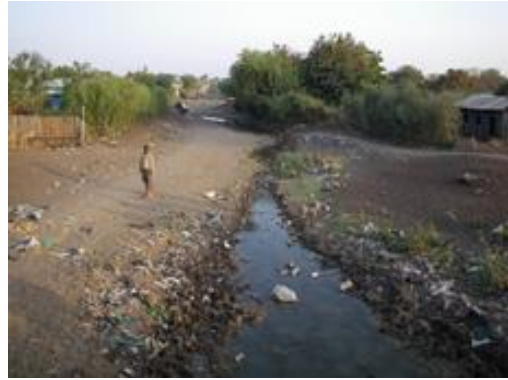
Downstream of Merire River (upstream view) squatter's houses are on the left bank of the river channel

Regarding the socio-economic problems, mainly in the downstream of the Merire River, houses are built in the riparian land illegally. Consequently, it is very difficult to widen the river channel. This issue should be encountered, too.

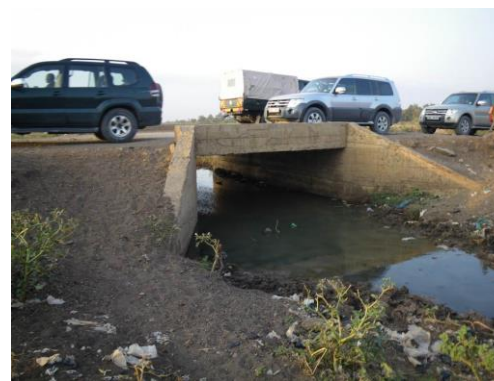
Sediment runoff occurs in the upstream of the Merire River and accumulates in the downstream. Not only the accumulation of sediment, but also the clogging of culverts by the illegally disposed garbage is one of the causes of reduction of flow capacity. A box-culvert located at the downstream end of the town area was clogged, and the upper side water of it was dammed up and water level became very high. For that reason, the inundated water depth became 2 to 3 meters.

A box culvert bridge at the downstream end of the town of the Merire River (Downstream view)

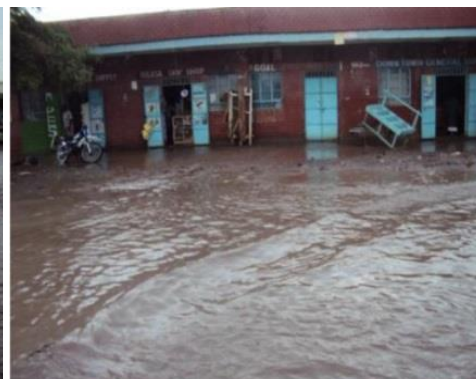
Situation of inundated house

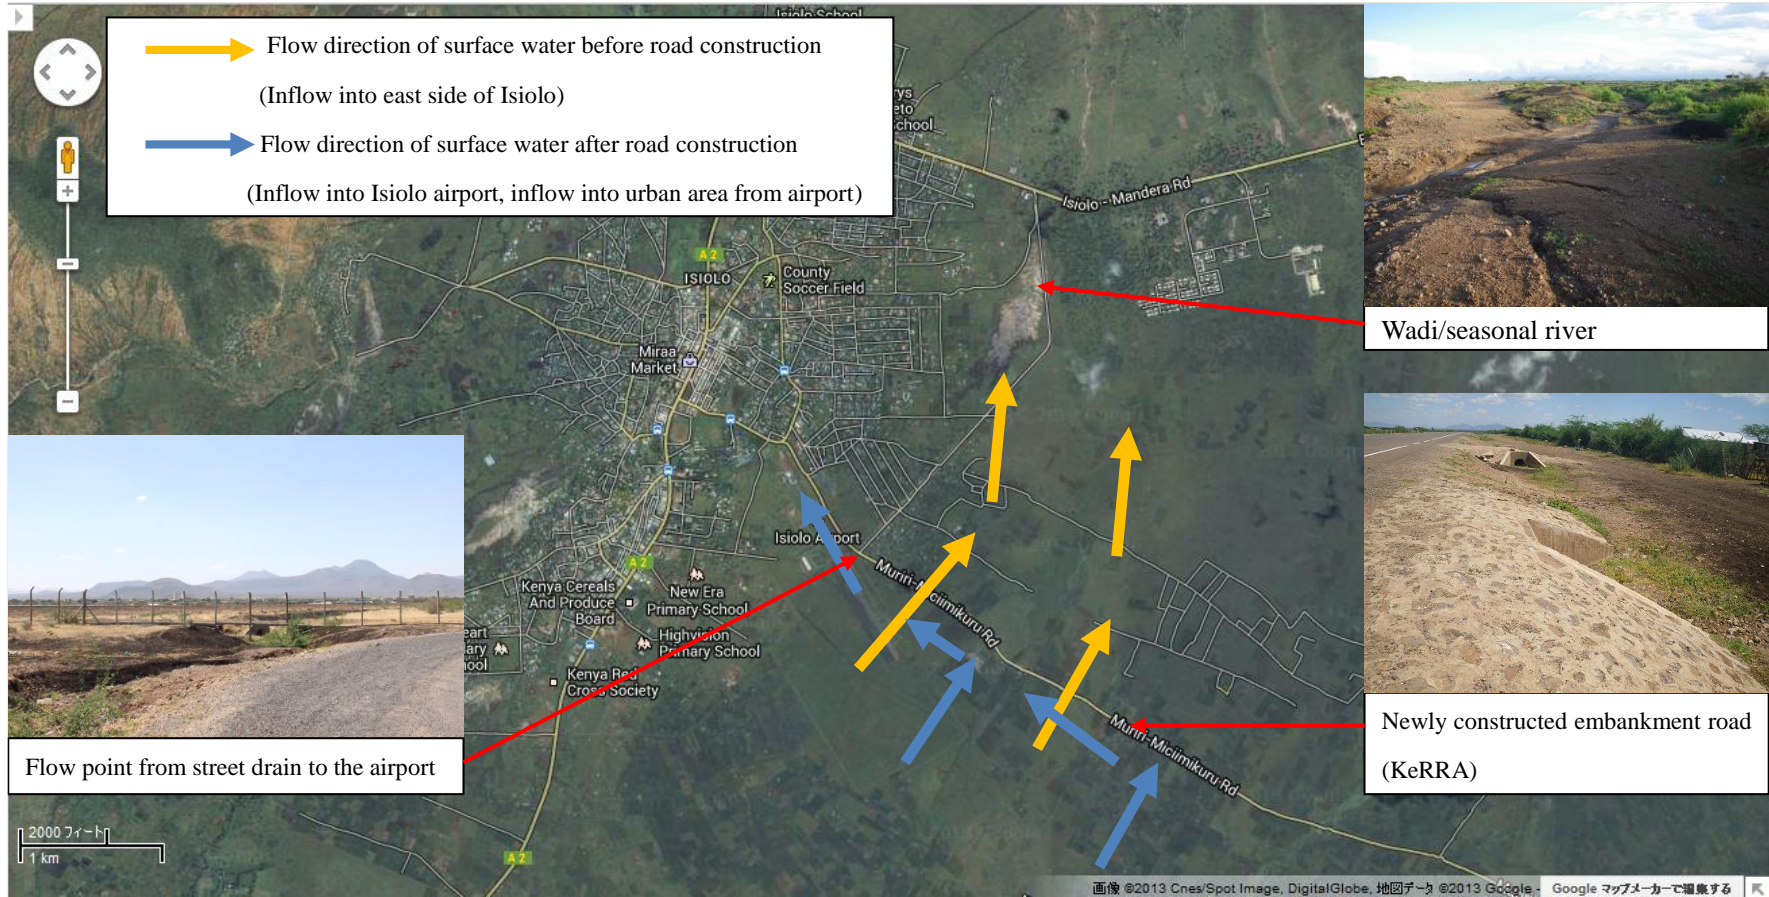
In the past rain water ran from southern part of urban area didn't flow in a direction to the town area, it traveled down to the north in the eastern slope of the town. After the construction of those facilities, rain water from the south is blocked by embankment for the airport and roads and it is leading to the town area.

Figure 3.2.3 Direction of Rain Water from Airport Area

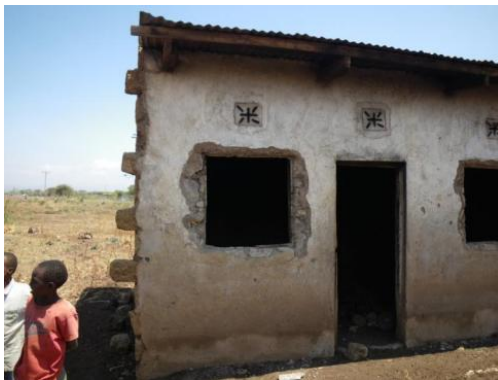
House was destroyed by flood

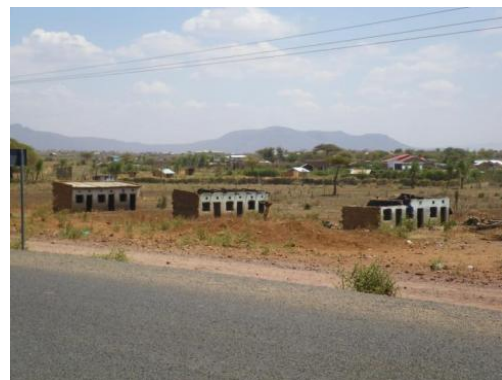
Houses were destroyed by flood

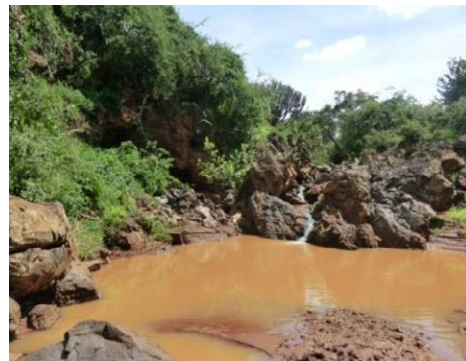
Status of water course after debris flow

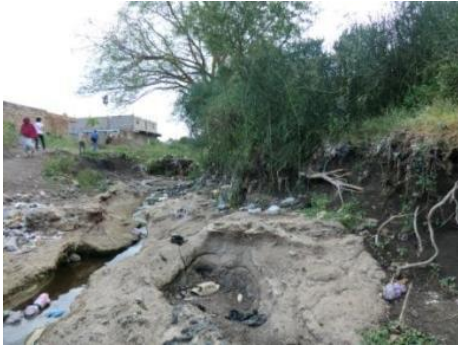
Bank erosion near urban area

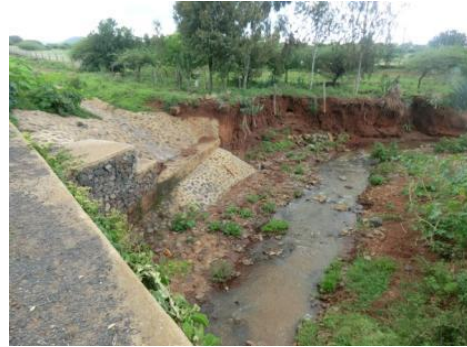
Bank erosion at the Eastern Marania River

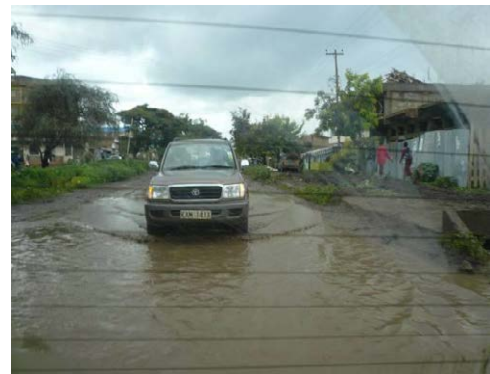
Inundated road in the urban area of Isiolo by flood (Place: Isiolo Town)

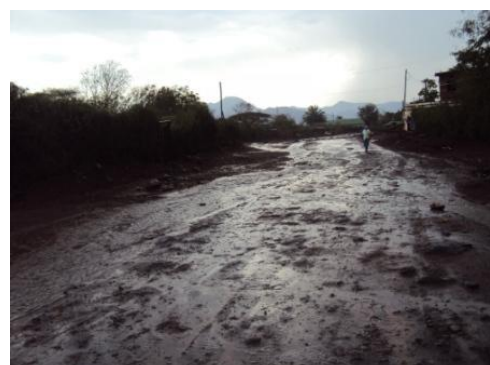
Road after flood (Place: Isiolo Town)

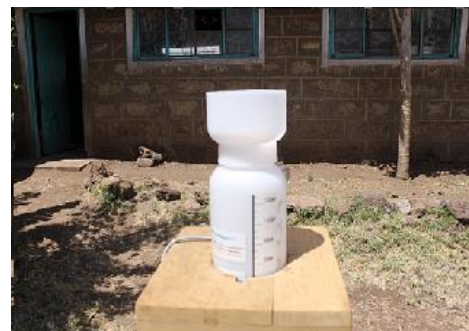
Simple Rain Gauge (Place: Nkando Primary School)

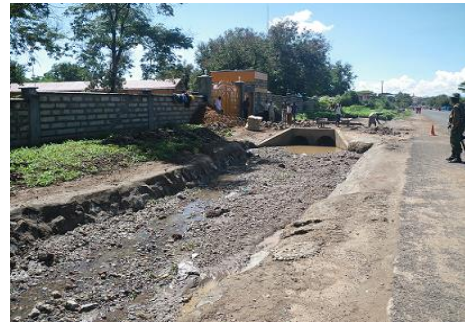
Very few drain channel installed in the urban area (Place: Isiolo Town)

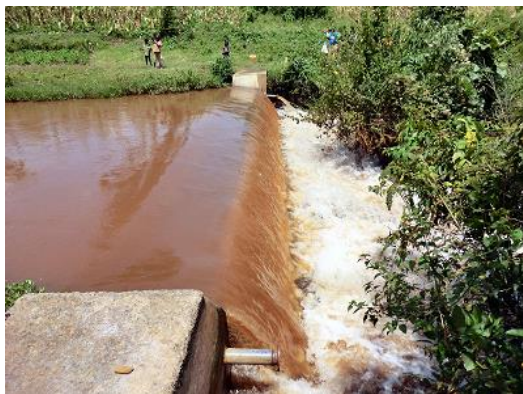
Example of check dam in Nzoia River

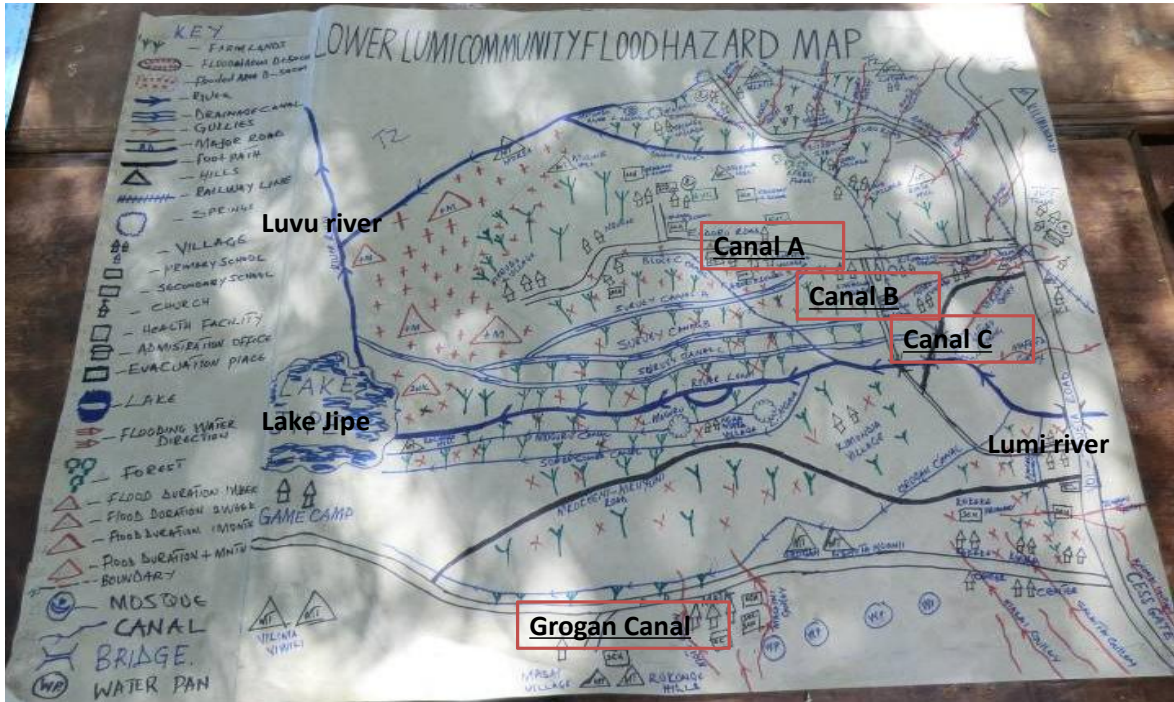
Figure 3.1.3 Location of Canals

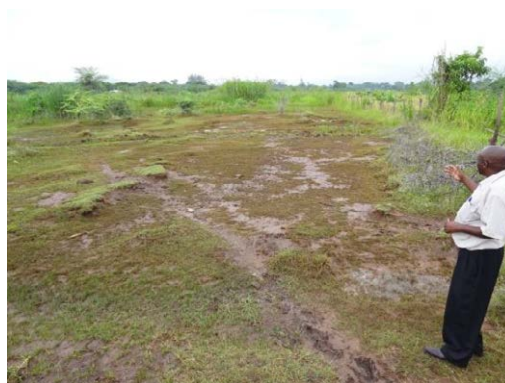
Photo 3.1.2 Broken point of the embankment Canal-C

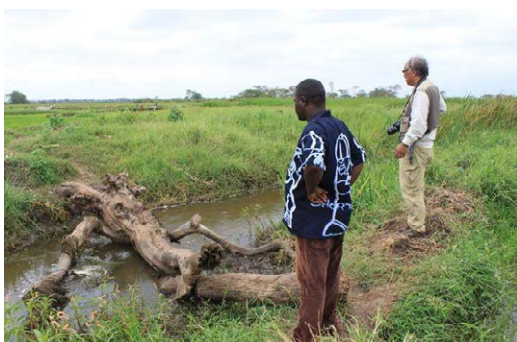
Photo 3.1.3 Canal-A around Kimorigo village

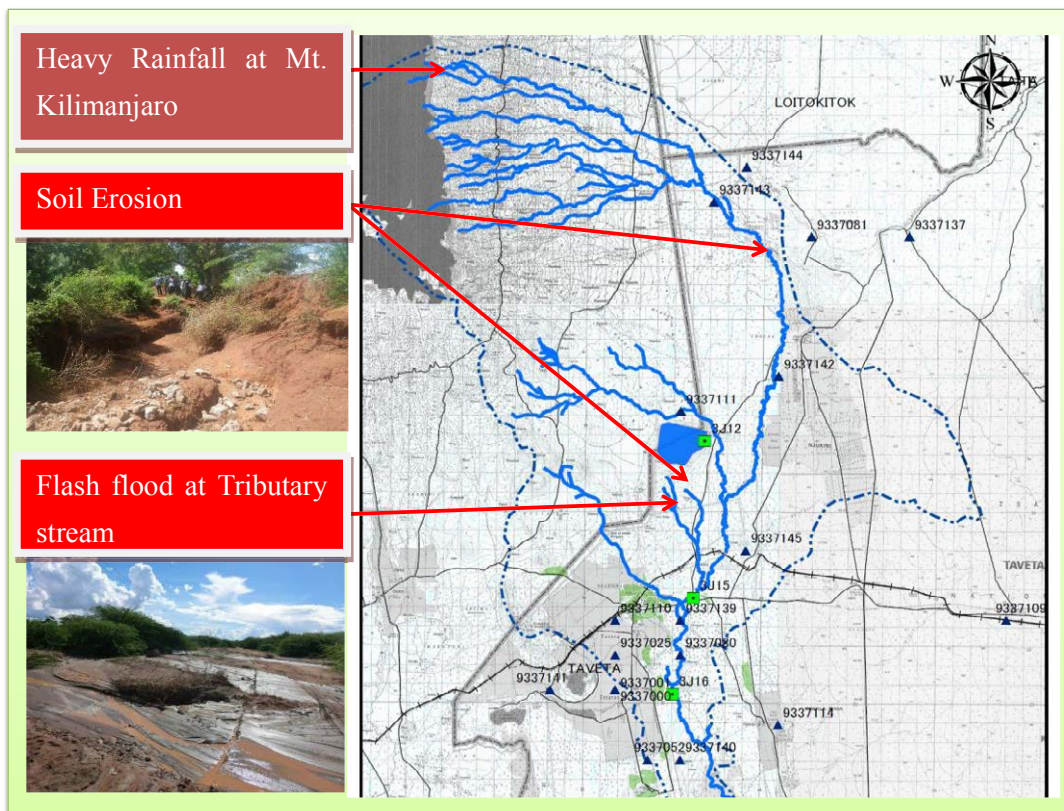
Figure 3.2.3 Flood Characteristics in upstream and middle stream

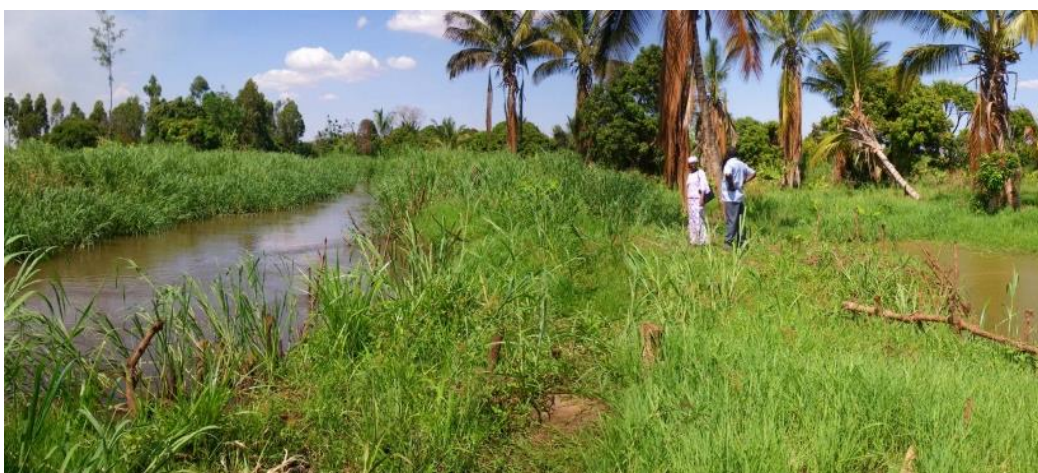
Photo 3.2.1 Near the mouth of the Lumi River
(the River is narrow and water level is higher than farming land)

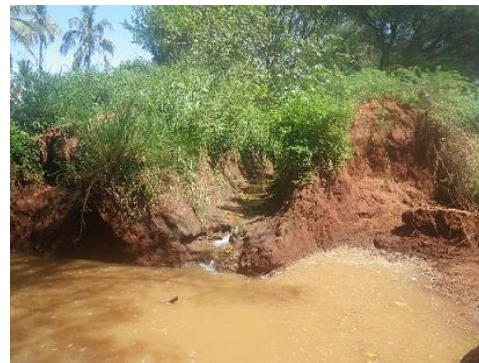
Irrigation canal broken down by flash flood from lateral face

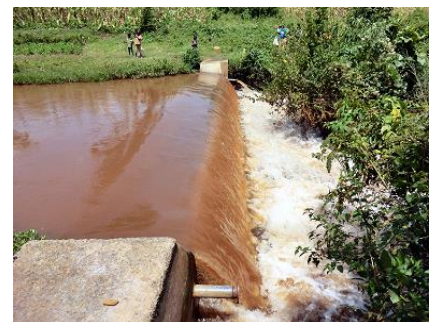
Check Dam
(Example of Nzoia River)

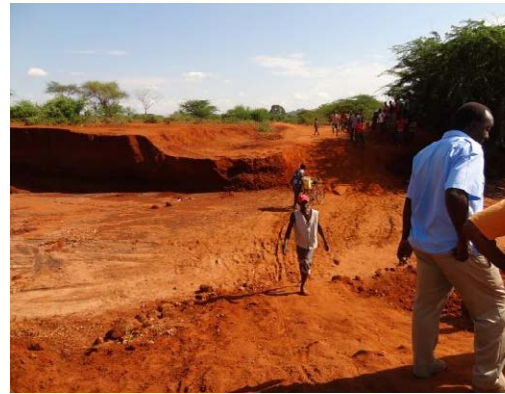
Road Bridge rushed out
Place : Rengesa

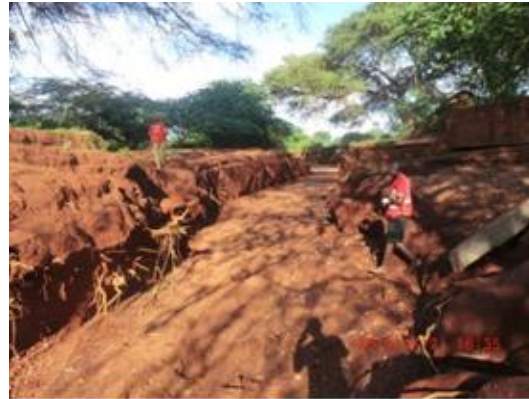
Wash out of land by bank erosion of seasonal river
Place: Rekeke

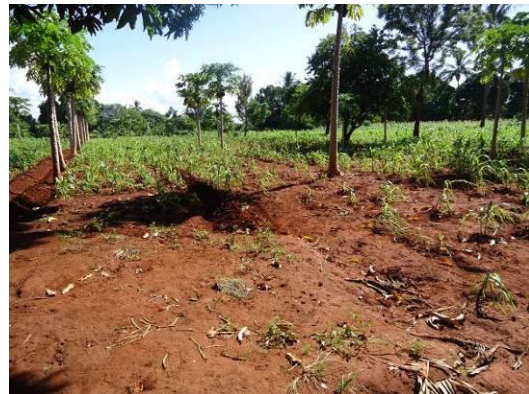
Agricultural land of which the surface soil has been washed out by flood
Place : Kimala Irrigation Scheme

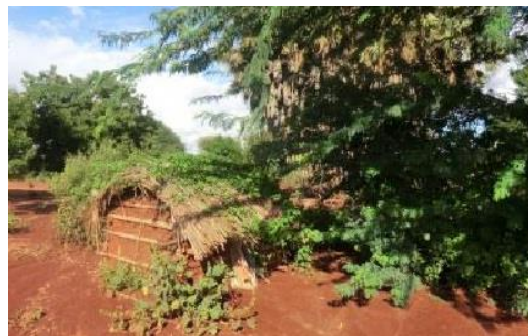
Toilet left as being buried by sedimentation by flood
Place: Rekeke

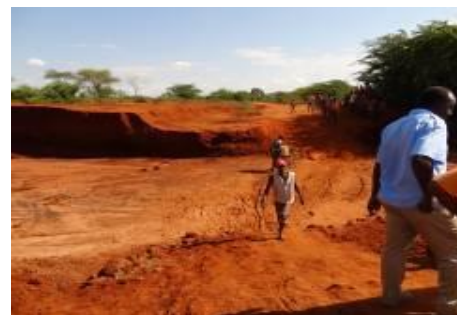
Washout of the concrete bridge of
the same structure to the above by
flash flood
Place : Rengesa

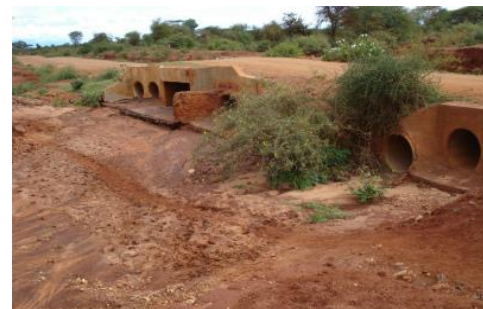
Bridge with pipe culvert installed at the
dry up river crossing the road
