Gucha Migori River Basin Integrated Flood Management Plan

**GUCHA MIGORI RIVER BASIN
INTEGRATED FLOOD MANAGEMENT PLAN
-ZERO DRAFT-**

**JULY 2014
WRMA and JICA**

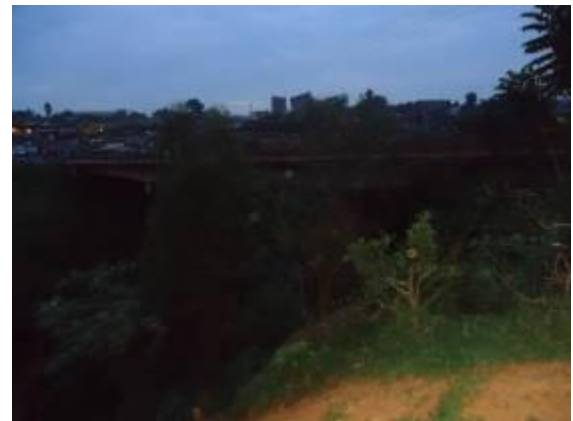
<p>Description : Kegati area in Kisii Town the river structure includes vehicular bridge that KisiiNarok road passes over the R. Gucha</p>	<p>Description : Kegati area in Kisii Town the water flows downstream and there is vegetation cover in the riparian areas</p>

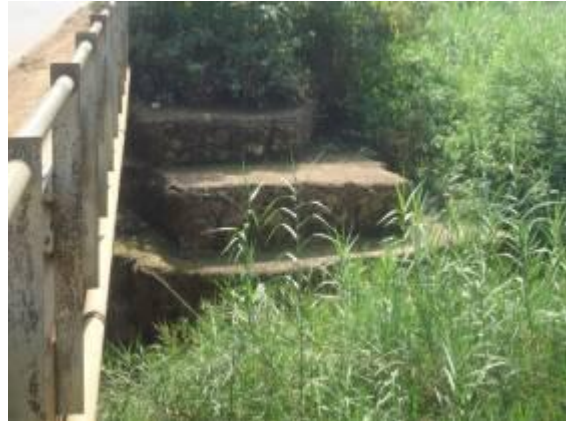
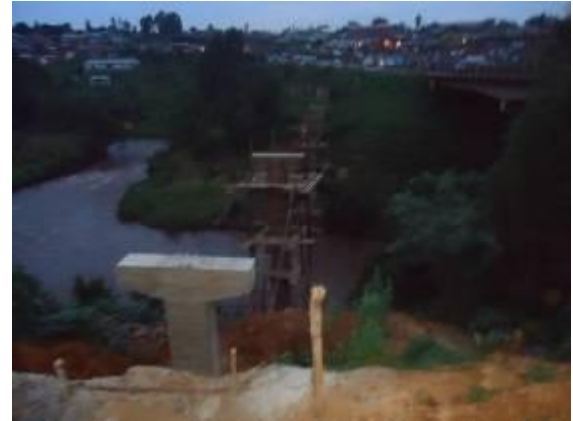
<p>Description :Ogembo town in Gucha District the river water is brown in colour and riverbed material is rocky and soil sediment there is minimal riverbank erosion</p>	<p>Description :Ogembo town in Gucha District the river structure includes vehicular bridge that KisiiKilgoris road passes over the R. Gucha</p>

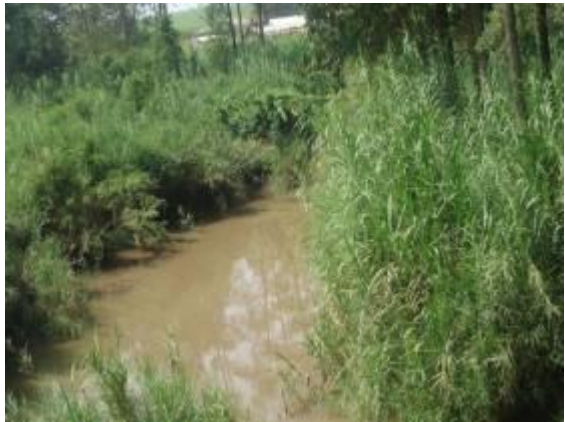
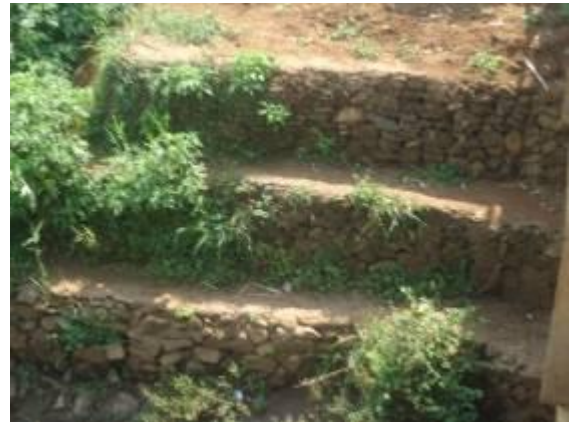
<p>Description : Ogembo town in Gucha District the river structure includes the gabion works used to reinforce the vehicular bridge that KisiiKilgoris road passes over the R. Gucha</p>	<p>Description : Ogembo town in Gucha District the river structure includes the under construction footbridge that will give pedestrian easy access to the market stalls</p>
<p>River Gucha System: Midstream</p>

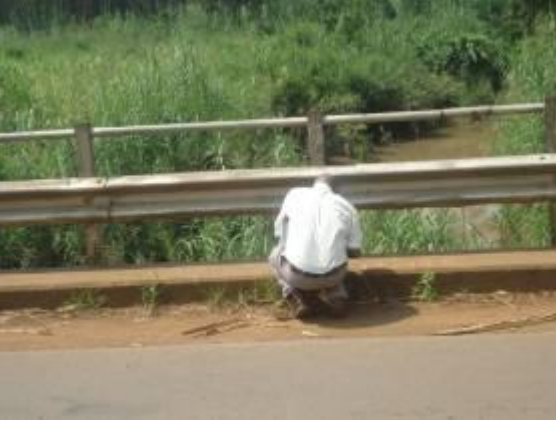
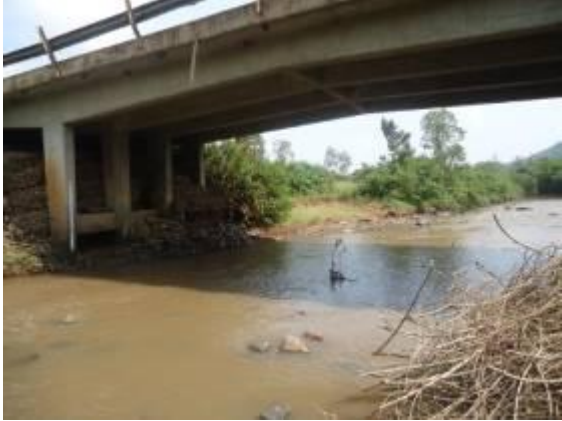
<p>Description : Sare bridge in Awendo town R. Sare a tributary of R. Gucha. The river water is brown in colour and riverbed material is rocky and sandy there is minimal riverbank erosion</p>	<p>Description :Sare bridge in Awendo town the river structure includes the gabion works used to reinforce the vehicular bridge that KisiiMigori road passes over the R. Sare</p>

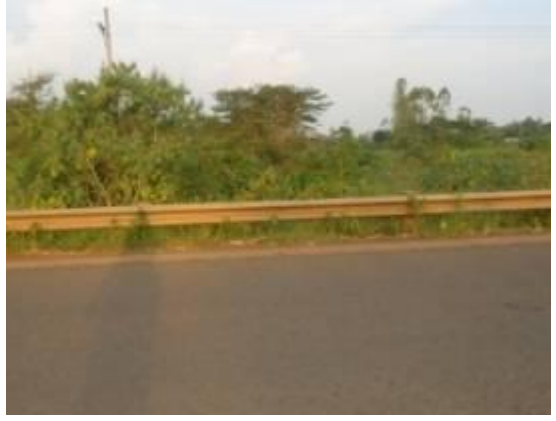
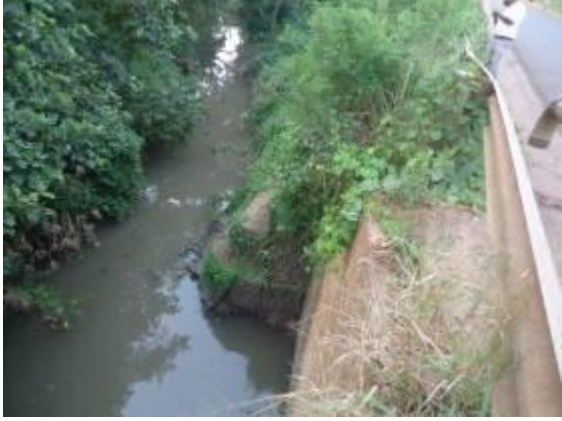
<p>Description : Oyani bridge where R. Oyani a tributary of R. Gucha passes under. The river water is brown in colour and riverbed material is rocky and sandy there is minimal riverbank erosion</p>	<p>Description : Oyani bridge near Awendo town the river structure includes the gabion works used to reinforce the vehicular bridge that KisiiMigori road passes over the R. Oyani and their debris in river channel</p>

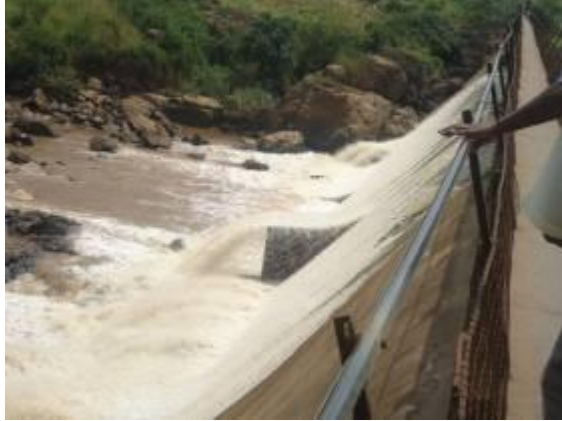
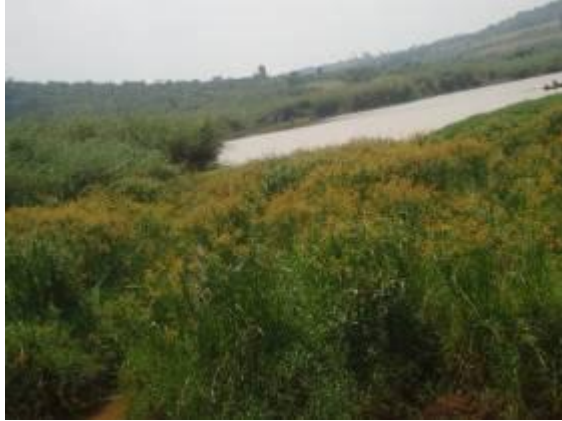
<p>Description : GogoKenGenGogoin Nyatike district R. Gucha flows downstream and the water colour is brownish and the riverbed material is rocky and soil sediments</p>	<p>Description : GogoKenGenGogo Hydroelectric plant on R. Gucha. River Structures include dam, water intake and footbridge. The dam is silted</p>

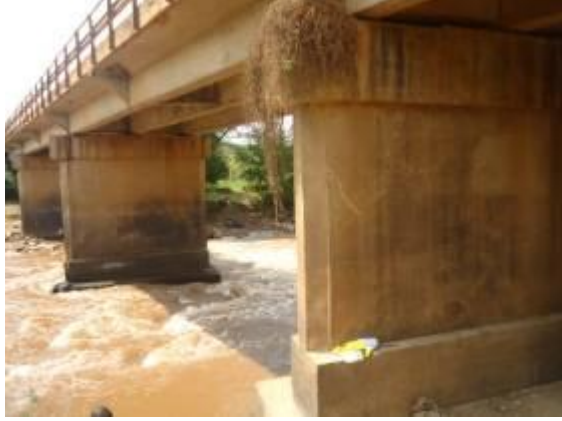
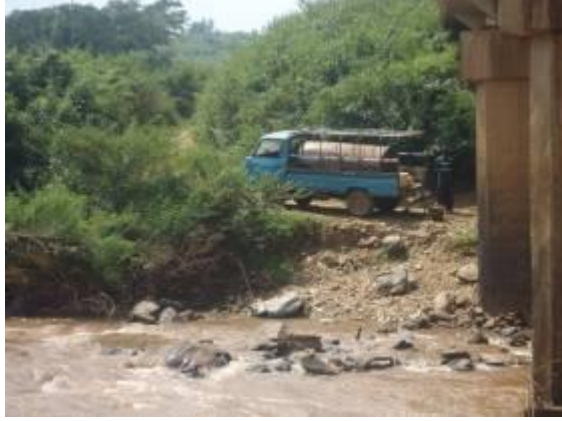
<p>Description : GogoKenGenGogo Hydroelectric plant on R. Gucha. The water flows at high velocity</p>	<p>Description : GogoKenGenGogo Hydroelectric plant on R. Gucha. The dam is silted leading to vegetation growth in some parts of the dam</p>

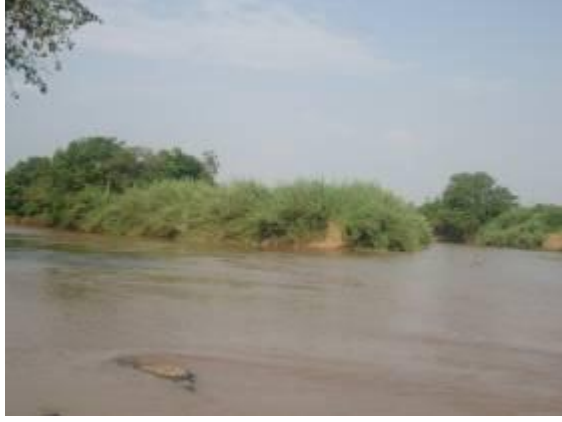
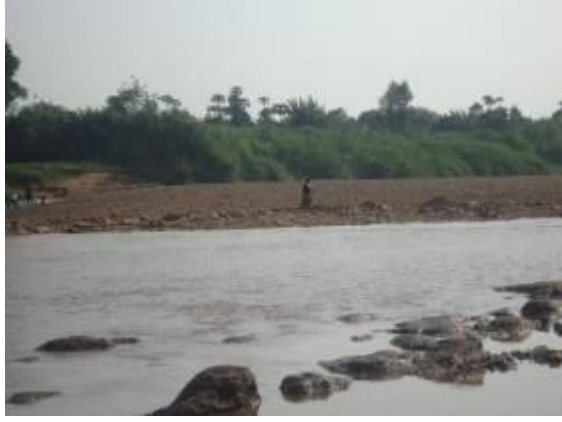
<p>Description : DarajaAego in Nyatike District, R. Gucha flows downstream and the water colour is brownish and the riverbed material is rocky and soil sediments. The river structure is the vehicular bridge on Migori-WathOnger road</p>	<p>Description : DarajaAego in Nyatike District, R. Gucha flows downstream and the water abstractors using pumps to pump into their lorry thereafter use the water to wash gold ore in the mines</p>

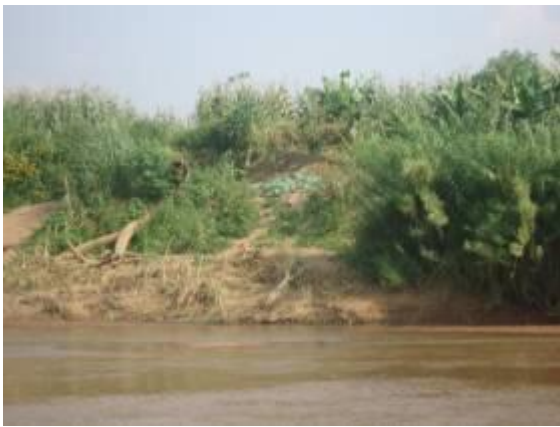
<p>Description : Sango area in Nyatike District, the confluence of R. Gucha and R. Migori the water colour is brownish and the riverbed material is rocky, sandy and soil sediments.</p>	<p>Description : Sango area in Nyatike District, the confluence of R. Gucha and R. Migori there is a huge deposit of soil sediments within the river channel which during rainy season is covered by water</p>

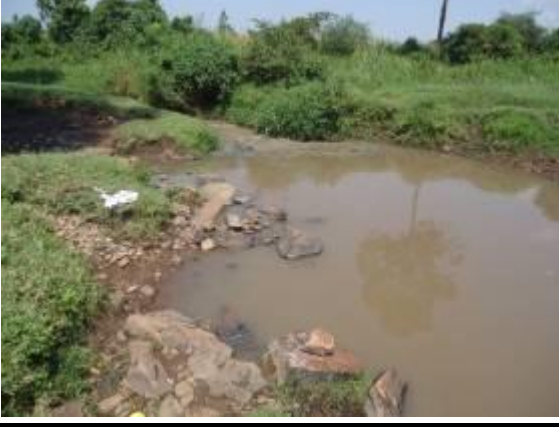
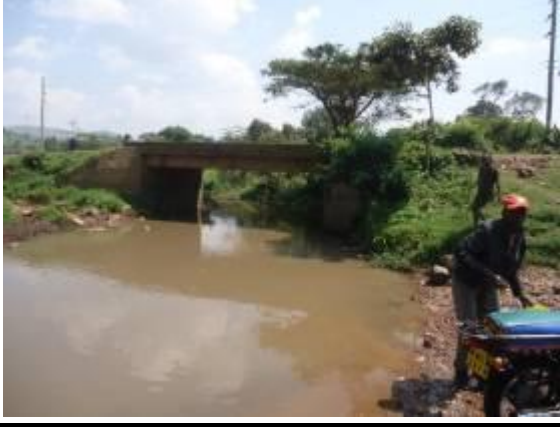
<p>Description : WathOnger R. GuchaMigori flows downstream the water is brownish in colour and the riverbed material is rocky, sandy and soil sediments and in the river structure includes vehicular bridge on WathOnger-Muhuru Bay road</p>	<p>Description : WathOnger R. GuchaMigori flows downstream the water is brownish in colour and the river structure includes WRMA's river gauge station and in the river channel there are wooden logs debris</p>
<h3>River Migori System: Upstream</h3>

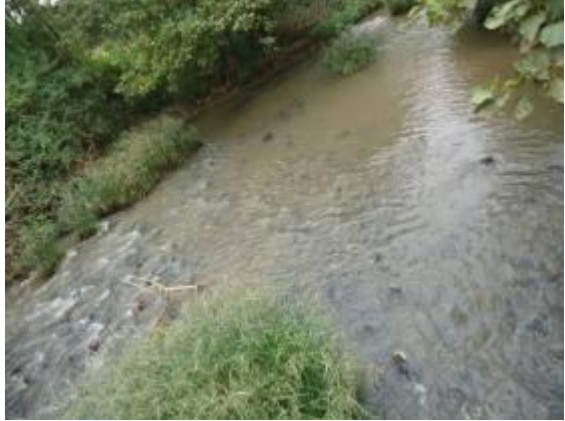
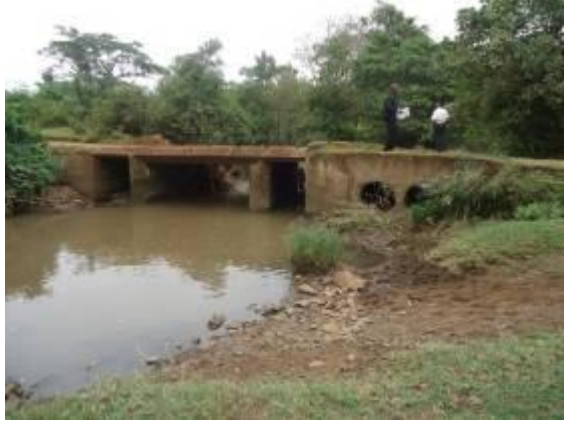
<p>Description : Enoosaen area in Keyian in Transmara District, R. Enoosaen that drains into R. Migori flows downstream riverbed material is rocky and sand alluvial</p>	<p>Description : Enoosaen area in Keyian in Transmara District, R. Enoosaen that drains into R. Migori flows downstream river structure is eight cylindrical culvert of which 2 are blocked</p>

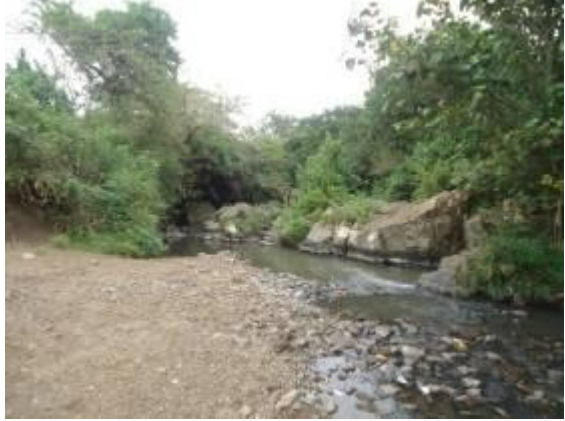
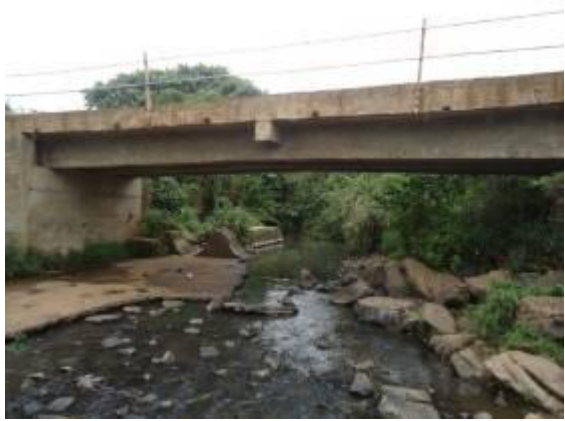
<p>Description : ASTU, Indiyano Sub-location Transmara District R. Remo that drains into R. Migori flows downstream riverbed material is rocky, pebbles and sand alluvial</p>	<p>Description : ASTU, Indiyano Sub-location Transmara District R. Remo flows through a river structure a box 3 compartment bridge for vehicular use and 2 cylindrical culvert compartments constructed as one unit</p>

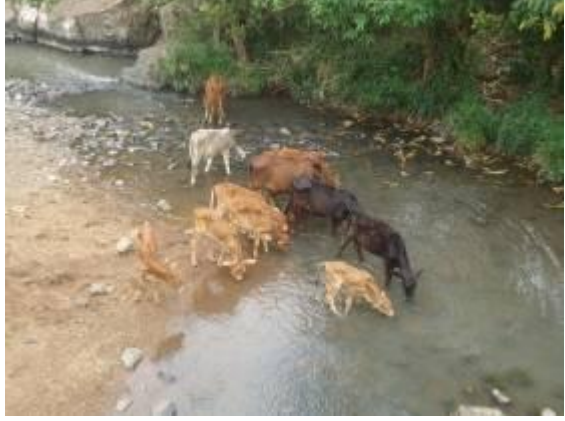
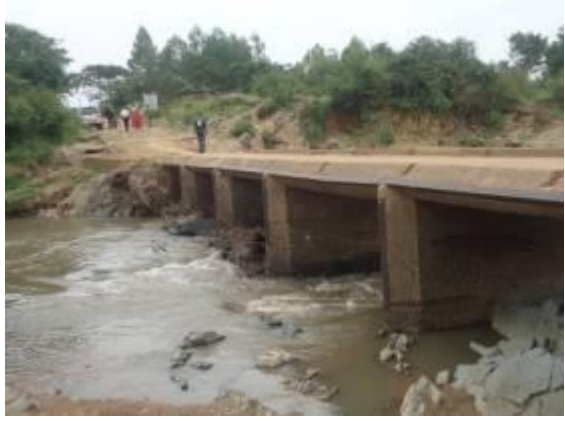
<p>Description : Ndiri area in Transmara District, R. Ndiri that drains into R. Migori flows downstream riverbed material is rocky pebbles and alluvial soil</p>	<p>Description : Ndiri area in Transmara District, river structure is a vehicular Bridge; and parts of old structures of the decommissioned bridge and also a watering point for livestock</p>
<p>River Migori System: Midstream</p>

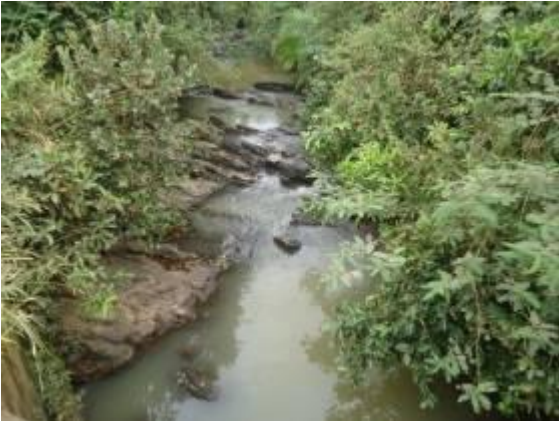
<p>Description : Nyeikute village, Komanga Sub-location in Kuria-Kihancha District R. Nyogoto a tributary of R. Migori has riverbed material of rocky and sand alluvial</p>	<p>Description : R. Nyogoto a tributary of R. Migori has river structure box culvert for vehicular use; River overflows the bridge and affects the farms nearby</p>

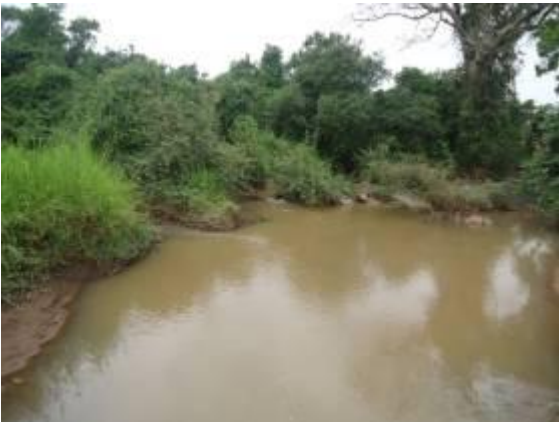
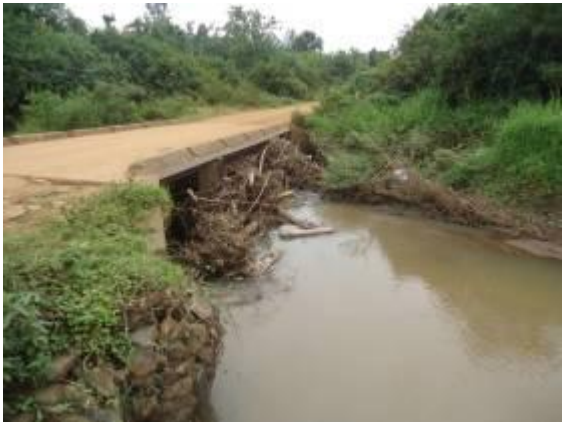
<p>Description : Daraja ya Masaba area boundary of Nthiange and Masaba sub-locations in Kuria District R. Bungenech a tributary of R. Migori has riverbed material of rocky and sand alluvial. River catchment is intact with minimal human activities observed</p>	<p>Description : R. Bungenech a tributary of R. Migori has river structure of box culvert on the road that links the two locations i.e. Nthiange and Masaba sub-locations in Kuria District</p>

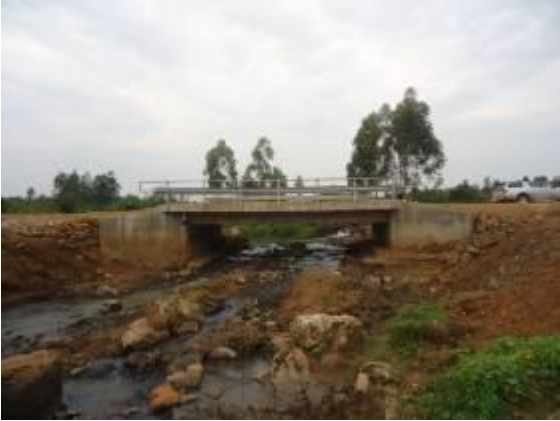
<p>Description : At the confluence of R. Bosara and R. Nyandara is where R. Hibwaa a tributary of R. Migori starts. Riverbed material are rocky, pebbles and sand Rocky, pebbles and sand alluvial</p>	<p>Description : R. Hibwaa has river structure a vehicular bridge and gabions. There are debris blockages on the bridge compartments</p>

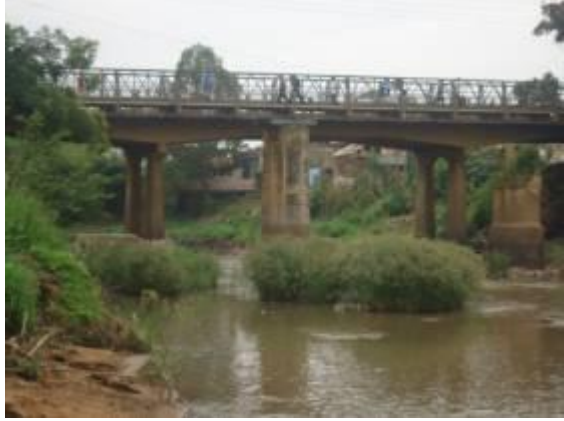
<p>Description : Ragane Area near the boundary of Kuria and Migori districts. R. Ragane a tributary of R. Migori flows and riverbed material is rocky and pebbles and one of the river structure is the vehicular bridge</p>	<p>Description : R. Ragane a tributary of R. Migori flows and the river structure includes gabion works that reinforces the bridge and drainage canal that drains run-off water into the river channel</p>

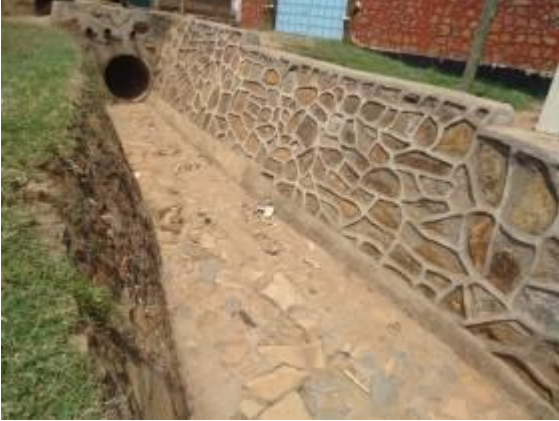
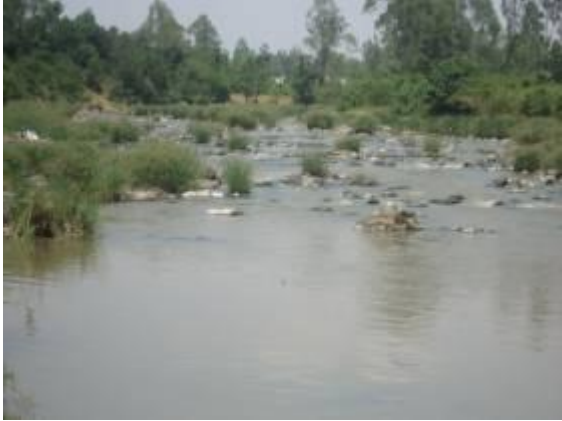
<p>Description : Nyasare estate in Migori Town: R. Nyasare a tributary of R. Migori and the riverbed material is rocky, pebbles and sandy</p>	<p>Description : R. Nyasare as it flows downstream it has river structure which is 5 compartment cylindrical culvert and a house is constructed just beside the river</p>

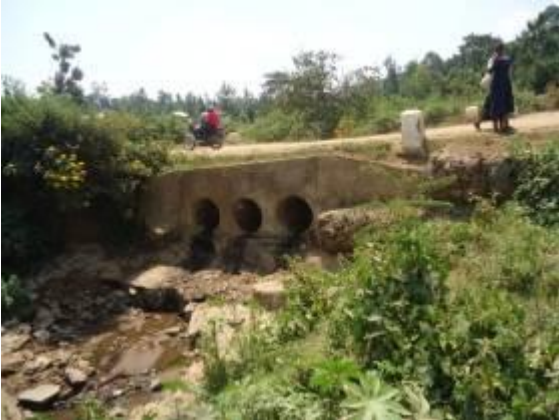
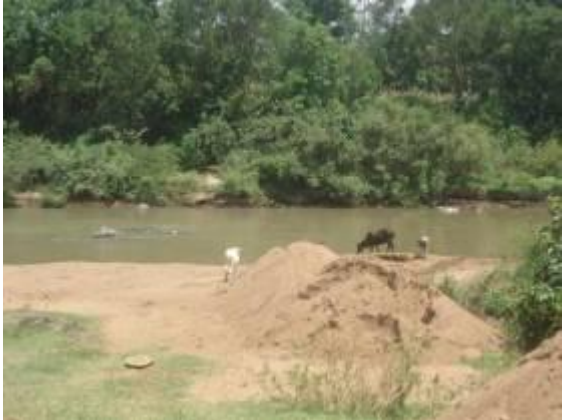
<p>Description : On R. Nyasare there is also a run-off water drainage that drains into the river channel</p>	<p>Description : R. Nyasare drains into R. Migori which is about 100 M apart at this point. There are no river structures on R. Migori at this point but there are vegetation growing in the river channel</p>

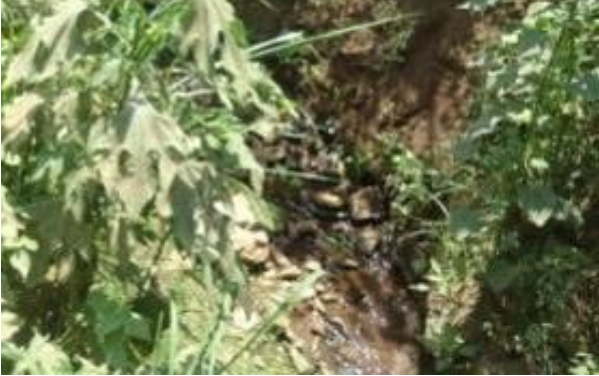
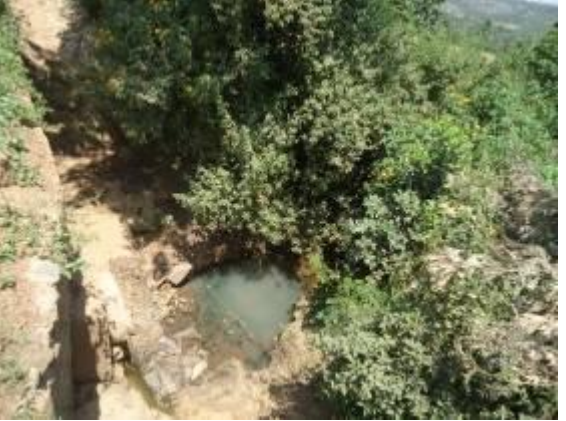
<p>Description : Kakrao area in Migori district R. Nyasarara a tributary of R. Migori and the riverbed material is soil sediments, rocky and pebbles</p>	<p>Description : R. Nyasarara that drains into R. Migori flows downstream river structure is 4 compartment cylindrical culvert of which some are blocked</p>

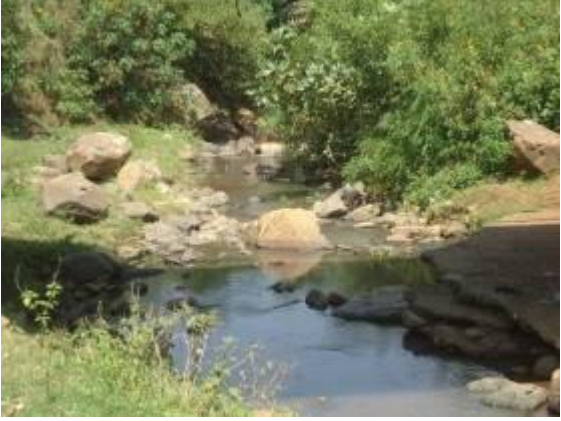
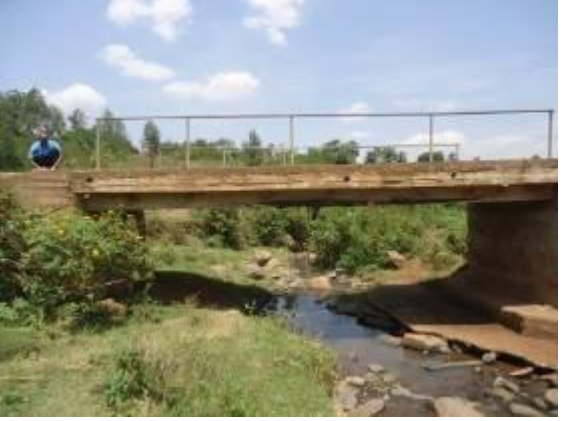
<p>Description : Othatcho location in Migori district R. Othatcho a tributary of R. Migori and the riverbed material is soil sediments, rocky and pebbles</p>	<p>Description : R. Othatcho drains into R. Migori and has river structure a 1 compartment cylindrical culvert and on its channel there is a natural indentation on the river channel that acts as a reservoir for water during dry season</p>

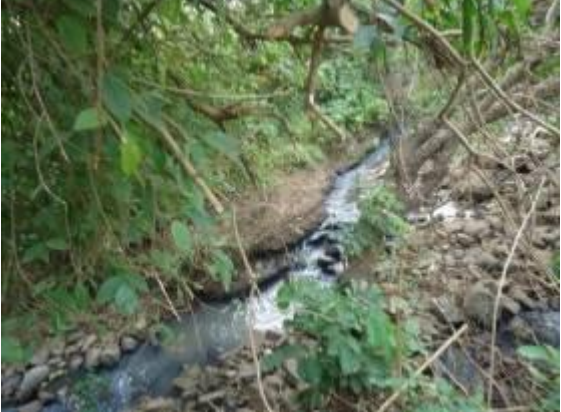
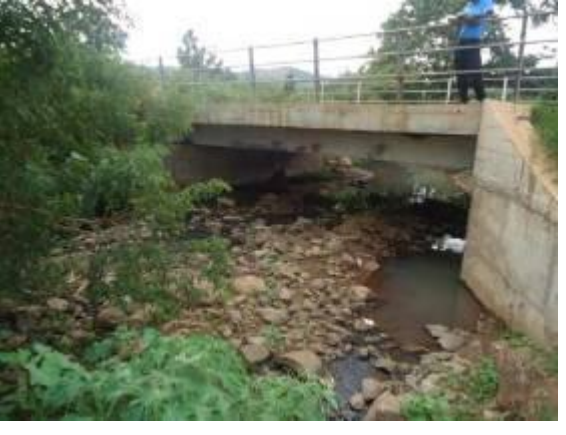
<p>Description : Eko area, Ajego sub-location in Migori district R. Eko a tributary of R. Migori and the riverbed material is soil sediments and rocky</p>	<p>Description : R. Eko has river structure is a vehicular bridge</p>
<p>River Migori System: Downstream</p>

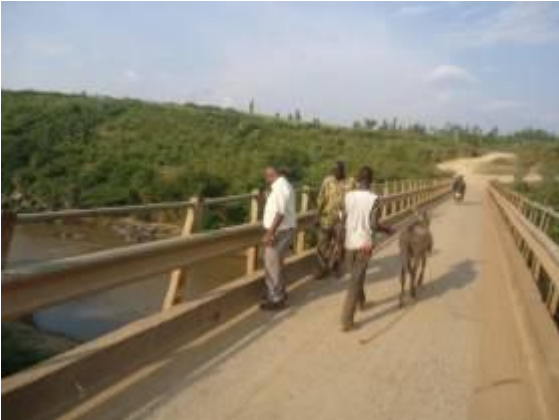
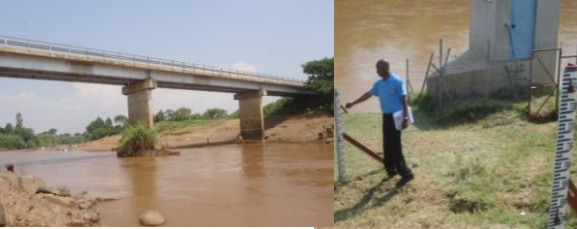
<p>Description : Kadem south - Othatcho locations boundary R. Owich though a seasonal river is a tributary of R. Migori and the riverbed material is soil sediments and rocky</p>	<p>Description : R. Owich drains into R. Migori and has river structure which is a 2 compartment cylindrical culvert and water pollution is negligible by evidence of breeding of tadpoles and other marine life</p>

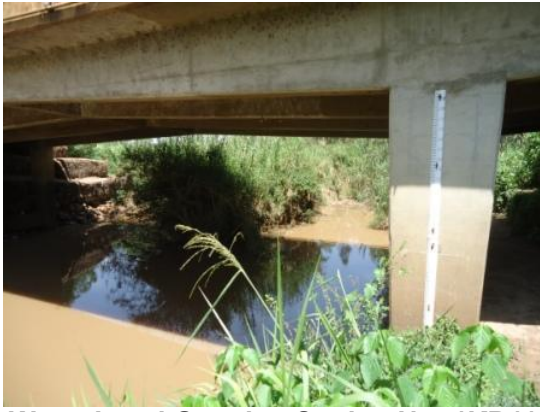
Water Level Gauging Station No.:1KB11
Observation River: Oyani River

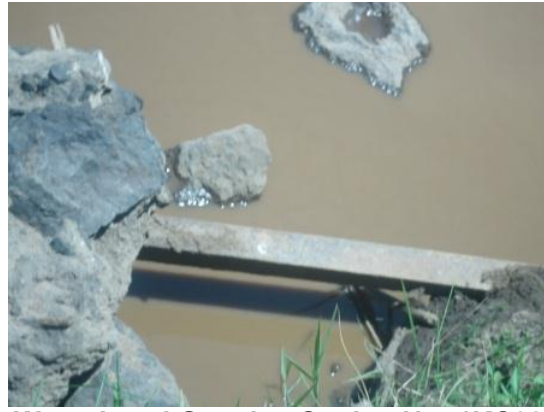
Water Level Gauging Station No.:1KC03
Observation River: Migori River
Special Note: Water level gauge is broken off and damaged.

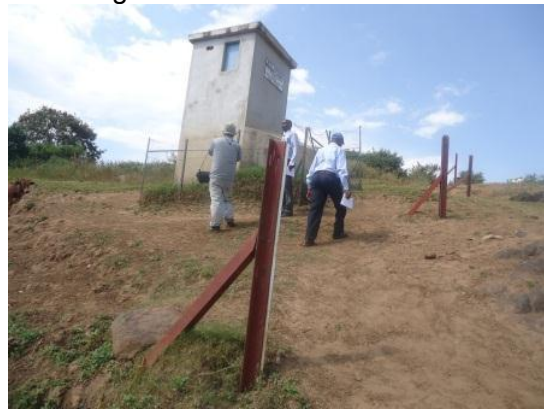
Water Level Gauging Station No.:1KB05
Observation River: Gucha Migori River

Water Level Gauging Station No.:1KB05
Observation River: Gucha Migori River
Special Note: This is an automated gauge station that transmit data to WRMA Regional Office

The secondary data collected from Lake Basin Authority “RIVER PROFILE STUDIES VOLUME IV, LOWER KUJA, IRRIGATION DEVELOPMENT ANNEX II HYDROLOGY OCT 1985” reports that: The Kuja flow record at 1KB05 provides an annual series of 15 years. Although this record is short it has the benefit of the station being reasonably calibrated up to 5.78M (534M³/S). the highest level at which flows have been gauged by current meter; with the highest observed level in 15 years being at 6.70M, under 1M higher than the maximum gauged by current meter. By contrast, records at 1KB1, 1KB1A and 1KC3 are longer but have less certain flood flow ratings. The highest gauged flow of the Kuja at 1KB1/1KB1A is only 139M³/S, although the 1KC03Migori has been gauged at 477 M³/S.⁴ (Page A2-17)

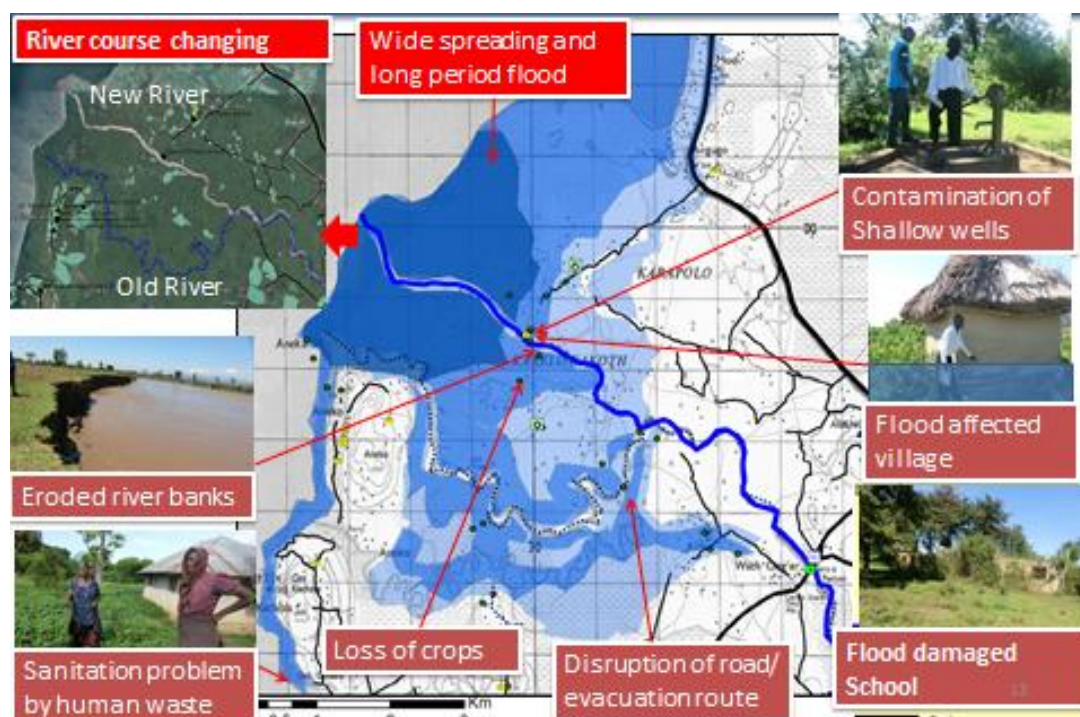
Figure 3.2.3 Flood Characteristics in the Low-lying area of Lower Gucha Migori River

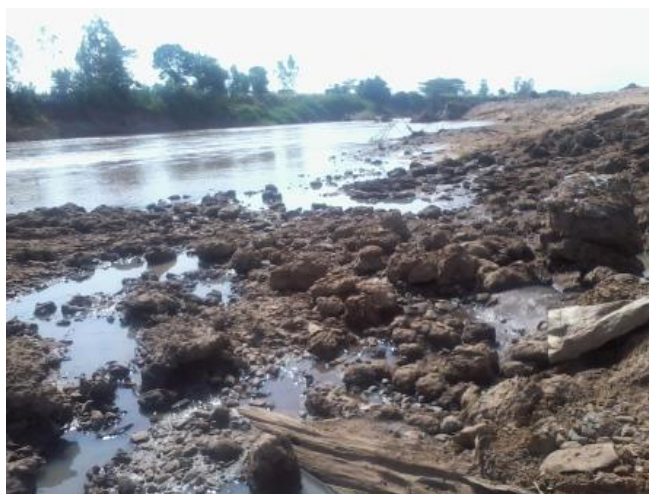
Figure 3.2.4 Flood Characteristics near the Gucha Migori River’s Tributaries

Around upstream to middle stream, sediment outflow occurs heavily with farmland erosion caused by furious rainfall and high velocity sheet flow. Interviews with Agricultural Officers in the upstream revealed that there is heavy erosion during heavy rains and that the storm water flows through the many murrum feeder roads into the river channel.

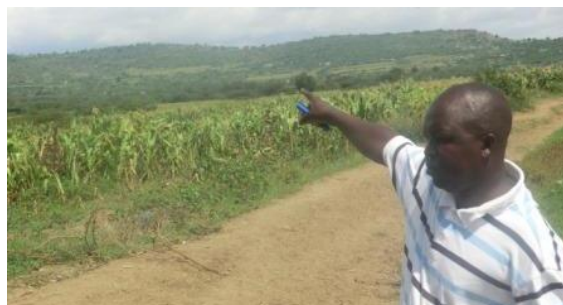
Figure 3.2.6 Flood Characteristics: Run-off water from nearby hills flow downstream

Agriculture, motorcycle transport and livestock rearing are the major source of livelihood in this area	Agricultural activities are affected, lack of grazing land for livestock, and transport by motorcycle is disrupted
Unpaved community road	The tarmac roads becomes the channel through which the storm water flow on and aftermath of flash floods the roads are severely damaged by floods

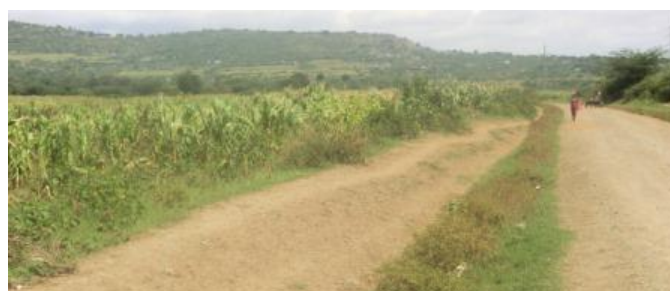
Figure 3.2.7 Flood Characteristics: The road through which the run-off water flow on

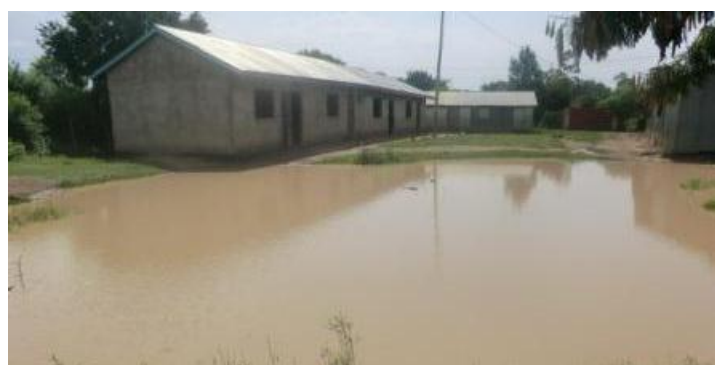
Figure 3.2.8 Flood Characteristics: The rain run-off water flow into the township

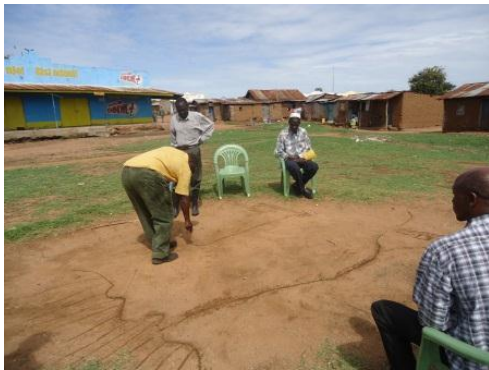
Drawing the map on the ground

Figure 3.2.9 Flood Characteristics: The Community-driven Flood Hazard Map

Example of the community driven flood hazard map is shown in the figure 3.2.8 below.
