**Implementation Plan of the Pilot Project at Lower Lumi
sub-catchment**

**REPUBLIC OF KENYA
PROJECT ON CAPACITY DEVELOPMENT
FOR
EFFECTIVE FLOOD MANAGEMENT IN FLOOD PRONE AREA**

**SELECTION PROCESS AND IMPLEMENTATION PLAN
OF
THE PILOT PROJECT
AT
LUMI RIVER BASIN
- DRAFT -**

June 2013

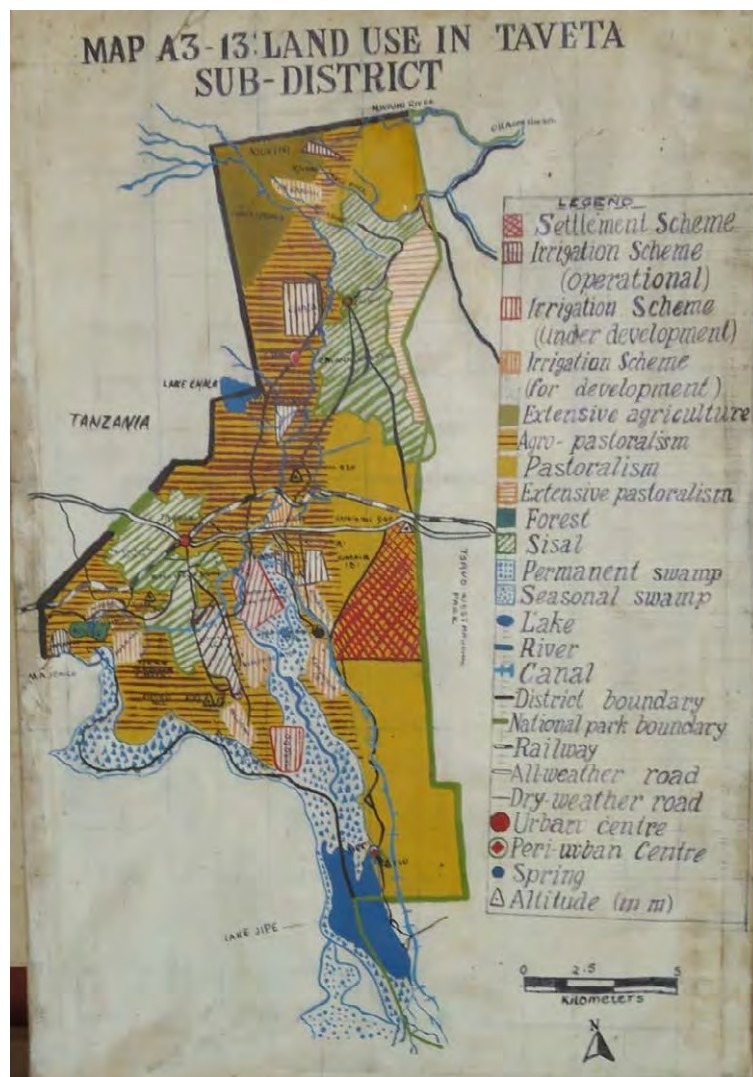
Figure 1.1.4 Land Use in Lumi River Basin

Land use characteristic in Lumi River Basin is shown in Figure 1.1.4. As shown in Figure 1.1.4, the river basin is generally utilized as agricultural land and cattle camp. In the vicinity of left bank of middle stream of Lumi River and at the east-south side of Taveta Town, sisal is grown. Low land nearby Lake Jipe is a wetland.

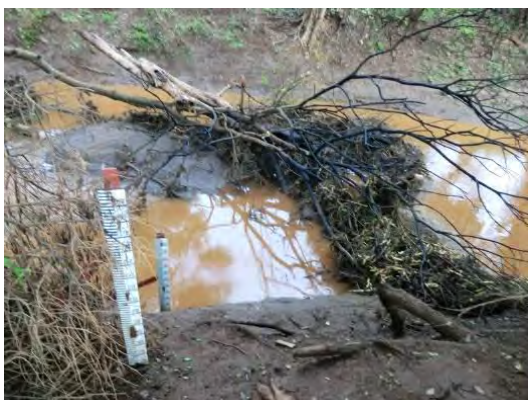
Water Level Gauging Station No. : 3J15
Measure water level of Lumi River.

Automatic measurement is not done at each water level gauging station, but the visual observation is carried out twice a day, i.e. in the morning and in the evening. Therefore, the river discharge at the time of flood is said to be inaccurate although the conversion is done from water level data to river discharge data.

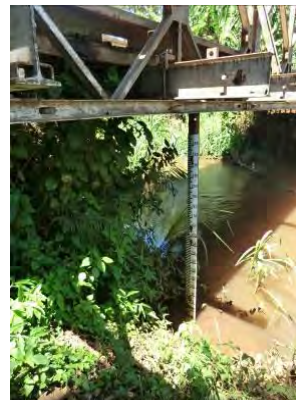
Water Level Gauging Station No. : 3J16
Measure water level of Lumi River. Install device under the pier.

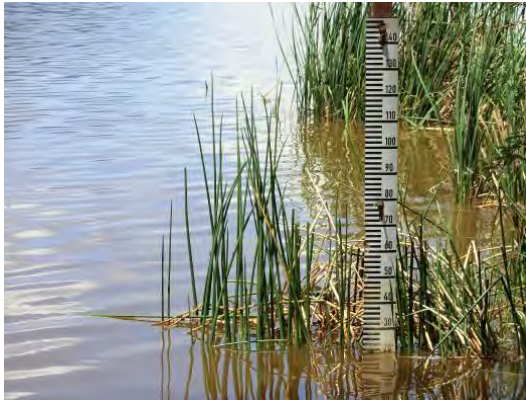
Water Level Gauging Station No. : 3J2
Water level gauging station inside Safari Camp
for measurement of water level of Lake Jipe

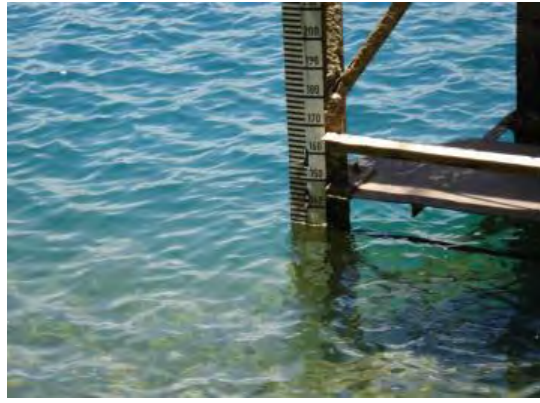
Water Level Gauging Station No. : 3J12
Measure water level of Lake Challa.

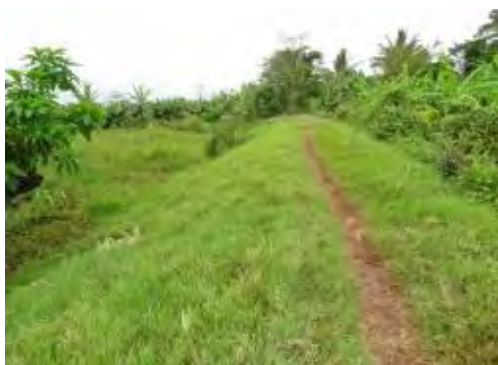
Photo 2.1.1 Embankment of the Canal-C

prevention at school, early flood warning system, etc. are considered. Further, to force an end of inundation from Lumi River, the countermeasures such as widening of and improvement by dredging, etc. of Lumi River, improvement of the existing drainage canal in low-lying area and dredging of Lake Jipe to improve the storage capacity are considered. There are three major existing drainage canals of Canal A, Canal B and Canal C. It is considered to reduce the flood damages largely by heighten the flow capacity of these Canal A, Canal B and Canal C by way of dredging and improvement. Especially, though the bank of Canal C is partly broken down at present, it is one of the options to rehabilitate the bank.

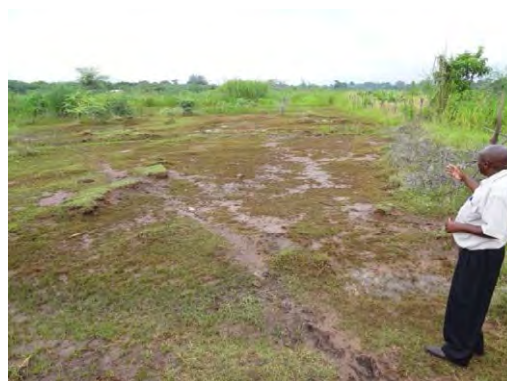
Photo 2.1.2 Broken Point of the Embankment Canal-C

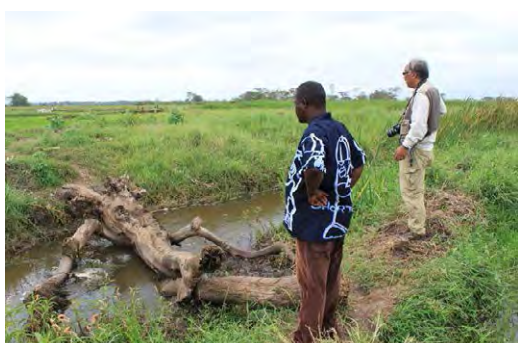
Photo 2.1.3 Canal-A around Kimorigo Village

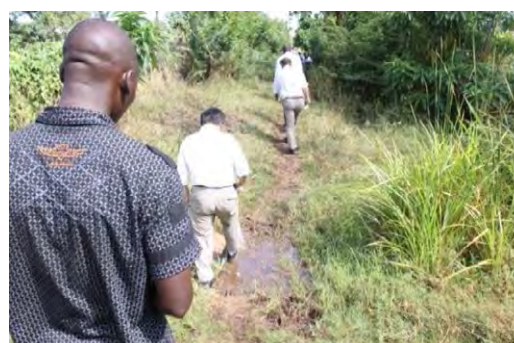
Photo 2.1.4 A Point of Artificially-destroyed Embankment
 (take agricultural water from Lumi R. of the left side on the photo and supply to the right side)

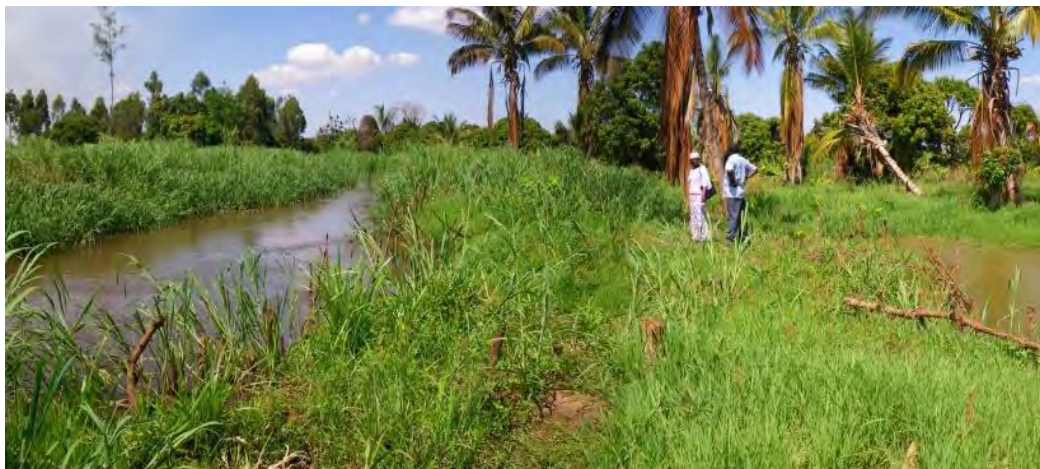
- Low-lying area is inundated by flood water of over flow and dyke break from the Lumi River due to lack of flow capacity.
- The lack of flow capacity is caused by narrowness, high bedded and gentle slope of the Lumi River. Aggradation of river bed levels is generated by discharged sediment. Moreover gentle slope (1/1000 - 1/500) of river profile is causing low flow velocity. (Reference on Photo which was taken near the mouth of the Lumi River)
- Drainage canals (Canal-A, -B and -C) which are located in the inundation area don't have enough flow capacity and part of embankment along the canals is broken; hence these canals don't fulfill their function of existed facilities.
- Inundation is prolonged at the low-lying area because gradient of land features is gentle (1/1000 - 1/500).
- In addition, due to rising water level of the Lake Jipe, flooding water has nowhere to go

Photo 2.2.1 Near the Mouth of the Lumi River
(the River is narrow and water level is higher than farming land)

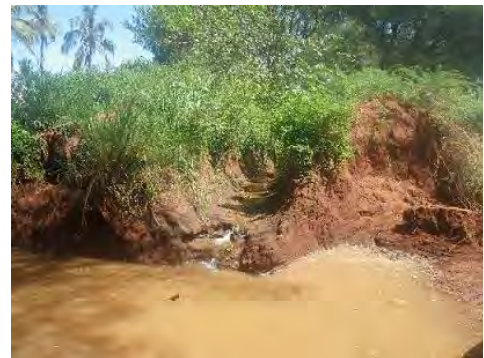
Irrigation canal broken down by flash flood from lateral face

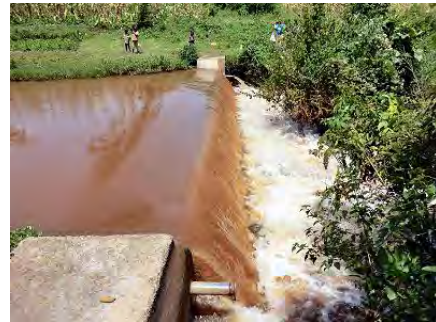
Many flash floods occur during rainy season in the middle to upstream of Lumi River. Flash flood brings about a lot of damages inducing debris flow. To prevent flowing out of debris flow, Check dam is considered as a countermeasure. On the other hand, damage on soil erosion becomes a serious issue. Flowing out of earth and soil causes irrigation pond to be buried by soil erosion, and this induces another issue to lose the primary function of the irrigation pond. To cope with this issue, strengthening of soil by restriction of logging, forestation activity, etc. is considered effective.

Check Dam
 (Example of Nzoia River)

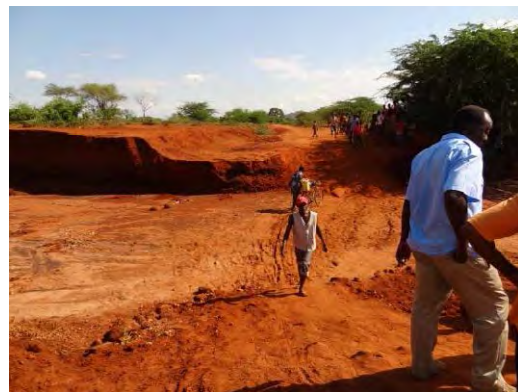
Road Bridge rushed out
Place : Rengesa

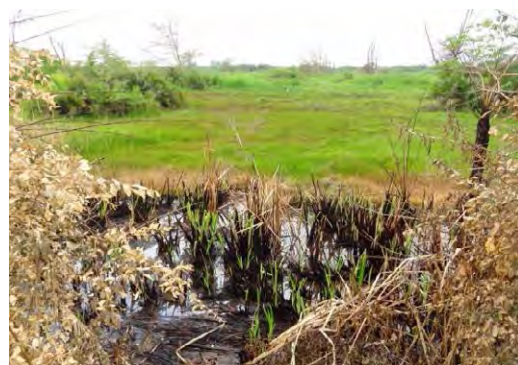
Damp ground where the bank of Canal-C has been washed out

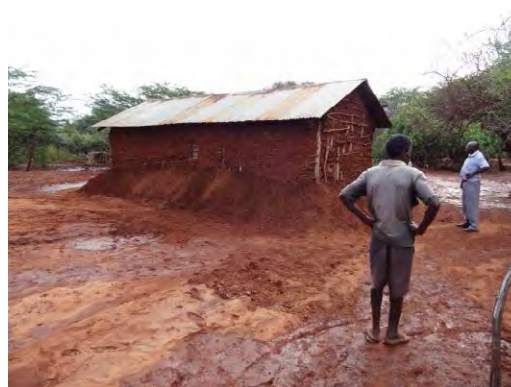
Land elevation after inundation of house
Place : Rengesa

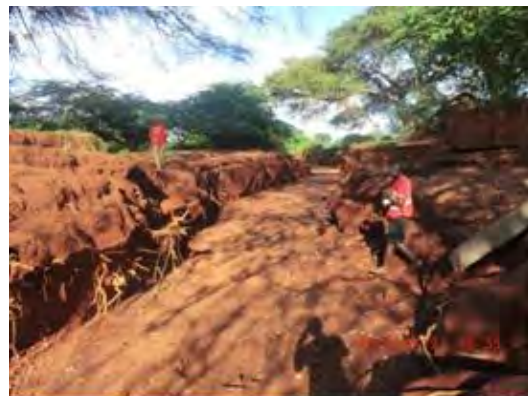
Wash out of land by bank erosion of seasonal river
Place: Rekeke

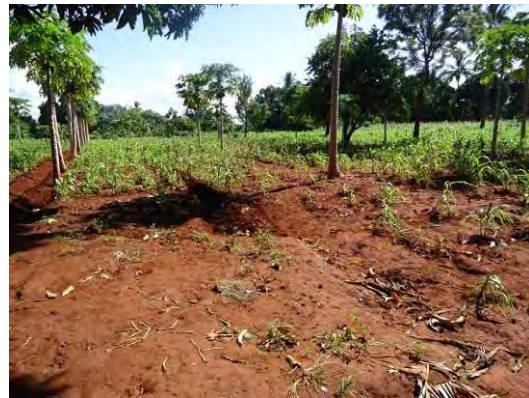
Agricultural land of which the surface soil has been washed out by flood
 Place : Kimala Irrigation Scheme

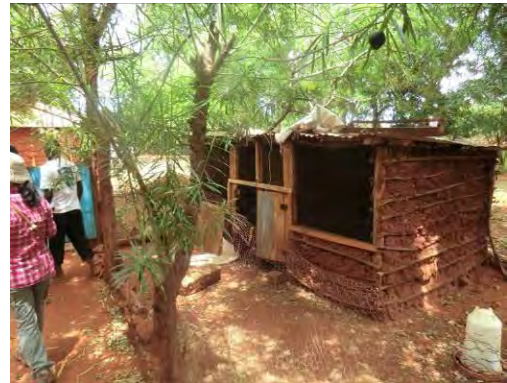
Regarding loss of livestock and agricultural products, lack of knowledge and information to reduce damage by resident level becomes obstacles. For instance, chicken house is constructed directly on the ground though it is submerged every year by flood. Accordingly, chickens are easily drowned by the inundation caused by flood. There is a possibility to reduce damages by raising elevation of chicken house not to be submerged under water like the south east Asian countries where many floods hit every year. It is quite important that the residents shall have such a knowledge for reduction of damage, and minimizing the flood damage will largely contribute to the recovery of living after flood damage.

Chicken House

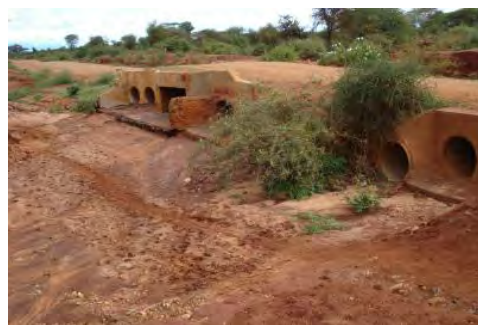
Bridge with pipe culvert installed at
the dry up river crossing the road

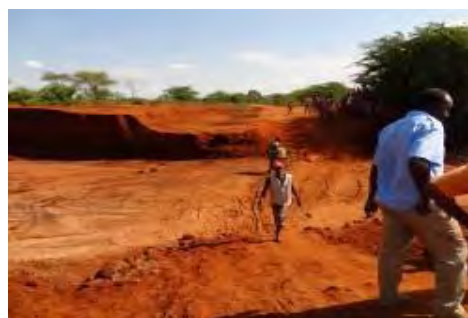
Washout of the concrete bridge of the same structure to the above by flash flood
Place : Rengesa

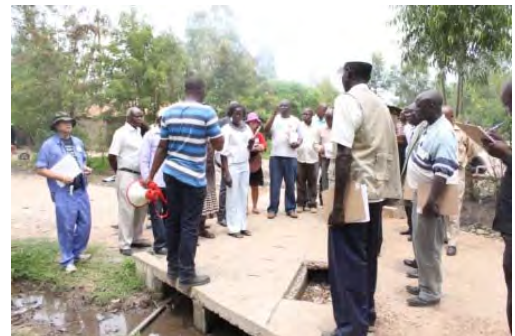
- ✓ Operation and Maintenance of the Structures: The CFMO Chairperson pointed out the difficulties the CFMO faces in maintaining culverts within the village. O&M of culverts is voluntary and lacks any incentives for the community members to be involved in the maintenance.

Explanations on small culverts

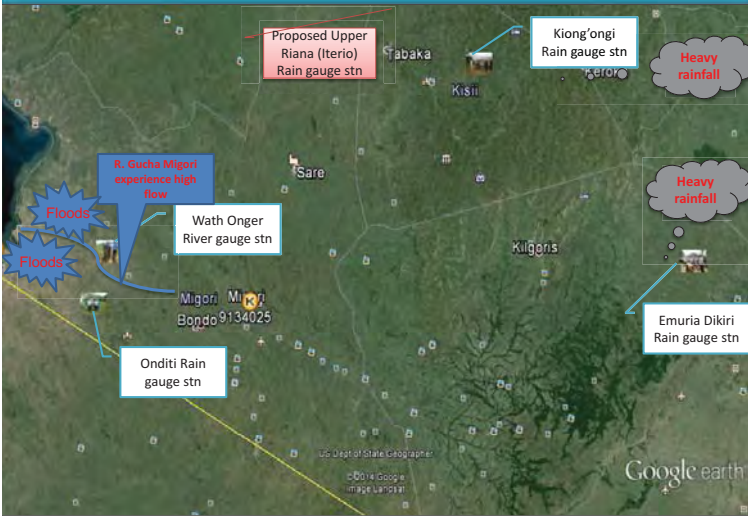
Installation of Community-based FEWS in the Upstream.

Two rain gauges have been installed in the upstream parts of Kisii and Transmara sub-counties. In Kisii the rain gauge and sensor was installed Kiang'ong'i Secondary School and a teacher who is also Middle Gucha WRUA member is in charge but the school and the WRUA assigned Mr. Omsa school watchman as an observer.

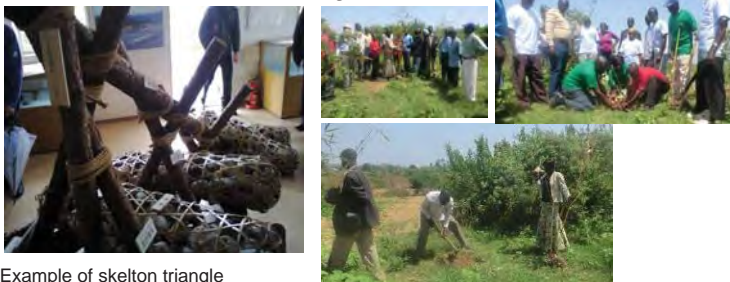
Use of skeleton triangle structures to control river bank erosion this is applicable in LOGUMI SC. To execute this bamboo reeds should be planted in the wetlands and riparian areas this will also help in riverbank protection and restoration of the depleted wetlands and thereafter the bamboo will be harvested and used for construction of skelton triangle structures.

Example of skelton triangle structures in Japan

Planting of bamboo trees to protect the riverbanks

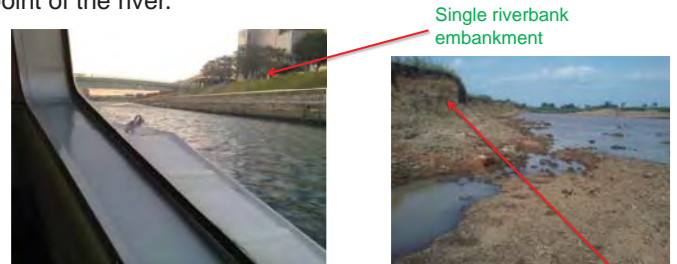
Single river bank embankment can be applied at new deviation point of the river.

Current status of damaged riverbank at R. Gucha Migori

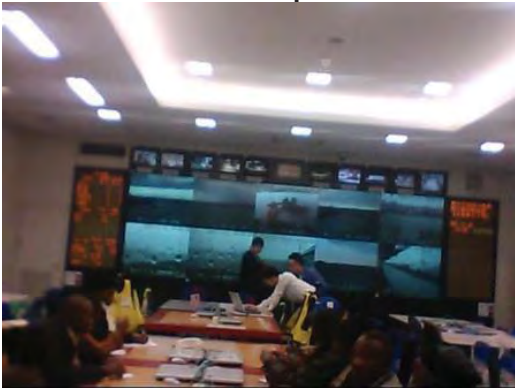
Arakawa Disaster Operation Centre

This is an advanced disaster operation centre that manages R. Arakawa disasters including flooding. The centre is equiped with state of art equipment whereby river water levels can be monitored electronically and information disseminated to relevant stakeholders through digital TV, Internet, radio etc

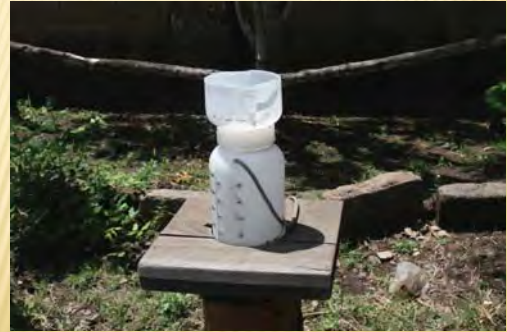
LESSONS LEARNT PLASTIC BUCKET IS TORN OUT

1 Plastic Bucket is damaged by ultra violet rays

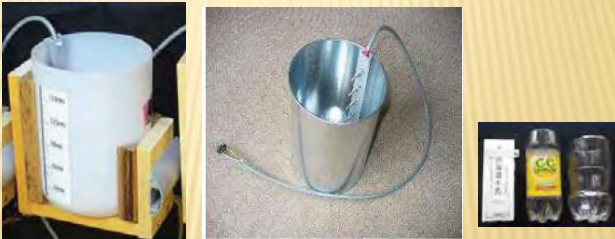
PLASTIC BUCKET (NEW TYPE)

New Plastic Bucket (separation type) or tin Bucket

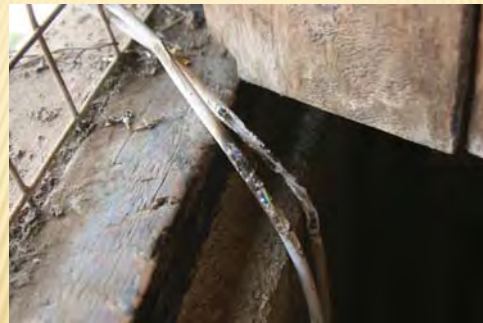
MOUSE BITE IN TWO A CABLE

>>>> PVC pipe cover

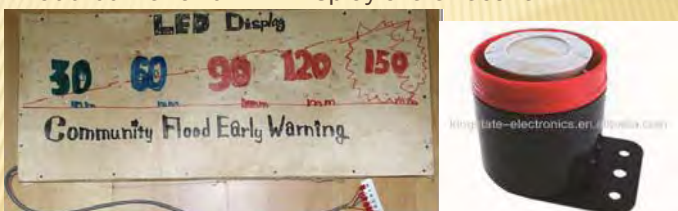
BUZZER

Loud buzzer and LED Display are effective

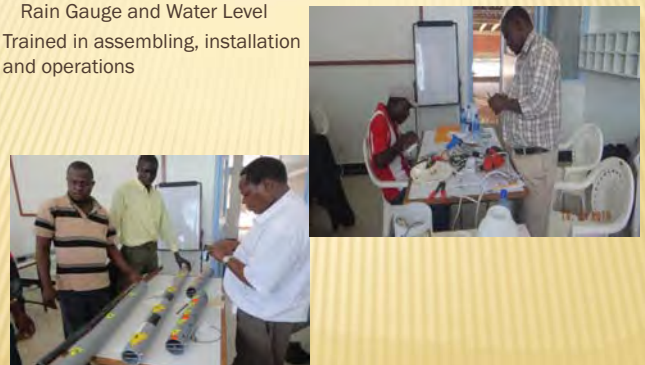
Rain Gauge and Water Level

Manufacturing can be done Locally

- Trained in assembling, installation and operations

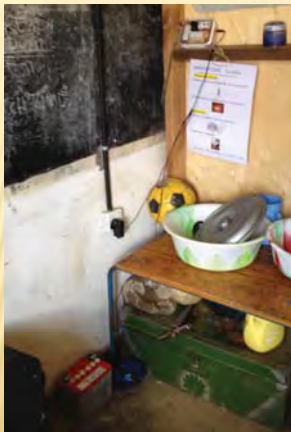
OBSERVER BACKUP POWER

- ✘ Solar panel and battery improve observer's motivation G I
 - + Flash Light, mobile phone charger, animal's protection and etc.
- ✘ Install to existing river gauge is easy to understand of water level
- ✘ Vandalize protection is effective
- ✘ Cooperation with upper WRUA
 - + After site visit from upper WRUA, they understand the flood situation and cooperative
 - + it need one more rain gauge station

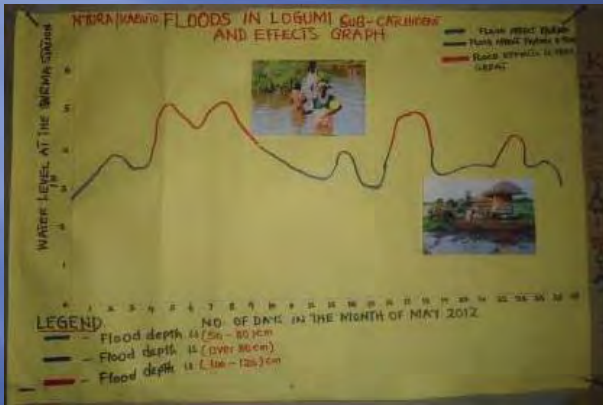
Picture of the Hydrograph Developed

- During flooding in LOGUMI SC one of the major problem is flood damage to the homes leading to loss of lives and properties.
- It was noted that if early warning is issued on time then the human loss and suffering will be reduced during flooding period.
- LOGUMI WRUA therefore in pursuit of community based early warning developed a hydrograph.
- Following the sustained effort of collecting flood information and correlating the same with river gauge heights at Wath Onger station the WRUA managed to develop a flood hydrograph.

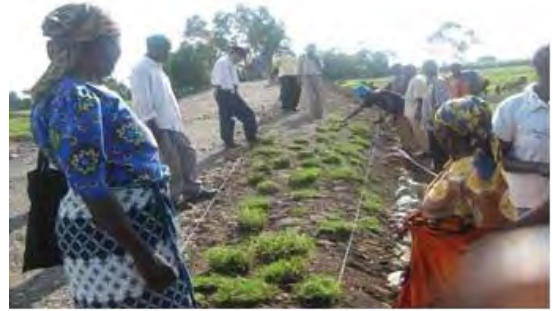
Sodding

- 1) Cover 50% of the slope area with sod/turf
- 2) Plant sod/turf in a triangle format. This will help to reduce the velocity of the surface runoff at the slopes hence reducing soil erosion

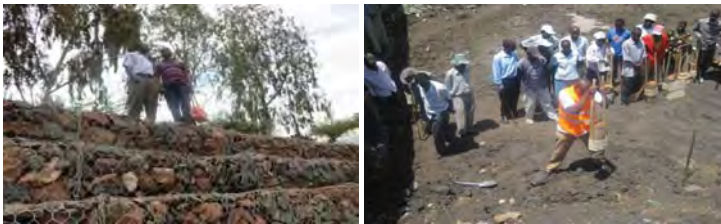
Maintenance

- 1) Regularly check the gabion boxes and fix any torn/cut gabion net.
- 2) Galvanized wire, pliers, wheelbarrow, spade, mattock are essential tools for maintenance of the gabion box
- 3) Add more backfill material when the back fill settle down .

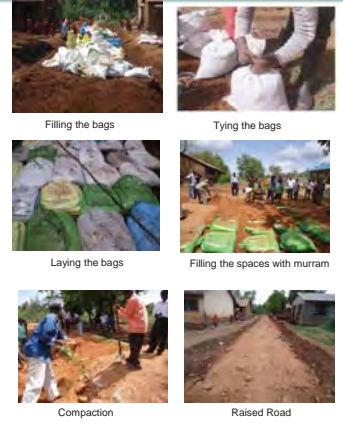
Filling up of the Donou Bags

- Fill the Do-nou bags with the recommended amount of soil and tie tightly.
- Lay Do-nou bags appropriately.
- Compact Do-nou by at least 20 strokes
- Fill the space between the Do-nou bags
- Apply a 10cm thick murrum layer and compact.
- If the soil is too dry, water it to facilitate compaction

- Each rainy season, road constructed using Do-nou technology require regular maintenance offer.
- Shapes: any damages, survivals
- Exposed Do-nou bags
- Sunken road profile
- If road surface is damaged,
- Lay the additional layer of Do-nou
- Cover the top layer of Do-nou with murrum
- Compact the murrum.

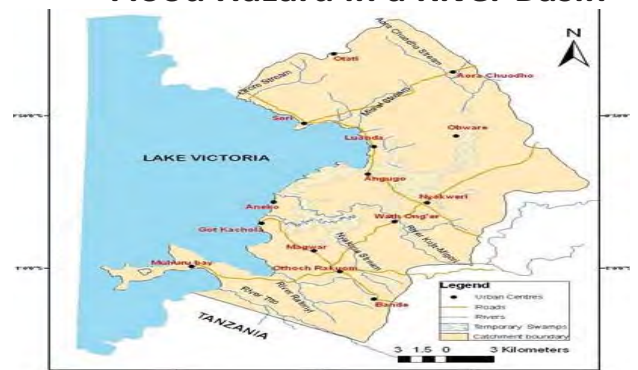
Figure 4 Satellite Map of LOGUMI Sub-Catchment

Flood Hazard in a River Basin

Source: LOGUMI WRUA SCMP
