**Ex-Post Project Evaluation 2013:  
PACKAGE II-3  
(Cameroon, Ethiopia)**

EV
JR
14-27

Ex-Post Evaluation of Japanese Grant Aid Project  
“Project for the Construction of Primary Schools (Phase IV)”

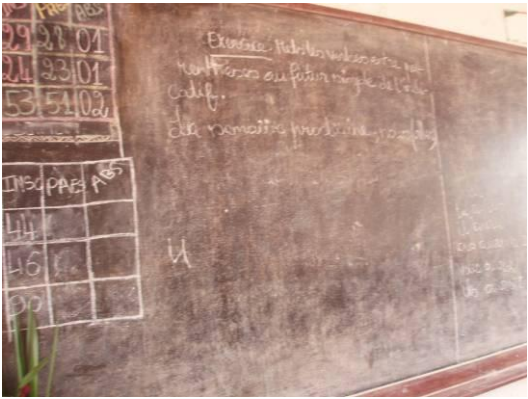
As a relatively slight problem concerning technical matters, through FGD during the site visits, teachers in eight sites out of the ten pointed out that the blackboards provided in the project were so slippery that they wrote with difficulty. Some of them claimed that more frequent repainting was required. It was implied in FGD that the current practice of repainting would be technically inappropriate in terms of selection of material and method. It was also mentioned that the slipperiness depends on the

Figure 3. Blackboard regarded as slippery

quality of used chalks. The “Manual on the Maintenance of School Infrastructure” only indicates the need to repaint a blackboard annually with slate paint and does not specify the materials and methods to be used in detail. Therefore, it is concluded that the problem can hardly be resolved at the school level (see Figure 3).

- As it is frequently pointed out that the blackboard made of plywood is too slippery to write on with a chalk, the Japan Grant Project Execution Unit of MINEDUB is recommended to give the project target schools advice on the necessary solution after assigning its technical staff or commissioning external technicians to carry out technical investigation on the painting material and method for surface and on how to use and clean it. Information on the paint appropriate for repainting the blackboard has already been obtained from the CM consultant and conveyed to the unit by the evaluator so that it is required to confirm whether the same sort of paint is used or not. Furthermore, the unit should consider the necessity to inquire of paint manufacturers what measures must be taken in using, cleaning, and repainting the blackboard properly and instruct

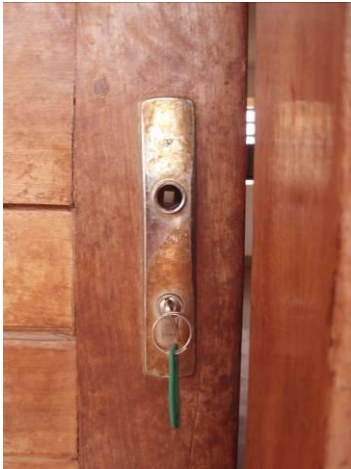
Meanwhile, there are several problems common to all schools. Door handles and locks of classrooms are so vulnerable that a large number of them are either left broken or replaced (Figure 4). The installed door handles lack durability that frequent use of the movable parts cannot be sustained. Since pupils’ frequent use of the door handles is inevitable according to the nature of the school, it is a concern that the handles have to be repeatedly damaged and replaced.

Figure 4. Vulnerable Door Handle

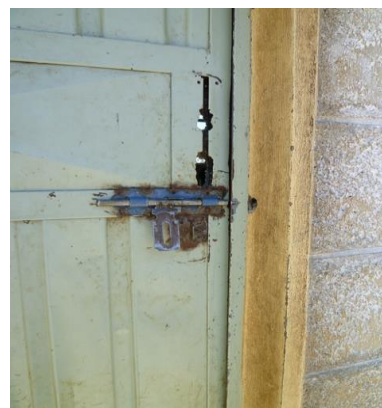
By confirming the situation at the directly visited school sites, door problems such as damage to knobs and keys were obvious in most of the schools. (The problems could have been avoided by using a different type of key, such as a bar-type lock.) In addition, problems were found of cracks in the concrete basement, floors and walls, leaking roofs in several schools, and a cover of precipitating tank of the latrine and a big hole in 1 school, which would not be regarded as minor defects and raise concerns in view of safety and durability. Most of the water

Figure 2 Broken door knob & key hole that is changed to a bar key

- Regarding the facilities and equipment at the target sites, OEB is requested to grasp the current situation in collaboration with local education offices in view of safety and durability as well as urgency and need for repairs. In doing so, it is recommended to include technical personnel with professional knowledge in construction and design because a deliberate survey is required to assess the cause of the defects, including whether there are any serious defects. In addition, the school directors need to take measures to mobilize the budget which will be necessary on a regular basis for maintenance (repainting and sludge removal) together with the PTA and village educational management committee members.
