Ex-Post Project Evaluation 2013 :
Package II - 7
(Tonga, Vanuatu, Angola)

Ex-post Evaluation of Japanese Grant Aid Project
“The Project for Construction of the Inter-Islands Vessel”

External Evaluator: Keisuke Nishikawa
Japan Economic Research Institute Inc.

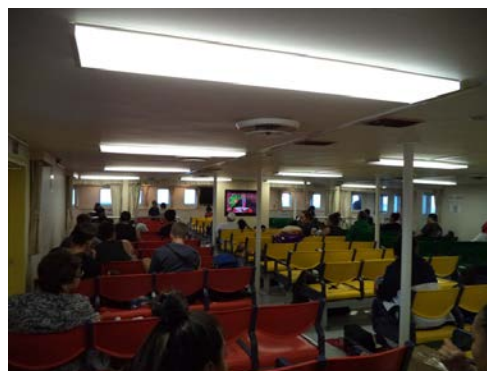
Photo 1: Main Cabin (Economy Class)

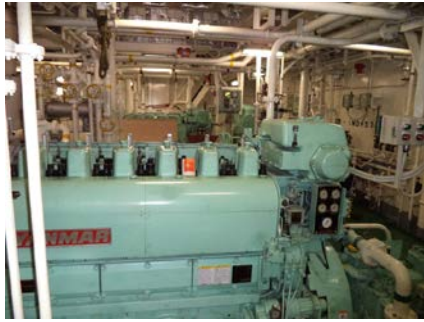
Photo 3: Engine Room maintained in clean condition

FISA has a small workshop in the headquarters and has been conducting on-board maintenance except for dry-docking of the keel. In this project, as well as procuring a ferry, containers and forklifts, a PMP was formulated as described in '3.5.2 Technical Aspects of Operation and Maintenance', whereby the items to be implemented to keep the vessel in good condition were specified together with the timeline (daily, weekly, monthly, yearly and every several years), such as greasing the cargo cranes (monthly) and checking the bow thruster shafting condition (yearly). In fact, the PMP was introduced right from the start of operations, with all inspections apart from dry-docking regularly conducted by the workshop staff and crew members and dry-docking in Fiji implemented once every year.

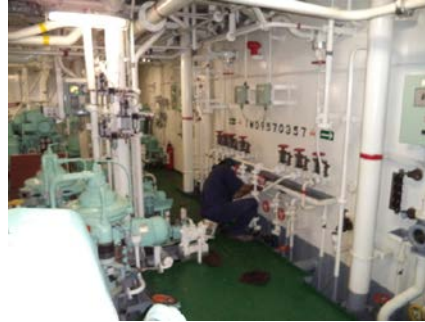
Photo 4: Inspection of the Engine Room

The PMP had not been introduced to MV Olovaha, and there were difficulties in addressing breakdowns as the vessel deteriorated. The actual confirmation of MV ‘Otuanga’ofa’s maintenance status during the ex-post evaluation study showed that the hull, engine, electrical system and equipment remained in good condition and the engine was also inspected and repaired as required. No cancellations due to sudden breakdowns had occurred since it started operation, and it can be said that the vessel has been operated generally in good condition. The workshop, despite its small size, basically seemed to be equipped with tools and equipment required to carry out inspection and repair work of the procured vessel.

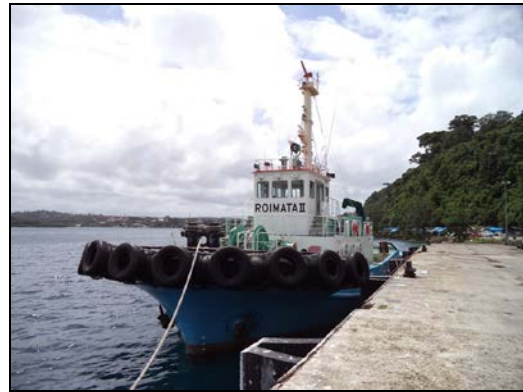
Photo 2: Tugboat provided under this project

A fire extinguishing device for other boats was installed on a tugboat to deal with fire accidents at sea and on land facilities. While there have been no cases where firefighting actions were required using the tugboat, port service functions are considered to have improved as it became possible to respond to fires with the procurement of the tugboat though there were no equipment to respond to the occurrence of fires on a boat in the harbour and near the wharf. According to the implementing agency, fire drills are implemented by the crew on a quarterly basis.

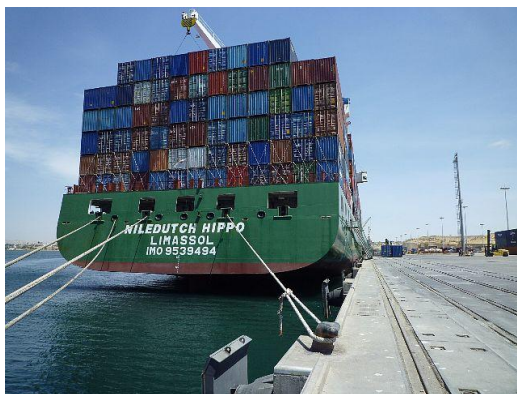
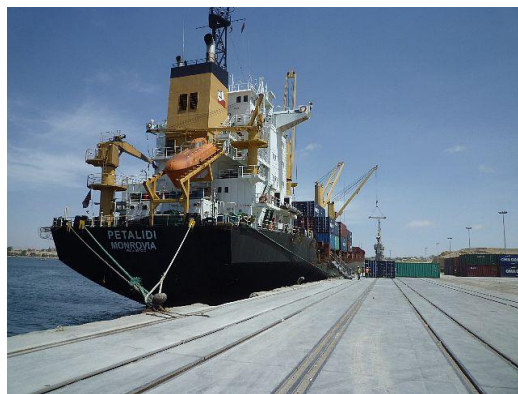
Photo 3 Ship Berthing at 3A Wharf (Project Area) Photo 4 Ship Berthing at 3B Wharf

Freight ship safety is confirmed to have improved with no ship holds striking the pier corners when berthing since project completion. Still, within two and a half years after the project completion, plates have collapsed for pier fenders²⁰ No. 4, No. 15 and No. 16²¹, and damage has also been observed on fender No. 3. These fenders require some sort of measures.

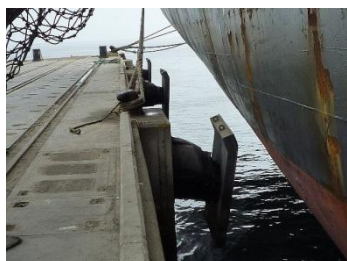
For berthing work, EPN has no issues in terms of tugboat operation and other such technical skills. The problem that arose in berthing operations had to do with bumper O&M as the number of ships with tonnage exceeding design standards increased. EPN must now work to increase berthing operation skills, such as establishing basic limits for port entry of higher tonnage ships, and communicating closely with ships and dropping berthing speed further when forced to grant entry to ships at high tide at the ship's responsibility.

Photo 14 Fender No. 3

The Luanda Port Authority (APL²³) and Lobito Port Authority (EPL²⁴) are ahead of EPN in terms of capability and experience with regards to O&M of fenders and other port facilities, as well as operational skills for berthing heavy ships. EPN needs to learn from APL and EPL on these topics.

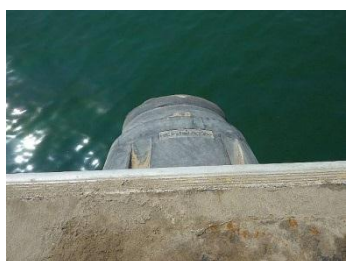
Photo 17 Fender No. 15
