Pilot Survey for Disseminating SME's
Technologies for Applicability of
Dewatering Equipment for Septage
Management of Cebu City

Summary Report

January, 2016

AMCON, INC.

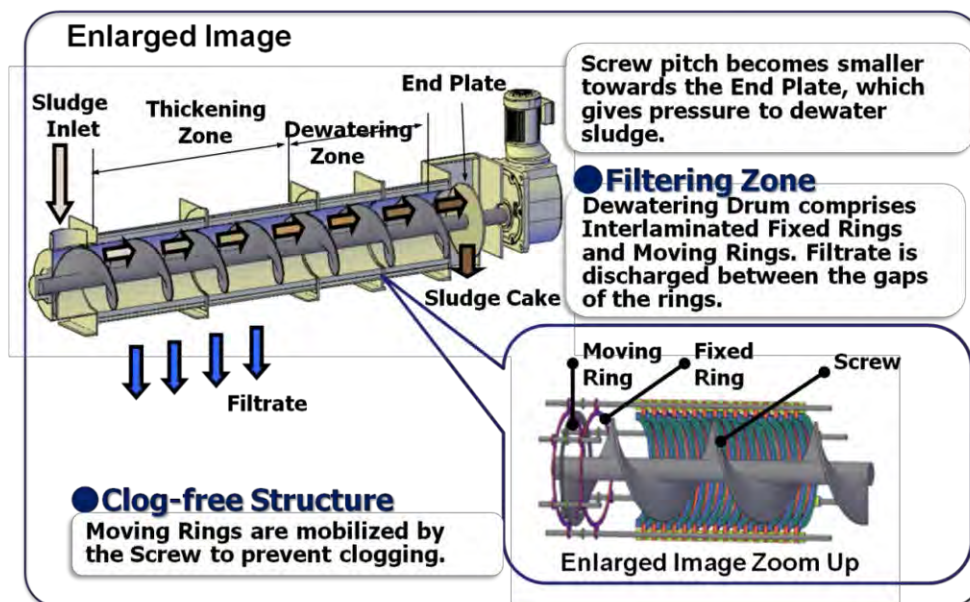
Volute is a type of proposed dewatering equipment for septage treatment in this project. This technology has various unique features and can offer many technological advantages, including providing a clog free solution for the dewatering process which other common technologies such as belt press and screw press types cannot provide. This is possible through the patented Volute Dewatering Press, which has unique cylinders structure as shown in the diagram below. With this unique structure, Volute can also provide various economic benefits such as lower electricity and water consumption than other dewatering devices, and environmental benefits such as less solid content leaking to the filtrate water. In addition to this, Volute has other advantages for instance sludge treatment without the use of a thickening tank, low burden for maintenance, correspondence from high sludge concentration to low sludge concentration, energy-saving (saving about 20% from other equipment), unattended operation, compact size, and lower costs.

These innovative features have made AMCON's Volute dewatering press widely accepted in various countries (2,689 Volute machines have been introduced in 63 countries as of December, 2015). In Japan, joint research conducted between AMCON and the Japan Sewage Works Agency verified its applicability to direct sludge dewatering from oxidation ditch tanks and entire unattended operation, and therefore it is recommended as suitable equipment for small-scale sewage treatment plants. At present, 1,100 machines have been introduced in municipalities in Japan. The feasibility study and pilot project conducted by the joint venture of AMCON and EXRI in 2013 also showed its effectiveness when it comes to the septage collected in Cebu City.

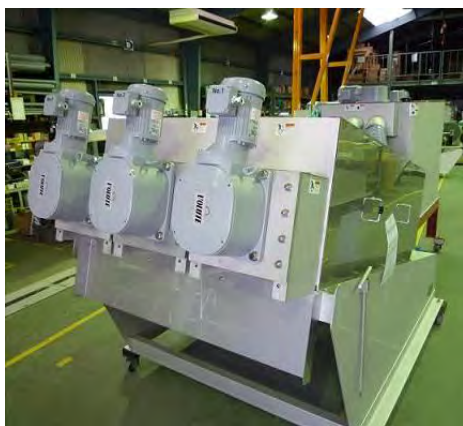
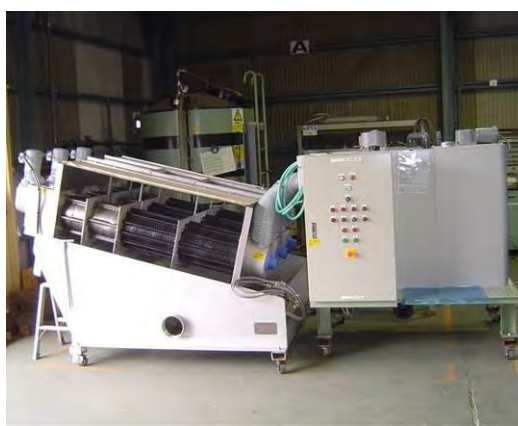
ES-303 was selected for this survey. Volute ES-303's capacity is 10m³/hr and considered to be able to handle 80m³/day. It is compact with a size of 3,605mm (L), 1,590mm (W), and 1,555mm (H) as shown below.

Considering the amount of septage generated in Cebu City of 80m³/day (maximum), Volute

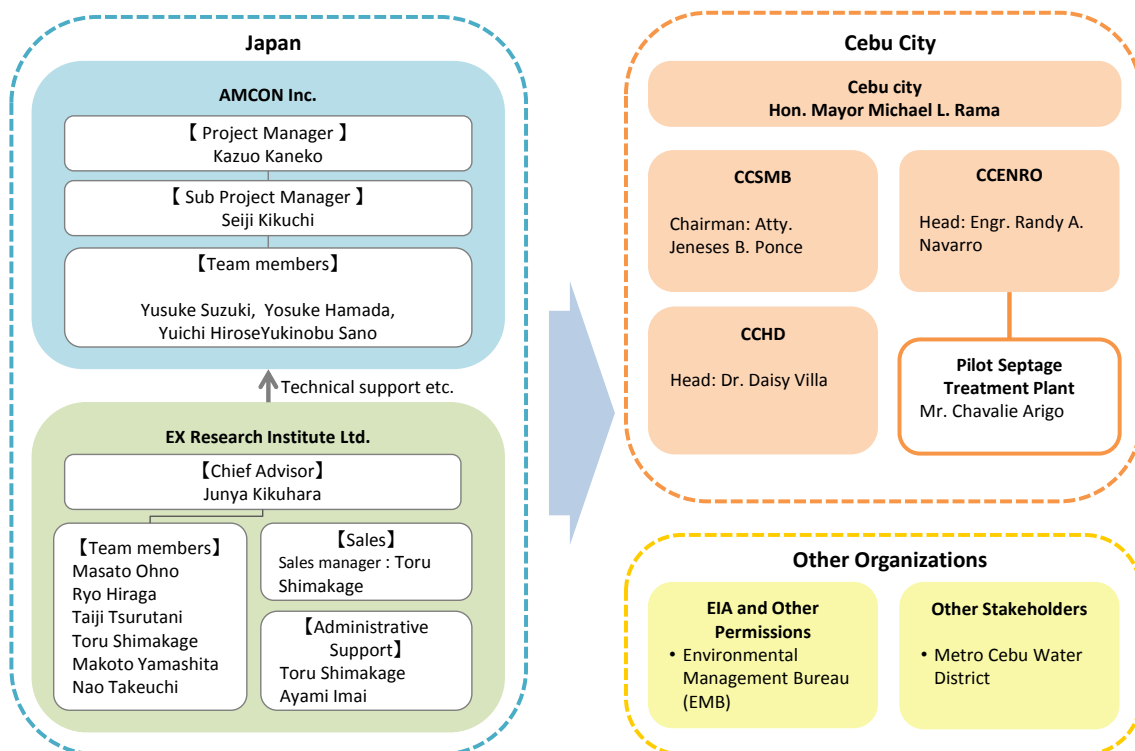
Further, communications was maintained and information was collected from the Environmental Management Bureau regarding EIA and other environmental permission, as well as with Metro Cebu Water District (MCWD) regarding septage management issues. The implementation structure is shown below.

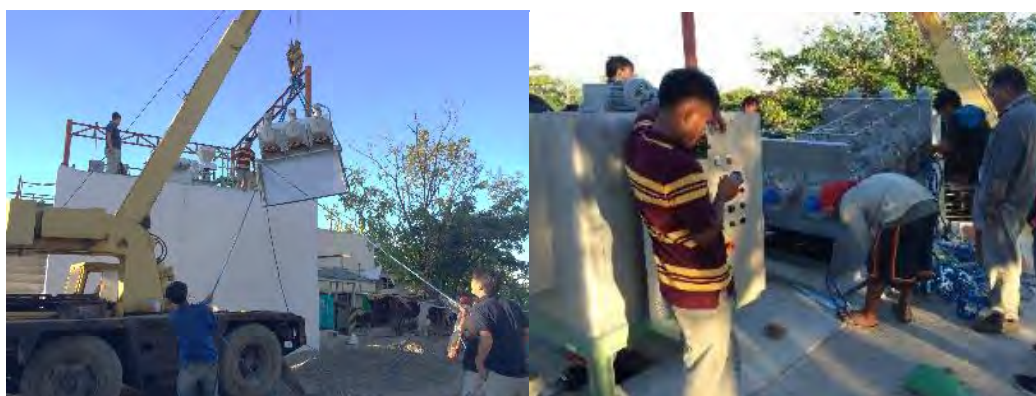
Photo: Scenes from the installation of the dewatering equipment

Construction was carried out and completed over the schedule below of a pilot septage treatment plant, including the installation of septage intake tanks and sludge dewatering equipment, at the existing sewerage treatment plant within Cebu City.

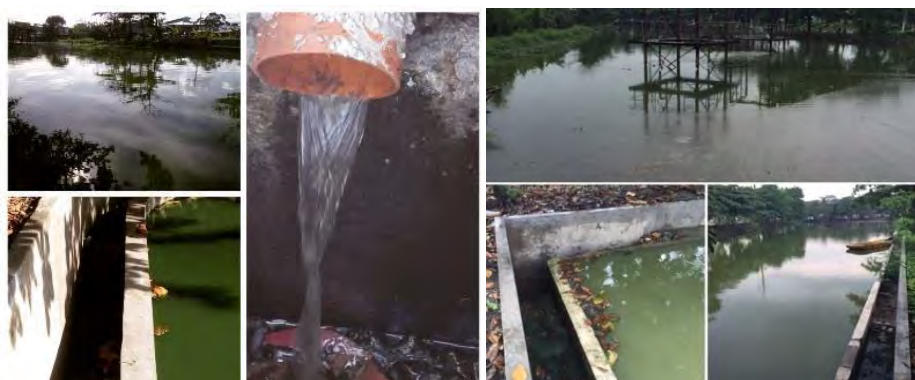
Photo: Lagoon and discharge from the pilot septage treatment plant
(Left: March 2015, Right: Septemeber 2015)

From its subsequent operation, 34,000m³ of septage has been treated from its cumulative 3,400 hours of operation thus far. This amount of septage would have been discharged directly into the environment without this project, therefore it could be said that this pilot survey contributed to reducing pollution in Cebu City. The pictures below show the lagoon and treated water of the pilot septage treatment plant in March and September 2015. The water in the lagoon and effluent is clear.

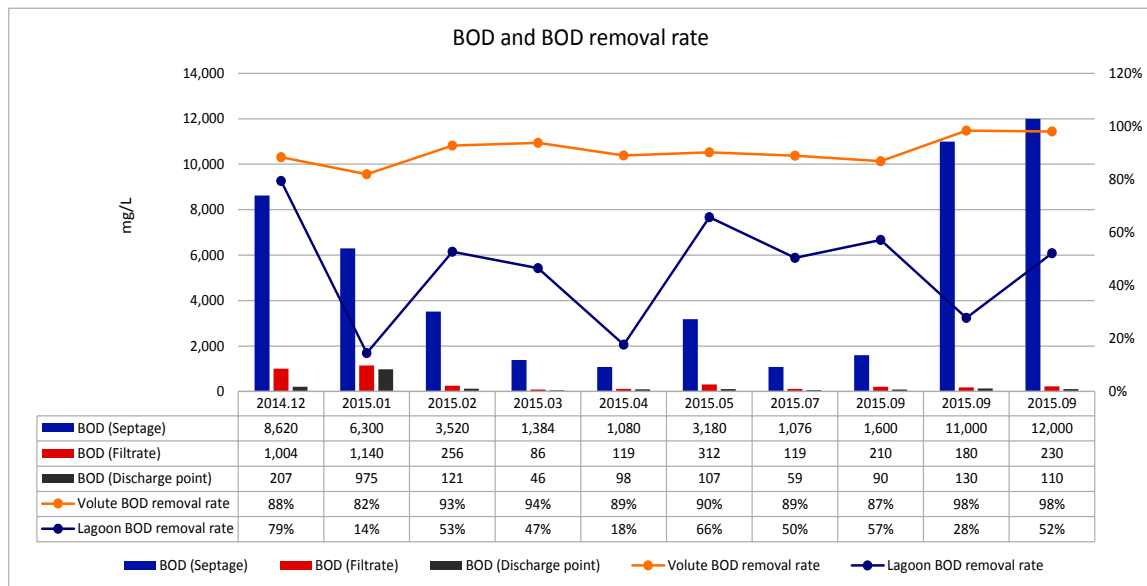
The graph below shows the transition in the BOD removal rate of both the dewatering equipment and the lagoon. The BOD removal rate of the dewatering equipment hovered around 85 to 98%, while the BOD removal rate of the lagoon fluctuated and fell to less than 20% on occasions. This indicates that the dewatering equipment is effective in directly treating septage, though it takes time for the water quality of the lagoon to recover once it has been polluted. The fact that non-septage material was dumped in the lagoon during its pilot operation is believed to have affected the results in terms of the instability of the BOD removal rate for the lagoon as shown in the pictures below. Therefore, improvement measures were proposed that include thorough gate management, such as prohibiting the intermixing of raw night soil and industrial effluent, as well as enhancing aeration of the lagoon and constructing an artificial wetland.

Fig: BOD and BOD removal rate of the dewatering equipment and lagoon

Considering the fact that the effluent BOD level have hovered around the standard value of 100mg/L, this made it clear that if lagoon improvements, flocculation control, and gate management could be properly performed, then the effluent standards could be attained.

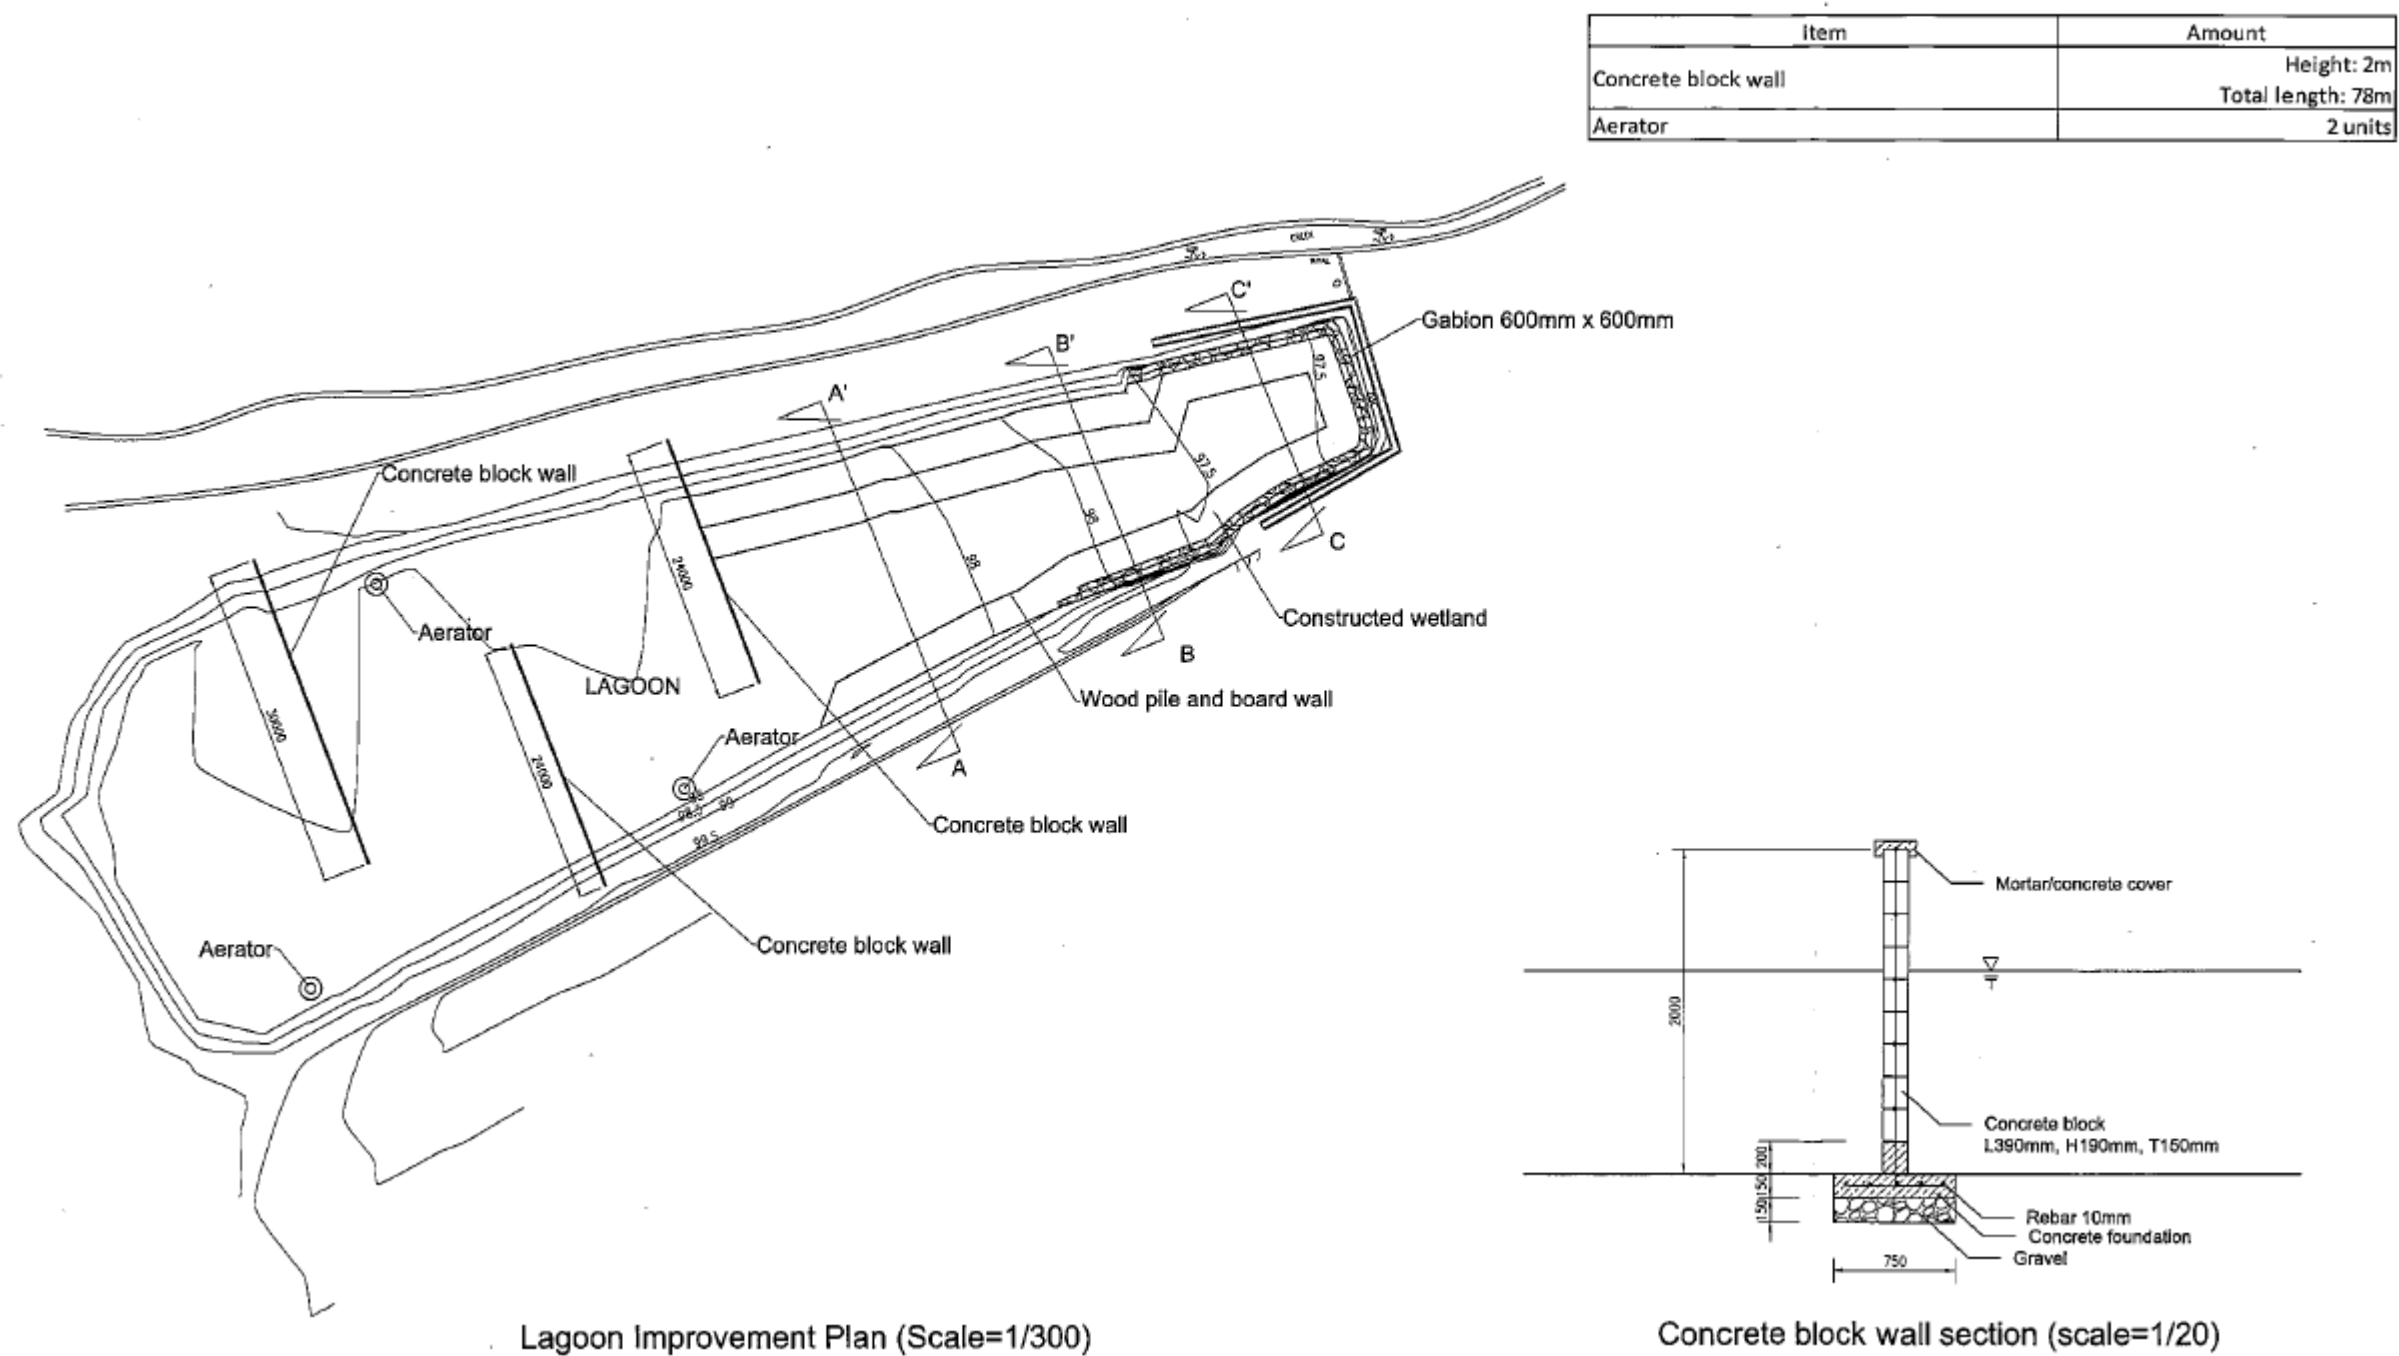
Fig: Proposed lagoon improvement plan -1

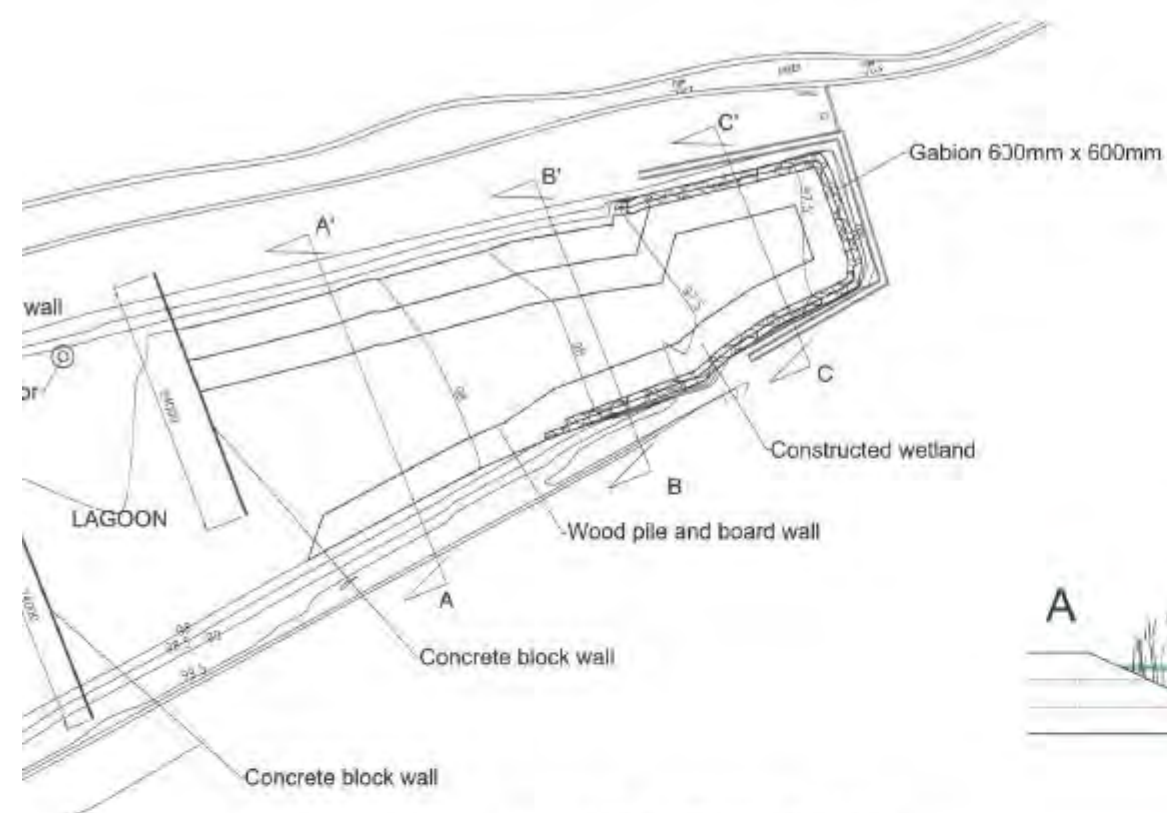
Lagoon Improvement Plan (Scale=1/300)

Item	Amount
Gabion 600mm x 600mm	Total length: 120m
Wood pile (D: 75mm, H: 725mm)	500
Wood pile (D: 75mm, H: 1000mm)	48
Wood board (H: 600mm, W: 1000-2000mm)	48m
Wood board (H: 360mm, W: 1000-2000mm)	500m

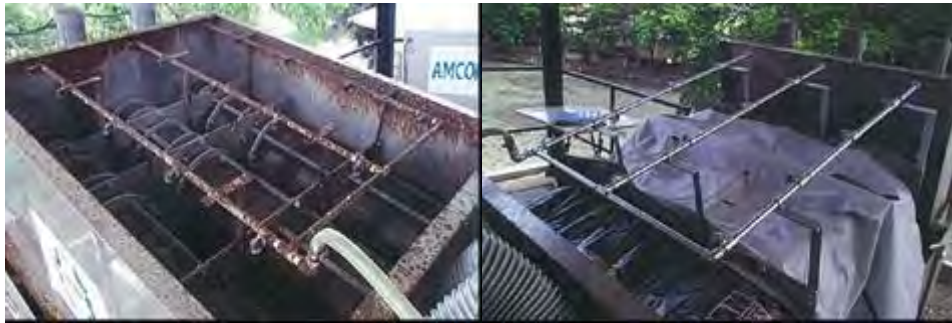
Other than the fluctuations in the water quality in the lagoon, several other issues arose during the pilot operation. The first is an issue with the cleaning water for the dewatering equipment. Since tap water's pressure was not sufficient enough a well was dug to supply water, but since this water contains salt it caused the machinery to rust. Thereafter, a deep well was dug out, but the water from this deep well also contains salt, and so the aforementioned issue has not been resolved.

Photo: Dewatering press become rusty and after providing protection (Aug, 2014)

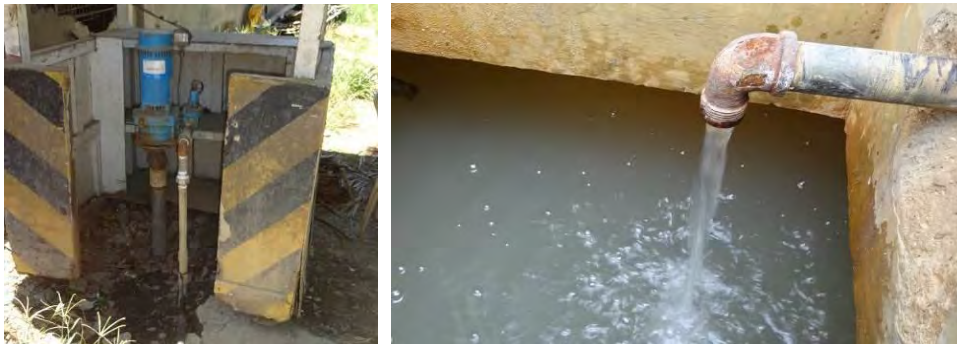
Photo: Deep well and its water (July, 2015)

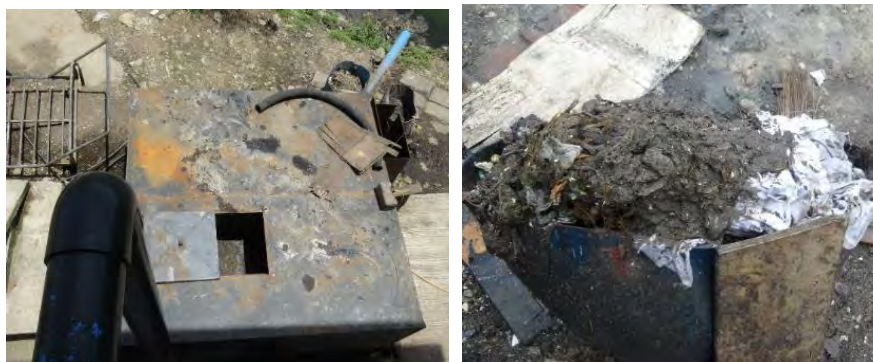
The second issue involves the perpetual clogging of the sludge feed pump. A pump with different specifications to what was initially planned was supplied, and solids that were larger than expected were found within the septage. As a result of these, the pump from the vacuum truck to the septage intake tank became clogged. A screen for the septage intake tank designed to remove these solids was proposed to Cebu City as a way to handle this, but the specifications of the tank that was installed differed from the proposed specifications. Therefore, it was recommended to Cebu City that a screen made by AMCON be installed and that two locally-sourced blowers be installed. As of December 2015, the screen made by AMCON was installed and blowers are planned to be installed by Cebu City.

Photo: Septage receiving tank temporarily placed to remove solids in septage and removed solids

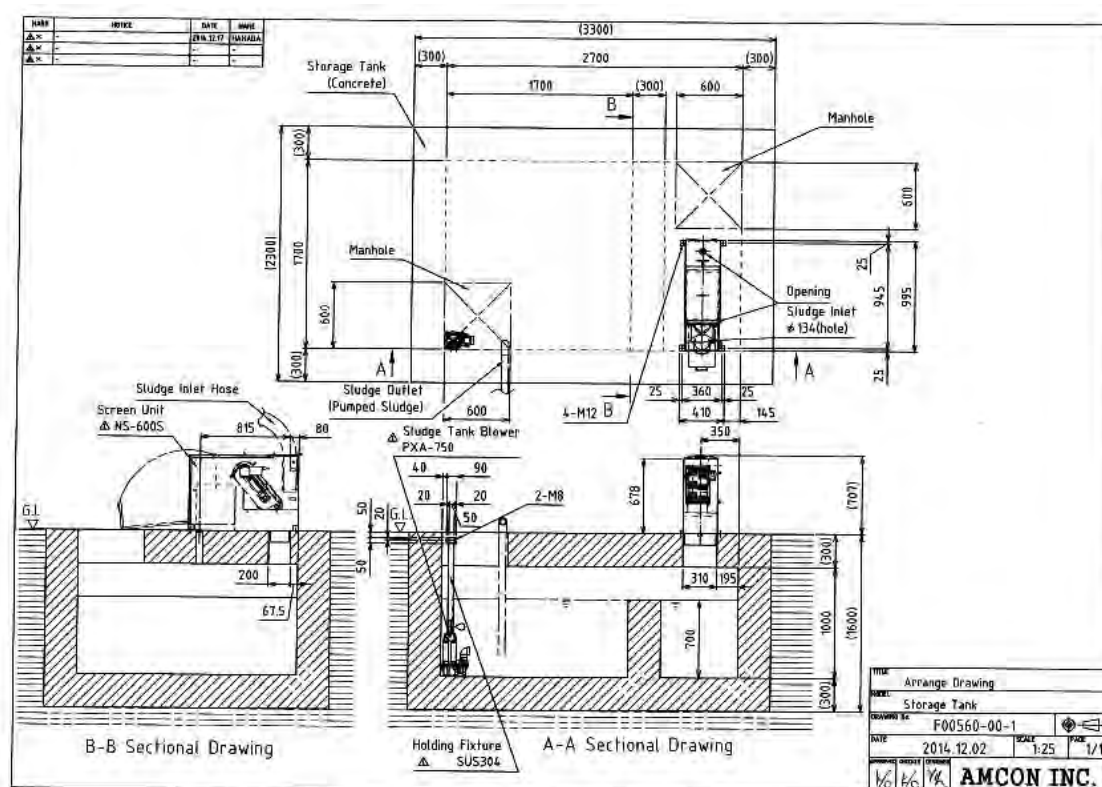
Fig: Drawing of the proposed septage receiving tank

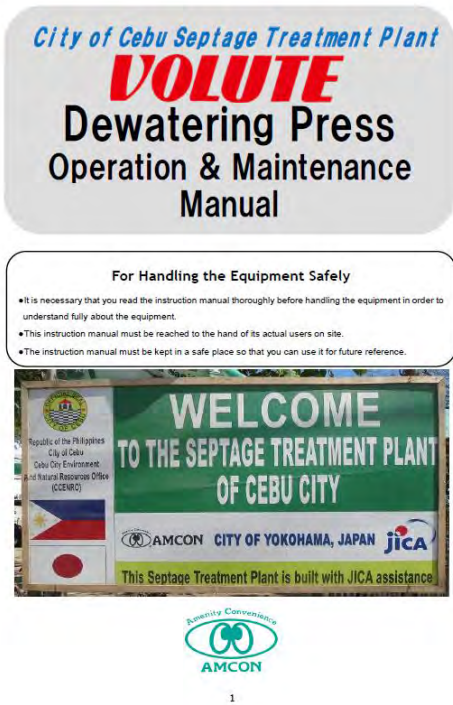
6.2. Daily Flocks Condition Check Sheet

Flocks Condition Check Sheet

Every morning and afternoon, please check the flock condition. If flock condition is ok, please check it.

Fig: The Final-edition Operation & Maintenance Manual (Excerpt)

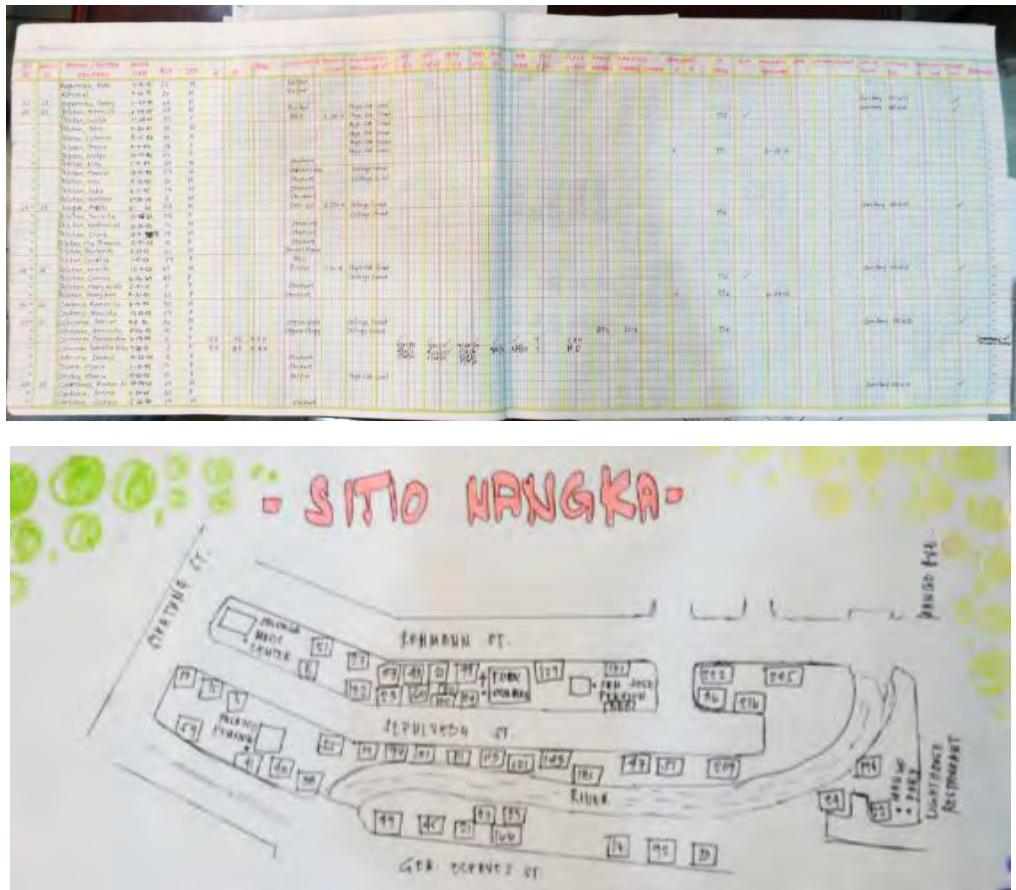
Photo: Health information for individual households maintained by each barangay

A pilot septic tank study was carried out in Barangay Zapatera, which is one of the urban barangays in Cebu City. This study revealed that Cebu City has detailed health information inventories for each individual household in every Barangay. It came to light that these were collected from a health study on all of the children in the city conducted by CCHD (Operation Timban) and the health surveys for renewing business permits. Therefore, it is decided to add the septic tank related simple

four questions such as: (1) whether or not there are septic tanks, (2) the year they were installed, (3) the type of septic tank, and (4) whether they can be accessed by vacuum trucks. We proposed a system for collecting base data on septic tank inventories that included a division of roles between CCHD and CCENRO of Cebu City.

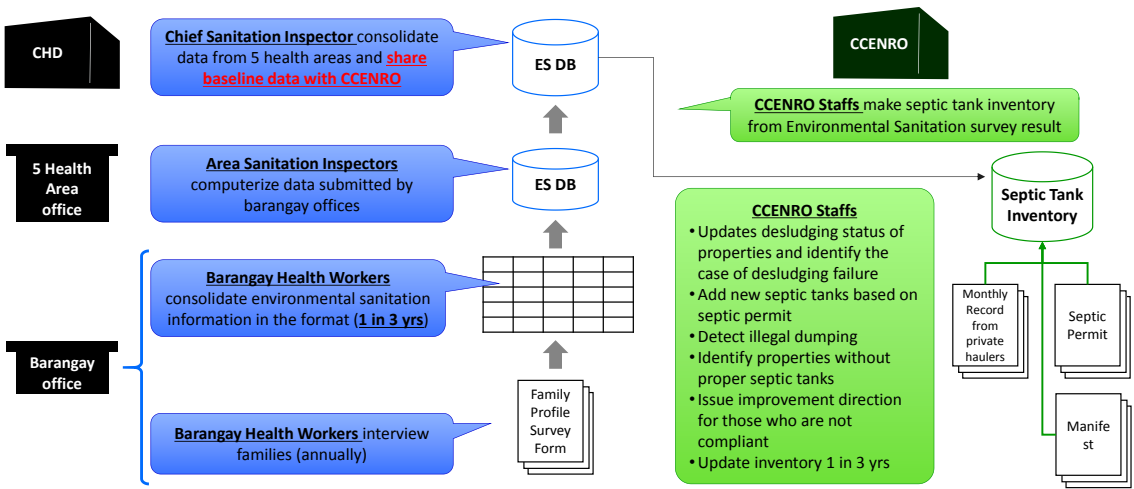
Fig: Proposed system on how to organize septic tank inventory data

Afterwards, a simple Excel form for organizing these inventories was prepared, and instruction was given to CCENRO staff members on how to organize the inventory data. So far, data on 23 barangays has been organized.

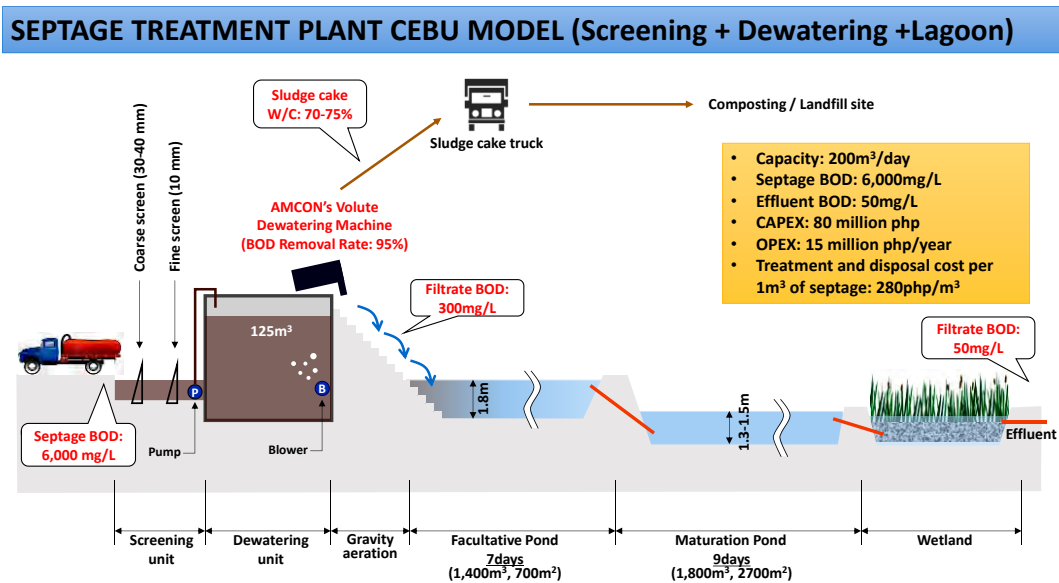
The septage treatment plant model (shown below) studied in this survey was presented. This can offer a solution for LGUs and WDs who look for inexpensive yet workable technology to treat septage. As our result of survey it was estimated that CAPEX of this model septage treatment plant with capacity of 200m³/day is 80 million pesos, which is less than about two thirds of CAPEX of fully mechanized septage treatment plant. It was also calculated that the septage treatment and disposal cost of this model plant is about 300 pesos/m³, which is about two thirds of average cost of 450 pesos/m³/day.

Fig: Septage treatment plant model using AMCON'sVolute + facultative and maturation pond

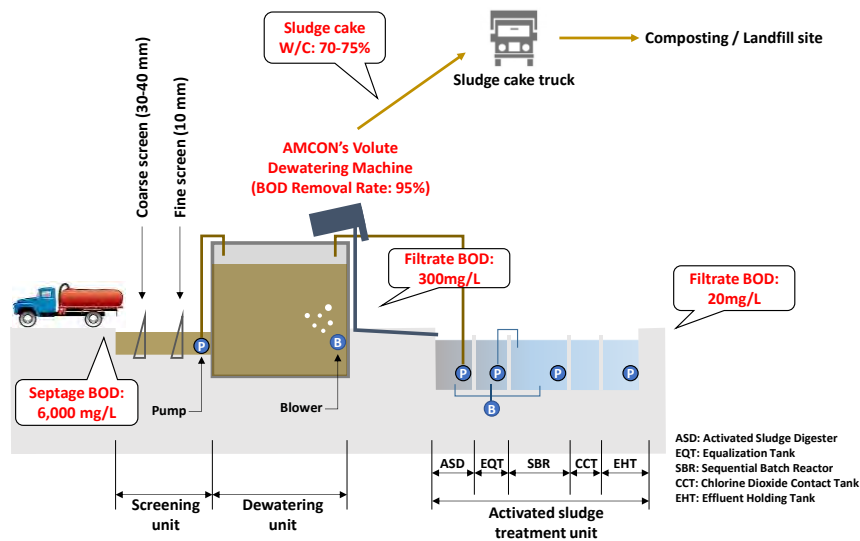
SEPTAGE TREATMENT PLANT CEBU MODEL (Screening + Dewatering +Activated Sludge)

Fig. Septage treatment plant model using AMCON's Volute + combined with SBR

In addition to this, other septage treatment models using AMCON's Volute dewatering equipment combined with a sequence batch reactor (SBR) and aerated pond were developed as shown below. A table comparing different factors according to these technological options was also prepared.

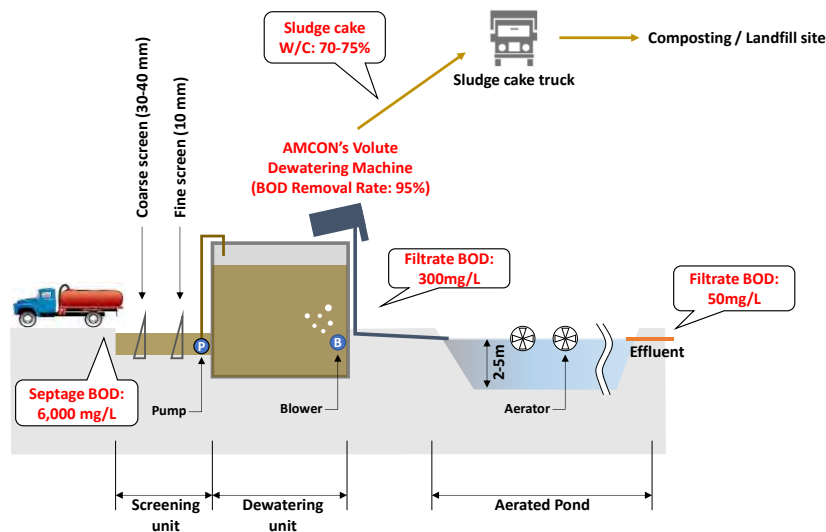
SEPTAGE TREATMENT PLANT CEBU MODEL (Screening + Dewatering +Aerated Pond)

Fig. Septage treatment plant model using AMCON's Volute + aerated pond

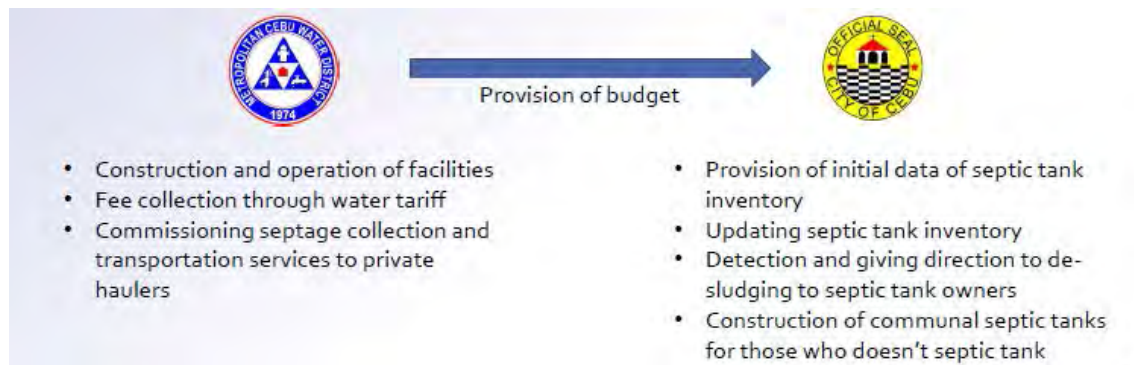
Fig. Recommended roles and responsibilities between MCWD and Cebu City

In light of all the lessons learned and recommendations above, cooperation and collaboration for the implementation of the septage program between MCWD and Cebu City is necessary. Based on the survey results, the following shows the recommendations for the roles and responsibilities to be divided up between MCWD and Cebu City/other LGUs.
