**Ex-Post Project Evaluation 2014:Package I-6
(Kenya, Tanzania, Zambia)**

September 2015

JAPAN INTERNATIONAL COOPERATION AGENCY

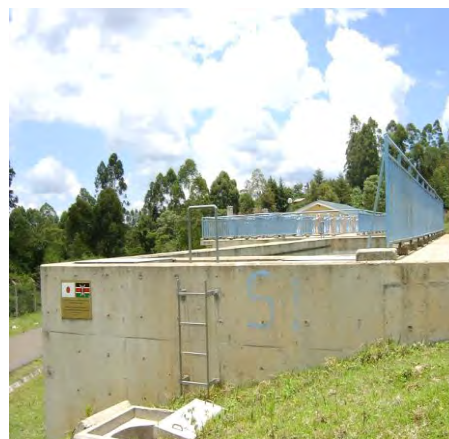
Sedimentation Pond of the Water Treatment Plant

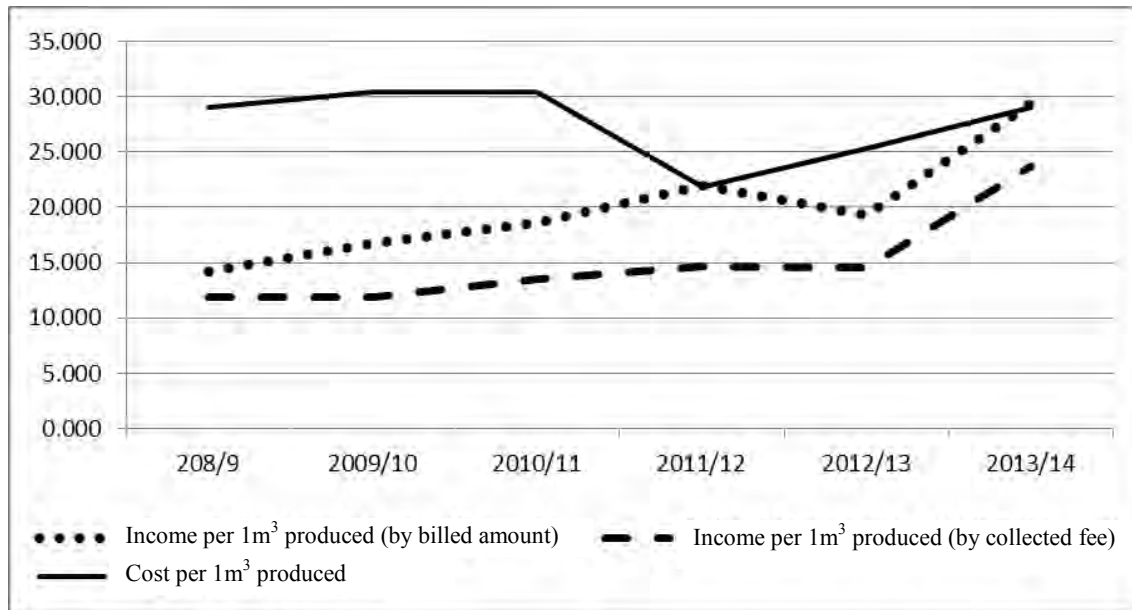
Figure 5: Cost and Income per 1m³ of Produced Water (Unit: Kenya shillings)

Figure 5 is a graph showing the trend in cost and income per cubic meter of the total volume of water produced at the treatment plant. Because all the water produced at the

water treatment plant has a cost, turning a profit on water production requires not just the sold water but looking at the produced water as a whole. The graph shows that in FY2013/2014 income and costs were in line with each other on a “billed amounts basis,” and that if the fee collection ratio were 100% then enough income to cover the water production costs could be ensured. Although strictly speaking a more detailed analysis is needed, it can be said that as a business the water supply system is approaching profitability. However, it still cannot be said that costs and income are approximately in balance (it is not structured for profit) and that the system has reached a condition of contributing to stable operations.

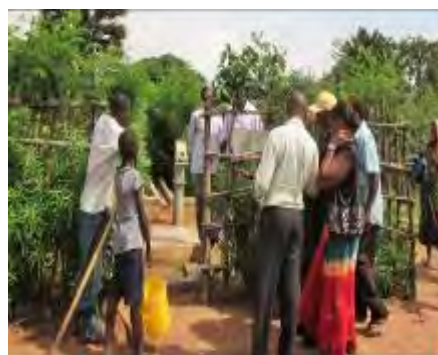
Platform in Mhulya Village, Kwimba District, Mwanza Region

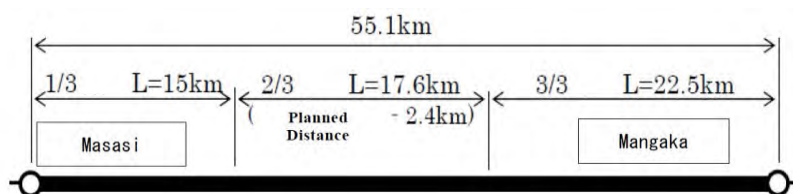
Figure 2: Road Section by Project Phase

¹² In May 2008, the initially planned distance for Phase 2 was reduced by 2.4km due to the steep rise in the price of materials such as gasoline, asphalt, reinforcing rods, cement, etc. Subsequently, based on the results of the Preparatory Survey Report on the Project for Upgrading the Masasi-Mangaka Road, the distance for Phase 3 was increased by 2.4km, so that the total distance was 55.1km as initially planned. (Materials provided by JICA: Preparatory Survey Report on the Project for Upgrading the Masasi-Mangaka Road).

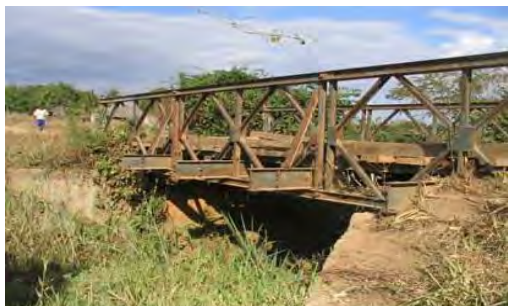
(Source) Preparatory Survey Report
Figure 3: Bridge Subject to Flooding Before the Project

There are no data on the reduction in the number of days or hours of flooding²⁴, but according to the implementing agency, the problem of flooding was resolved as a result of anti-flooding measures taken in the project. In interviews, cashew nut traders said that at a number of points prone to flooding²⁵ each time there was flooding the road would be impassable for 3-5 hours, but after completion of the project, traffic delays caused by flooding had disappeared.

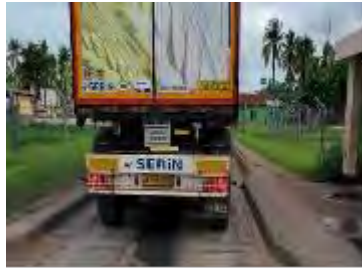
Imposition of Axle Load and Vehicle Weight Measurement
Mingoyo Weighing Station in Mtwara Region

In order to prevent the overloading of large vehicles, there is a weighing station in Mingoyo near Mtwara, where all large vehicles heading to Mtwara or Masasi are measured. The construction of a weighing station in Mangaka is also planned. A crackdown on violations of the weight/axle load restrictions in recent years has reduced the number of violations by large-size vehicles across the board.⁶³

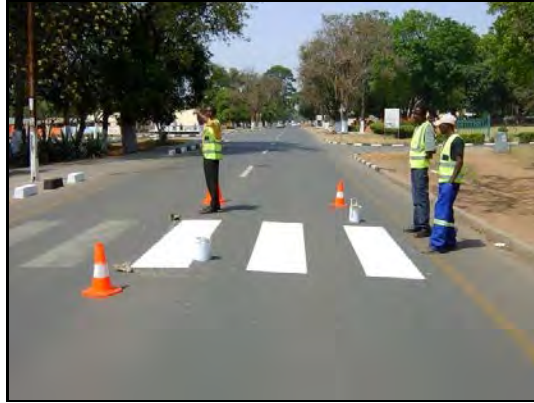
Maintenance work on the markings on Independence Way, Ndola
