**Ex-Post Project Evaluation 2014: Package IV-2
(Pakistan, Nepal, Micronesia)**

August 2015

JAPAN INTERNATIONAL COOPERATION AGENCY

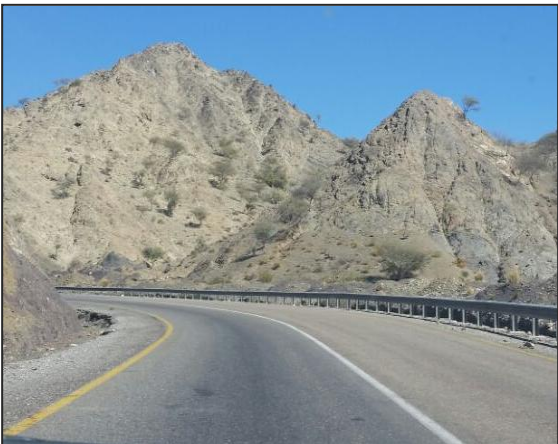
Improved Road

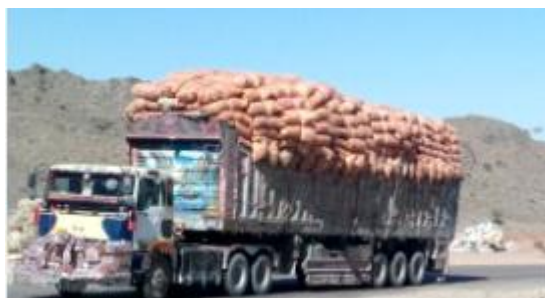
When local consultant was travelling the target road, heavy loaded vehicles with marbles, agricultural products, etc. were frequently seen. There are motorway police in national highways in Pakistan with more than 4 lanes. Since the target section is a two lane highway, no motorway police are allocated. Therefore, heavy loaded vehicles are not fully controlled,

(Photo) Heavy loaded truck with agricultural products

which caused damage to part of the road surface. In the target section, a weight scale is also not placed, thus measures to control heavy loaded vehicles are considered necessary.

Heavy loaded vehicles were occasionally confirmed during the ex-post evaluation. Allowing those vehicles to drive on the roads leads to damage to the road surface, and is not preferable in terms of safety. Heavy loaded vehicles are not controlled in the target section, since motorway police are not allocated to two lane national highway. However, NHA has to deal with heavy loaded vehicles immediately through measures such as placing measuring instruments and awareness activities for drivers coordinated with police.

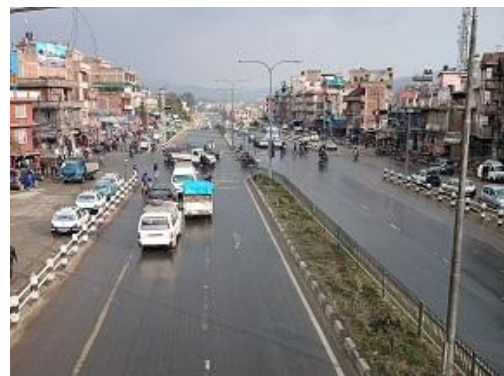
The road developed in this project

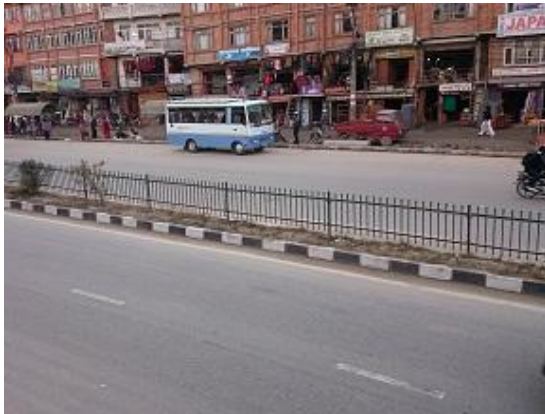
constructed guard fences at the median strips (6km) to cover a whole section of the Road in addition to the original project scope. The Nepali side also constructed 11 overhead bridges and three units of traffic signals¹⁰.

Picture 1 Guard fences at the median strip

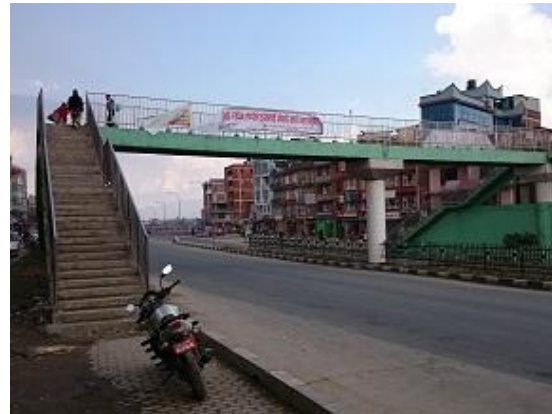
Picture 2 Overhead bridge
(Constructed by the Nepali side)

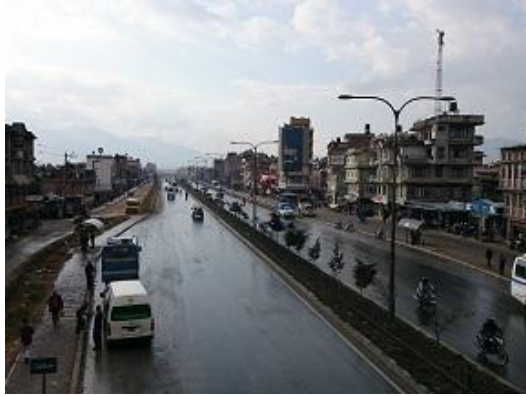
Bus stations established on the Road are used as expected, and embarkation and disembarkation of passenger outside of bus stations are hardly observed. However, around the Koteswore bus stop which many buses use, passengers are embarking and disembarking on the traffic lanes outside the bus station. Similarly, the embarkation and disembarkation of passengers were observed at five intersections where there were no traffic signals.

Photo 3 Small buses using bus stops

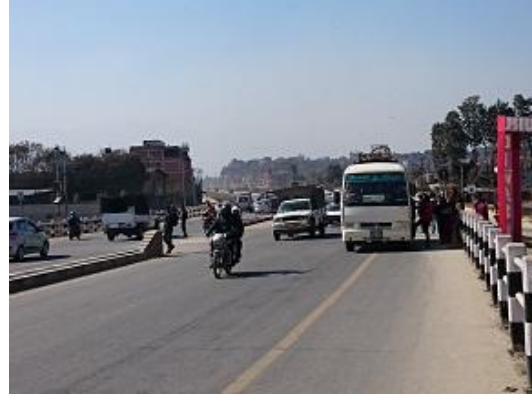
Photo 4 Buses parked in the intersections without traffic signals

Although bus stations on the Road are properly operated in general, some buses load and unload passengers at intersections without traffic signals, and such embarkation and disembarkation is not necessarily safe. Therefore, it is recommended that the implementing agency enhance collaboration with the Traffic Police to strengthen the traffic safety measures at such intersections. (For example, the Traffic Police is recommended to prohibit buses to load and unload passengers outside bus lanes. The Traffic Police is also recommended to instruct bus passengers to use bus stops).

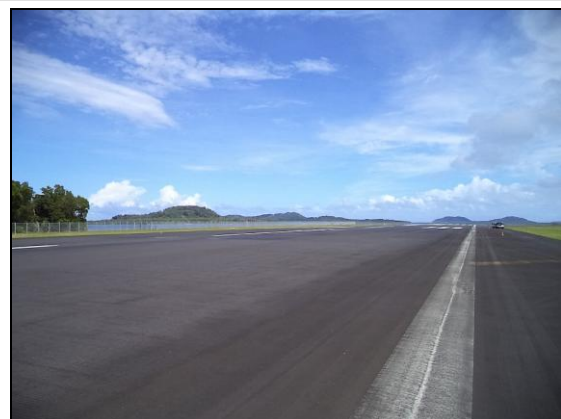
Runway extended in this project
