**The University of the South Pacific
The Republic of Fiji**

**Follow-up Cooperation Study Report
on
The Project for Upgrade of USPNet
Communication System
in
The Republic of Fiji**

August 2016

**Japan International Cooperation Agency
Relo Panasonic Excel International Co., Ltd**

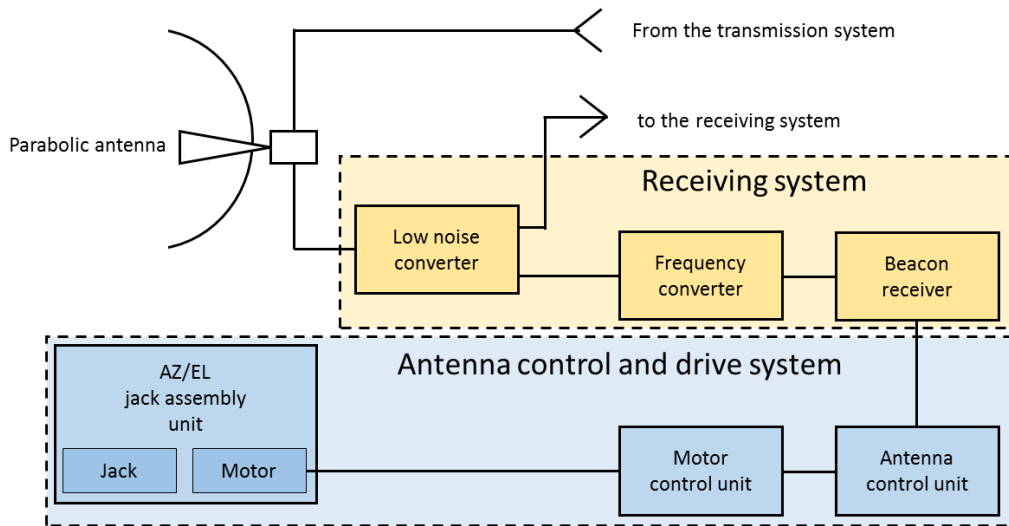
Figure 2.4-1: Structures of Parabolic Antenna, Antenna Control and Drive System, and Receiving System

Figure 2.4-1 shows the structures of the parabolic antenna, the antenna control and drive system and the receiving system. The larger the aperture of a parabolic antenna, the sharper the main beam and the higher the directivity. However, communication satellites move in figure-8 in shape orbits, mainly tracing a geostationary orbit due to the non-spherical nature of the Earth and other factors. Thus, large, high-directivity antennae must automatically track the moving communication satellites so that their beams face the satellites at all times. This is why large antennae are moved by motors to the proper elevation and azimuth angles to track satellites so that they can receive and maximize standard signals from the satellites.

Specifically, a parabolic antenna receives beacon signals from a communication satellite, and the low noise converter and frequency converter of the receiving system convert the signal to intermediate frequency L band to be received by the beacon receiver. The beacon receiver transmits the signal level it receives to the antenna control unit of the antenna control and drive system, which gives the motor control unit the amount of motor control to achieve the elevation and azimuth angles required to maximize the signal level and engages the motor of the AZ/EL jack assembly unit to move the antenna. This operation is repeated within a set amount of time, and the antenna is controlled in such a way as to maximize the level of beacon signals received. This is the tracking function. Interruptions to the tracking system likely indicate malfunctions in the parabolic antenna, receiving system or antenna control and drive system.

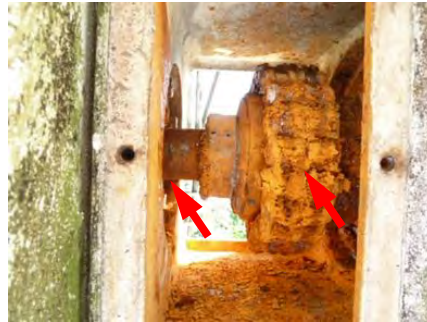
Picture 5: EL (elevation) Motor Shaft

Rust has occurred on the EL (elevation motor reducer), and a chalky substance has made it stick in place. The shaft and reducer sticking in place and refusing to rotate place an overload on the motor and lead to motor malfunction. If only the reducer is stuck, torque cannot be controlled, and too much torque can be transferred to the screw jack and the antenna cannot be moved with the motor. Rust has caused the material of the motor housing to curl, and its deterioration has progressed. It no longer protects the resolver (rotation angle detector)/ limit switch (position detector) module well, and an immense number of ants have invaded. The lack of protection allows humidity inside, which has caused rust damage to the resolver case. The EL jack screw had only a thin grease coating, and rust on the screw has caused it to deteriorate. In addition, the flange is rusted and has deteriorated significantly. The screw is stuck to the flange and has difficulty expanding and contracting normally.

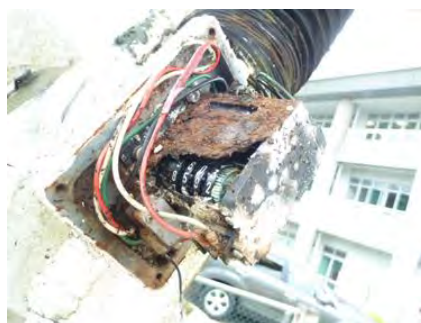
Picture 7: Damage to EL Resolver (elevation rotation angle detector)
/ Limit Switch Module (position detector)

Overall, they are recognized, the deterioration of the EL jack assembly, the motor shaft and reducer sticking due to rust and the chalky substance, damage to the resolver/limit switch module, and the screw deteriorating and sticking to the flange due to rust. It has progressed further than that of the AZ jack assembly (Jack Assembly for Azimuth).

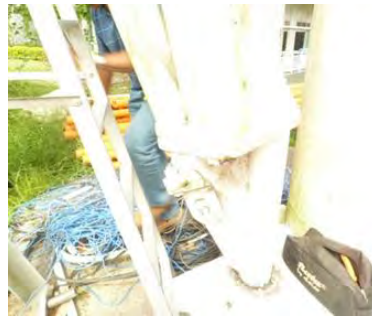
Picture 9: V-Beam, Pedestal

The pedestal that joins the V-beam (V-shaped Steel Material) that secures the EL jack assembly (Jack Assembly for Elevation) is curling due to rusting, putting it at high risk of deteriorating strength as a supporting member.

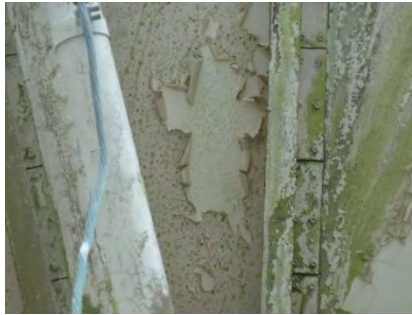
Picture 11: Peeling Paint on Rear of Main Reflector

The main reflector is made of aluminum and thus has not rusted, but peeling paint and mold are occurring throughout its surface. It has no effect on the instrument, but its location roughly 700 meters from the coast puts it at risk of salt damage and deterioration of surface materials after the salt-resistant paint peels away.

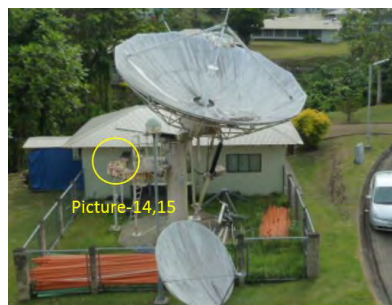
Picture 13: Cable Ladder Location

The cable ladder is stored in C-shaped housing that is corroded by rust and has deteriorated significantly. The study team noted significant deterioration of the outer jackets of cables and waveguides.
