## 6. その他の資料・情報

### 6-1 敷地測量図

GEOTECHNICAL REPORT - BOYANE .....	2
1.0 INTRODUCTION .....	2
2.0 SCOPE OF WORK .....	2
3.0 SITE DESCRIPTION .....	2
Location and Topography .....	2
Rainfall and Drainage .....	2
Access .....	3
4.0 GENERAL GEOLOGY OF SITE .....	3
5.0 GEOTECHNICAL FIELD INVESTIGATIONS AND LABORATORY TESTING .....	3
Methods of Investigation and Testing .....	3
6.0 INTERPRETIVE INFORMATION .....	6
Site Stratigraphy .....	6
Materials .....	6
Engineering Geological Evaluation .....	7
7.0 CONCLUSION AND RECOMMENDATIONS .....	<b>Error! Bookmark not defined.</b>
GENERAL NOTES ON THE REPORT .....	10
APPENDIX A .....	11
APPENDIX B .....	15

This report is based on the Preparatory Survey on “the Project for the Construction of New Secondary Schools and Upgrading of Facilities in Existing Secondary Schools aimed at Promoting Inclusive Education” based upon request from the Government of Swaziland to the Japan International Cooperation Agency (JICA). The survey is to obtain geotechnical data and information at Boyane, central Swaziland, where the proposed Boyane High School will be constructed, for the design of earthworks, foundation and structures of the buildings.

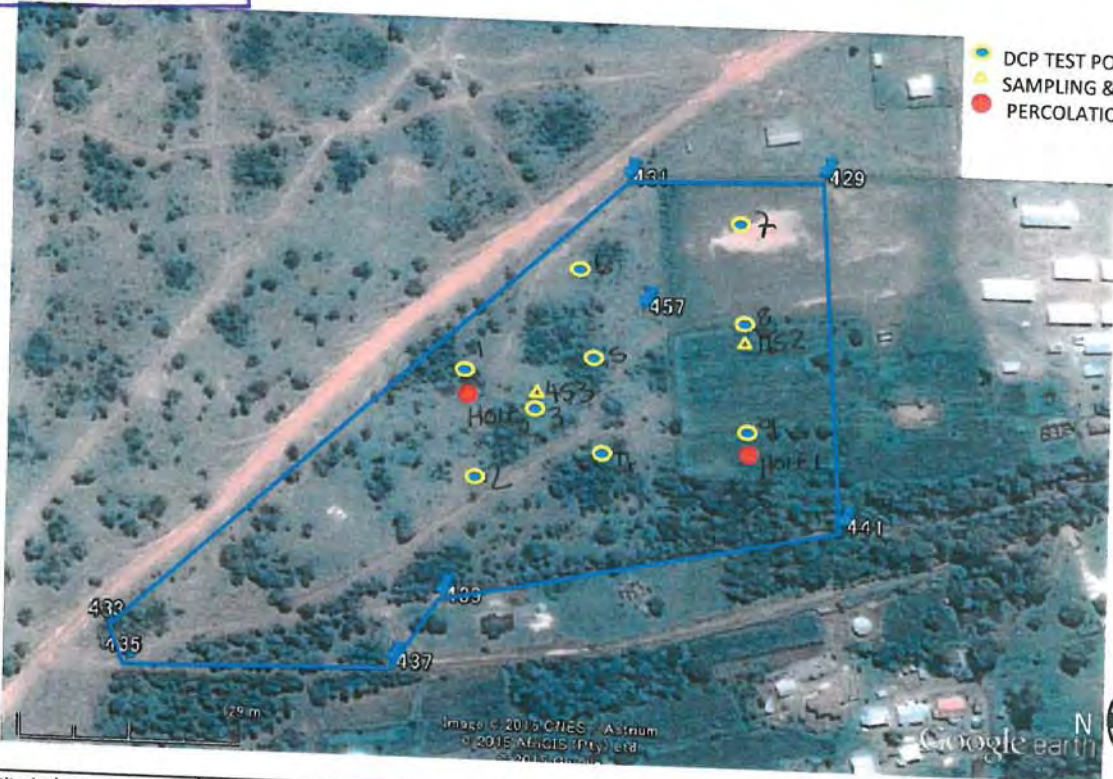
**Other information**  
The boundary of the site is indicated by blue line. All boundary points have been staked with red sprayed rebars. If you contact to the person mentioned above, they show you the boundary points.  
The Surveyor should excavate two pits in total indicated in the map.

● DCP TEST POINTS  
▲ SAMPLING & PIT POINTS  
● PERCOLATION TEST POINTS

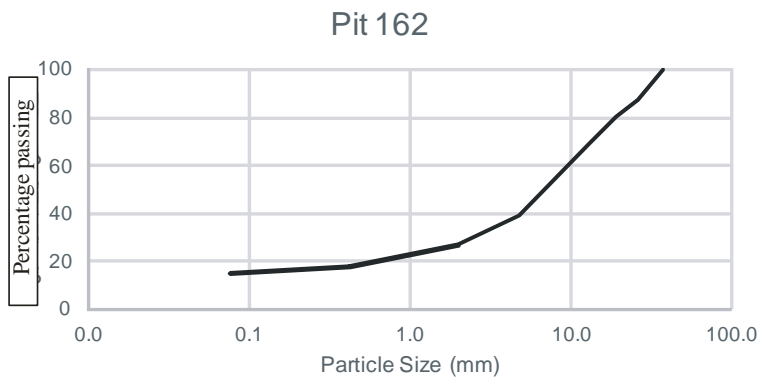
sieve size mm	Percentage passing
75	
53.0	
37.5	100
26.5	87
19.0	80
13.2	69
4.75	39
2.00	27
0.425	18
0.075	15

Liquid Limit (LL)	42
Plastic Index (PI)	17
Linear Shrinkage	4.5
Grading Modulus	2.4
Natural Moisture Content	12.6
PI of whole sample	
AASTHO Classification	A-2-7(0)
TRH 14
