National Water Supply & Drainage Board

The Completion Report of Verification Survey with the Private Sector for Disseminating Japanese Technologies for Non-Revenue Water Reduction Program

November, 2017

Japan International Cooperation Agency

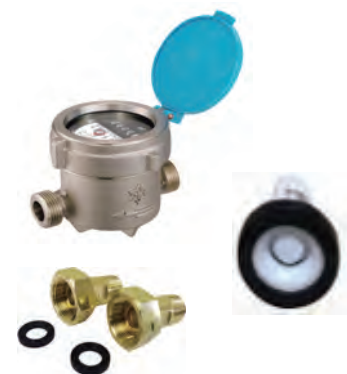
a) Water Meter

Name	Water Meter
Specification	Vane wheel type meter $\phi 15\text{mm}$
Dimension	L:100mm H:92mm W:89mm
Characteristics	Only a small vane wheel exists in the meter duct. Obstruction of water flow is minimum.
Comparative advantage	Meter defective rate is 1/10000 or less

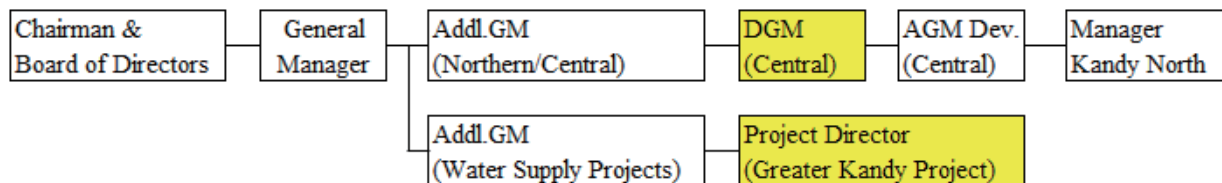
Figure1 Organization chart

Under the Ministry of City Planning and Water Supply, there is the National Water Supply and Drainage Board which is responsible for national water supply. The water supply system in Harispattuwa is administered by the Manager (Operation and Maintenance), Kandy North under Regional Support Centre-Central (RSC-Central).

Greater Kandy Water Supply Project (GKWSP) is responsible for the construction of the purification plant and the pipe line.

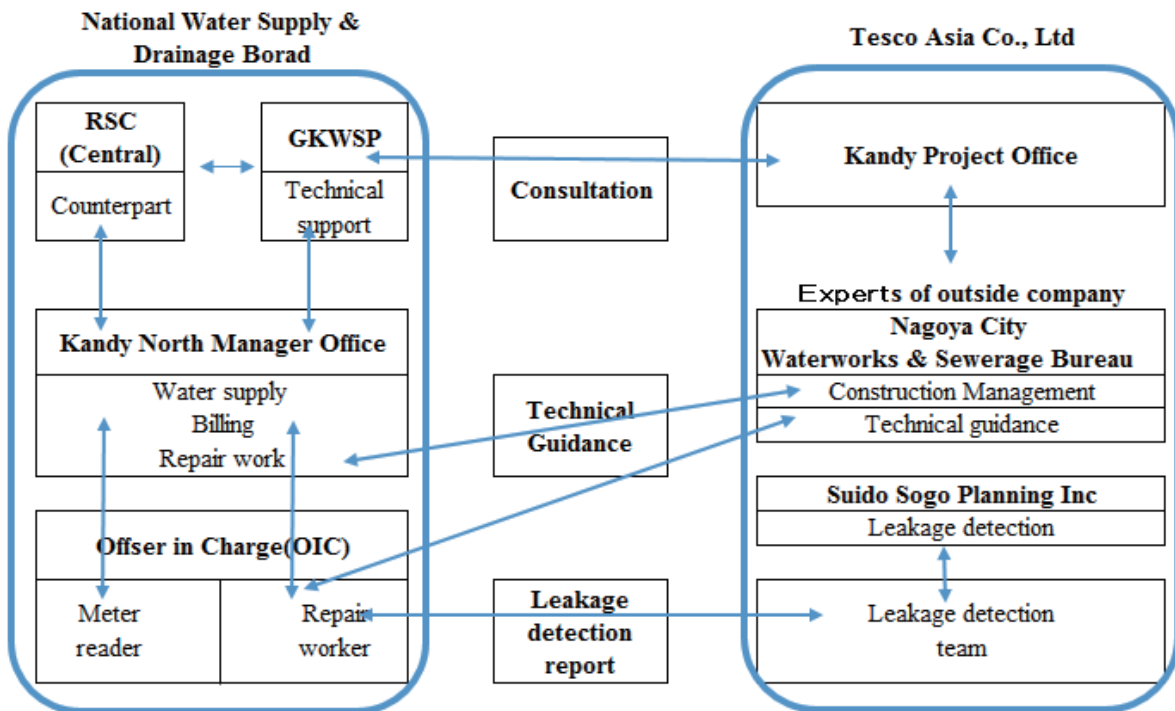
Figure 2 Project implementation structure

The counterpart of TA in this project is Regional Support Center (Central). However GKWSP, Manager (O/M), Kandy North and TA discussed from time to time to proceed the project. Actual project works such as meter replacement, were carried out by the direction of engineers of both GKWSP and Kandy North Manager mobilizing workers of contractors. TA’s experts gave guidance to the works.
