Ex-Post Project Evaluation 2015 :
Package IV-8 (Burundi)

FY2015 Ex-Post Evaluation of Japanese Grant Aid Project

“The Project for Rehabilitation of Roads and Infrastructures for Bujumbura City”

External Evaluator: Keisuke Nishikawa, Japan Economic Research Institute Inc.

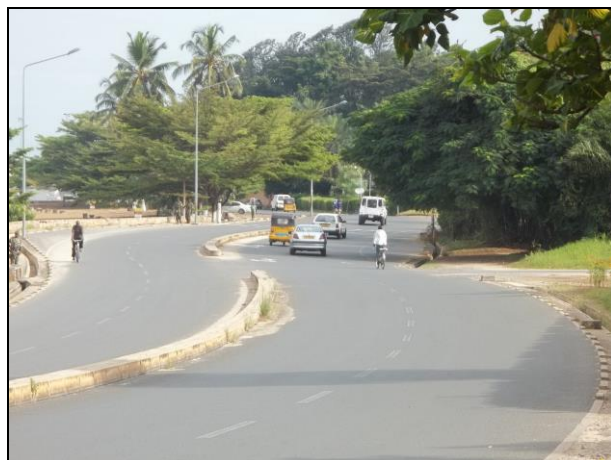
A Road Section Improved in this Project
(Avenue de la Plage)

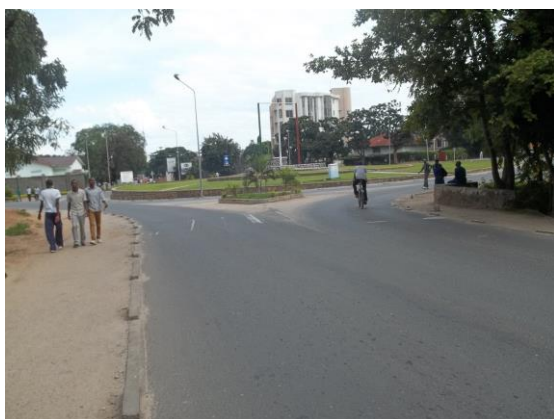
Roundabout at the ending point of Boulevard Yaranda

- Change in the cross-sectional road alignments of Boulevard Yaranda (to make it easier to access the houses along the road).
- Replacement of the road bed of Avenue du Large (due to the detection of ground water and soft ground under the widened part of the road).
- Application of improved asphalt (to increase durability in consideration of the passing of heavy vehicles at a total of five locations such as the starting point and the roundabout at the ending point of Boulevard Yaranda, etc.).
- Change in the location of a new culvert connection at the starting point (to prevent sediment deposition).
- Reinforcement of existing buried water pipes.
- Protection of buried pipes (for electricity and communication lines at the roundabout at the ending point of Boulevard Yaranda).

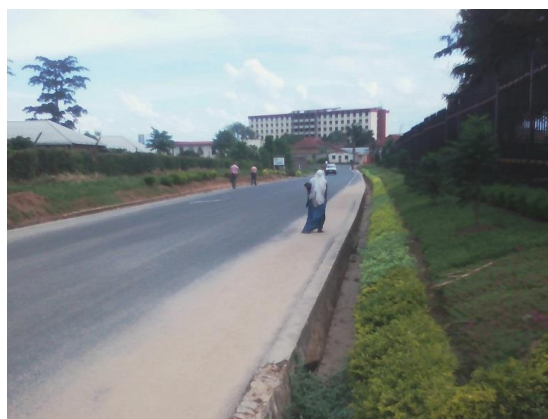
Rue de la Cathédrale additionally developed

A major change in project outputs was the addition of paving Rue de la Cathédrale (248m), which is connected to Boulevard Yaranda. According to the implementing agency and the project consultant, the change was implemented in response to an additional request made by the Burundian side in an attempt to mitigate traffic congestion occurring daily around the church. As the road was adjacent to Boulevard Yaranda and led to smoother traffic flow in the surrounding area, it can be judged to have been an adequate change.
