**Ex-Post Project Evaluation 2017 : Package III-2
(Kiribati, Palau, Tajikistan)**

JAPAN INTERNATIONAL COOPERATION AGENCY

FY2017 Ex-Post Evaluation of Japanese Grant Aid Project

“The Project for Expansion of Betio Port”

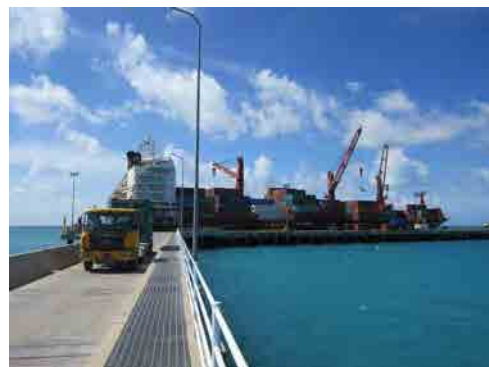
Wharf and Access Trestle Developed in This Project

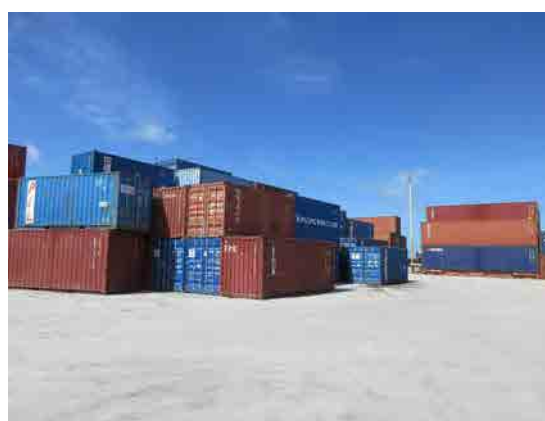
Container Yard (outside the scope of this project)

The weight limit of the wharf during handling operations is 30 tons per container, but it has been restricted to 25 tons since September 2016 as the pavement of the container yard, outside of the scope of this project, is deteriorated. This means that the maximum weight of the containers unloaded at Betio Port has been reduced by 17%, and an immediate redevelopment of the container yard has been requested by port users¹⁷.

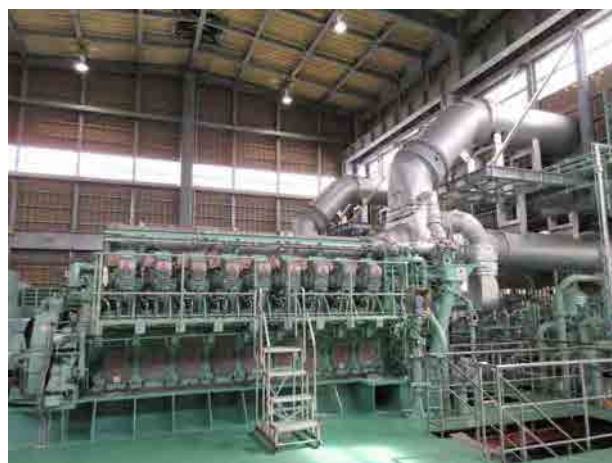
Generator Installed in this Project

The power generators and facilities at Aimeliik Power Plant developed through this project were all operating in good condition at the time of ex-post evaluation with smooth procurement of spare parts. It was confirmed that the operating data were recorded every hour and the items to be inspected and maintained periodically were also recorded.

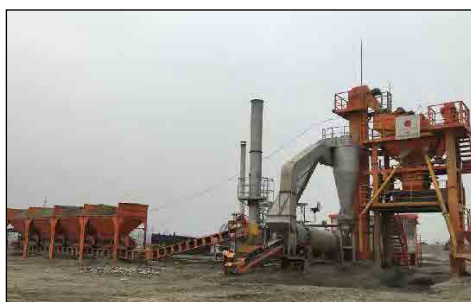
Asphalt Plant

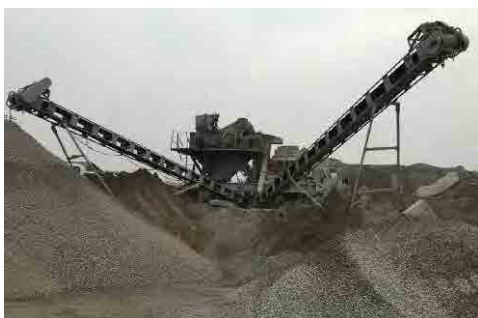
Crushing Plant (C/P)
