Development and Field Practice of Several Inspection Systems with Tablet Computer for Local Government and Developing Country

Prof. Kou IBAYASHI

National Institute of Technology, Nagaoka College

Development of road condition evaluation system using a smartphone

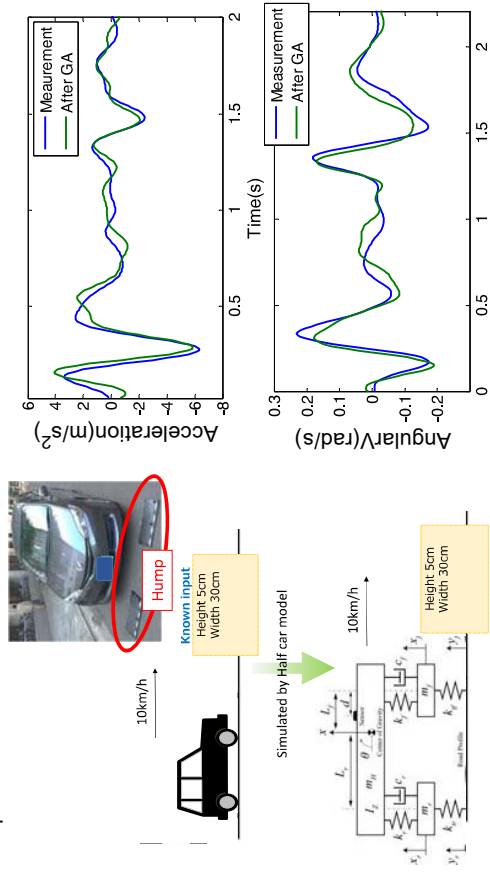
Hump calibration

The vehicle is modeled as a half-car model using hump passage responses

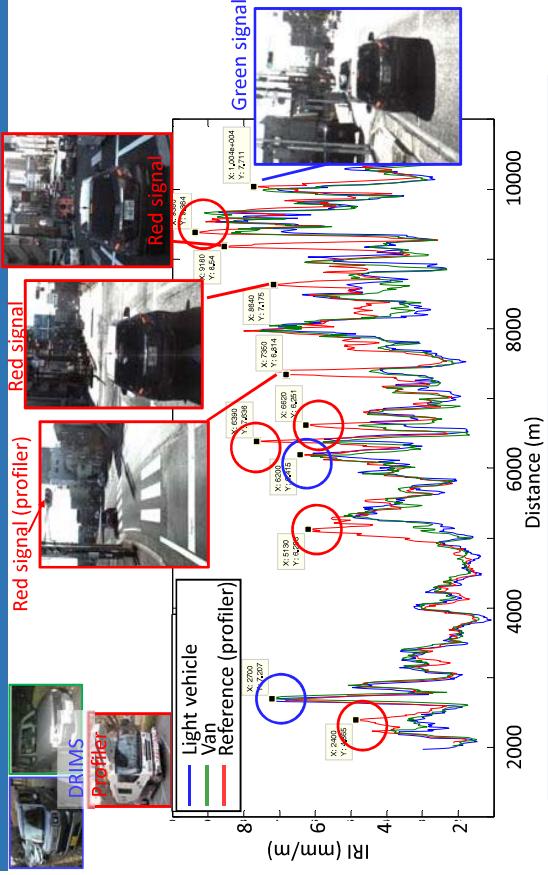
IRI estimation accuracy based on profile estimation

DRIMS performs even better than the profiler at start/stop sections

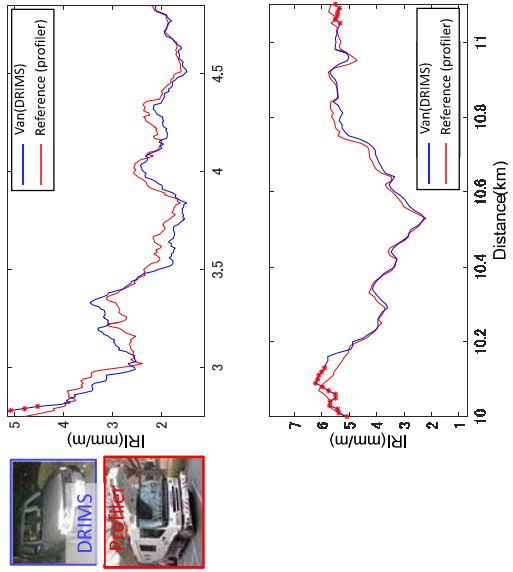
IRI estimation accuracy at good measurement condition

When drive speed is almost constant, the DRIMS and profiler gives almost identical IRI.

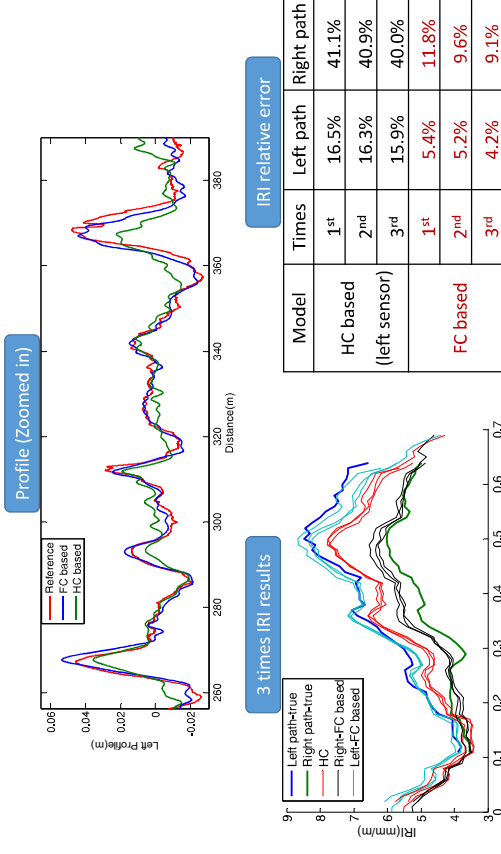
Experiment validation

IRI of both left and right paths are accurately estimated using the FC model

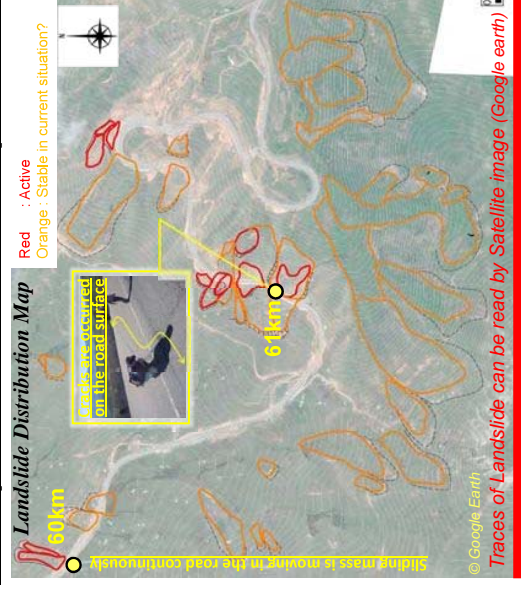
Site Inspection Result of Landslide (OSI Road 61km: DEP959)

[Features of Reddish formations]
In the case of high water - retaining condition, it becomes easy to be fluidized.

Easily causes landslides

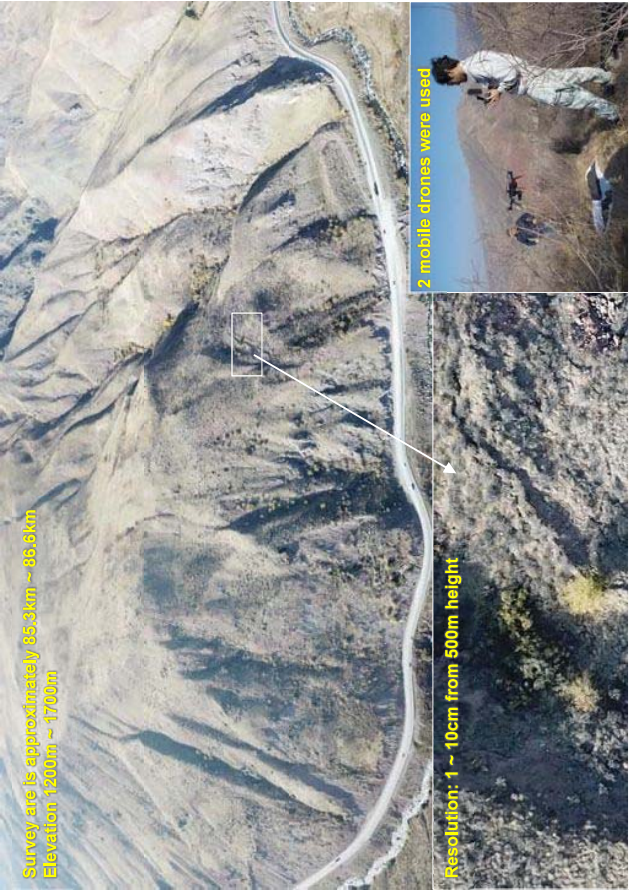
RESULT OF DRONE SURVEY

Survey are is approximately 85.3km ~ 88.6km
Elevation 1200m ~ 1700m

Resolution: 1 ~ 10cm from 500m height

2 mobile drones were used

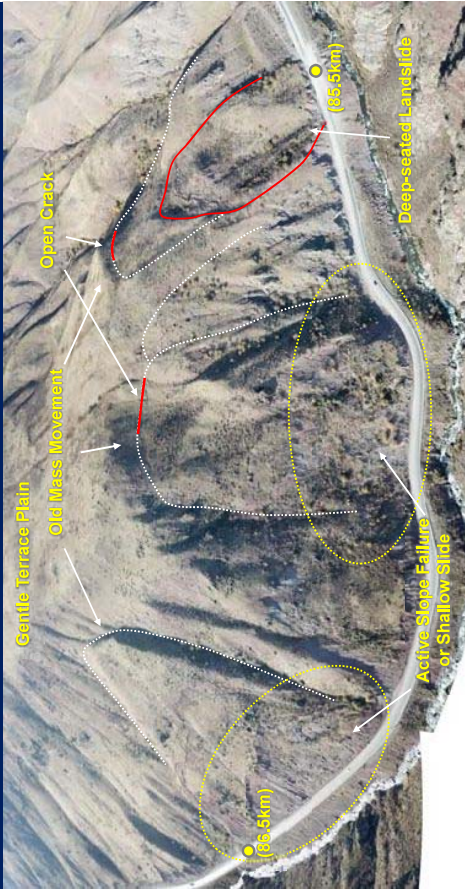
OVERALL PICTURE at 85.3km~86.6km

- In previous time, huge mass-movements occurred at margin of gentle terrace plain according to river erosion. Those have been stable for long time.
- Due to road construction and widening (cutting slopes), the end of slopes became unstable. Slope failure continuously occurred.
- At 85.5km, unloading of slope foot caused deep-seated landslide.

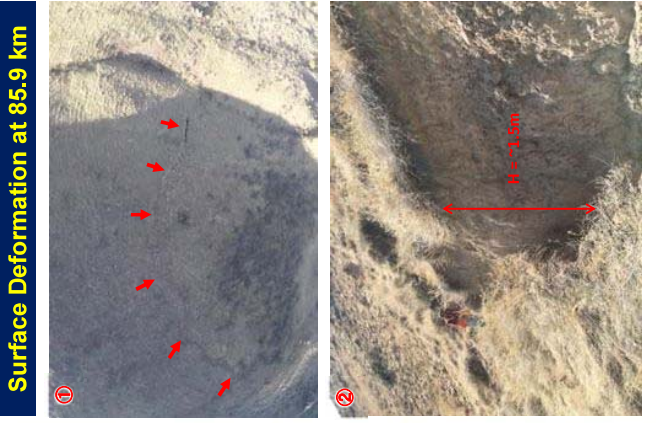
Surface Deformation at 85.9 km

Aligned cliff and open crack are observed along the scarp of old mass movement. It may be reactivated in future.
