## 1.0 INTRODUCTION

This report embodies the findings of a preliminary study of the Rio Cobre (RC) and its contribution to the pollution load in the Kingston Harbour. The study determines surface water quality and the pollution load on the basis of BOD. It also categorises the pollution load by sector i.e. agricultural, industrial and domestic.

PLATES

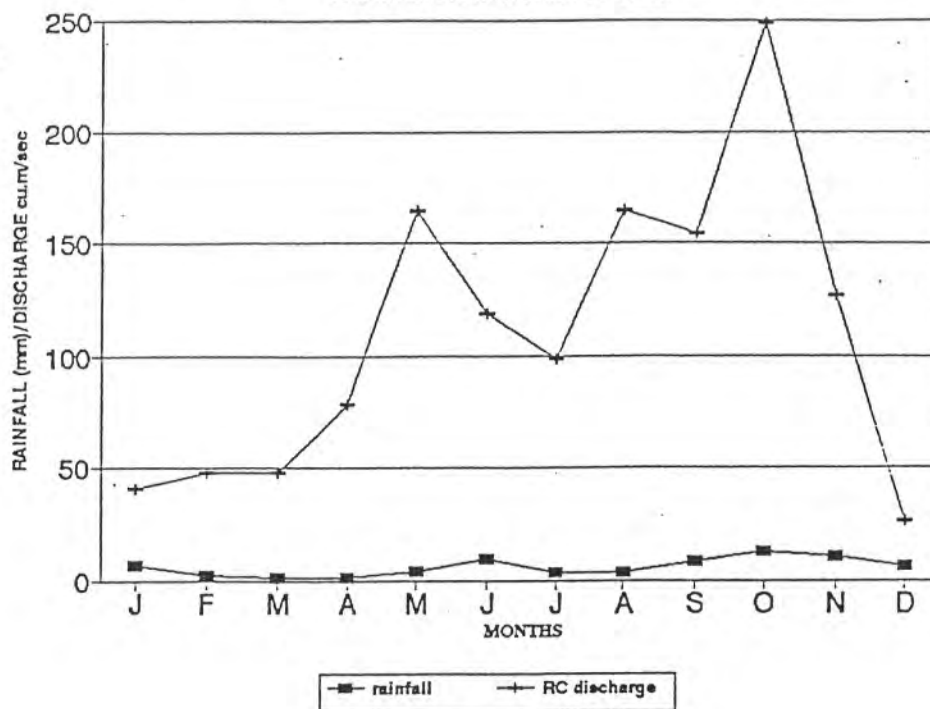
GRAPH 4.1 COMPARISON BETWEEN RAINFALL  
AND RIVER DISCHARGE HEADWORKS

The plot of discharge and rainfall as seen in Graph 4.1 shows that rainfall increases as river discharge increases and visa versa.

The 30-year average rainfall for selected regions in St. Catherine was plotted against RC discharge to determine the relationship between discharge and rainfall. In this case the regions used for the comparison were Headworks and Central Caymanas as these are the closest to Hunts Bay. Table 4.2 details annual readings of rainfall data from 1951-1980 for Headworks and compares these with RC discharge.

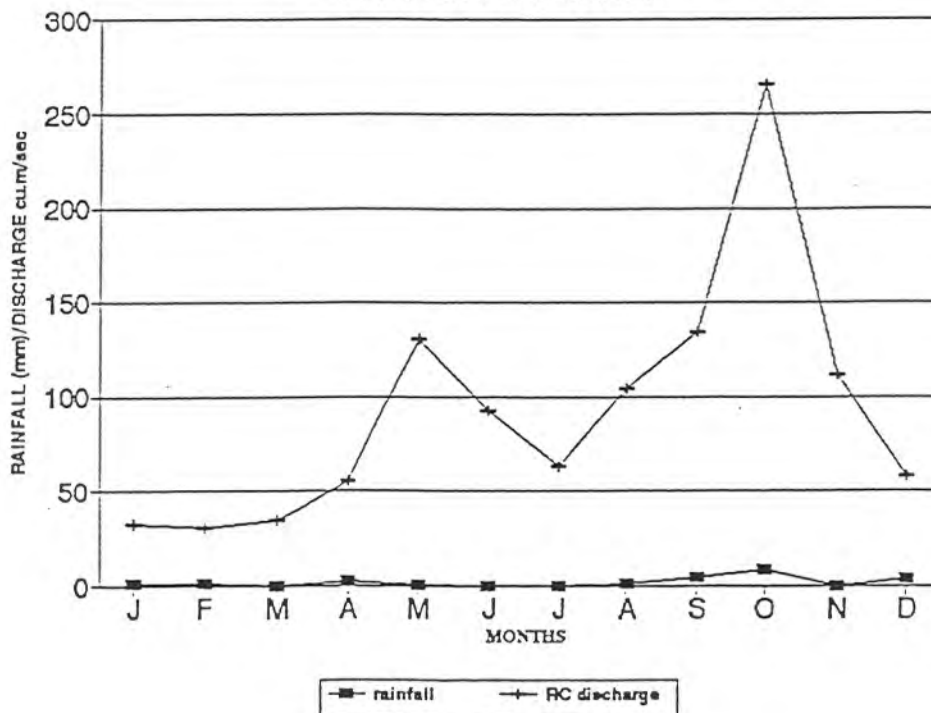
GRAPH 4.2 COMPARISON BETWEEN RAINFALL  
AND RIVER DISCHARGE CAY/CRUM

RC flow at Crum Ewing is considered to be the typical discharge into Hunts Bay. A comparison was done of RC discharge at Crum Ewing and rainfall in the Central Caymanas areas in Table 4.3 and Graph 4.2. Unfortunately only one year (1992) was available for the river as against 30 year mean for rainfall. However the data was sufficient to help establish a trend, as was the case at Headworks.

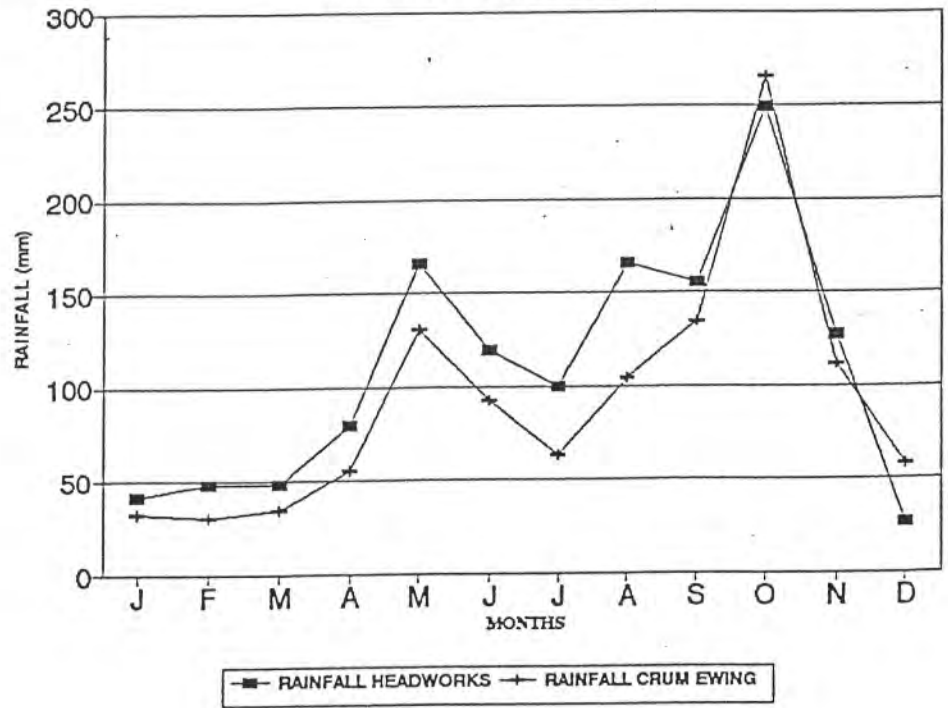
GRAPH 4.3 COMPARISON OF RAINFALL AT HEADWORKS AND CENTRAL CAYMANAS

The relationship between river discharges and rainfall is well known and has been established in Section 4.2. Graph 4.3 shows that the rainfall in Central Caymanas is lower than at Headworks. This suggests that river discharge at Crum Ewing will be consistently lower than Headworks.

In order to verify the most appropriate station (Crum Ewing or Headworks) to extract river flows for load calculations (for the Kingston Harbour) and given the availability of more accurate data at Headworks. The rainfall figures for Headworks were plotted against those for Crum Ewing (Central Caymanas), in Graph 4.3.

The differences in flow between Headworks ( $5.50 \text{ m}^3/\text{s}$ ) and Crum Ewing ( $2.41 \text{ m}^3/\text{s}$ ) is therefore understandable. RC discharge at Crum Ewing will be used in calculating the pollution load contribution to the Bay. For the purpose of this study, the readings taken in 1992 were averaged and the results used as the characteristic discharge of RC at Crum Ewing.

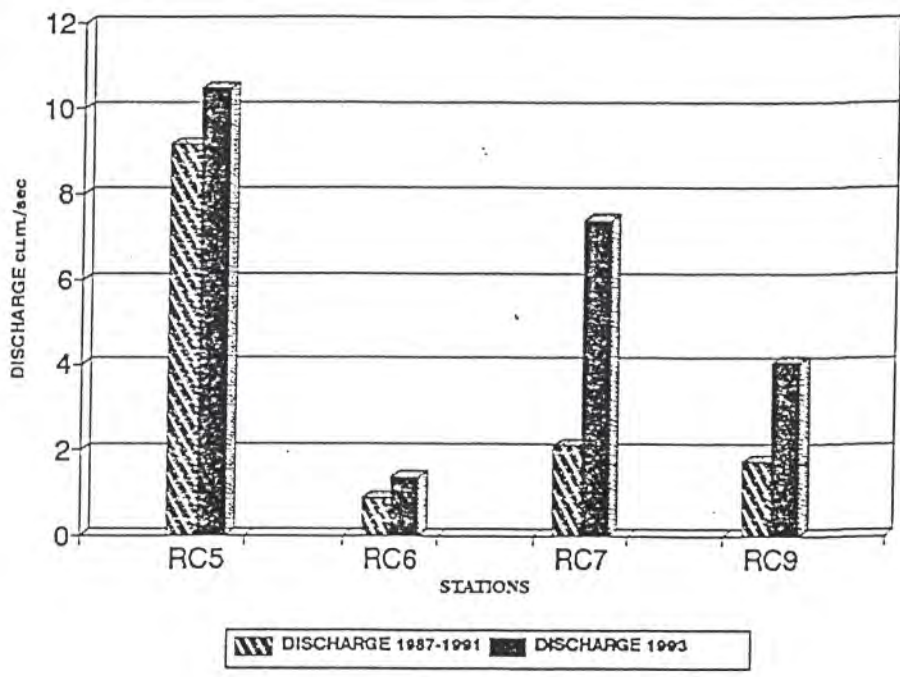
GRAPH 4.4. COMPARISON OF RIVER DISCHARGE FROM APRIL 1987-1991 AND APRIL 1, 1993

A comparison of RC discharge in April for 1987 - 1991 with readings obtained on April 1, 1993 highlights the increased flows (Table 4.4 and Graph 4.4). The calculations for BOD loading along RC's course were done using the April 1, 1993 data instead of historical averages because of the usually heavy flows during the period. Appendix VIII - XIII contain data on 1993

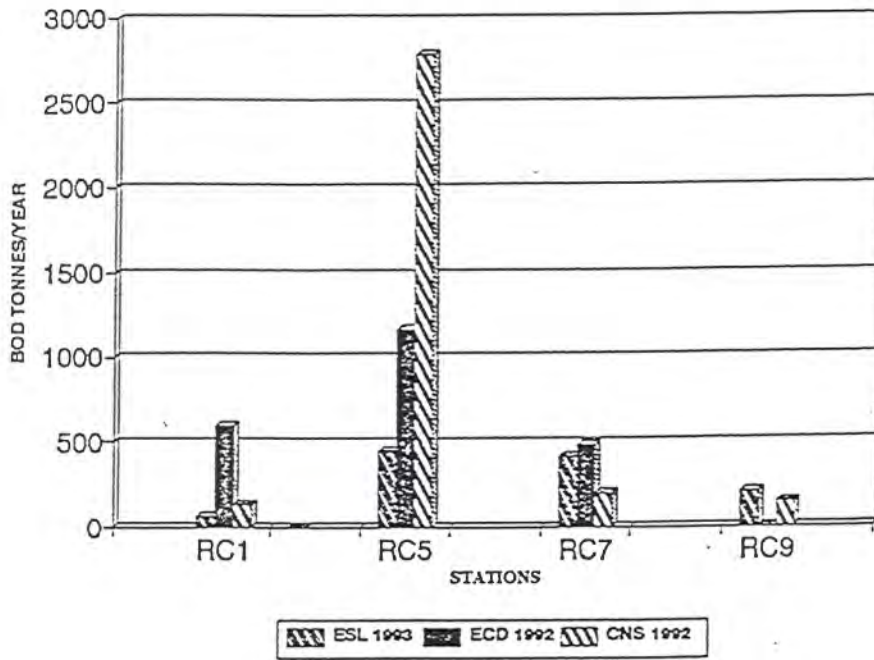
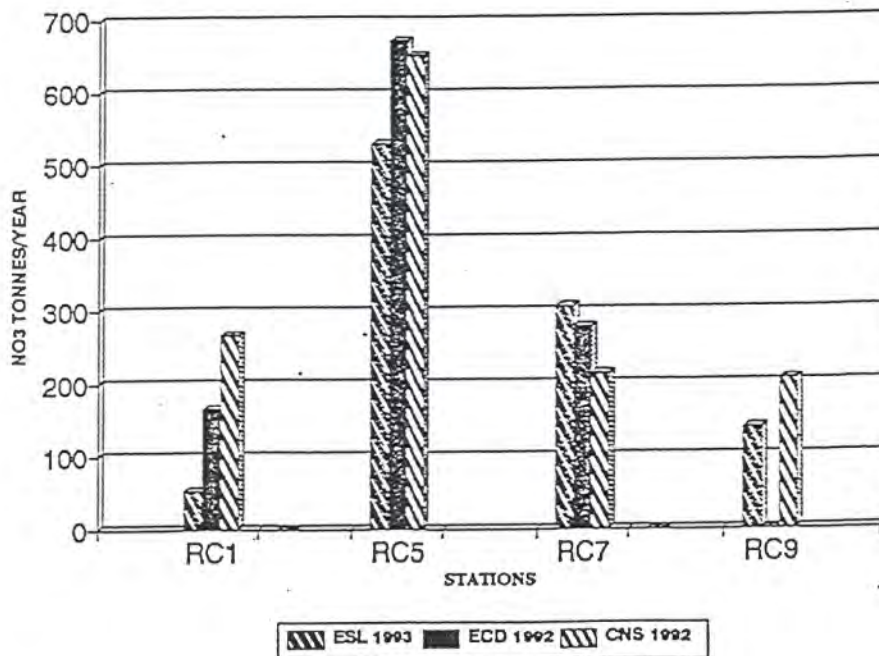
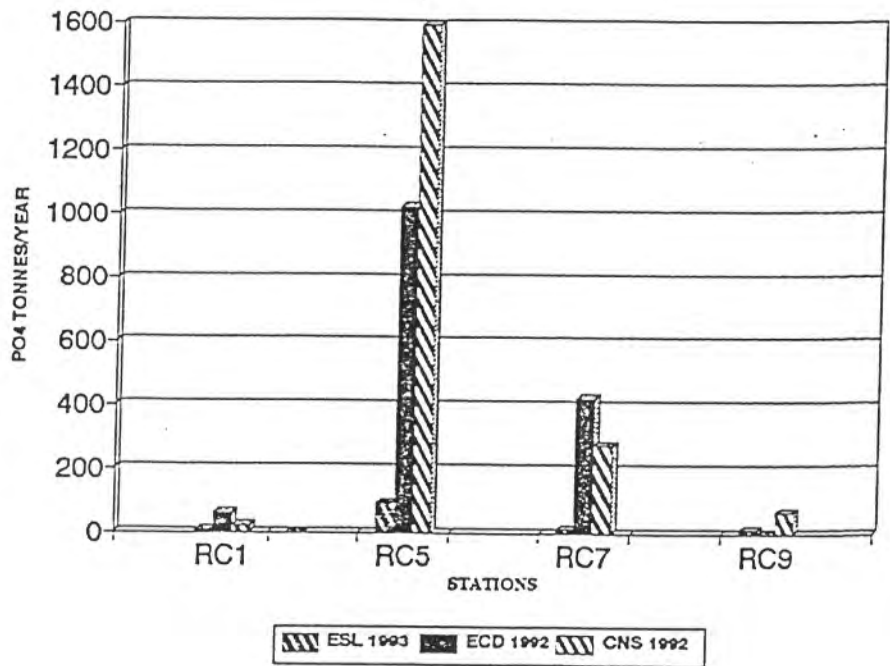
Graphing the BOD, phosphate and nitrate values (Graphs 5.1 -5.3) shows that the loadings peak in the Bog Walk area and then decreases as the river moves closer to the Harbour. One possible reason for the increased load is due to the merging of the major tributaries in the Bog Walk area. The decrease observe at Headworks is due to the diversion of the river for irrigation purposes. The diversion ultimately reduces the BOD and nutrient loading which finds its way into the Harbour via the Cobre.

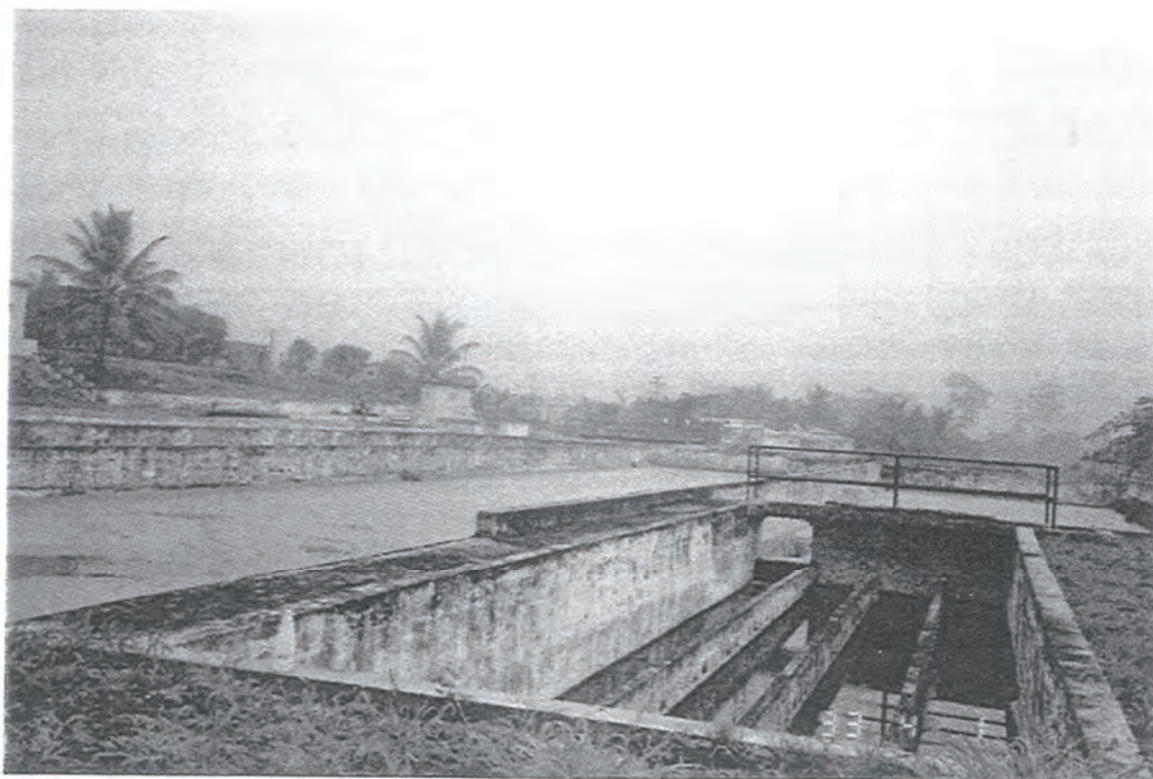
Sampling point 2 is the discharge from the Sewage Treatment Plant (STP) for the Charlemont Housing Scheme (Plate 2). This facility discharges into a gully which empties into the RC.

Plate 2 Sampling point 2 - Sewage Treatment Plant at Charlemont Housing Scheme

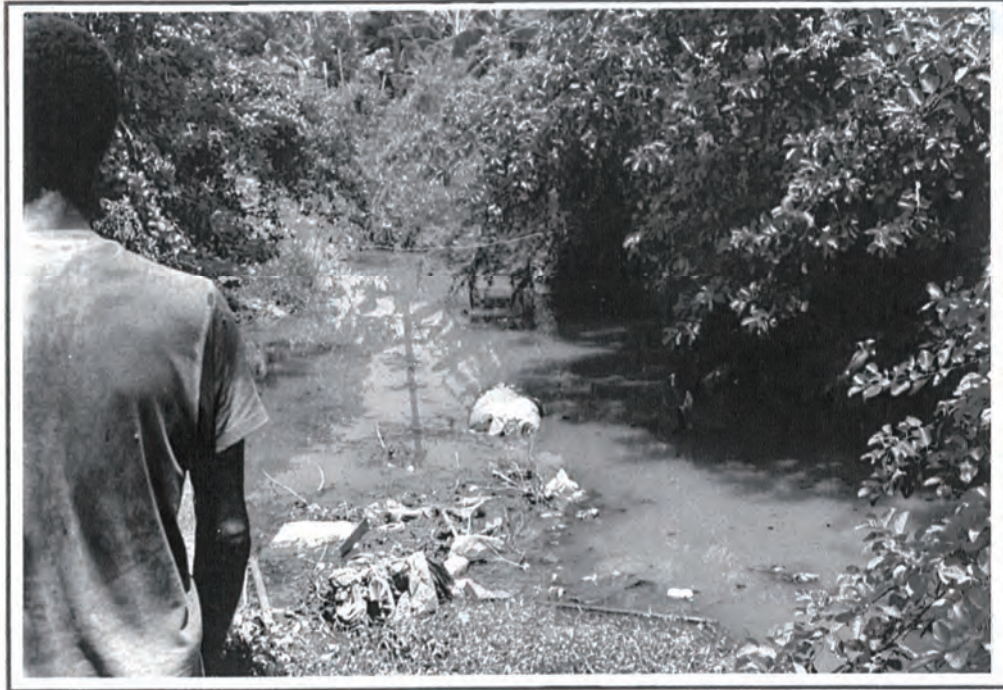
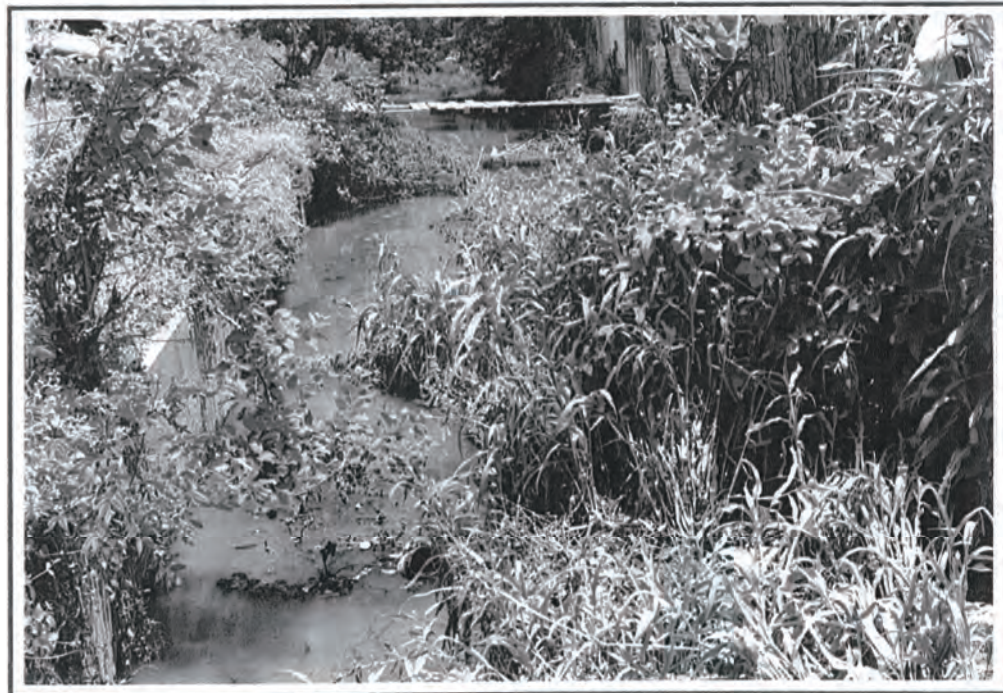
Plate 2 - Plates 1 and 2; The Northern Gully blocked with garbage and vegetation.

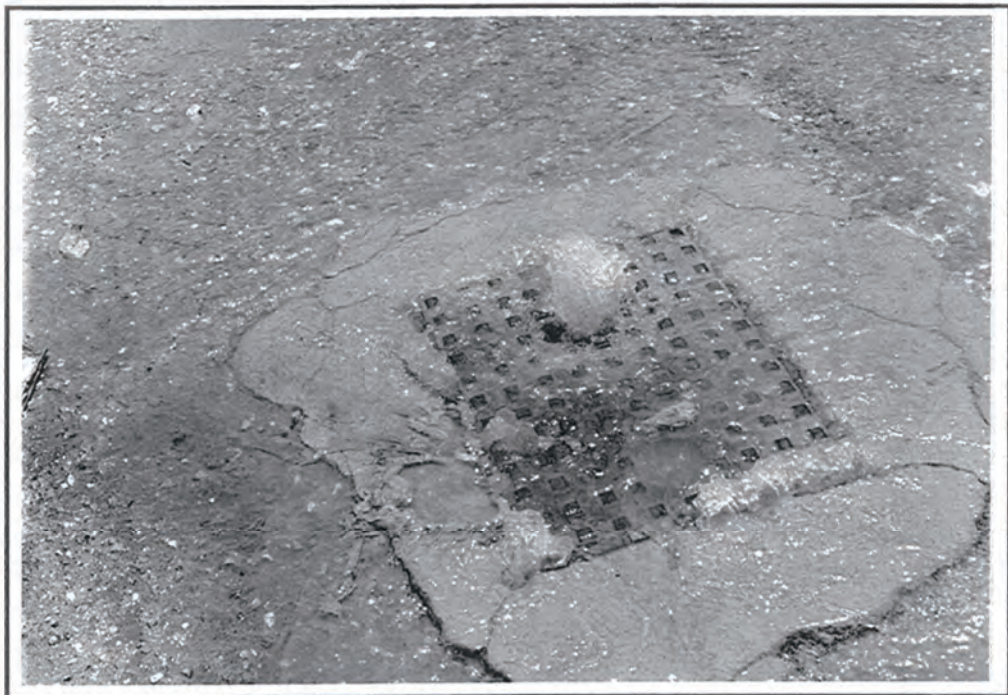
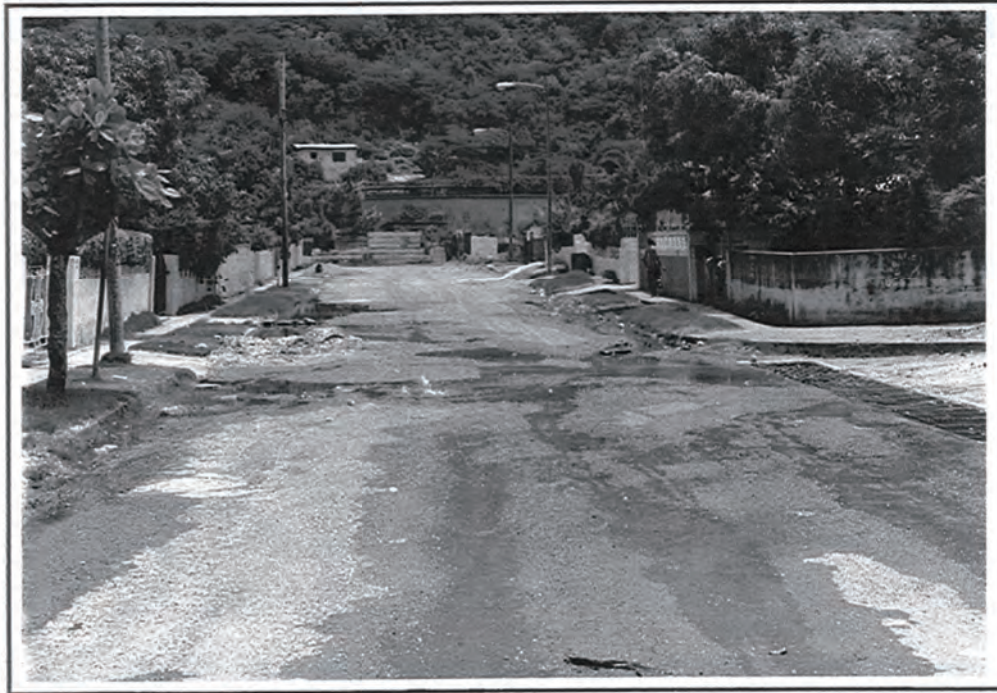
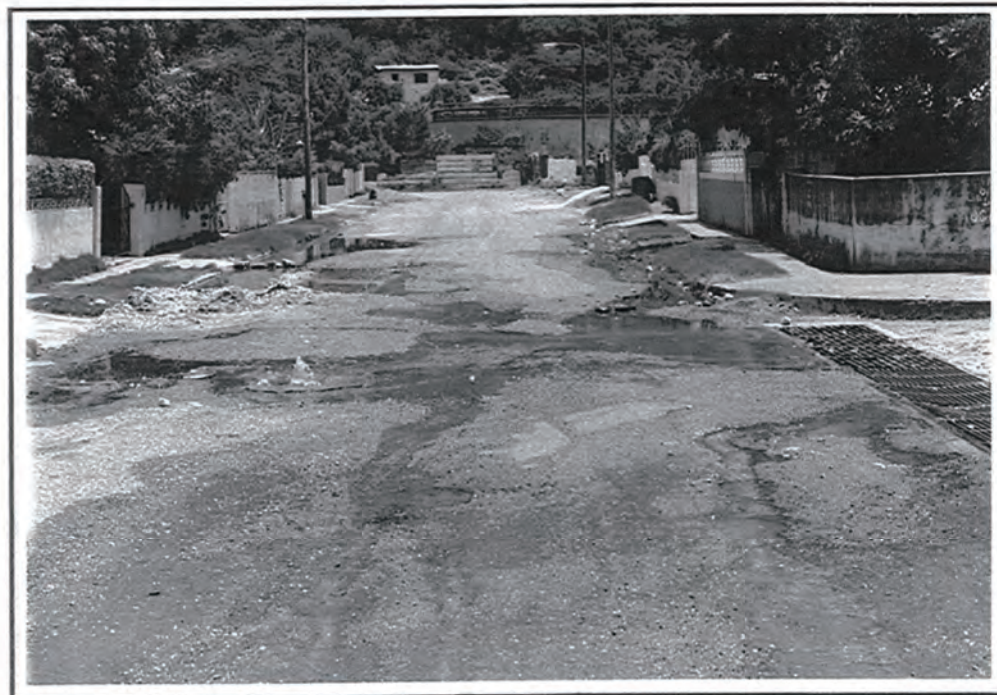
Plate 6 - Plates 4, 5, 6; Sewage emanating from surcharged sewer and entering storm drains. Note the retired Duhaney Treatment Plant in the background.

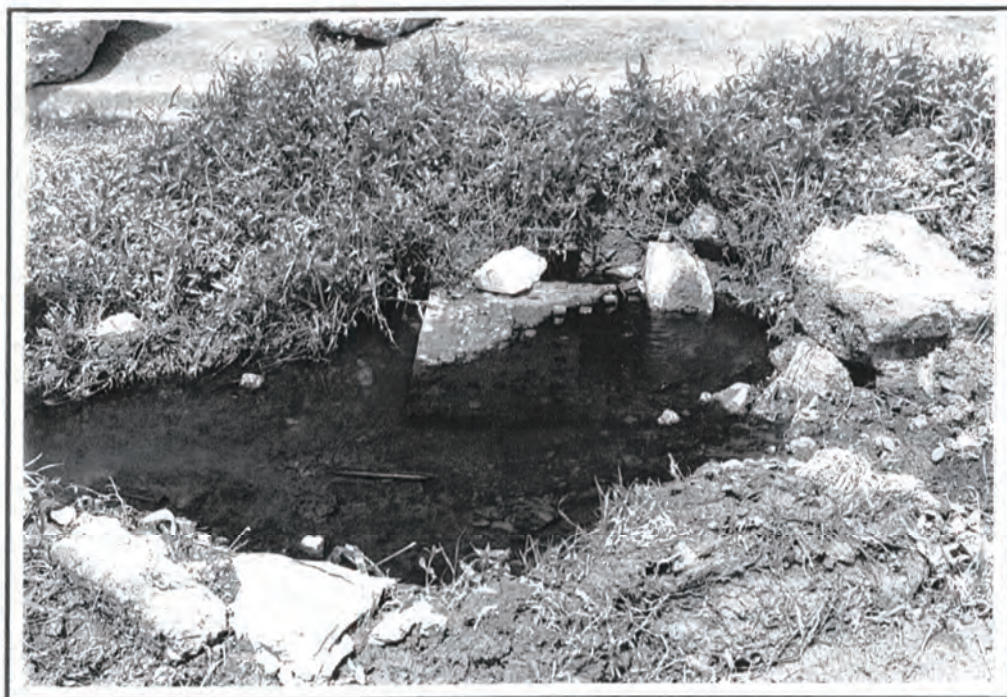
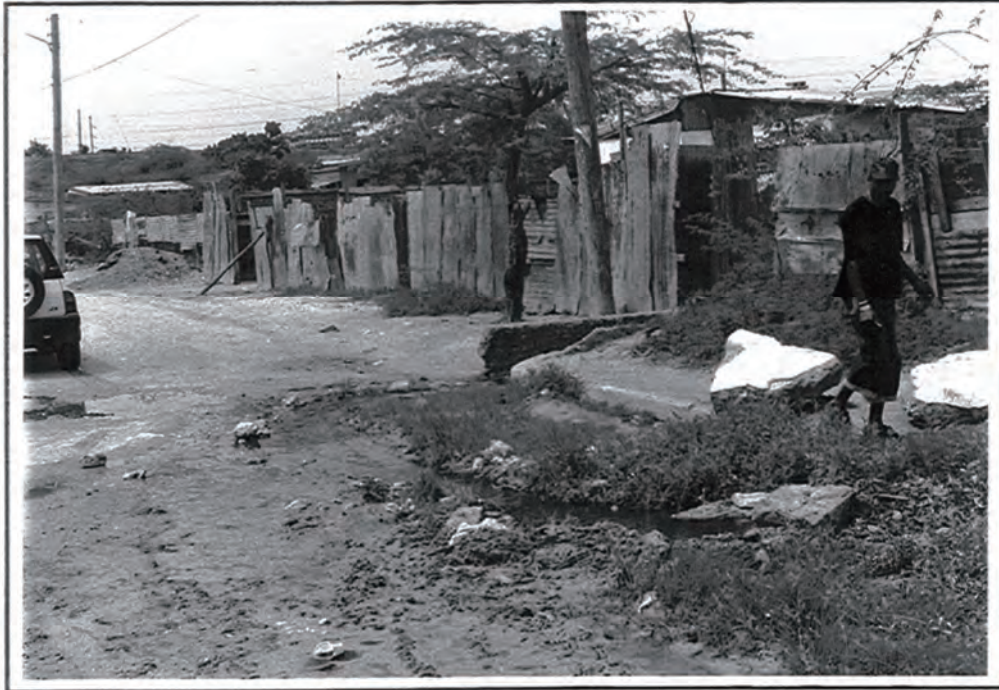
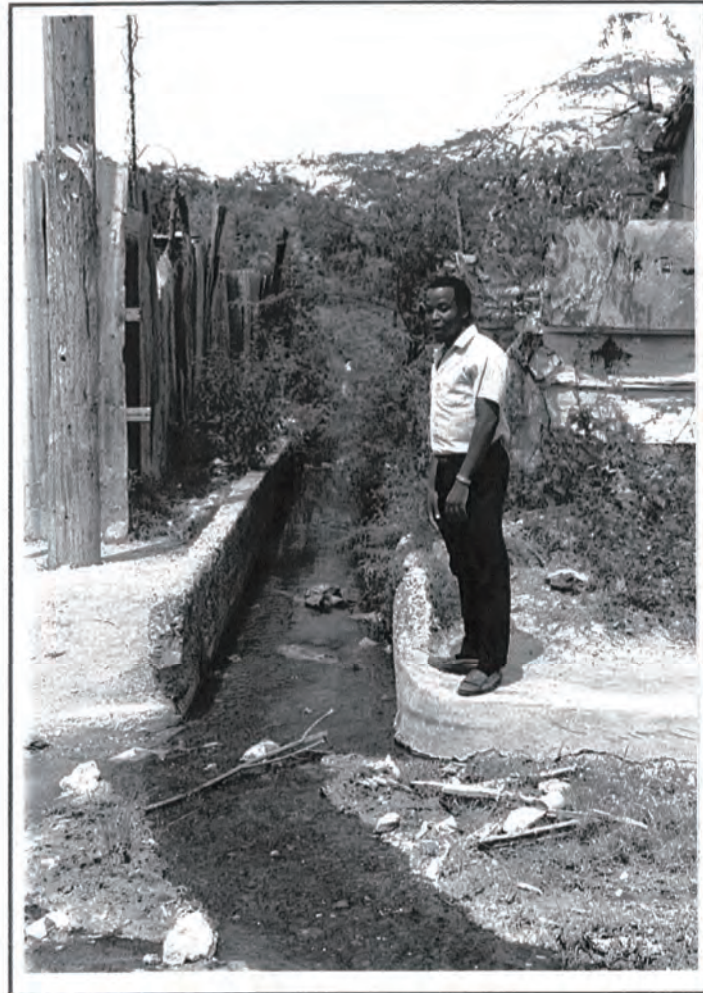
A broken sewer just south of the New Haven pumping station results in a constant stream of raw sewage to storm drains, which drain to the Duhaney River (see Plates 7, 8, 9 and 10).

Plate 10 - Plates 8, 9, 10; Sewage from sewer flows to the Duhaney, south of the New Haven pumping station.

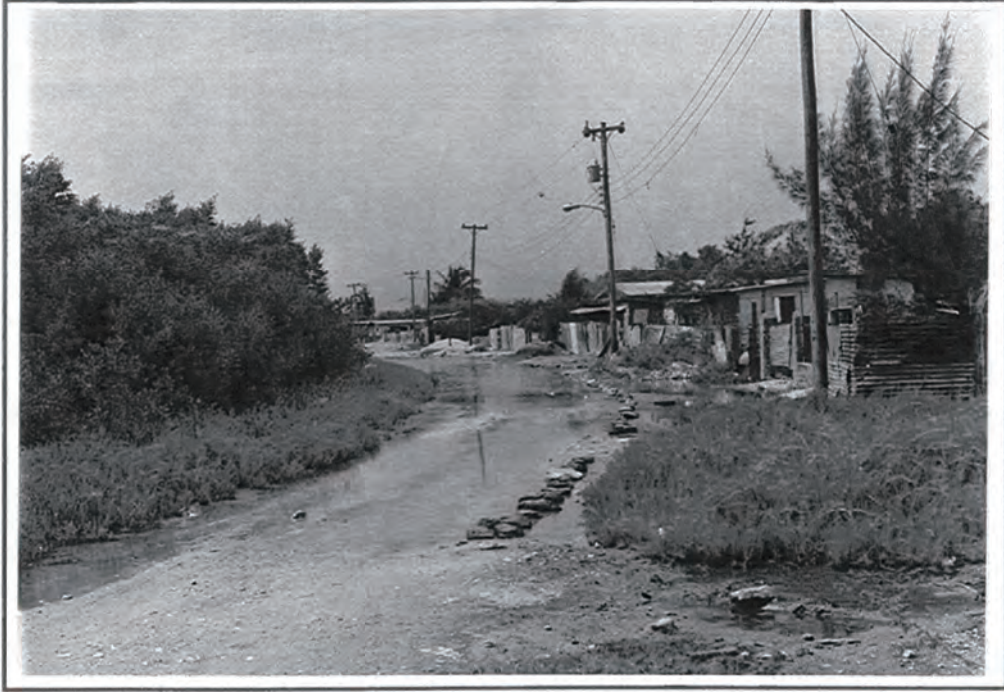
Plate 11 - The wetlands overflows onto the road in Riverside Gardens.
