Final Report of Stage II of the Project for Technical Assistance in Solid Waste Management in Palestine

**- A Technical Cooperation between Ministry of Local Government (MoLG) of
Palestine and Japan International Cooperation Agency (JICA) -**

Updated Version (31st July 2019)

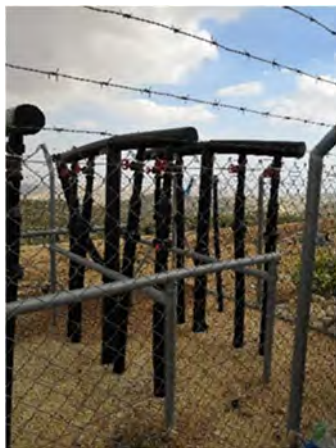
Gas Collection System at Al Menya Landfill

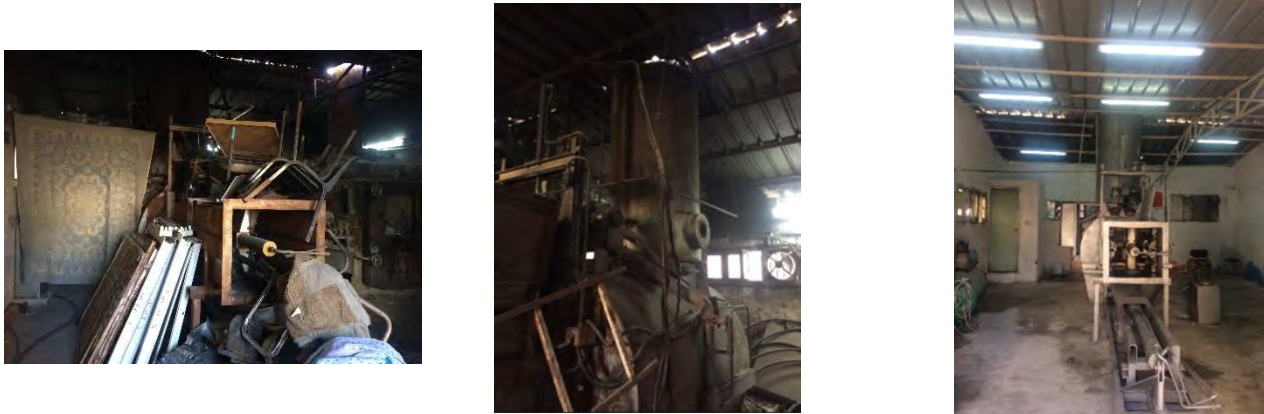
Figure II-10: Rehabilitation of Al Shifa Hospital Incinerator in Gaza (Before and After)

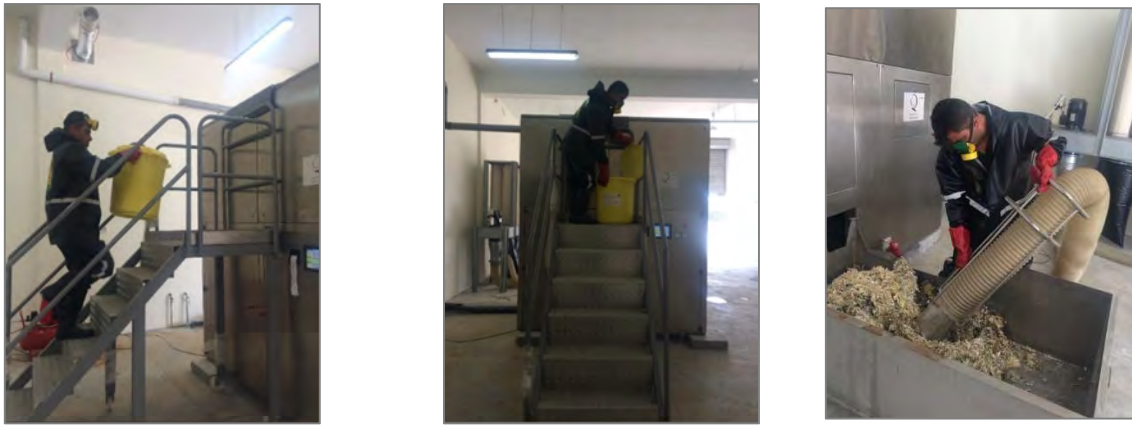
Figure II-13: Treatment Process using Autoclave in Gaza

The average production of infectious and sharps from target places is 900kg/month, 580kg/month, and 1,326 kg/month from UNRWA, MoH and MSF clinics respectively. Whereas the average generation from the lab and hemodialysis departments of Al Shifa hospital is 4,220 kg/month.

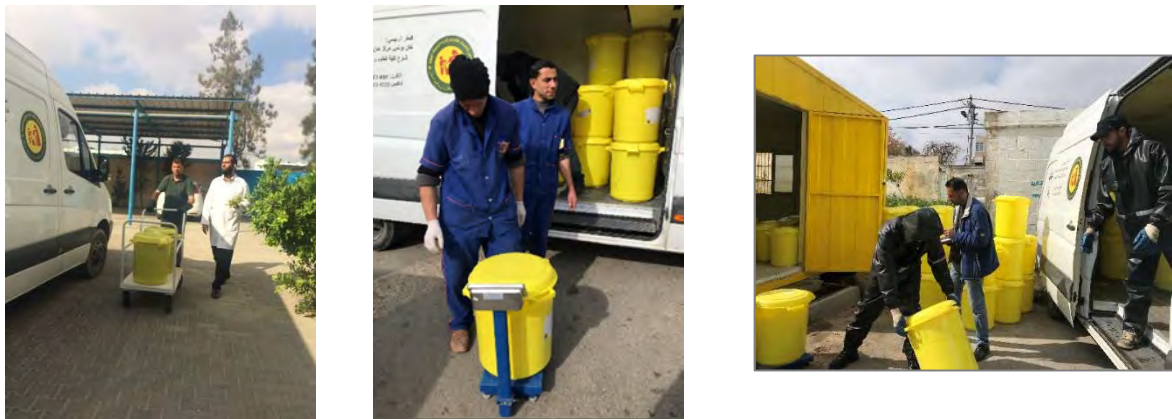
Figure II-14: Infectious waste collection process in Gaza

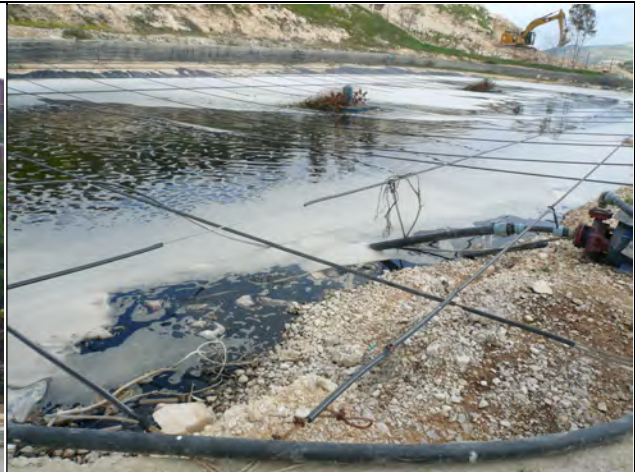
Leachate pond-2017

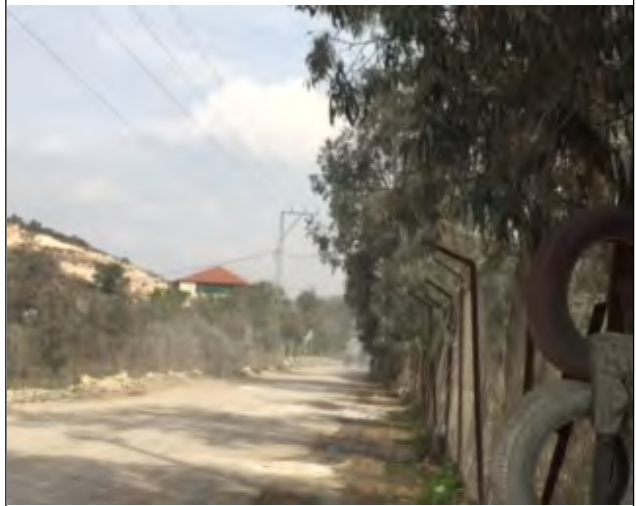
Dust improperly controlled-2018

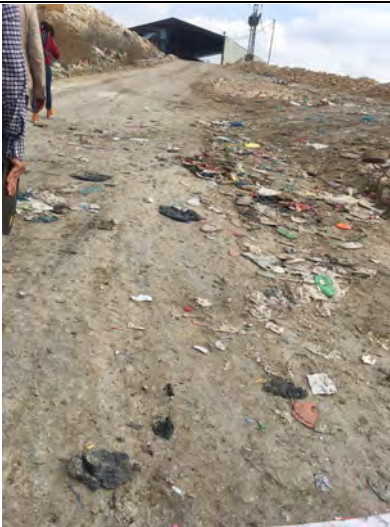
Internal road (Improperly paved and not clean)-2018

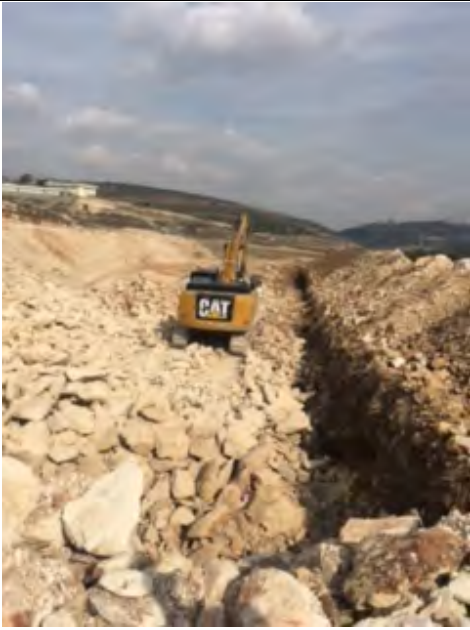
Construction works in new leachate pond (2018)

<p>Other observation / (Immediate) Action is Required on;</p> <p>Immediate action on the implementation of daily cover soil and on the selection of this cover seems to be necessary specially for the new constructed cell, in order to overcome the problems faced during operating the old cell.</p>					
<p>Site Operator's Comments:</p> <p>The operator commented that there is no significant issue on the operation.</p>					
<p>Samples Taken: Yes/<input checked="" type="checkbox"/>No</p>					
<p>Photographs Taken: <input checked="" type="checkbox"/>Yes/No</p>

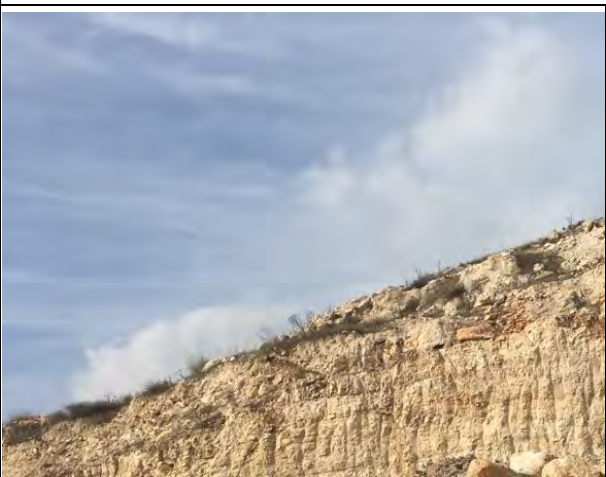
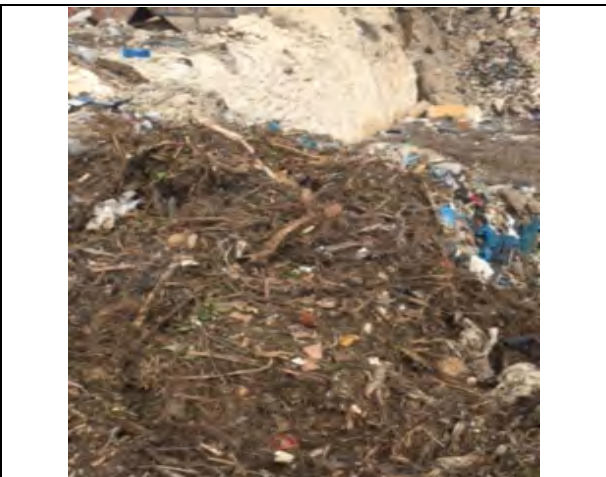
<p>Construction on Leachate Pond (2018)</p>		<p>Trees Branches added to leachate pond to reduce odour(2018)</p>

<p>Other observation / (Immediate) Action is Required on;</p> <p>What is most important is to stop the uncontrolled discharge to outside the landfill, and to follow the issue of treating leachate as soon as possible.</p>				
<p>Site Operator's Comments:</p> <p>They are seeking optimum method to treat the leachate. As since the last auditing on in March 2017, the operator tried to test a treatment of leachate using chemicals (pictures) proposed by external company , but unfortunately the method failed to, treat the leachate and then , the operator now is waiting to find a financial support in order to finance the implementation of treatment technology proposed by the consulting firms through MDLF, the results of this study already mentioned in this report.</p>				
<p>Samples Taken: Yes/<input checked="" type="checkbox"/>No</p>				
<p>Photographs Taken: <input checked="" type="checkbox"/>Yes/No</p>

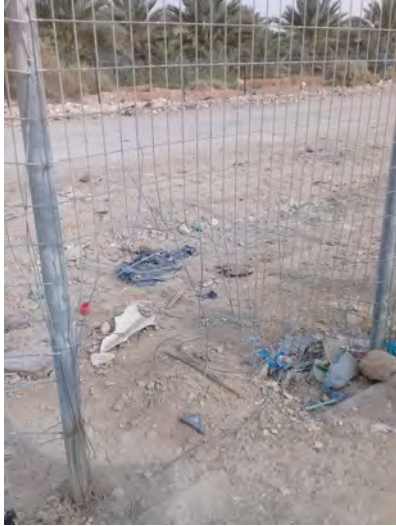
Photo (1) – damaged increment in the fence surrounding the landfill

Other observation / (Immediate) Action is Required on;					
Generally, the work in the site is not going completely as it must be, it is worse than situation in 2016, the new cell seems to be full very soon, so as an immediate solutions and measures need to be taken.					
Site Operator's Comments: the design of the landfill site was prepared according to international standards. Fukuka method (semi aerobic) landfill theory was adopted in Jericho landfill site. In this system landfill gas is collected and removed, where oxygen enters between waste layers leading to a semi aerobic environment condition.					
Samples Taken: Yes/ <input type="checkbox"/> No					
Photographs Taken: <input type="checkbox"/> Yes/No

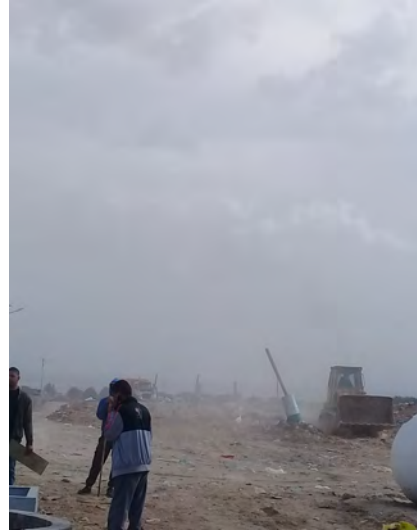
Photo (2) -Dust in the site caused by vehicle movement

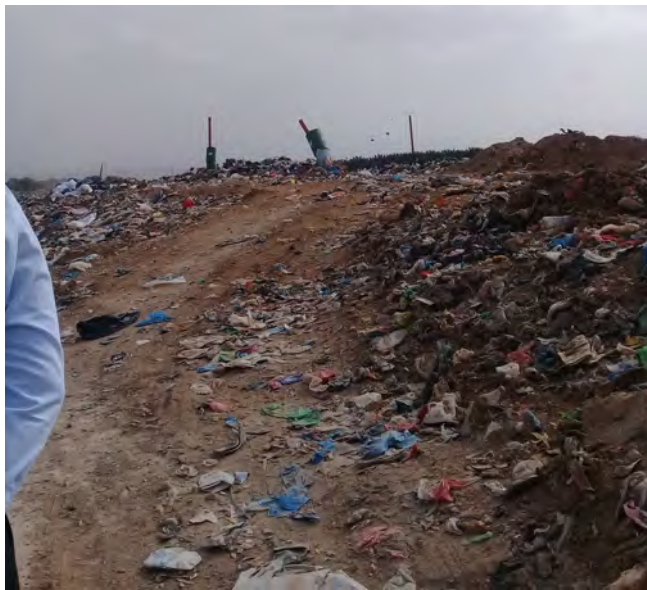
Photo (7)- Access Internal Road in the landfill

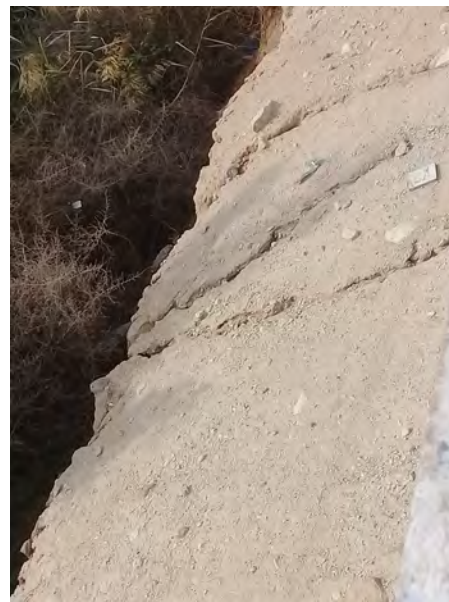
Photo (8)- Cracks in the retaining wall

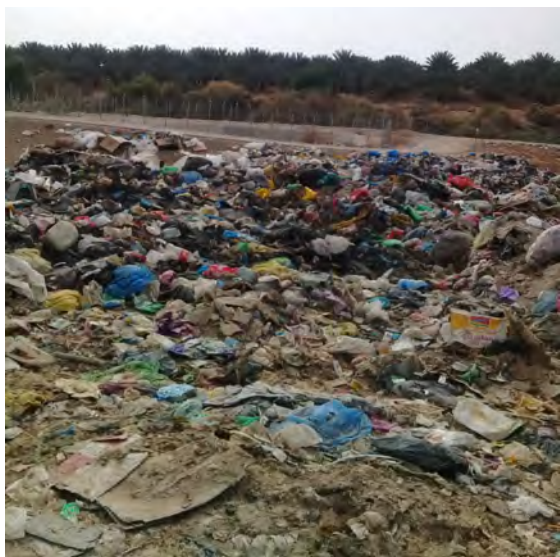
Exposed Working Face

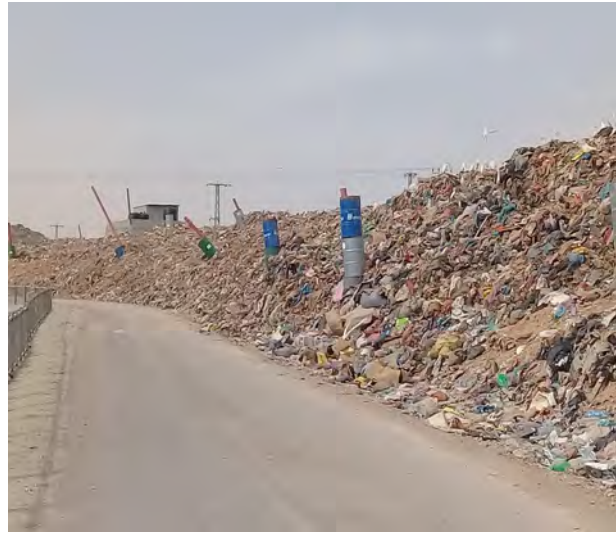
Gas Collection System in the new and old cells

None						
Site Operator's Comments: the smoke was due to a fire at the top of the landfill site and not due to landfill gases. This situation was solved. Maintenance of the landfill removal pipes and manholes is done before extension of the gas removal pipes. Although this issue will be taken into consideration and will be solved soon.						
Samples Taken: Yes/ <input type="checkbox"/> No						
Photographs Taken: <input type="checkbox"/> Yes/No

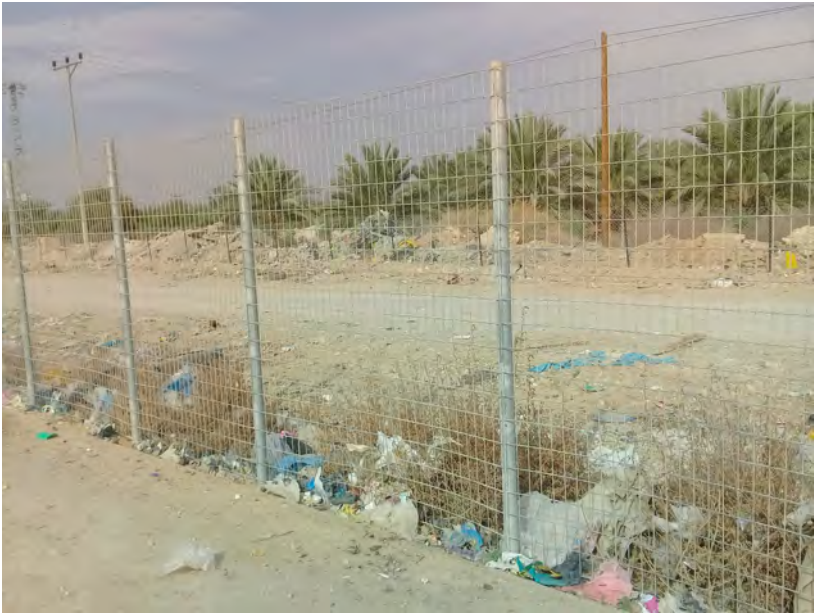
Waste Scattered around the Landfill site

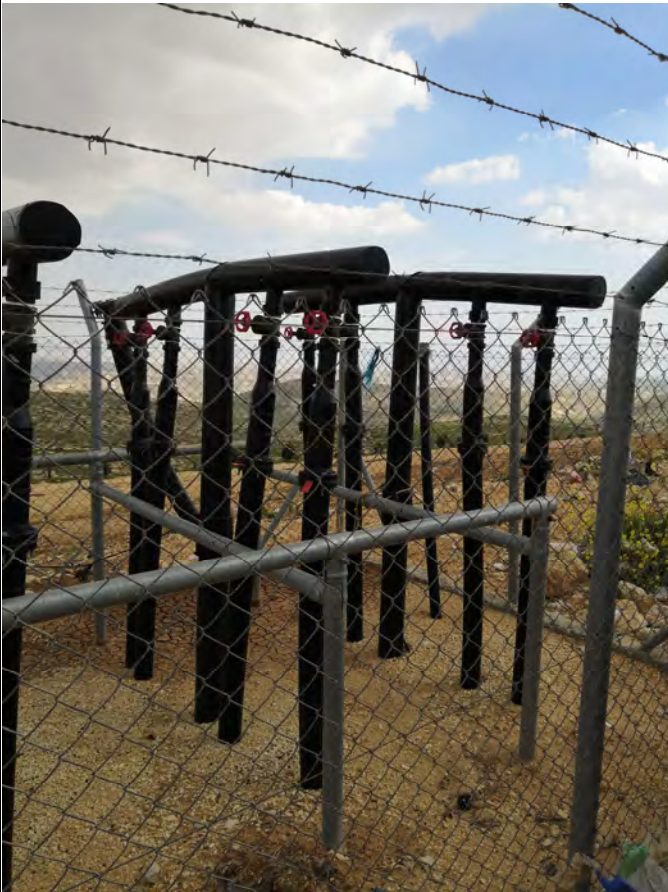
Gas Collection System in the new and old cells

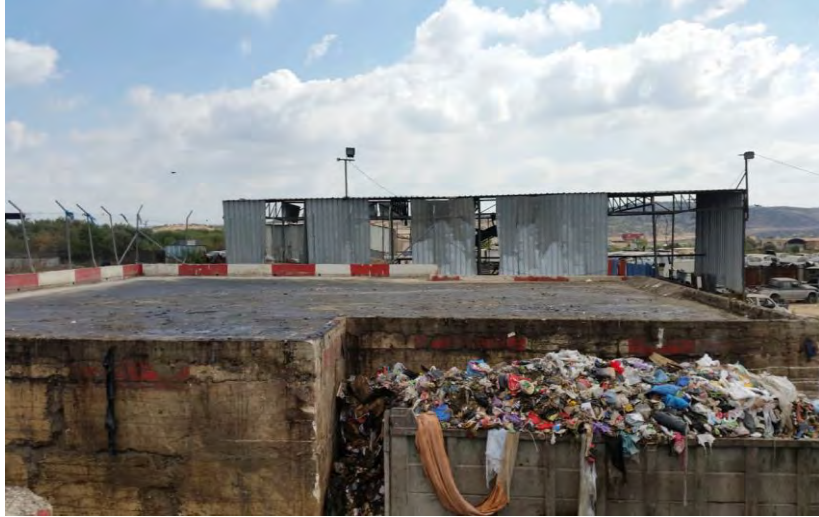
Waste Emptying Process into Bigger Containers

Overall comment						
Monitoring of waste staying period before being transferred, which should be less than 24 hours.						
Other observation / (Immediate) Action is Required on;						
Site Operator's Comments:						
Samples Taken: <u>Yes/No</u>						
Photographs Taken: <u>Yes/No</u>

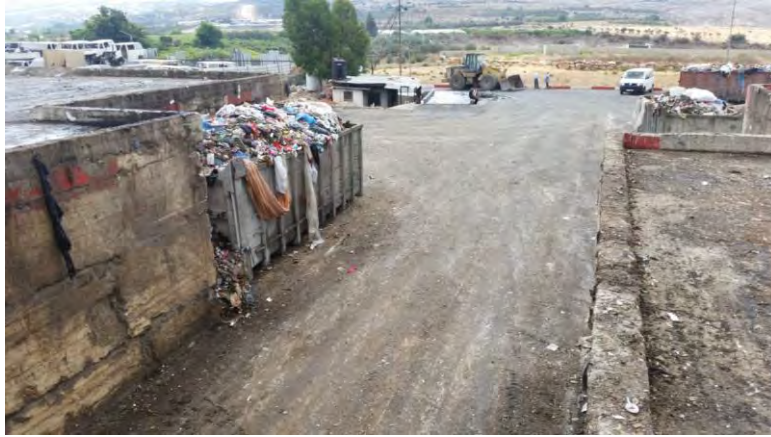
Waste Receiving Area in the Transfer Station

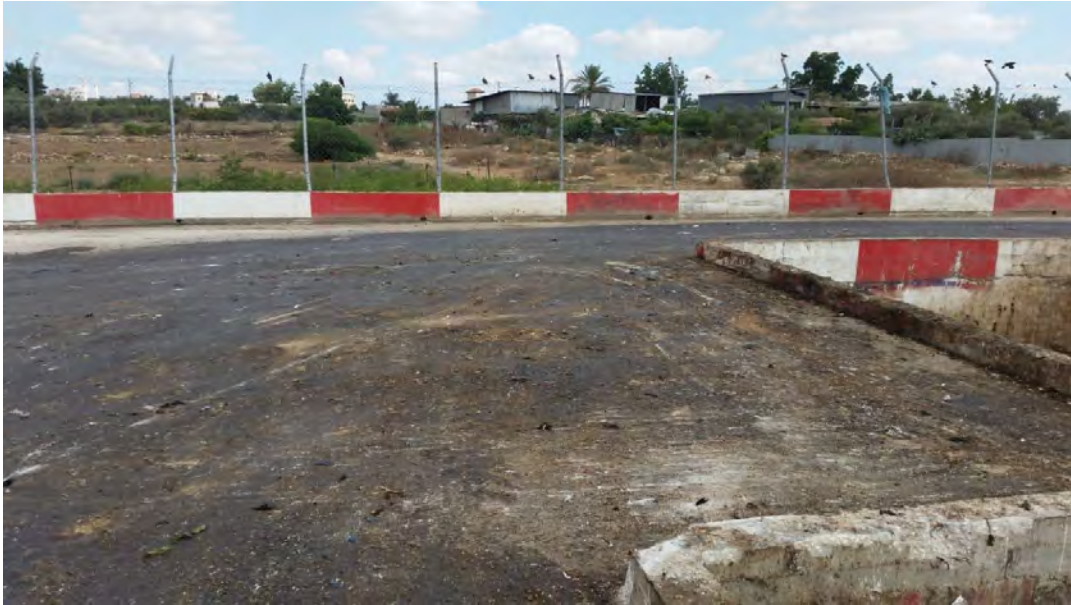
The Fence Surrounding the Transfer Station Site

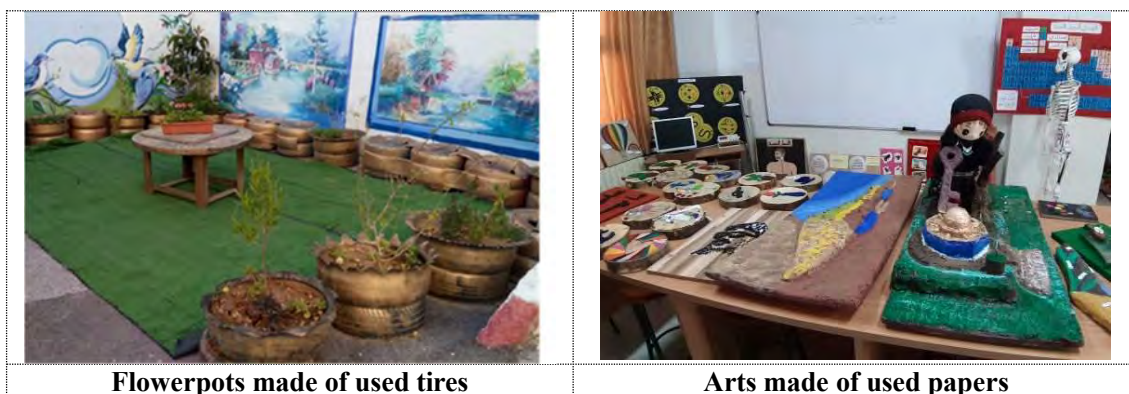
Flowerpots made of used tires
