**Preparatory Survey
on
Landslide Disaster Protection Project of
the National Road Network Phase 2
in
Sri Lanka**

**FINAL REPORT
APPENDIX**

Appendix 3 Inventory Sheet of 53 sites

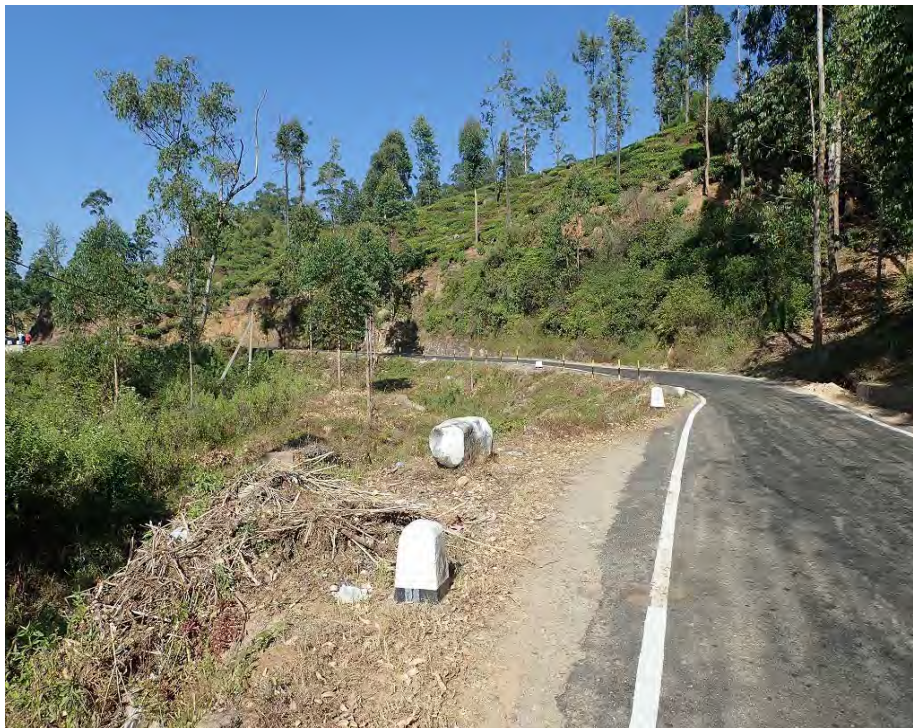
Site Photo

Site No.	1	District:	Nuwara Eliya	DS Division :	Hanguranketha
Road Class:	B	Route No.	B-413	Name of the Road:	Tennekumbura - Rikillagaskada - Ragala Road.
Start (Km/cul.):	66.75 km	End (Km/cul.):	67.0km		
Disaster Type :	Landslide	Width (m) :	250	Magnitude Score :	a
Year of Disaster Recorded:	2011	Potential Score :	i		
Detour Distance (km):	127	Detour Route:	B413-B51-Nitakupitiya Mapakada Wewa Road-A5-B471-B332-B413	Detour Score :	A

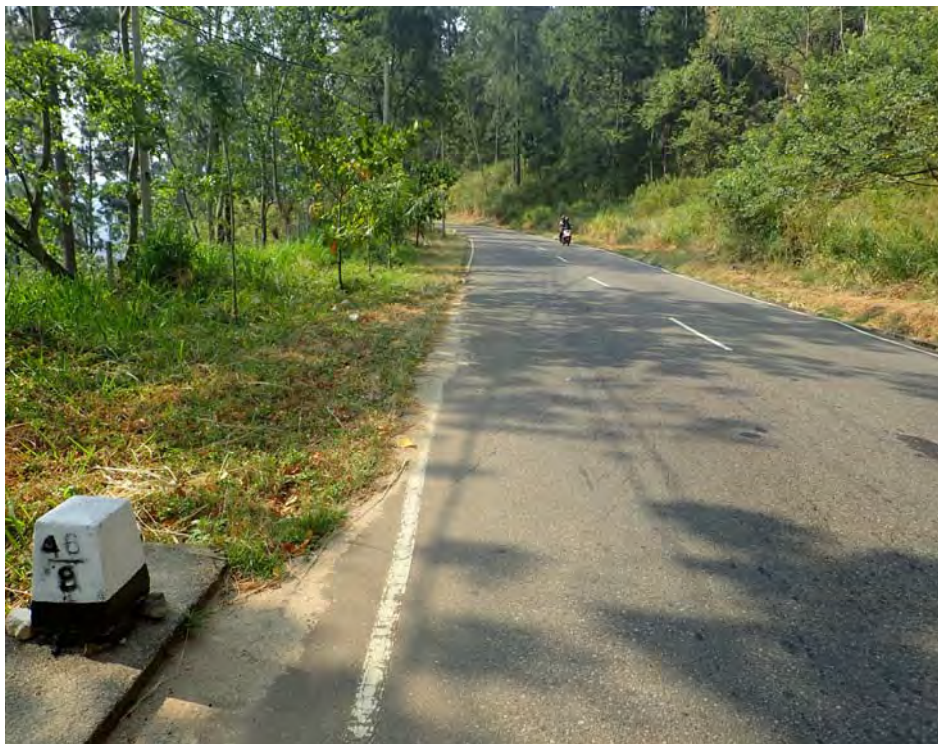
Site Photo

Site No.	2	District:	Nuwara Eliya	DS Division :	Nuwara Eliya
Road Class:	A	Route No.	A-055	Name of the Road:	Peradeniya - Badulla - Chenkaladi road
Start (Km/cul.):	46/2	End (Km/cul.):	46/3		
Disaster Type :	Landslide	Width (m) :	25	Magnitude Score :	a
Year of Disaster Recorded:	2016	Potential Score :	ii		
Detour Distance (km):	195	Detour Route:	A5-A7-A21-A1-A5	Detour Score :	A

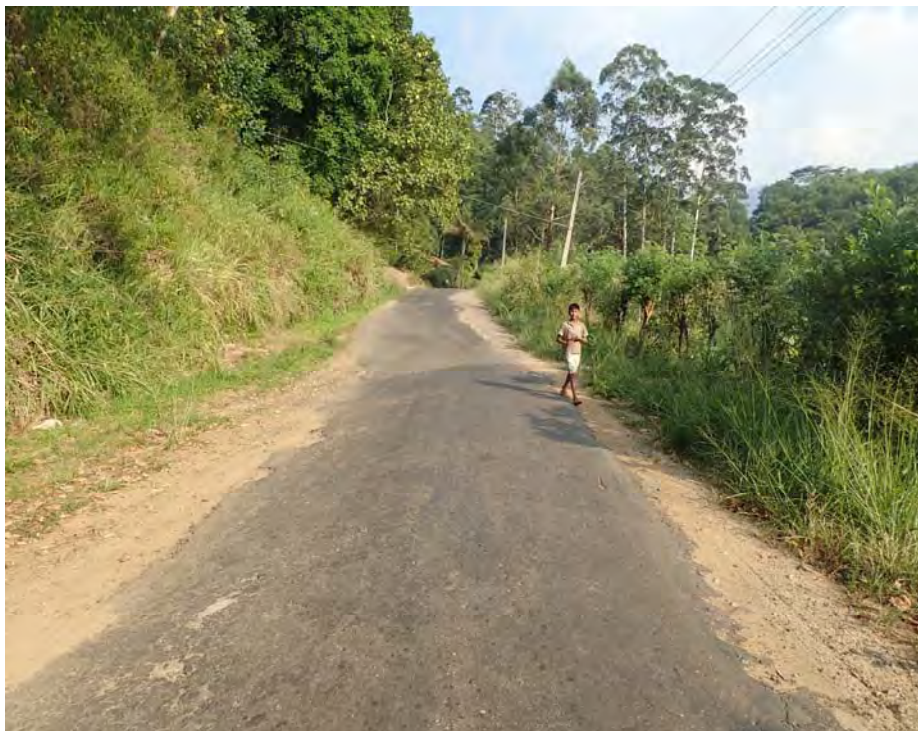
Site Photo

Site No.	3	District:	Nuwara Eliya	DS Division :	Nuwara Eliya
Road Class:	B	Route No.	B-582	Name of the Road:	Gomburu Oya - Balapokuna road
Start (Km/cul.):	6/3	End (Km/cul.):	6/5		
Disaster Type :	Landslide	Width (m) :	65	Magnitude Score :	b
Year of Disaster Recorded:	2007	Potential Score :	i		
Detour Distance (km):	20	Detour Route:	B412-B412 connection-A5-B431-B412		Detour Score : B

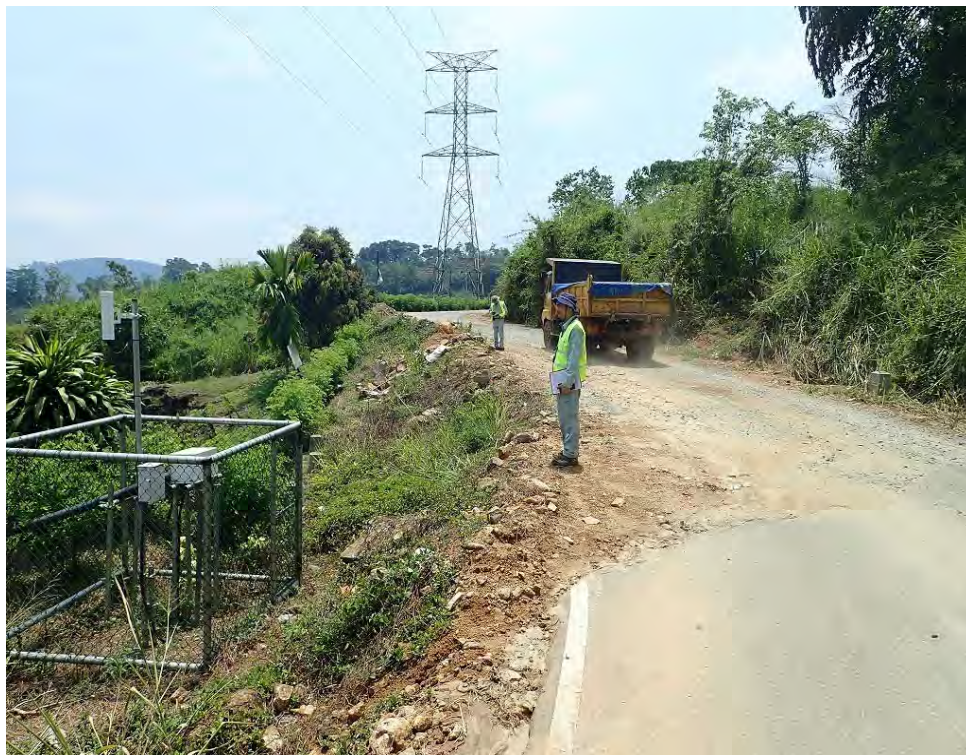
Site Photo

Site No.	4	District:	Ratnapura	DS Division :	Ratnapura
Road Class:	B	Route No.	B-391	Name of the Road:	Ratnapura - Wewalwatta Road
Start (Km/cul.):	11.9 km	End (Km/cul.):	12.0 km		
Disaster Type :	Landslide	Width (m) :	100	Magnitude Score :	a
Year of Disaster Recorded:	2015	Potential Score :	i		
Detour Distance (km):	78	Detour Route:	B39-B265-A4-B39	Detour Score :	B

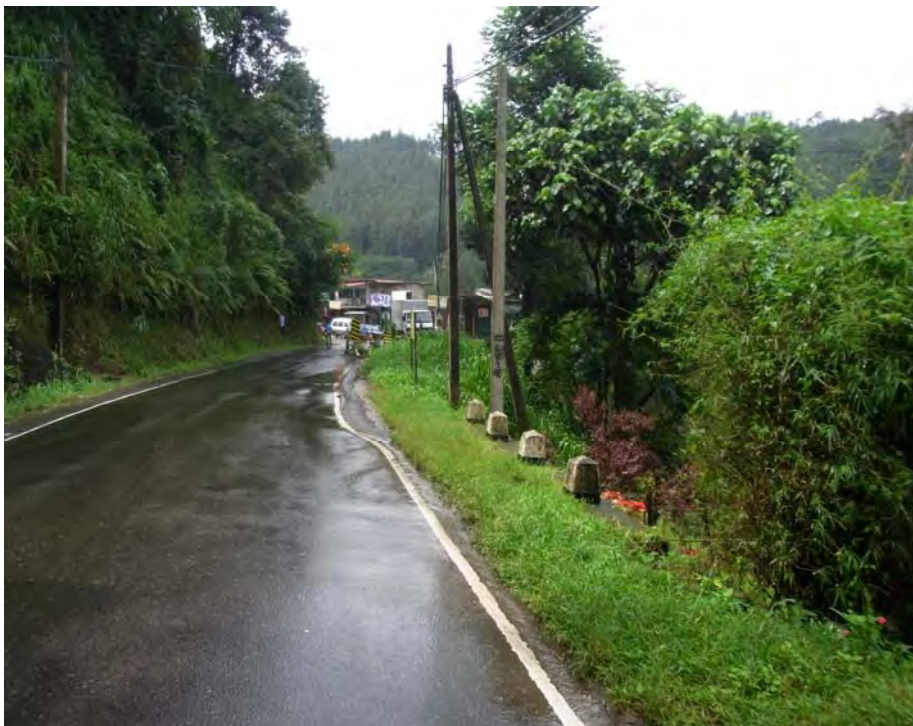
Site Photo

Site No.	5	District:	Nuwara Eliya	DS Division :	Nuwara Eliya
Road Class:	A	Route No.	A-007	Name of the Road:	Avissawella - Hatton - Nuwaraeliya
Start (Km/cul.):	55/1	End (Km/cul.):	55/2		
Disaster Type :	Slope Failure	Height (m) :	20	Magnitude Score :	b
Year of Disaster Recorded:	2012	Potential Score :	iii		
Detour Distance (km):	195	Detour Route:	A7-A5-A1-A21-A7	Detour Score :	A

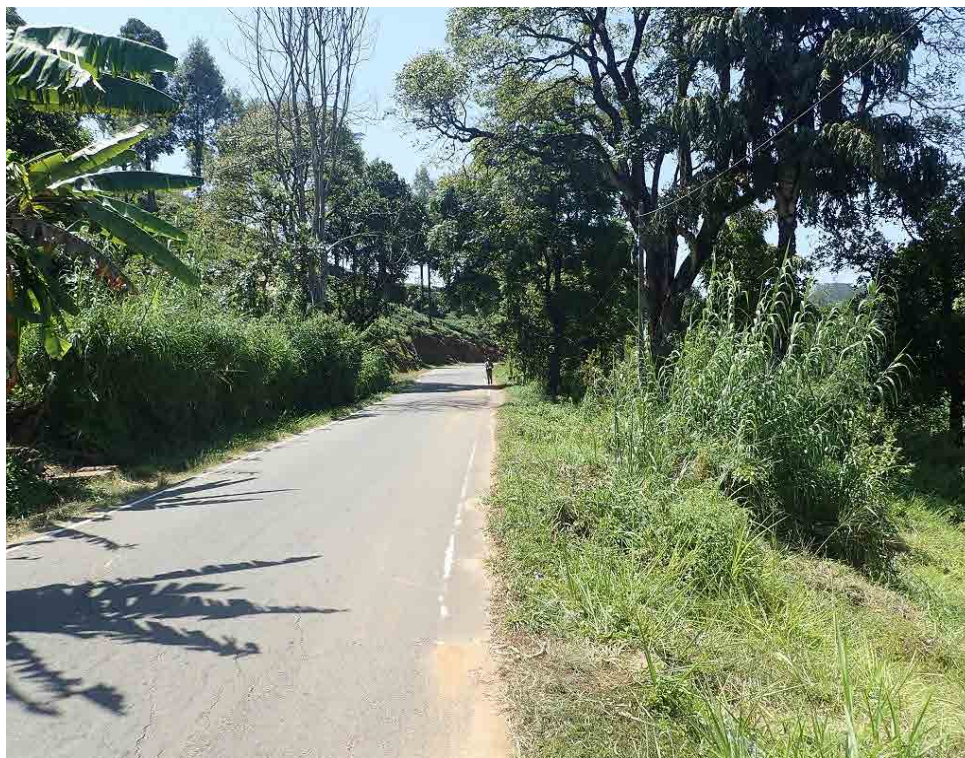
Site Photo

Site No.	6	District:	Nuwara Eliya	DS Division :	Nuwara Eliya
Road Class:	B	Route No.	B-412	Name of the Road:	Tawalanthenna-Thalawakele road
Start (Km/cul.):	30/9	End (Km/cul.):	30/11		
Disaster Type :	Landslide	Width (m) :	100	Magnitude Score :	a
Year of Disaster Recorded:	2007	Potential Score :	i		
Detour Distance (km):	63	Detour Route:	B412-B412 connection-A5-A7-Radella Short Road-A7-B412	Detour Score :	B

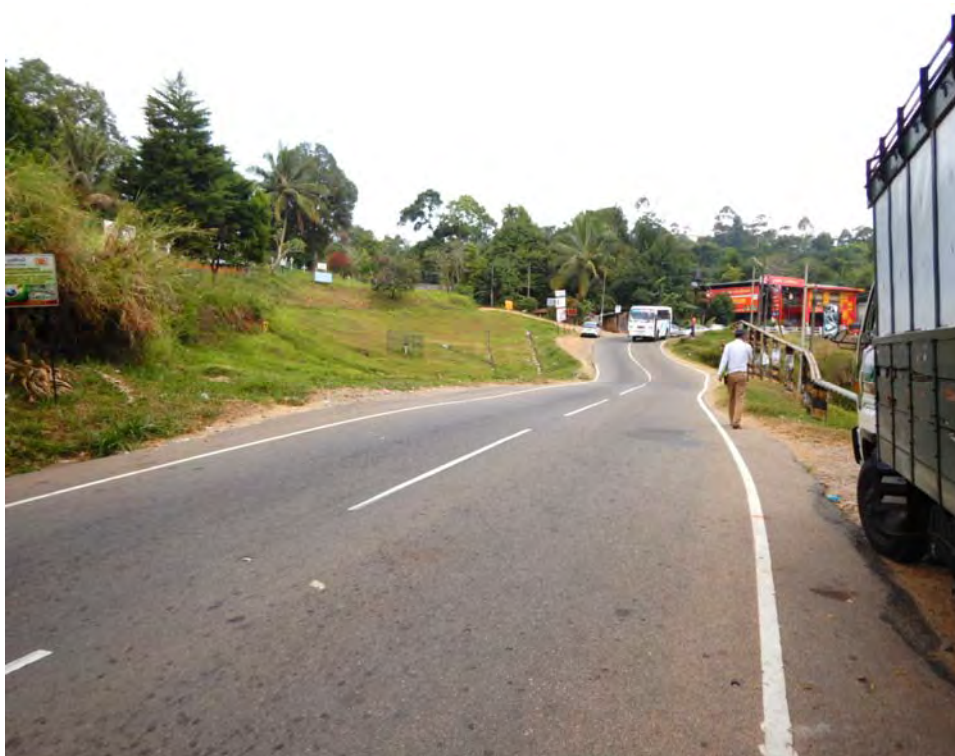
Site Photo

Site No.	7	District:	Kandy	DS Division :	Kadugannawa
Road Class:	A	Route No.	A-005	Name of the Road:	Peradeniya - Badulla - Chenkaladi road
Start (Km/cul.):	30/9	End (Km/cul.):	30/11		
Disaster Type :	Landslide	Width (m) :	200	Magnitude Score :	a
Year of Disaster Recorded:	1997	Potential Score :	i		
Detour Distance (km):	195	Detour Route:	A5-A7-A21-A1-A5	Detour Score :	A

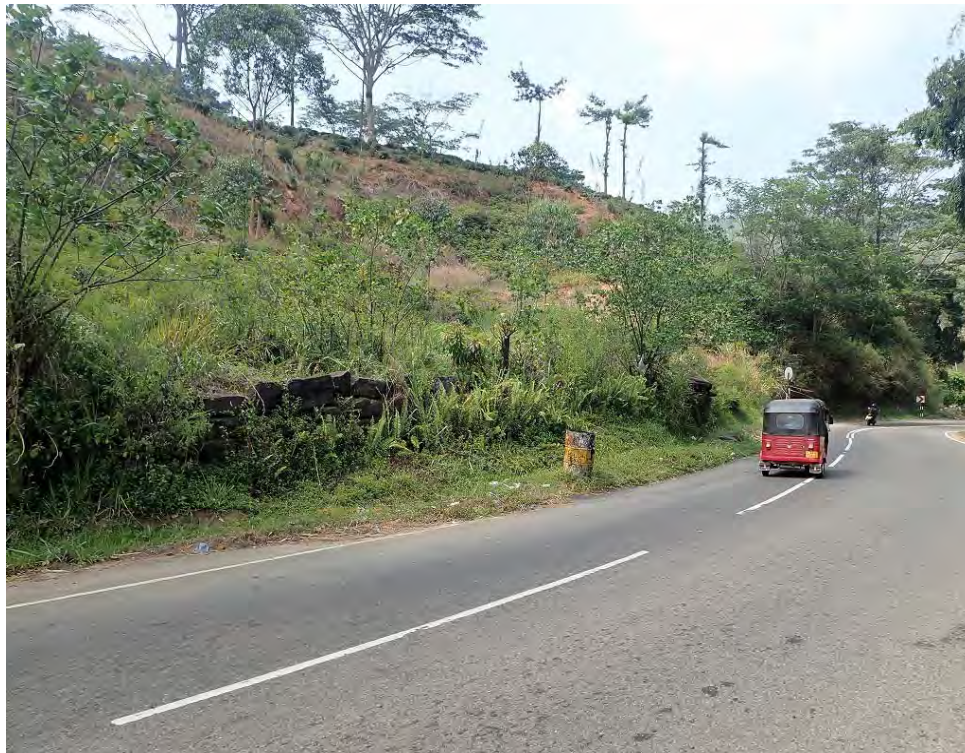
Site Photo

Site No.	8	District:	Kandy	DS Division :	Kadugannawa
Road Class:	A	Route No.	A-005	Name of the Road:	Peradeniya - Badulla - Chenkaladi road
Start (Km/cul.):	'28/4	End (Km/cul.):	'28/6		
Disaster Type :	Landslide	Width (m) :	30	Magnitude Score :	b
Year of Disaster Recorded:	2016	Potential Score :	ii		
Detour Distance (km):	195	Detour Route:	A5-A7-A21-A1-A5		Detour Score : A

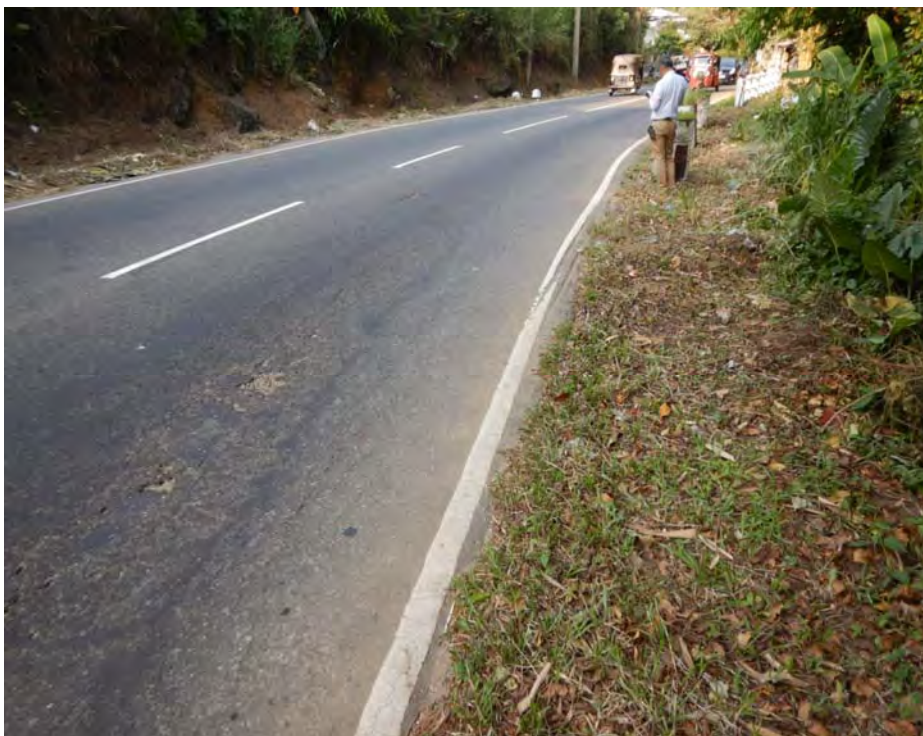
Site Photo

Site No.	9	District:	Kegalle	DS Division :	Ruwanwella
Road Class:	A	Route No.	A-007	Name of the Road:	Avissawella - Hatton - Nuwaraeliya
Start (Km/cul.):	'3/3	End (Km/cul.):	'3/5		
Disaster Type :	Slope Failure	Height (m) :	12	Magnitude Score :	b
Year of Disaster Recorded:	2014	Potential Score :	ii		
Detour Distance (km):	182	Detour Route:	A7-A21-A1-A4-A7	Detour Score :	A

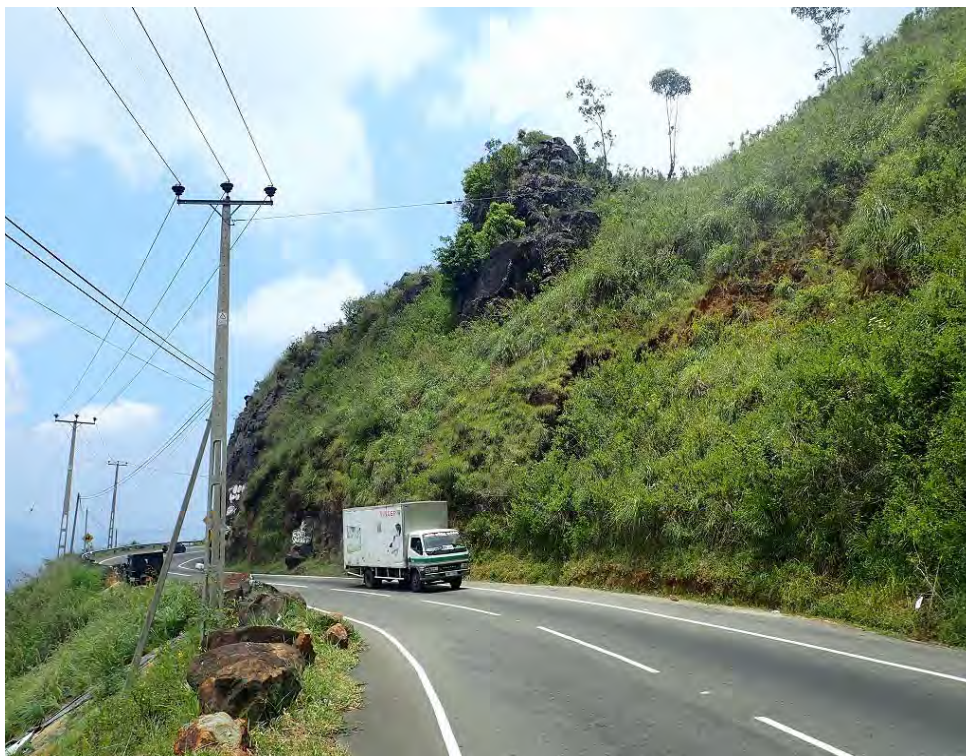
Site Photo

Site No.	10	District:	Badulla	DS Division :	Bandarawela
Road Class:	A	Route No.	A-016	Name of the Road:	Beragala - Haliela Road
Start (Km/cul.):	3.85km	End (Km/cul.):	4.2km		
Disaster Type :	Rock fall	Height (m) :	20	Magnitude Score :	b
Year of Disaster Recorded:	2014	Potential Score :	i		
Detour Distance (km):	78	Detour Route:	A16-A4-A23-A16	Detour Score :	B

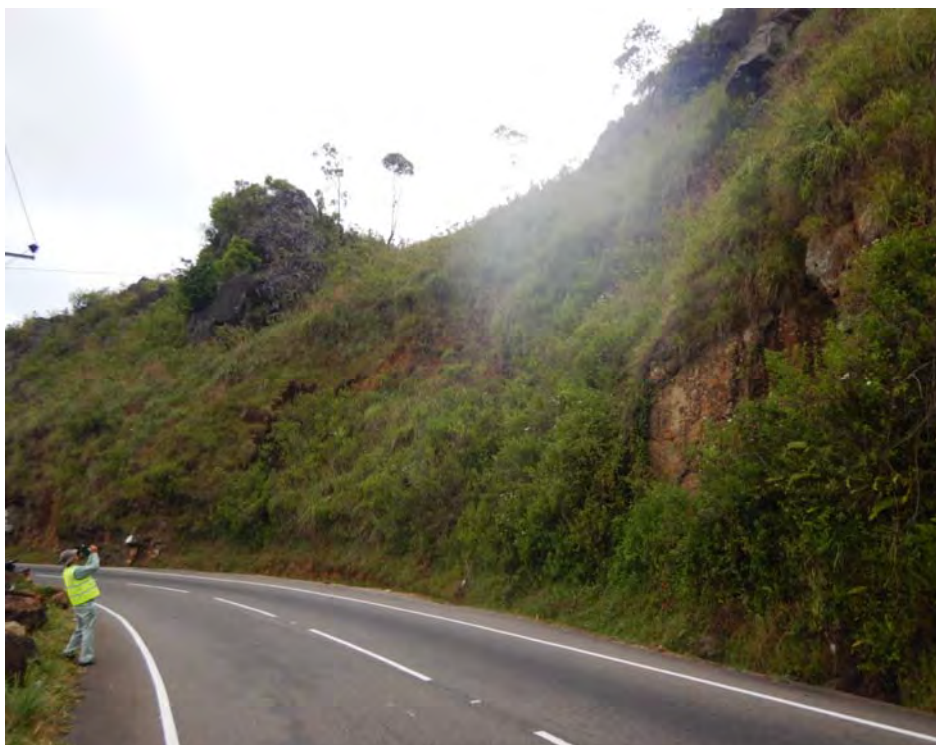
Site Photo

Site No.	11	District:	Badulla	DS Division :	Bandarawela
Road Class:	A	Route No.	A-016	Name of the Road:	Beragala - Haliela Road
Start (Km/cul.):	5/2	End (Km/cul.):	5/4		
Disaster Type :	Rock fall	Height (m) :	30	Magnitude Score :	a
Year of Disaster Recorded:	2014	Potential Score :	i		
Detour Distance (km):	78	Detour Route:	A16-A4-A23-A16	Detour Score :	B

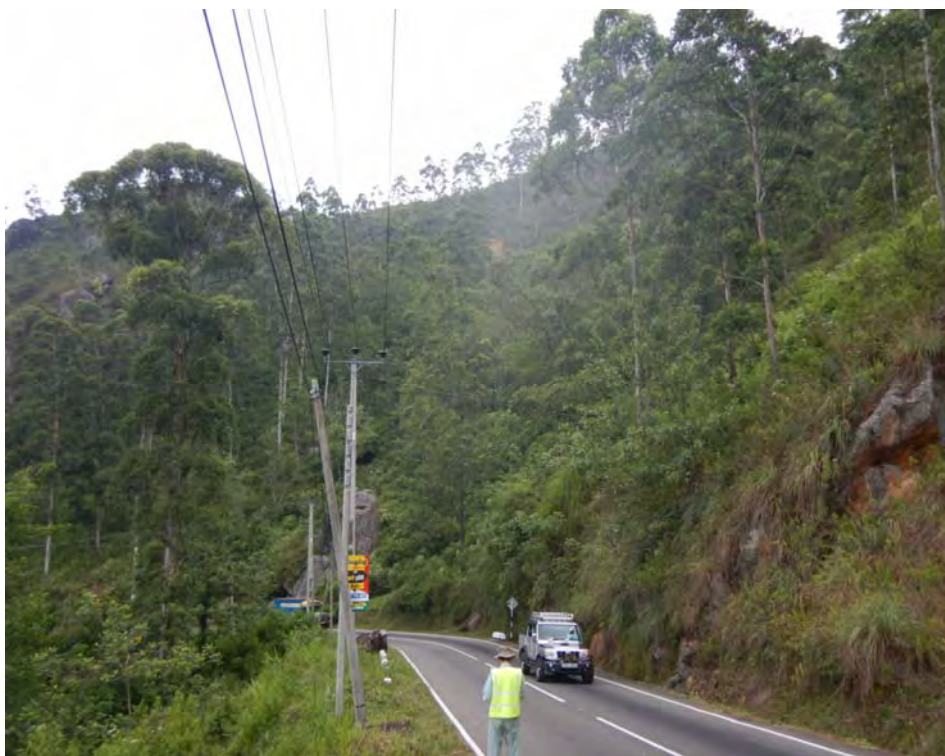
Site Photo

Site No.	12	District:	Badulla	DS Division :	Bandarawela
Road Class:	A	Route No.	A-016	Name of the Road:	Beragala - Haliela Road
Start (Km/cul.):	5/6	End (Km/cul.):	5/8		
Disaster Type :	Rock fall	Height (m) :	20	Magnitude Score :	b
Year of Disaster Recorded:	2014	Potential Score :	i		
Detour Distance (km):	78	Detour Route:	A16-A4-A23-A16	Detour Score :	B

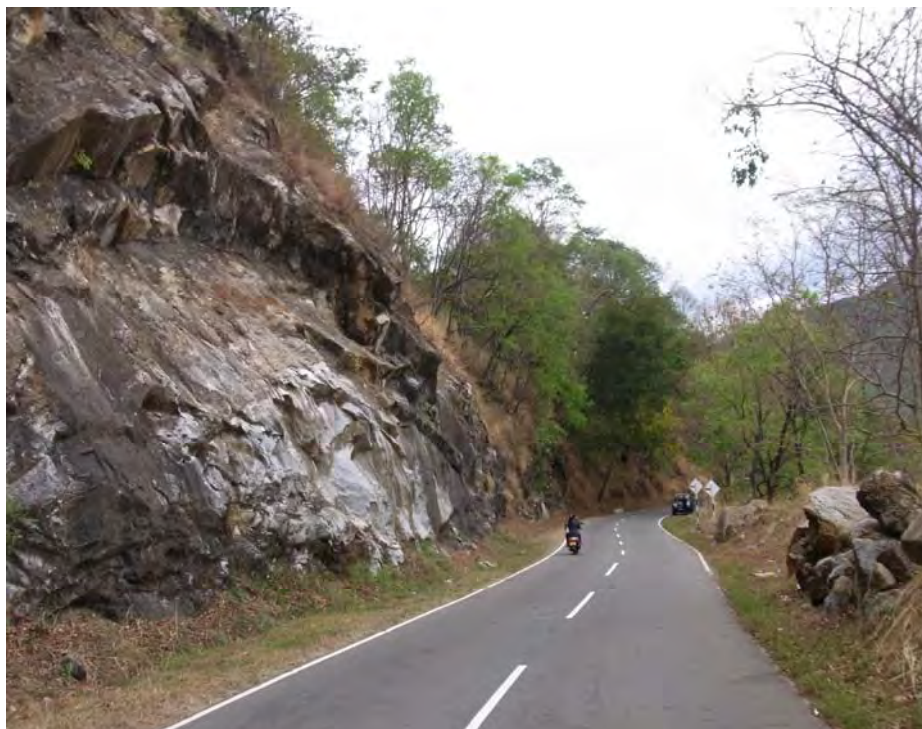
Site Photo

Site No.	13	District:	Badulla	DS Division :	Bandarawela
Road Class:	A	Route No.	A-023	Name of the Road:	Wellawaya - Ella - Kumbalwela road
Start (Km/cul.):	19/8	End (Km/cul.):	19km		
Disaster Type :	Rock fall	Height (m) :	15	Magnitude Score :	b
Year of Disaster Recorded:	2013/15	Potential Score :	ii		
Detour Distance (km):	78	Detour Route:	A23-A4-A16-A23	Detour Score :	B

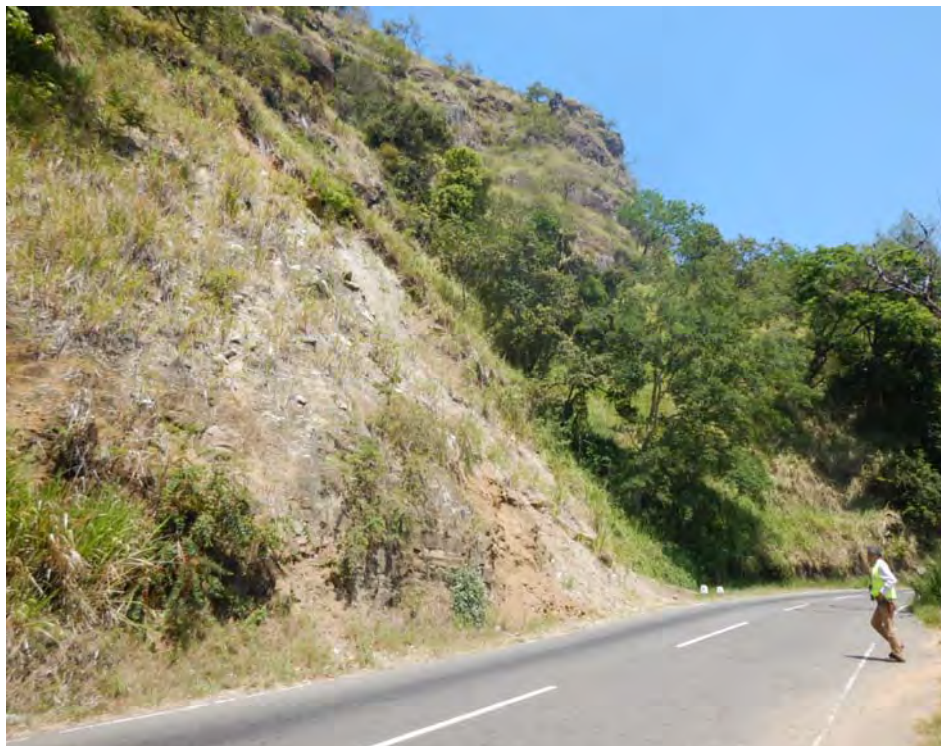
Site Photo

Site No.	14	District:	Badulla	DS Division :	Bandarawela
Road Class:	A	Route No.	A-023	Name of the Road:	Wellawaya - Ella - Kumbalwela road
Start (Km/cul.):	'25/1	End (Km/cul.):	'25/3		
Disaster Type :	Rock fall	Height (m) :	20	Magnitude Score :	b
Year of Disaster Recorded:	2014	Potential Score :	ii		
Detour Distance (km):	78	Detour Route:	A23-A4-A16-A23	Detour Score :	B

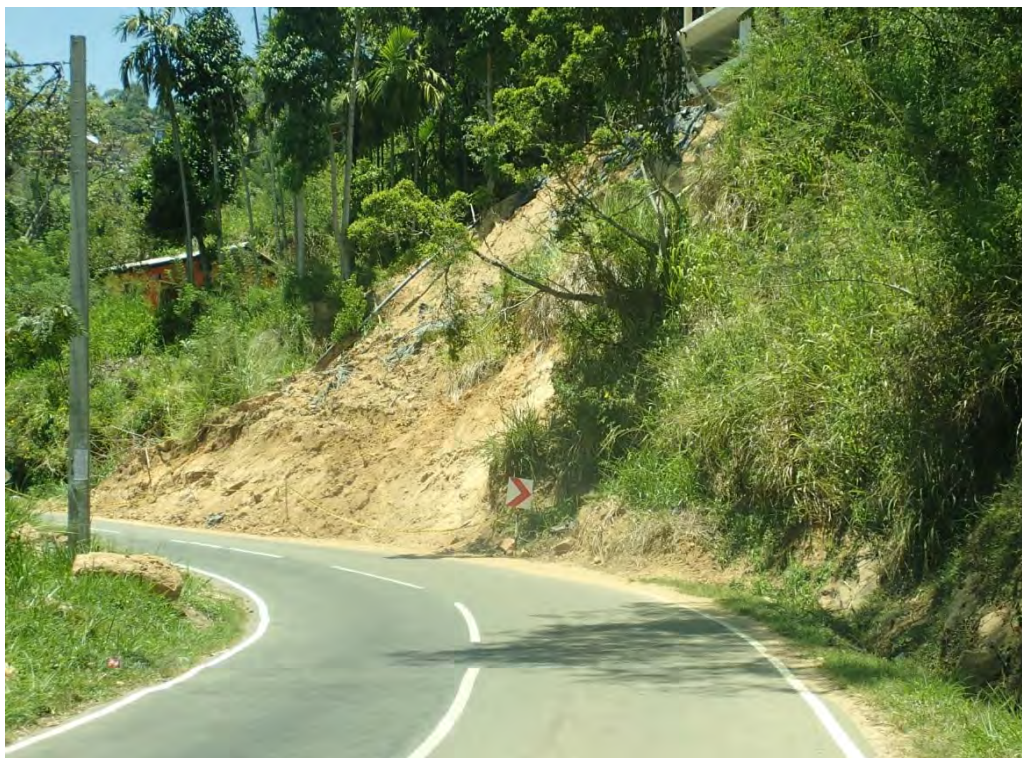
Site Photo

Site No.	15	District:	Badulla	DS Division :	Bandarawela
Road Class:	A	Route No.	A-023	Name of the Road:	Wellawaya - Ella - Kumbalwela road
Start (Km/cul.):	27/4	End (Km/cul.):	27/5		
Disaster Type :	Rock fall	Height (m) :	10	Magnitude Score :	b
Year of Disaster Recorded:	2014	Potential Score :	iii		
Detour Distance (km):	78	Detour Route:	A23-A4-A16-A23	Detour Score :	B

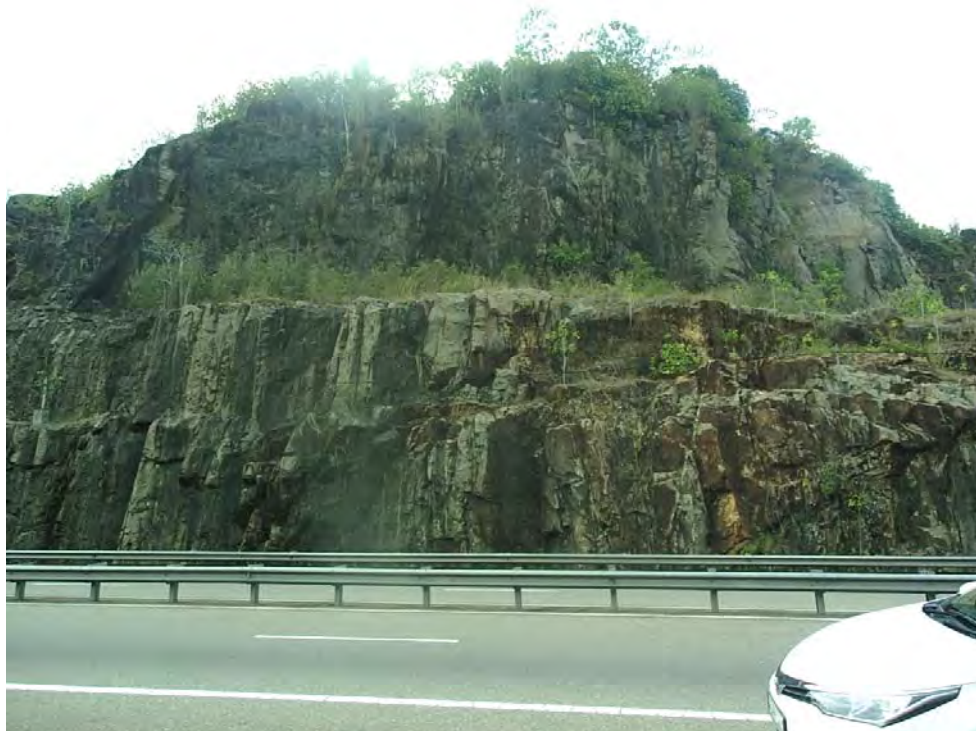
Site Photo

Site No.	16	District:	Galle	DS Division :	Elpitiya
Road Class:	E	Route No.	E-001	Name of the Road:	Kottawa - Godagama Section
Start (Km/cul.):	64.3km	End (Km/cul.):	64.5km	(Right lane)	
Disaster Type :	Rock fall	Height (m) :	10	Magnitude Score :	b
Year of Disaster Recorded:	2016/ 2017	Potential Score :	iii		
Detour Distance (km):	55	Detour Route:	B157-A2-B40-B14	Detour Score :	B

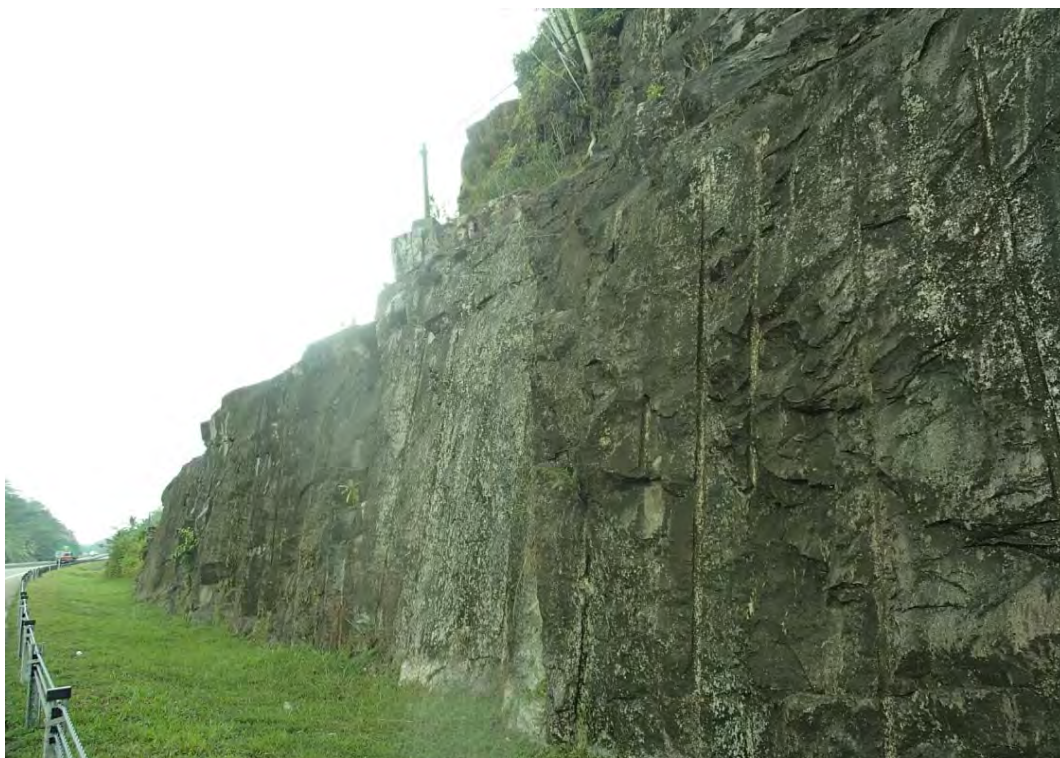
Site Photo

Site No.	18	District:	Galle	DS Division :	Welivitiya-Divithura
Road Class:	E	Route No.	E-001	Name of the Road:	Kottawa - Godagama Section
Start (Km/cul.):	74.8km	End (Km/cul.):	75.0km	(Right lane)	
Disaster Type :	Rock fall	Height (m) :	20	Magnitude Score :	b
Year of Disaster Recorded:	2016/ 2017	Potential Score :	ii		
Detour Distance (km):	18	Detour Route:	B143-B153-B320	Detour Score :	B

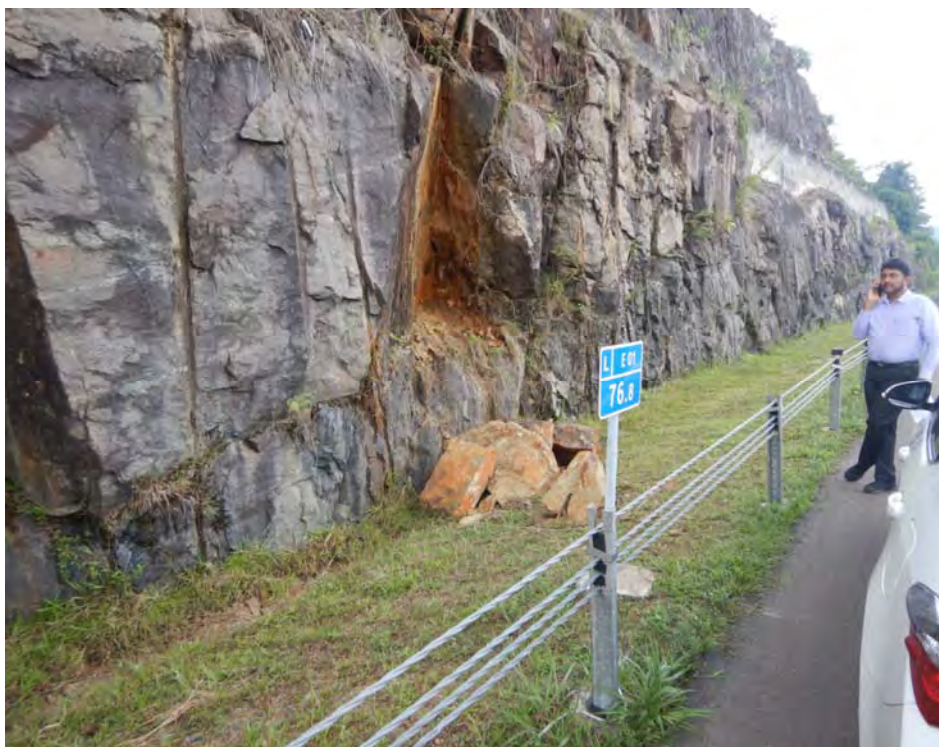
Site Photo

Site No.	19	District:	Galle	DS Division :	Welivitiya-Divithura
Road Class:	E	Route No.	E-001	Name of the Road:	Kottawa - Godagama Section
Start (Km/cul.):	76.7km	End (Km/cul.):	77.2km	(Left lane)	
Disaster Type :	Rock fall	Height (m) :	24.6	Magnitude Score :	a
Year of Disaster Recorded:	2016/ 2017	Potential Score :	i		
Detour Distance (km):	18	Detour Route:	B143-B153-B320	Detour Score :	B

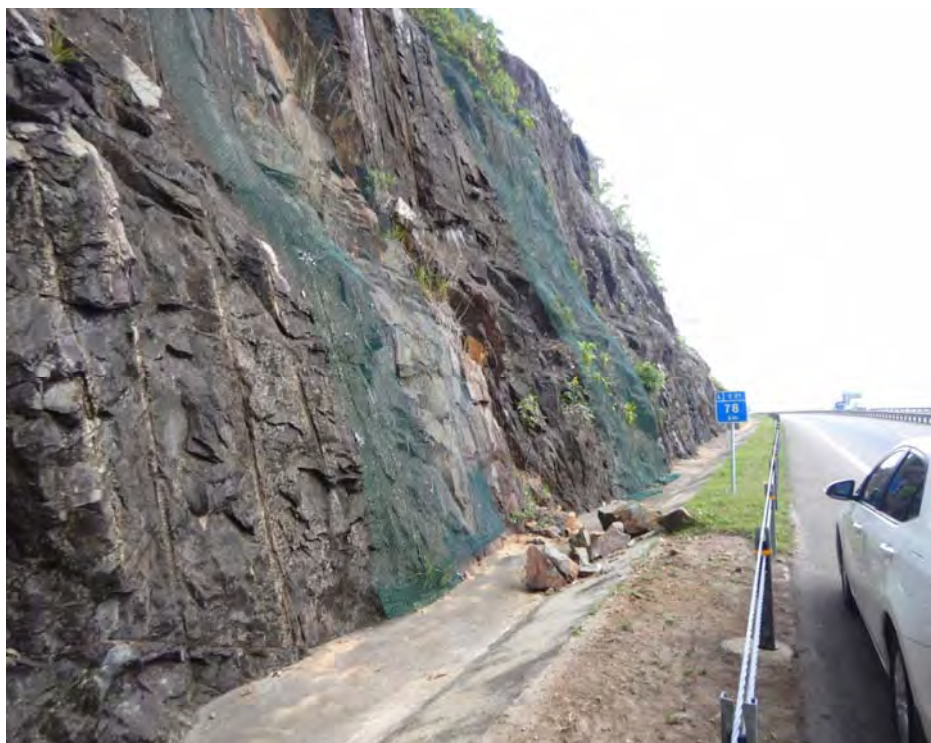
Site Photo

Site No.	20	District:	Galle	DS Division :	Welivitiya-Divithura
Road Class:	E	Route No.	E-001	Name of the Road:	Kottawa - Godagama Section
Start (Km/cul.):	77.9km	End (Km/cul.):	79.0km	(Left lane)	
Disaster Type :	Rock fall	Height (m) :	17.4	Magnitude Score :	a
Year of Disaster Recorded:	2016/ 2017	Potential Score :	ii		
Detour Distance (km):	18	Detour Route:	B143-B153-B320	Detour Score :	B

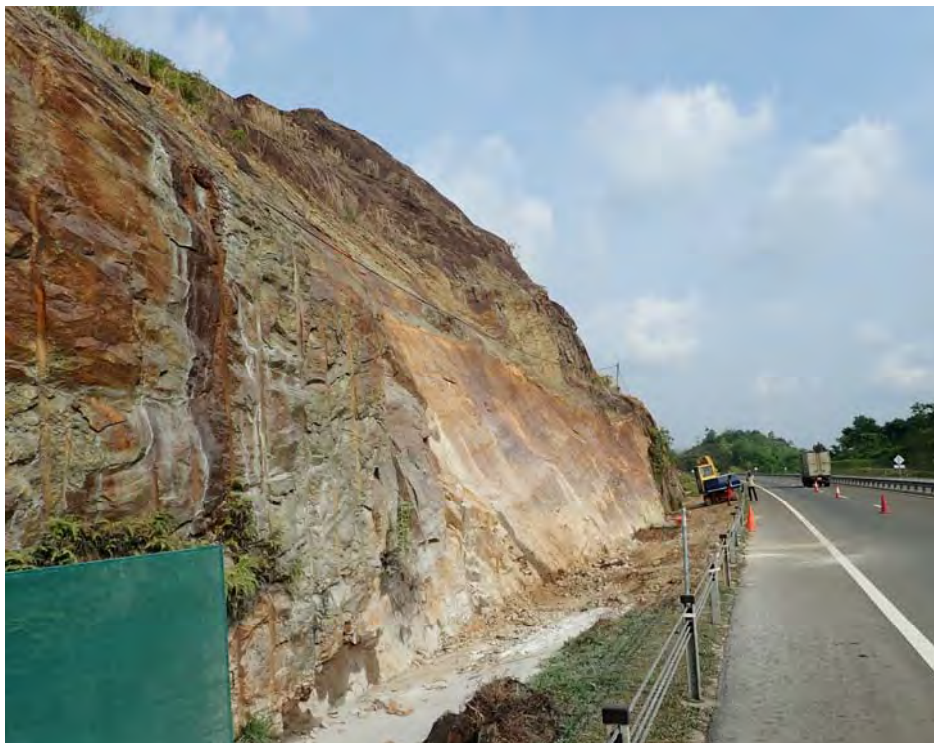
Site Photo

Site No.	21	District:	Galle	DS Division :	Baddegama
Road Class:	E	Route No.	E-001	Name of the Road:	Kottawa - Godagama Section
Start (Km/cul.):	86.6km	End (Km/cul.):	87.0km	(Left lane)	
Disaster Type :	Rock fall	Height (m) :	15	Magnitude Score :	b
Year of Disaster Recorded:	2016/ 2017	Potential Score :	ii		
Detour Distance (km):	28	Detour Route:	B320-B128-A2-B129	Detour Score :	B

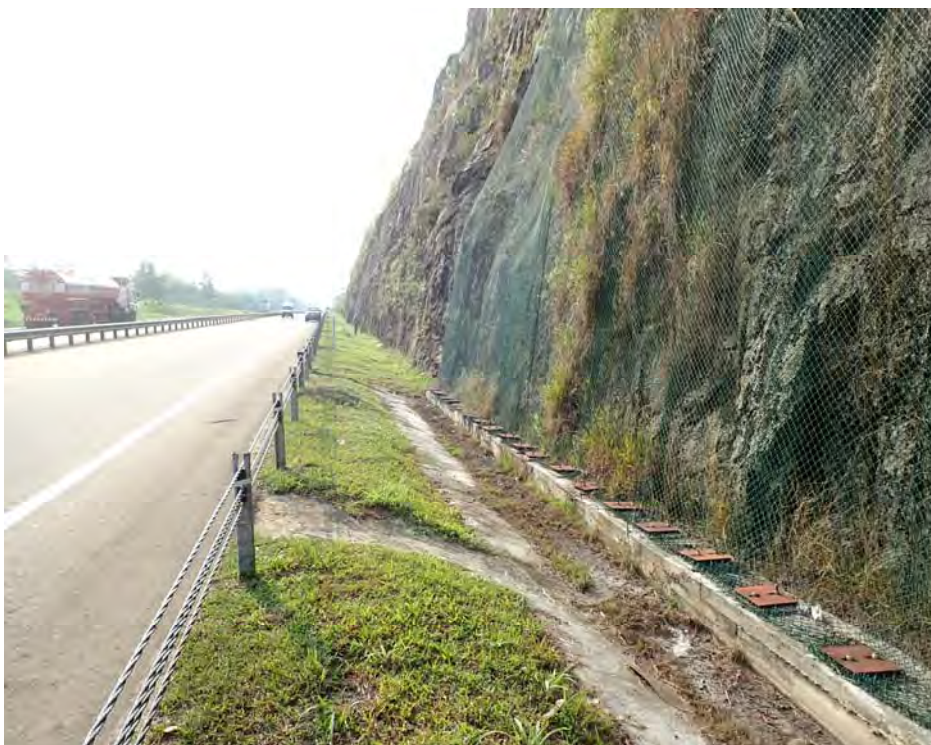
Site Photo

Site No.	22	District:	Galle	DS Division :	Baddegama
Road Class:	E	Route No.	E-001	Name of the Road:	Kottawa - Godagama Section
Start (Km/cul.):	88.0km	End (Km/cul.):	88.8km	(Left lane)	
Disaster Type :	Rock fall	Height (m) :	20	Magnitude Score :	a
Year of Disaster Recorded:	2016/ 2017	Potential Score :	ii		
Detour Distance (km):	28	Detour Route:	B320-B128-A2-B129	Detour Score :	B

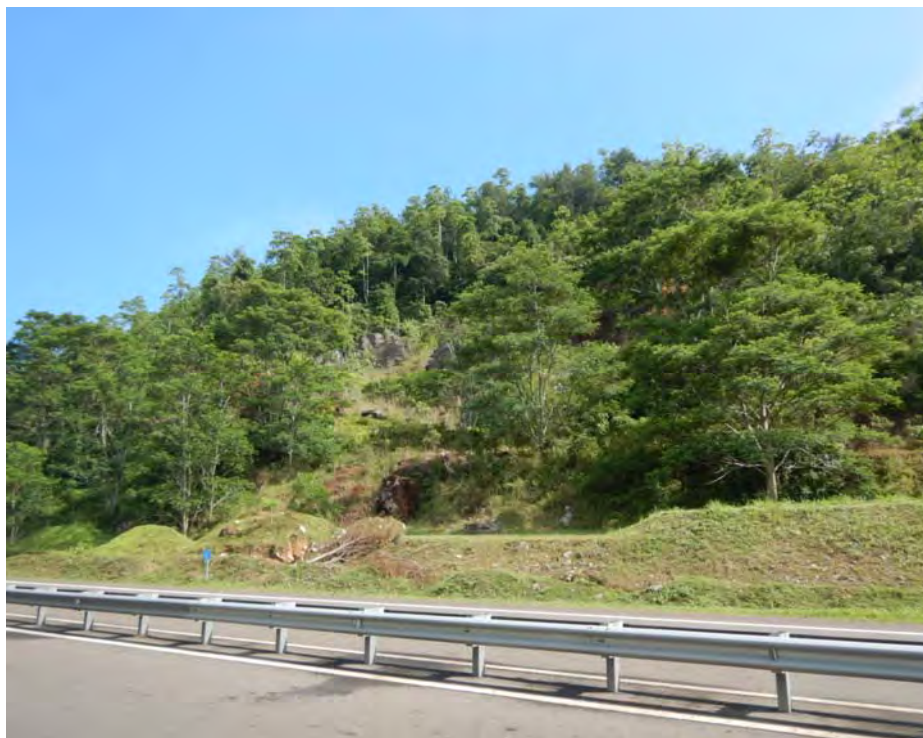
Site Photo

Site No.	25	District:	Galle	DS Division :	Imaduwa
Road Class:	E	Route No.	E-001	Name of the Road:	Kottawa - Godagama Section
Start (Km/cul.):	101.3km	End (Km/cul.):	101.7km	(Right lane)	
Disaster Type :	Rock fall/Landslide	Width (m) :	200	Magnitude Score :	a
Year of Disaster Recorded:	2016/ 2017	Potential Score :	i		
Detour Distance (km):	20	Detour Route:	B129-A2-A17	Detour Score :	B

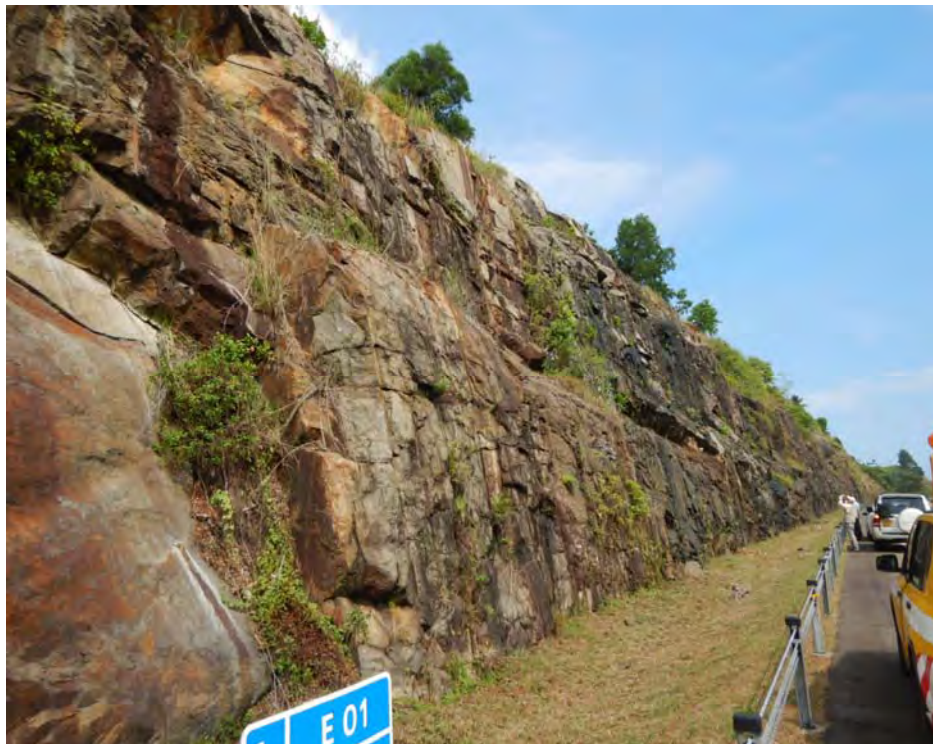
Site Photo

Site No.	23	District:	Galle	DS Division :	Bope-Poddala
Road Class:	E	Route No.	E-001	Name of the Road:	Kottawa - Godagama Section
Start (Km/cul.):	89.3km	End (Km/cul.):	89.6km	(Left lane)	
Disaster Type :	Rock fall	Height (m) :	20	Magnitude Score :	a
Year of Disaster Recorded:	2016/ 2017	Potential Score :	ii		
Detour Distance (km):	28	Detour Route:	B320-B128-A2-B129	Detour Score :	B

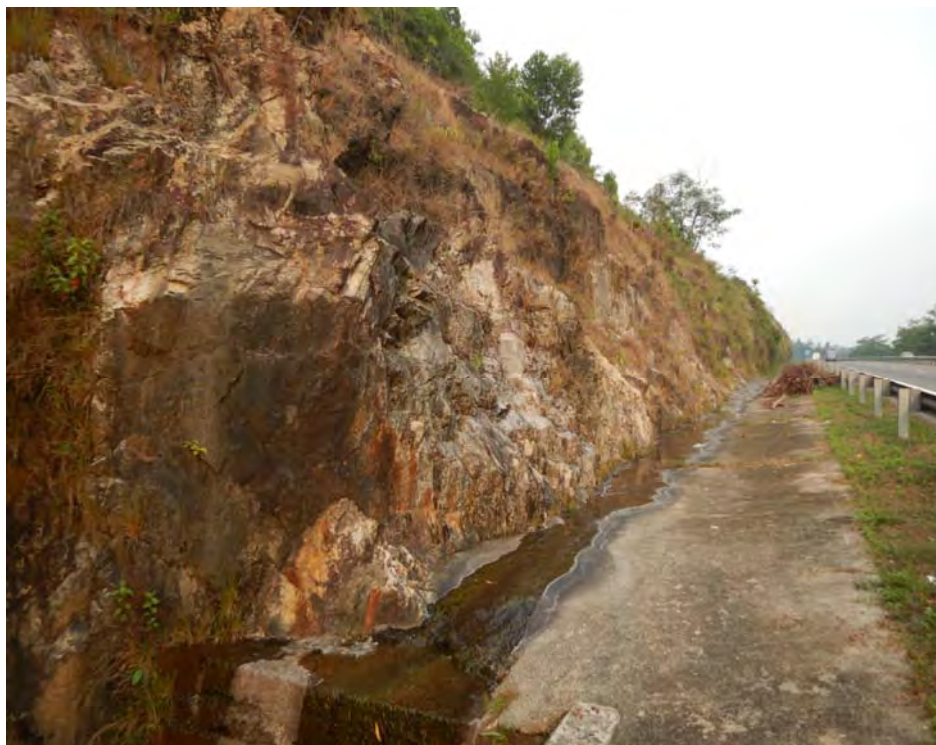
Site Photo

Site No.	25 ad-1	District:	Galle	DS Division :	Imaduwa
Road Class:	E	Route No.	E-001	Name of the Road:	Kottawa - Godagama Section
Start (Km/cul.):	103.7	End (Km/cul.):	104.1	(Left lane)	
Disaster Type :	Rock fall	Height (m) :	12	Magnitude Score :	b
Year of Disaster Recorded:	-	Potential Score :	ii		
Detour Distance (km):	20	Detour Route:	B129-A2-A17	Detour Score :	B

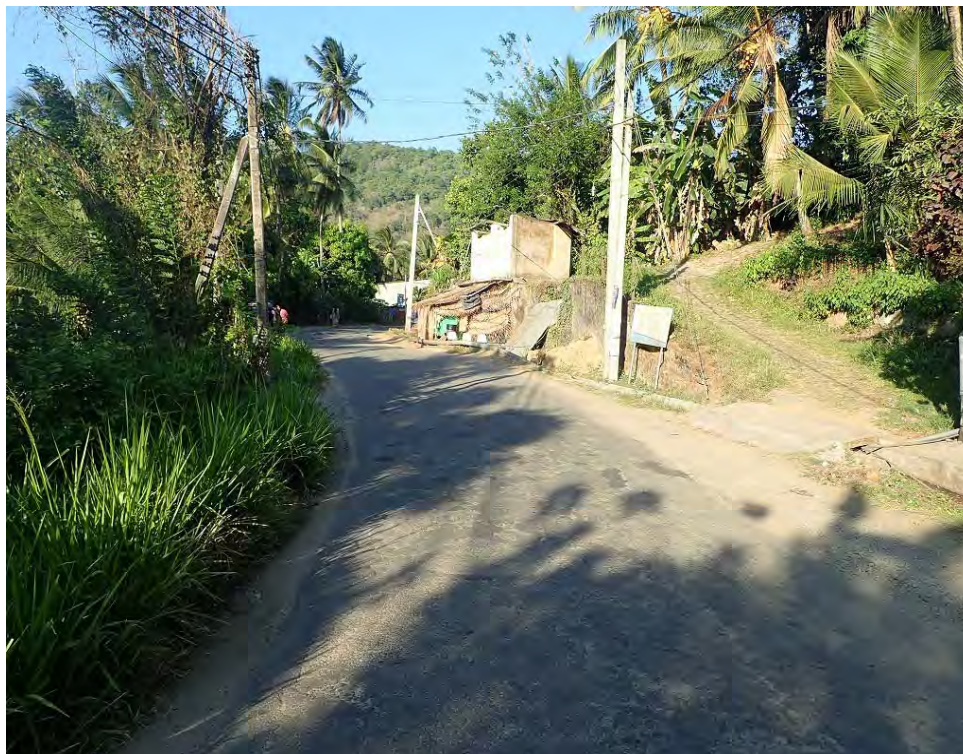
Site Photo

Site No.	26	District:	Matale	DS Division :	Matale
Road Class:	B	Route No.	B-274	Name of the Road:	Matale-Illukkumbura-Laggala road
Start (Km/cul.):	'11/2	End (Km/cul.):	'11/4		
Disaster Type :	Landslide	Width (m) :	100	Magnitude Score :	b
Year of Disaster Recorded:	2011	Potential Score :	i		
Detour Distance (km):	114	Detour Route:	B274-A9-B312-B274	Detour Score :	B

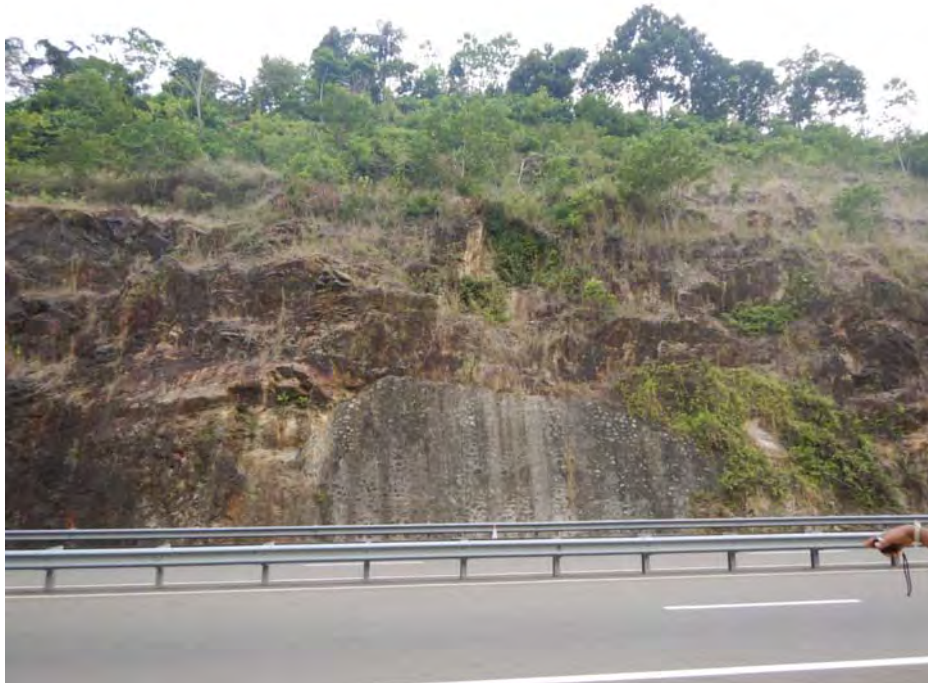
Site Photo

Site No.	25 ad-2	District:	Galle	DS Division :	Imaduwa
Road Class:	E	Route No.	E-001	Name of the Road:	Kottawa - Godagama Section
Start (Km/cul.):	108.6	End (Km/cul.):	108.7	(Right lane)	
Disaster Type :	Rock fall	Height (m) :	12	Magnitude Score :	a
Year of Disaster Recorded:	2018	Potential Score :	ii		
Detour Distance (km):	20	Detour Route:	B129-A2-A17	Detour Score :	B

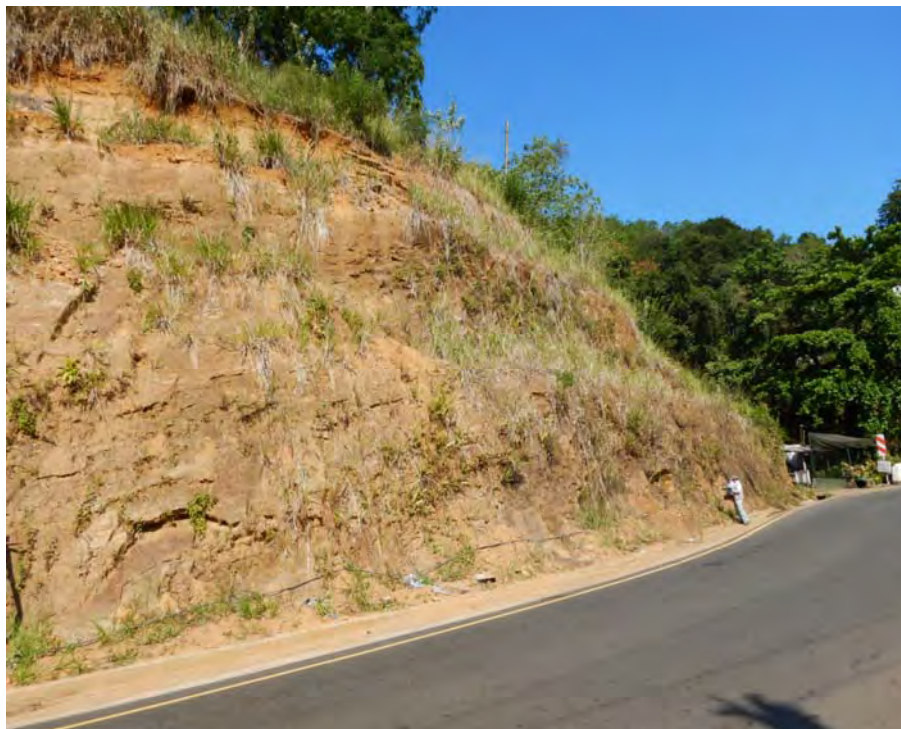
Site Photo

Site No.	28	District:	Matale	DS Division :	Matale
Road Class:	B	Route No.	B-462	Name of the Road:	Wattegama - Matale road
Start (Km/cul.):	'5/9	End (Km/cul.):	'6/1		
Disaster Type :	Slope Failure	Height (m) :	12	Magnitude Score :	a
Year of Disaster Recorded:	2018	Potential Score :	ii		
Detour Distance (km):	30	Detour Route:	B248-B180-B461-B248	Detour Score :	B

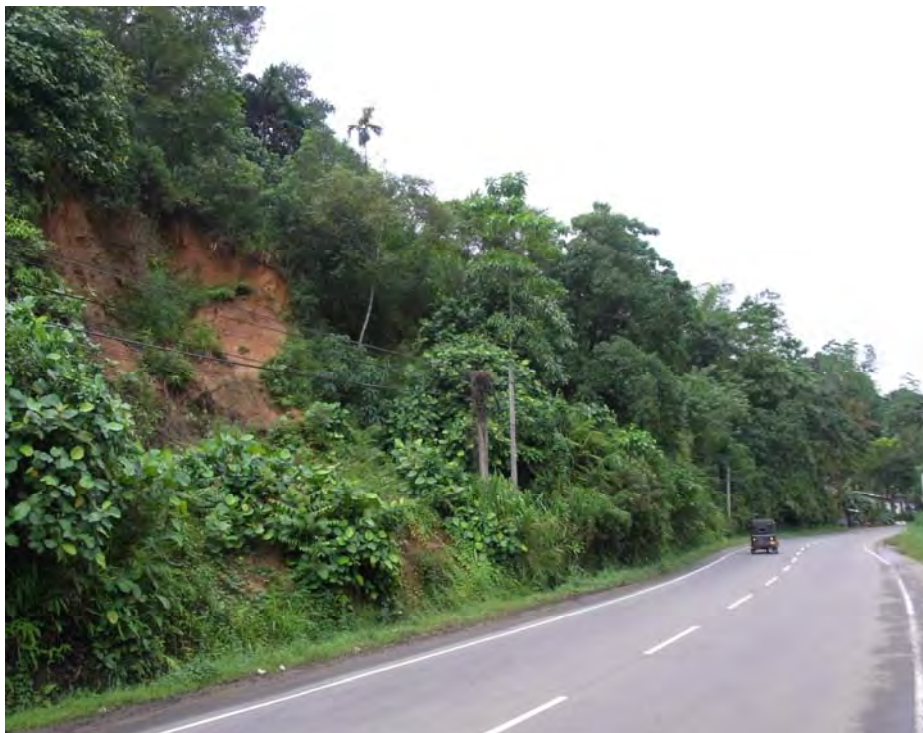
Site Photo

Site No.	29	District:	Ratnapura	DS Division :	Palmadulla
Road Class:	A	Route No.	A-004	Name of the Road:	Colombo-Ratnapura-Wellawaya-Batticaloa road
Start (Km/cul.):	'107/2	End (Km/cul.):	'107/3		
Disaster Type :	Slope Failure	Height (m) :	4	Magnitude Score :	b
Year of Disaster Recorded:	2017	Potential Score :	iii		
Detour Distance (km):	268	Detour Route:	A4-A16-A5-A7-A4	Detour Score :	A
