**Preparatory Survey
on
Landslide Disaster Protection Project of
the National Road Network Phase 2
in
Sri Lanka**

**FINAL REPORT
APPENDIX**

Appendix 3 Inventory Sheet of 53 sites

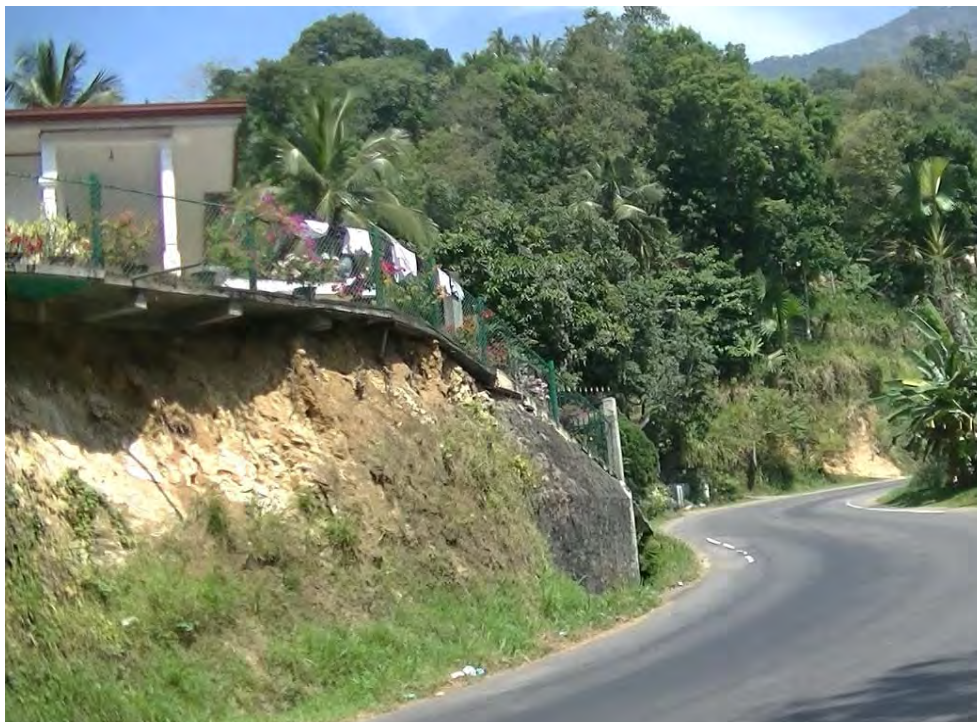
Site Photo

Site No.	30	District:	Ratnapura	DS Division :	Palmadulla
Road Class:	A	Route No.	A-004	Name of the Road:	Colombo-Ratnapura-Wellawaya-Batticaloa road
Start (Km/cul.):	'132/9	End (Km/cul.):	'132/11		
Disaster Type :	Slope Failure	Height (m) :	3	Magnitude Score :	b
Year of Disaster Recorded:	2012 / 2017	Potential Score :	iii		
Detour Distance (km):	270	Detour Route:	A4-A16-A5-A7-A4	Detour Score :	A

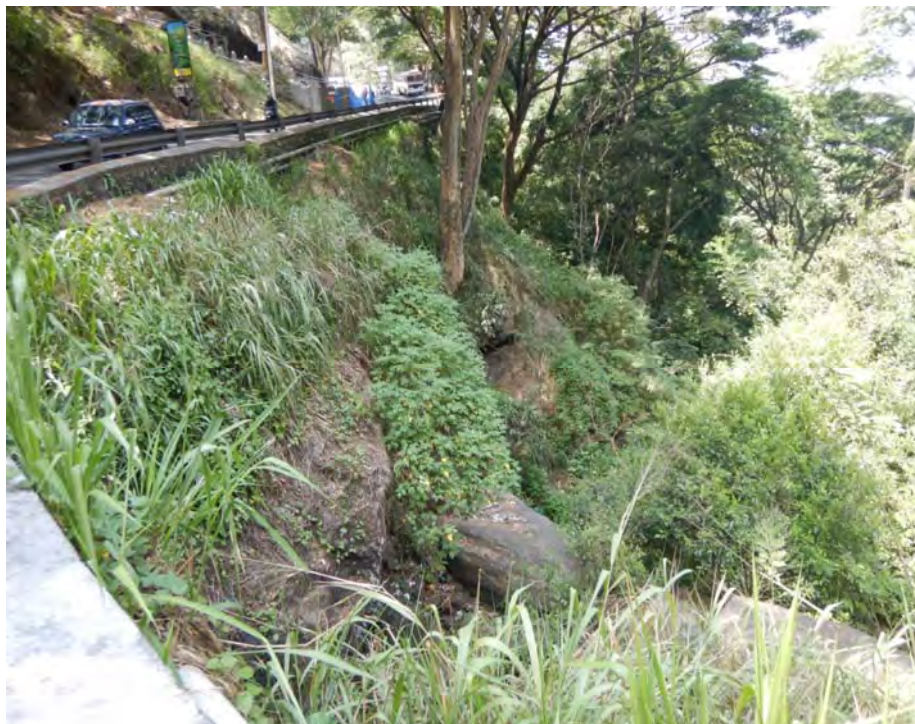
Site Photo

Site No.	31	District:	Kegalla	DS Division :	Kegalla
Road Class:	A	Route No.	A-001	Name of the Road:	Colombo - Kandy road
Start (Km/cul.):	'99/8	End (Km/cul.):	'99 km		
Disaster Type :	Slope Failure	Height (m) :	15	Magnitude Score :	a
Year of Disaster Recorded:	2016	Potential Score :	ii		
Detour Distance (km):	110	Detour Route:	A1-A19-A6-A10-A1	Detour Score :	B

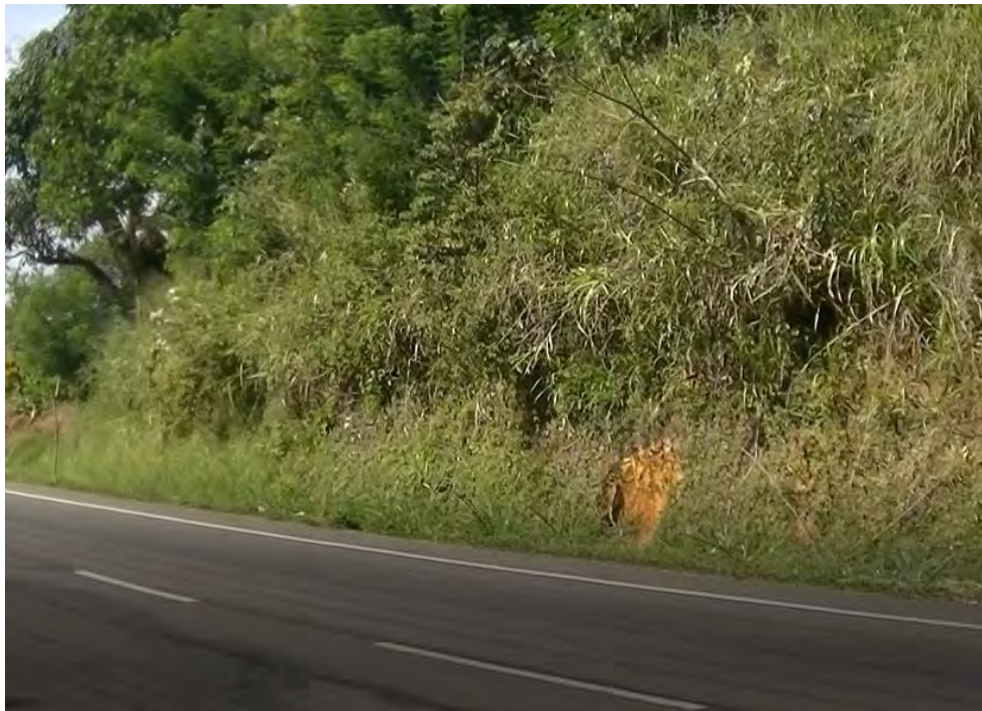
Site Photo

Site No.	32	District:	Ratnapura	DS Division :	Pelmadulla
Road Class:	A	Route No.	A-004	Name of the Road:	Colombo-Ratnapura-Wellawaya-Batticaloa road
Start (Km/cul.):	'167/10	End (Km/cul.):	'167/11		
Disaster Type :	Landslide	Width (m) :	20	Magnitude Score :	b
Year of Disaster Recorded:	2010	Potential Score :	iii		
Detour Distance (km):	270	Detour Route:	A4-A16-A5-A7-A4	Detour Score :	A

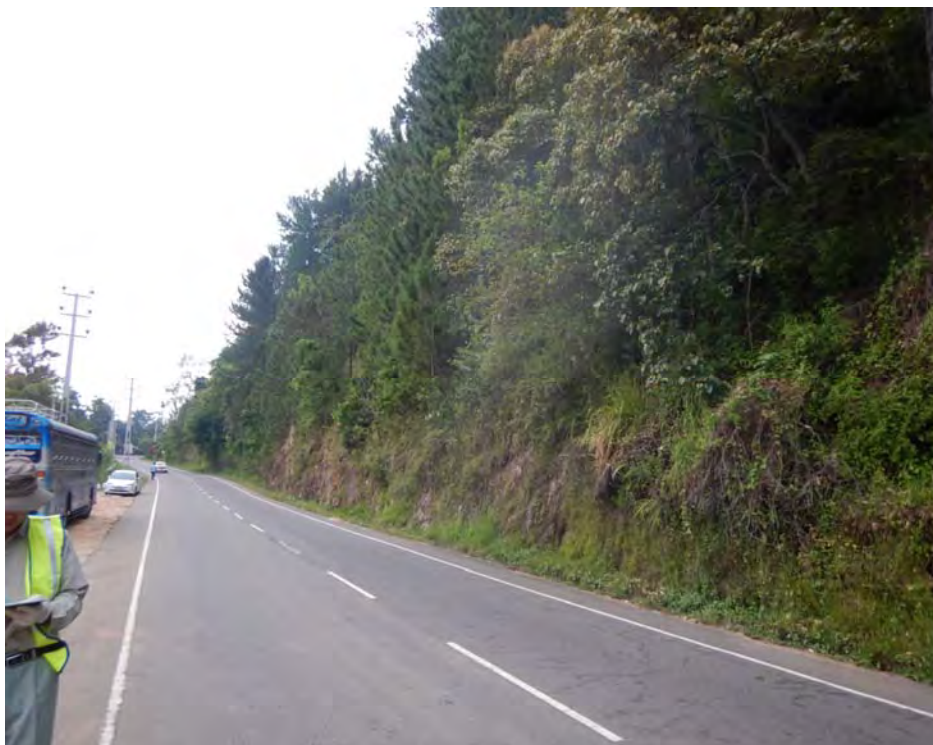
Site Photo

Site No.	33	District:	Badulla	DS Division :	Bandarawela
Road Class:	A	Route No.	A-004	Name of the Road:	Colombo-Ratnapura-Wellawaya-Batticaloa road
Start (Km/cul.):	'171/5	End (Km/cul.):	'171/7		
Disaster Type :	Rock fall	Height (m) :	5	Magnitude Score :	a
Year of Disaster Recorded:	2017	Potential Score :	iii		
Detour Distance (km):	270	Detour Route:	A4-A16-A5-A7-A4	Detour Score :	A

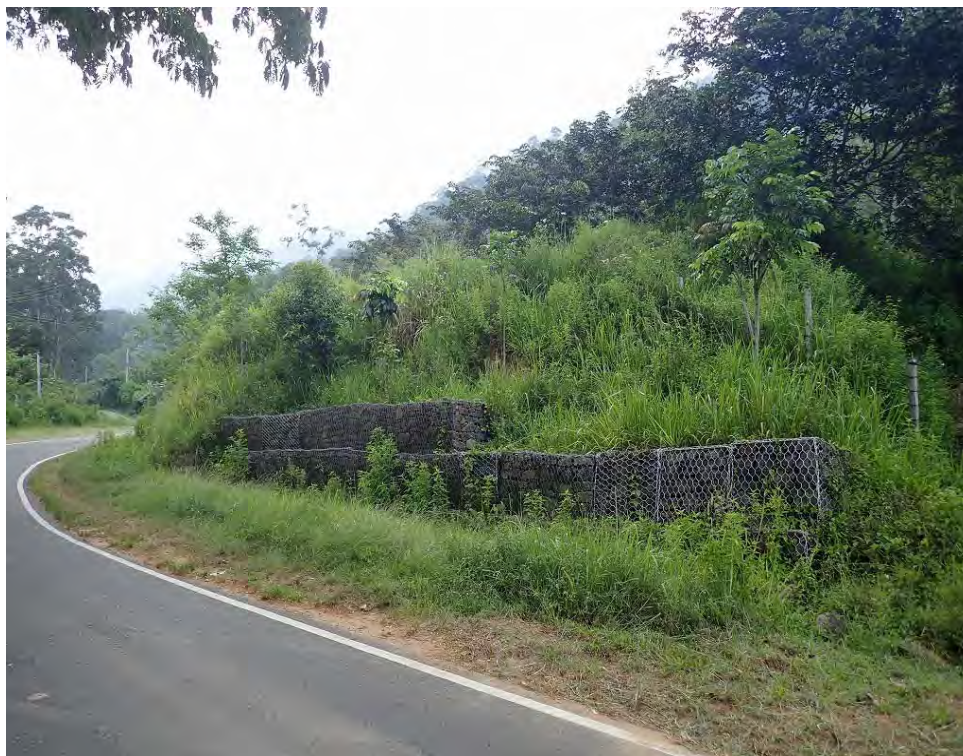
Site Photo

Site No.	34	District:	Badulla	DS Division :	Bandarawela
Road Class:	A	Route No.	A-004	Name of the Road:	Colombo-Ratnapura-Wellawaya-Batticaloa road
Start (Km/cul.):	183km	End (Km/cul.):	'185/14		
Disaster Type :	Landslide	Width (m) :	150	Magnitude Score :	b
Year of Disaster Recorded:	1994	Potential Score :	i		
Detour Distance (km):	74	Detour Route:	A4-A23-A16-A4	Detour Score :	B

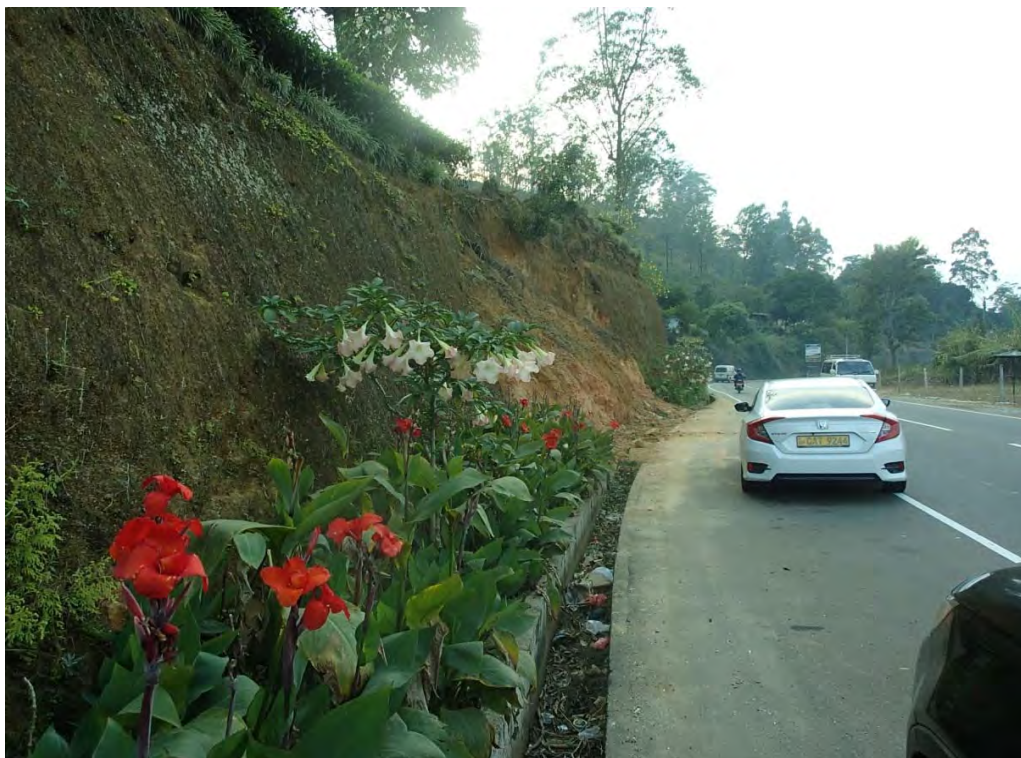
Site Photo

Site No.	35	District:	Nuwara Eliya	DS Division :	Norwood
Road Class:	A	Route No.	A-007	Name of the Road:	Avissawella - Hatton - Nuwaraeliya
Start (Km/cul.):	66/3	End (Km/cul.):	66/5		
Disaster Type :	Slope Failure	Height (m) :	7	Magnitude Score :	b
Year of Disaster Recorded:	2016	Potential Score :	iii		
Detour Distance (km):	195	Detour Route:	A7-A5-A1-A21-A7	Detour Score :	A

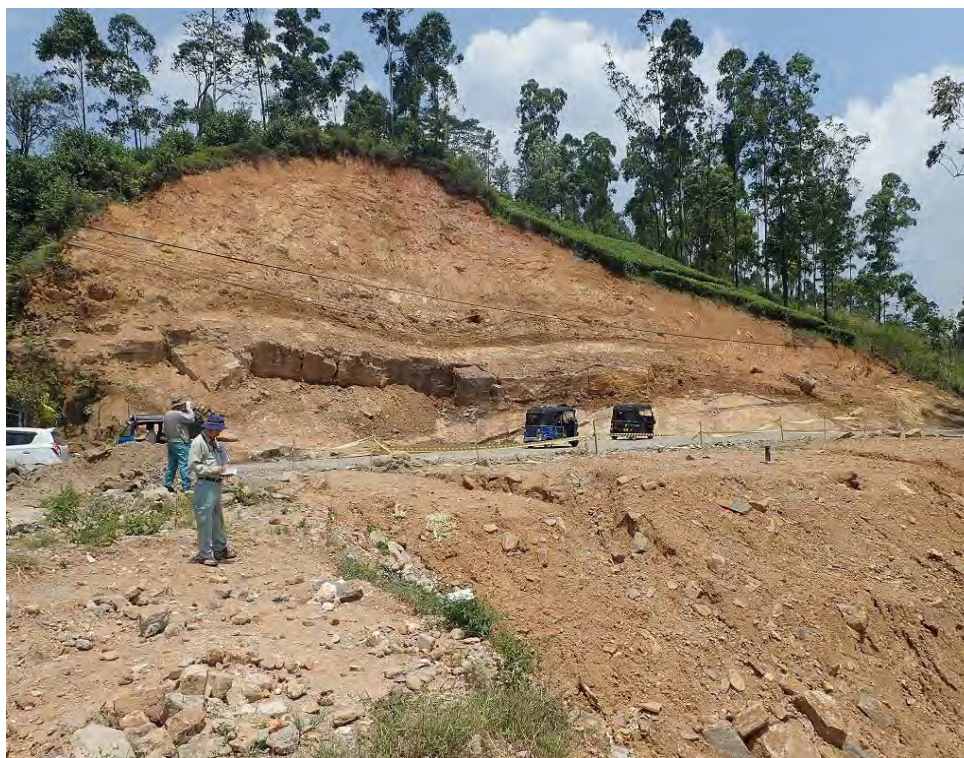
Site Photo

Site No.	36	District:	Nuwara Eliya	DS Division :	Norwood
Road Class:	B	Route No.	B-149	Name of the Road:	Hatton - Maskeleiya - Delhouse road
Start (Km/cul.):	9.000	End (Km/cul.):	9.100		
Disaster Type :	Landslide	Width (m) :	70	Magnitude Score :	a
Year of Disaster Recorded:	2018	Potential Score :	i		
Detour Distance (km):	42	Detour Route:	B339-B71-B328-B419-B339	Detour Score :	B

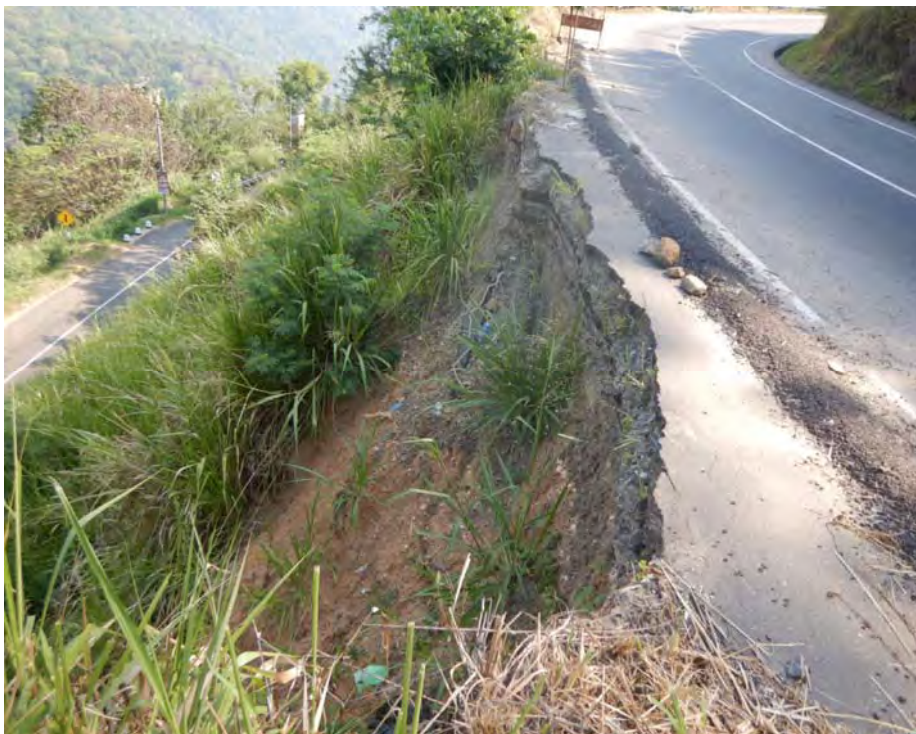
Site Photo

Site No.	37	District:	Badulla	DS Division :	Badulla
Road Class:	B	Route No.	B-036	Name of the Road:	Badulla - Karametiya - Andaulpotha road
Start (Km/cul.):	4/11	End (Km/cul.):	'5/3		
Disaster Type :	Slope Failure	Height (m) :	12	Magnitude Score :	a
Year of Disaster Recorded:	2014	Potential Score :	ii		
Detour Distance (km):	112	Detour Route:	Nitakupitiya Mapakada Wewa Road (NMWR)-B57-A5-NMWR	Detour Score :	B

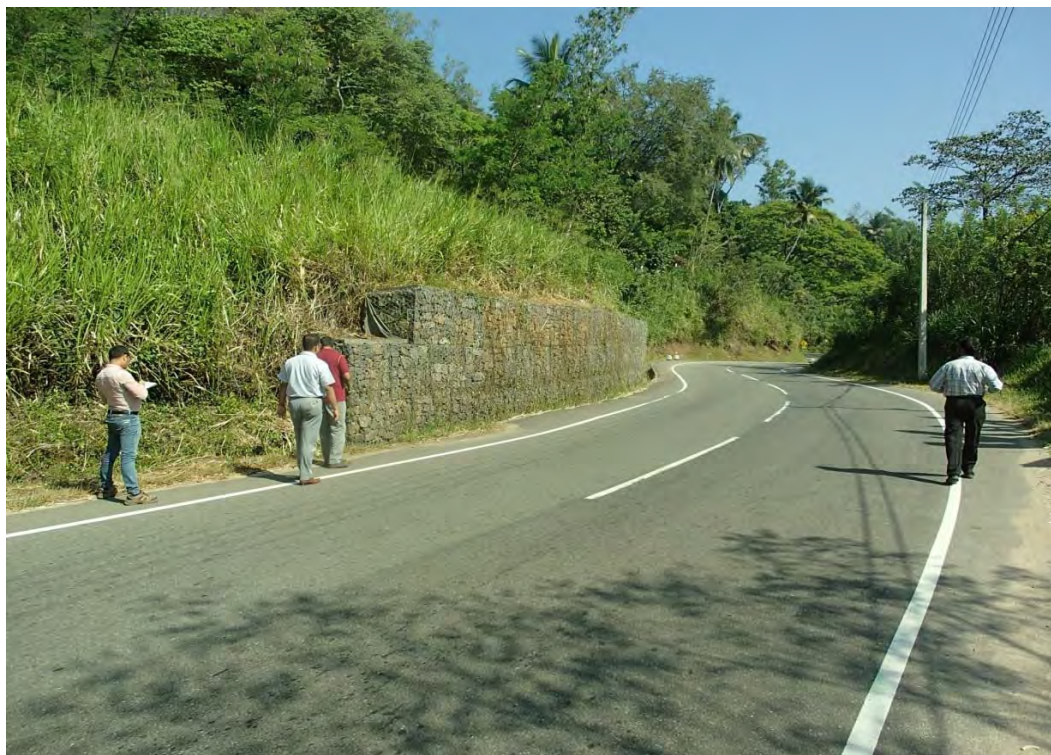
Site Photo

Site No.	38	District:	Badulla	DS Division :	Badulla
Road Class:	B	Route No.	B-036	Name of the Road:	Badulla - Karametiya - Andaulpotha road
Start (Km/cul.):	10km	End (Km/cul.):	10.2km		
Disaster Type :	Landslide	Width (m) :	50	Magnitude Score :	b
Year of Disaster Recorded:	2012	Potential Score :	ii		
Detour Distance (km):	112	Detour Route:	Nitakupitiya Mapakada Wewa Road (NMWR)-B57-A5-NMWR	Detour Score :	B

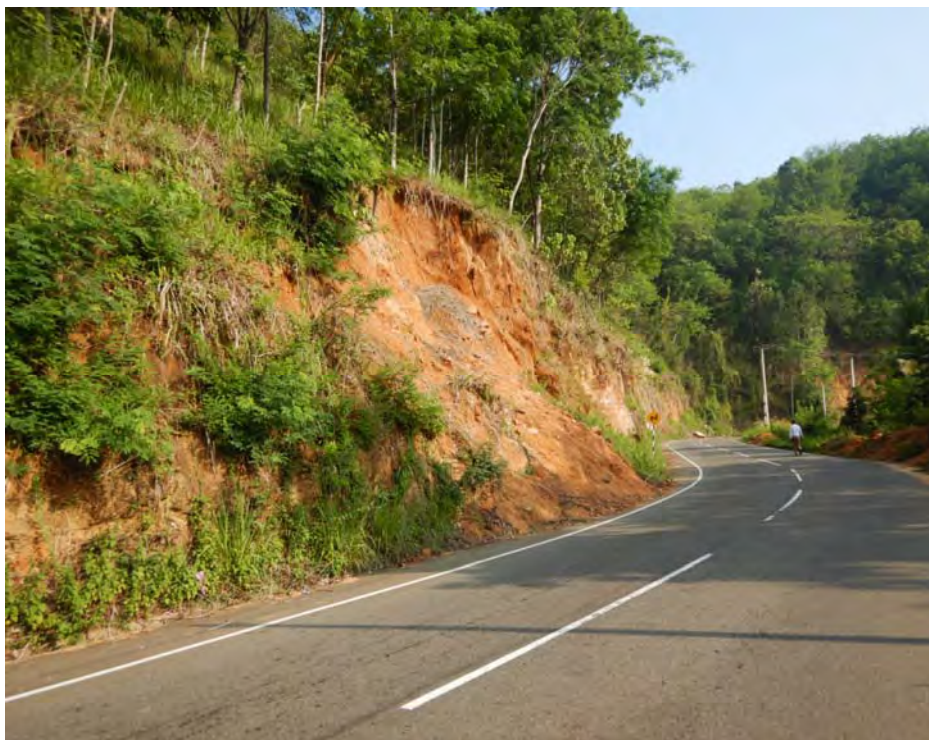
Site Photo

Site No.	39	District:	Kandy	DS Division :	Kandy
Road Class:	B	Route No.	B-122	Name of the Road:	Galagedara - Rambukkana
Start (Km/cul.):	'8/2	End (Km/cul.):	'8/4		
Disaster Type :	Slope Failure	Height (m) :	12	Magnitude Score :	a
Year of Disaster Recorded:	2014/2015	Potential Score :	ii		
Detour Distance (km):	44	Detour Route:	B122-B385-B281-A10-B122		Detour Score : B

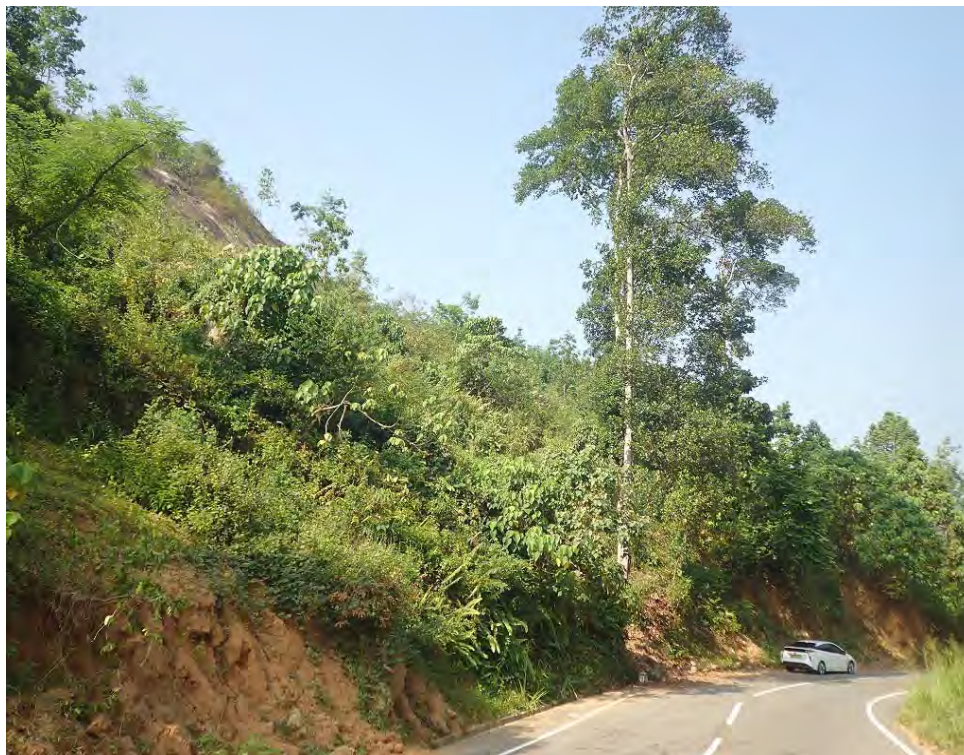
Site Photo

Site No.	40	District:	Kandy	DS Division :	Kandy
Road Class:	B	Route No.	B-122	Name of the Road:	Galagedara - Rambukkana
Start (Km/cul.):	'18/3	End (Km/cul.):	'18/5		
Disaster Type :	Slope Failure	Height (m) :	12	Magnitude Score :	a
Year of Disaster Recorded:	2014/2015	Potential Score :	ii		
Detour Distance (km):	44	Detour Route:	B122-B385-B281-A10-B122		Detour Score : B

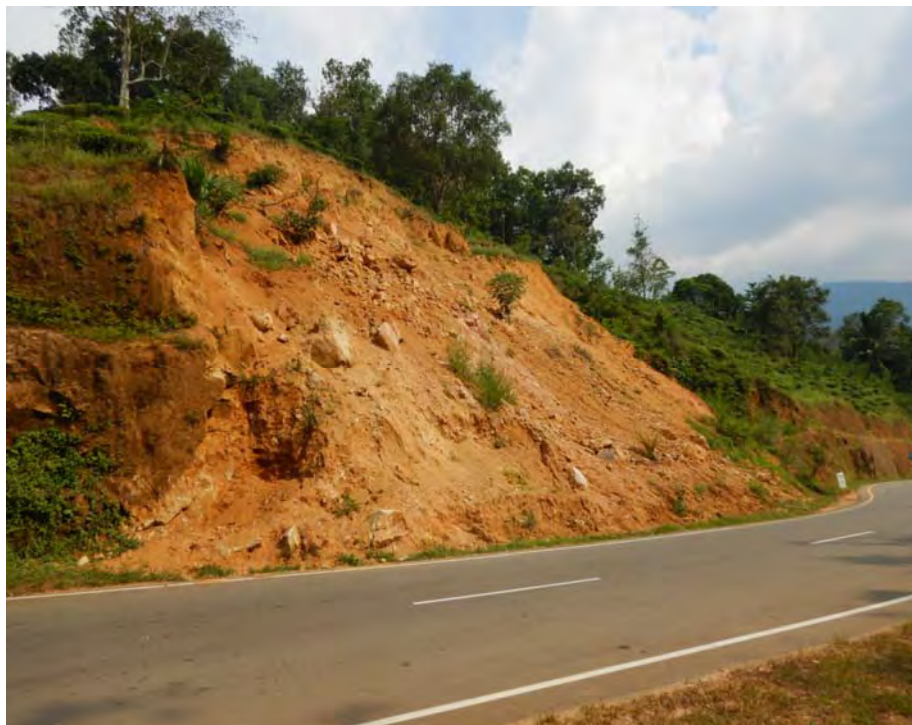
Site Photo

Site No.	43	District:	Ratnapura	DS Division :	Pelmadulla
Road Class:	A	Route No.	A-017	Name of the Road:	Galle-Deniyaya-Madampe road
Start (Km/cul.):	139	End (Km/cul.):	140/1		
Disaster Type :	Landslide	Width (m) :	7	Magnitude Score :	a
Year of Disaster Recorded:	2018	Potential Score :	iii		
Detour Distance (km):	226	Detour Route:	A17-A18-A2-A24-A17	Detour Score :	A

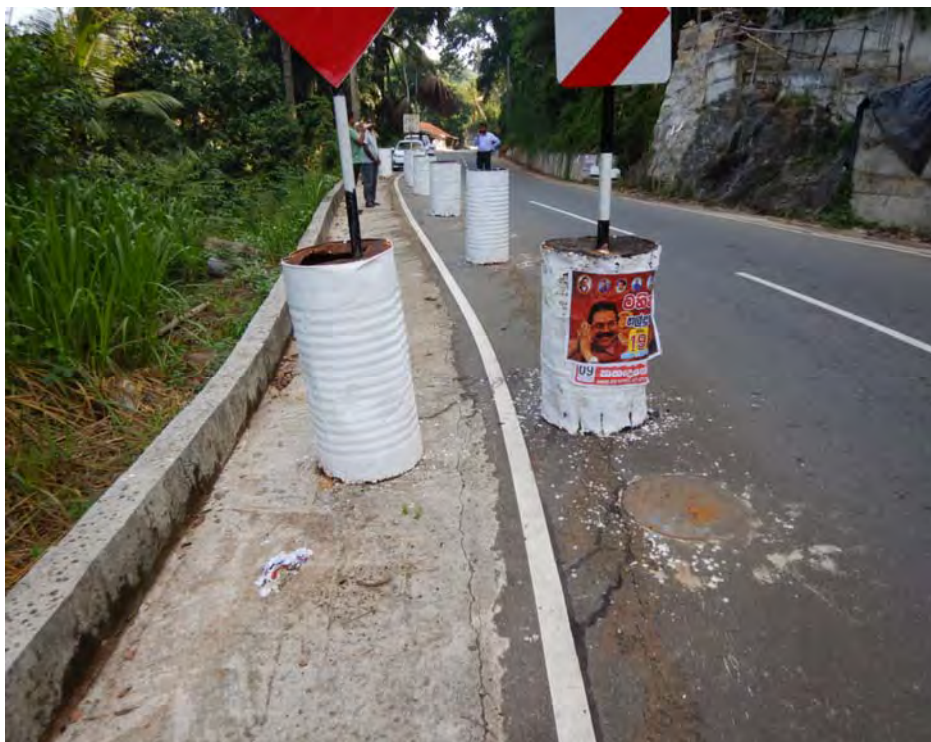
Site Photo

Site No.	44	District:	Kegalle	DS Division :	Ruwanwella
Road Class:	B	Route No.	B-457	Name of the Road:	Warakapola - Ruwanwella Road
Start (Km/cul.):	'13/2	End (Km/cul.):	13/5		
Disaster Type :	Slope Failure	Height (m) :	8	Magnitude Score :	b
Year of Disaster Recorded:	2017	Potential Score :	iii		
Detour Distance (km):	50	Detour Route:	B457-B539-A1-B127-A21-B457		Detour Score : B

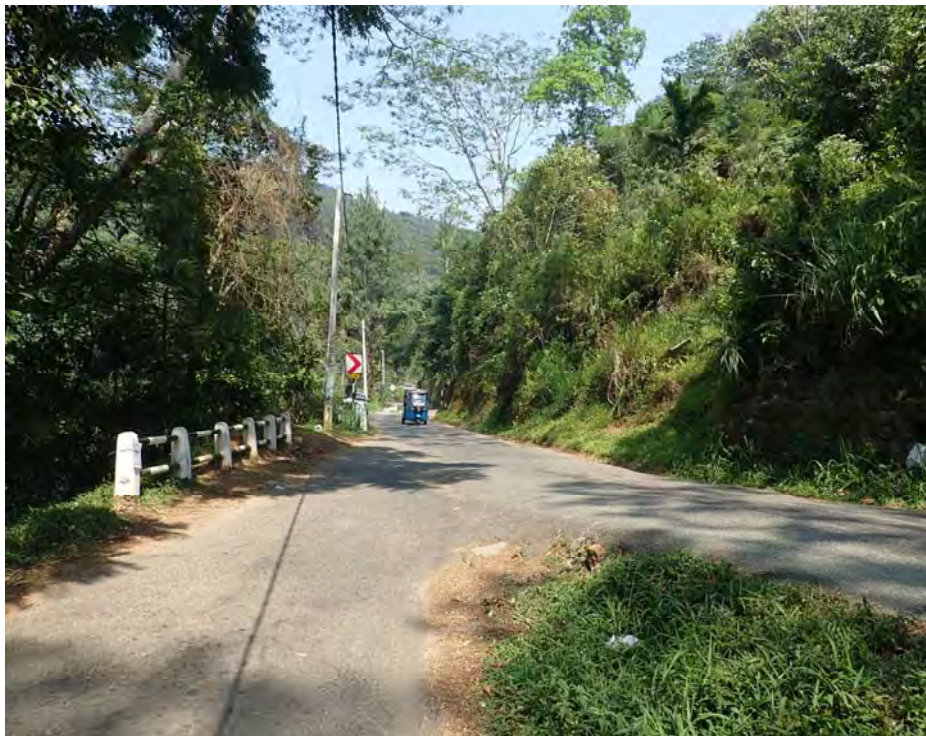
Site Photo

Site No.	46	District:	Rathnapura	DS Division :	Rathnapura
Road Class:	B	Route No.	B-390	Name of the Road:	Rathnapura- Palawela- Karavita Road
Start (Km/cul.):	7/10	End (Km/cul.):	7/11		
Disaster Type :	Slope Failure	Height (m) :	12	Magnitude Score :	a
Year of Disaster Recorded:	2017	Potential Score :	ii		
Detour Distance (km):	39	Detour Route:	B390-A4-B421-B390	Detour Score :	B

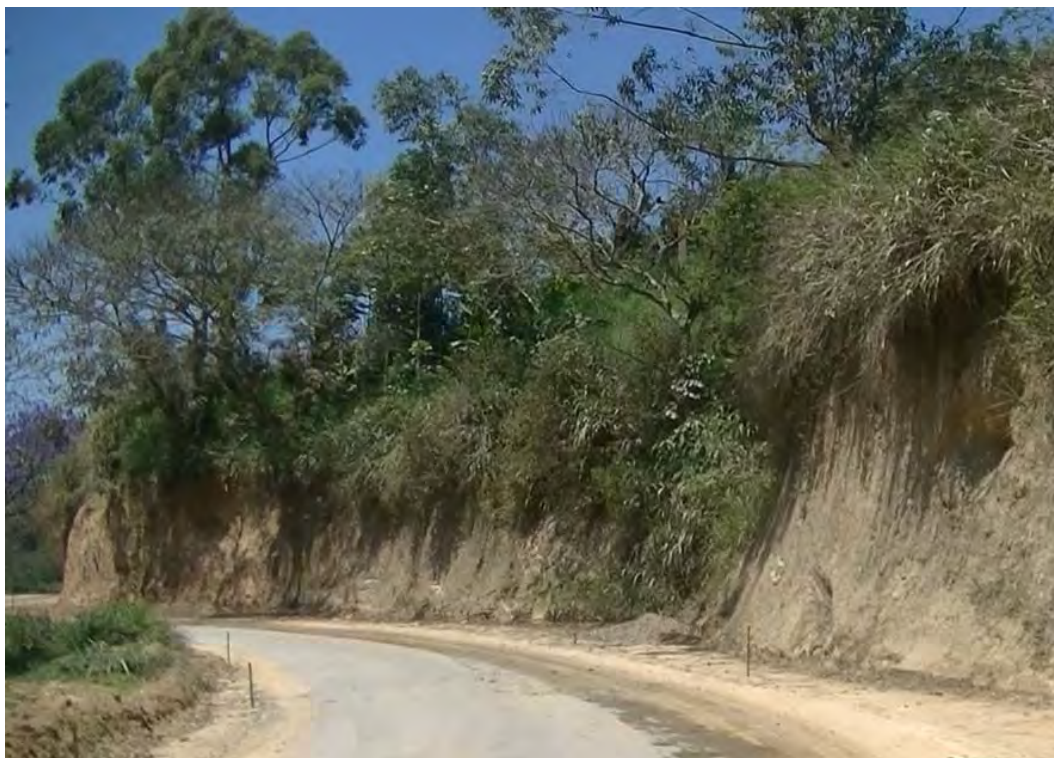
Site Photo

Site No.	48	District:	Rathnapura	DS Division :	Rathnapura
Road Class:	B	Route No.	B-390	Name of the Road:	Rathnapura- Palawela- Karavita Road
Start (Km/cul.):	12/4	End (Km/cul.):	12/7		
Disaster Type :	Slope Failure	Height (m) :	12	Magnitude Score :	a
Year of Disaster Recorded:	2017	Potential Score :	ii		
Detour Distance (km):	39	Detour Route:	B390-A4-B421-B390	Detour Score :	B

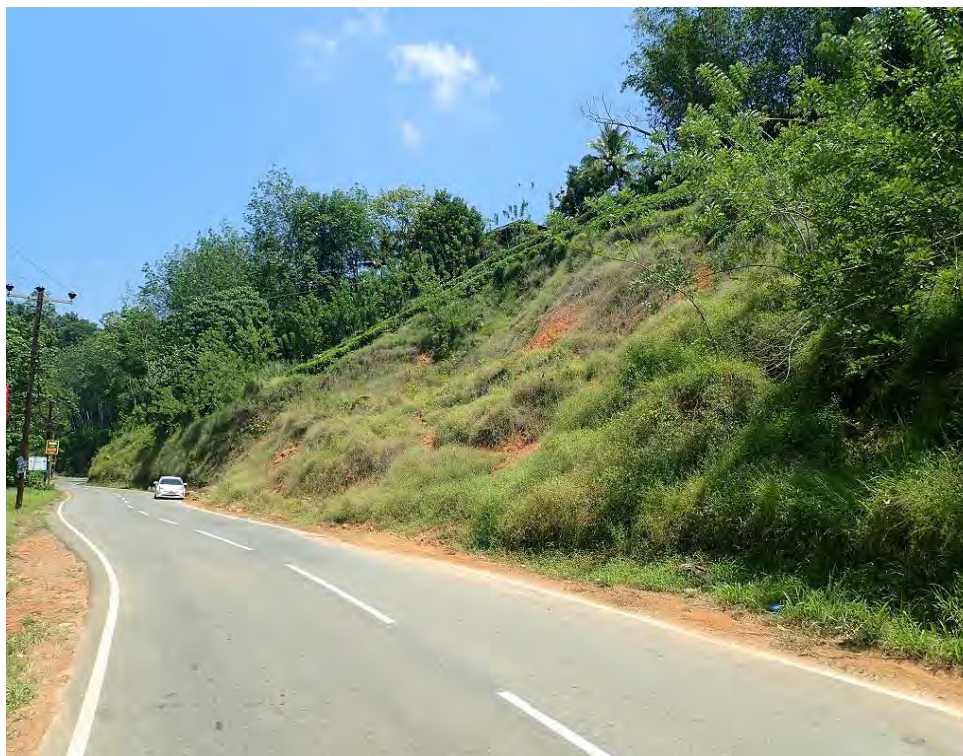
Site Photo

Site No.	49	District:	Rathnapura	DS Division :	Rathnapura
Road Class:	B	Route No.	B-390	Name of the Road:	Rathnapura- Palawela- Karavita Road
Start (Km/cul.):	20/9	End (Km/cul.):	21/3		
Disaster Type :	Landslide	Height (m) :	15	Magnitude Score :	a
Year of Disaster Recorded:	2017	Potential Score :	ii		
Detour Distance (km):	39	Detour Route:	B390-A4-B421-B390	Detour Score :	B

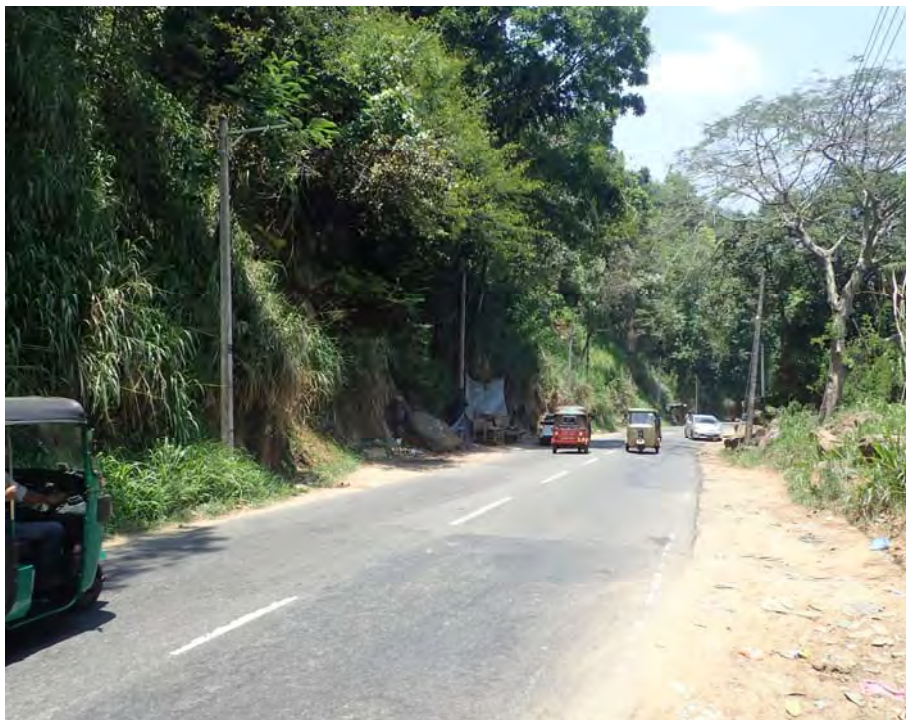
Site Photo

Site No.	50	District:	Kandy	DS Division :	Kandy
Road Class:	B	Route No.	B-365	Name of the Road:	Peradeniya - Halloluwa - Katugastota
Start (Km/cul.):	3 km	End (Km/cul.):	4km		
Disaster Type :	Rock fall	Height (m) :	10	Magnitude Score :	b
Year of Disaster Recorded:	2014/2015	Potential Score :	ii		
Detour Distance (km):	17	Detour Route:	B365-A9-A1-B365	Detour Score :	B

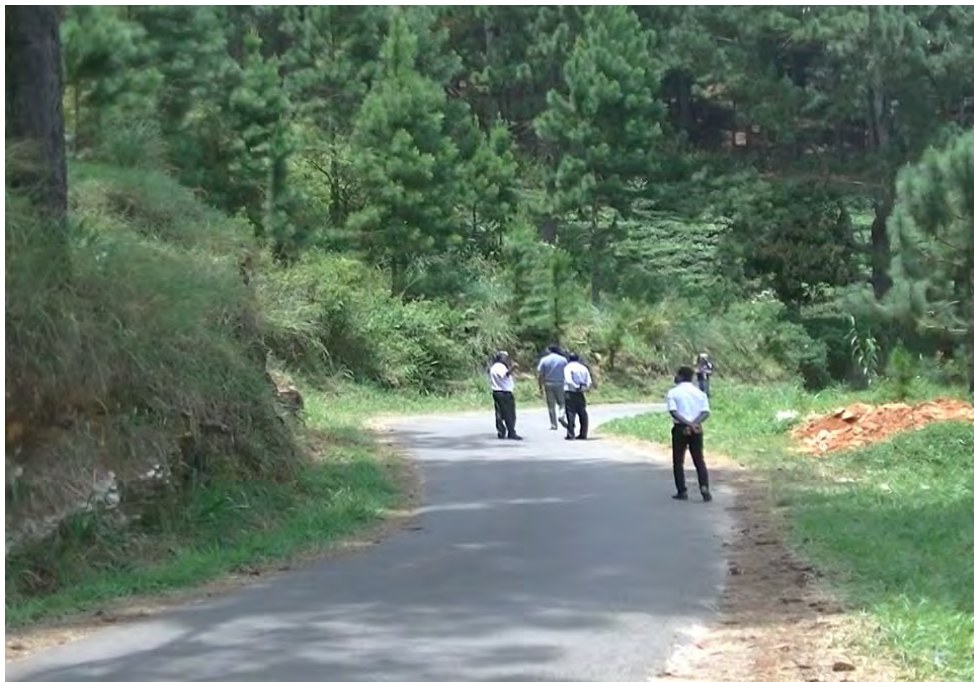
Site Photo

Site No.	52	District:	Nuwara Eliya	DS Division :	Hanguranketha
Road Class:	B	Route No.	B-364	Name of the Road:	Peradeniya-Delthota-Rikillagaskada Road
Start (Km/cul.):	40/2	End (Km/cul.):	40/3		
Disaster Type :	Landslide	Width (m) :	50	Magnitude Score :	b
Year of Disaster Recorded:	2014/2015	Potential Score :	ii		
Detour Distance (km):	79	Detour Route:	B364-B154-A1-B518-A26-B413-B364		Detour Score : B

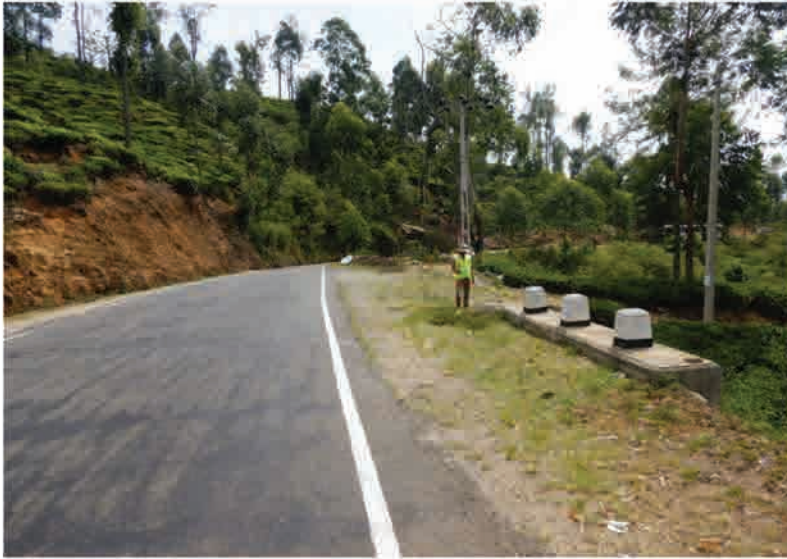
P1 The upper slope of the landslide area looking from the starting point of the road.

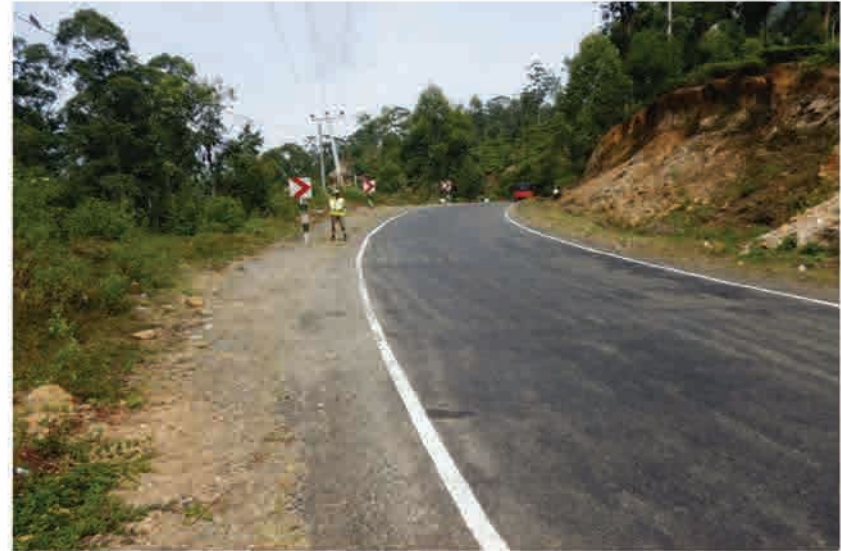
P2 The upper slope of the landslide area looking from the ending point of the road

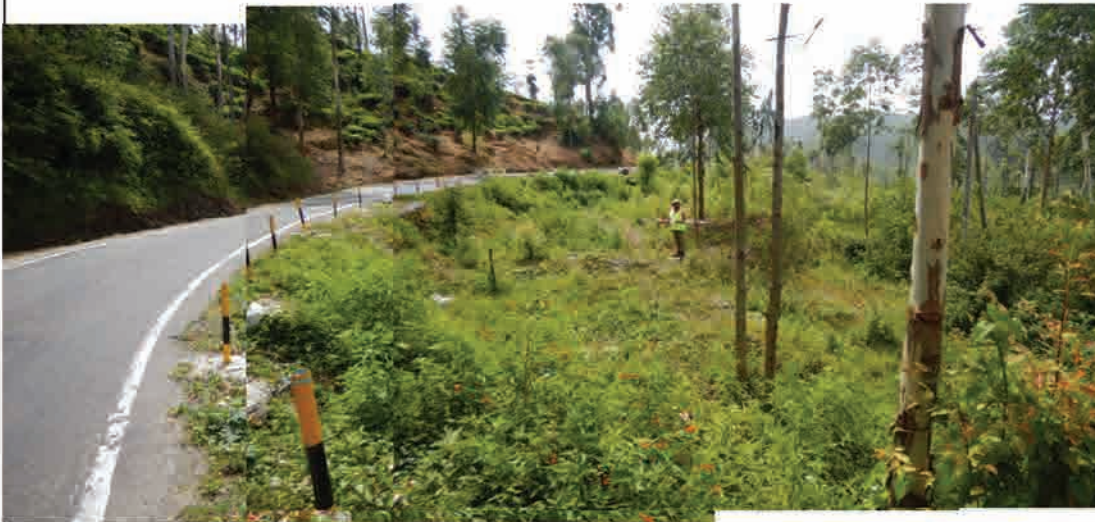
P3 Circular depression just along and below the road due to landslide movement

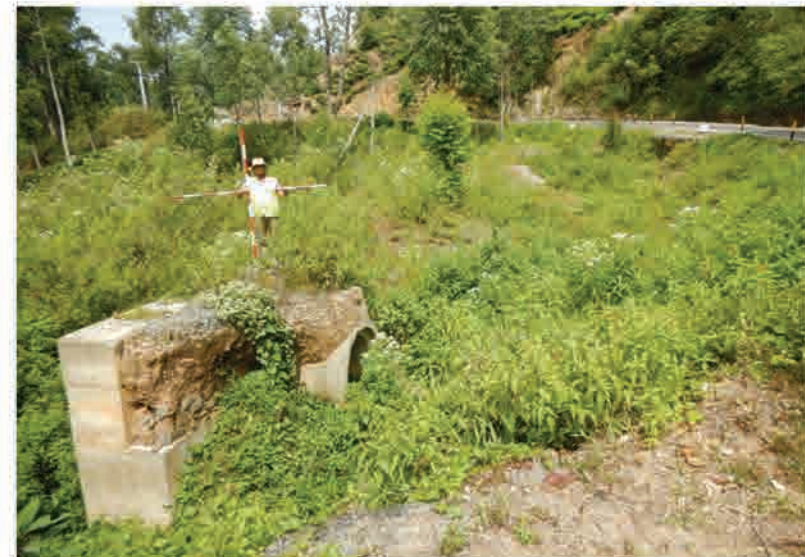
P4 Culvert destroyed by landslide movement

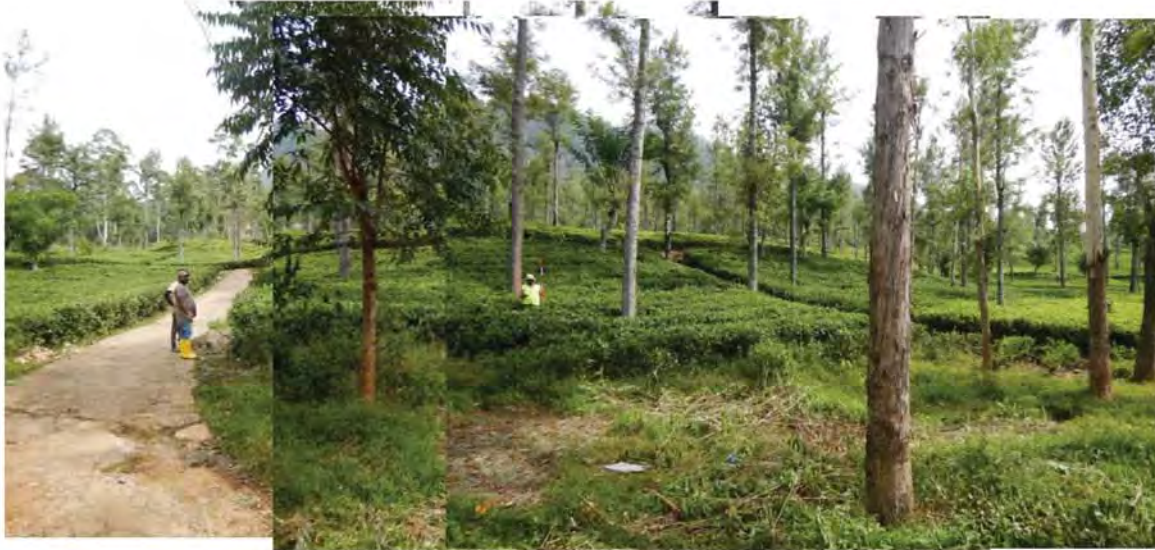
P5 The lower slope of the landslide looking upslope at the end of the landslide

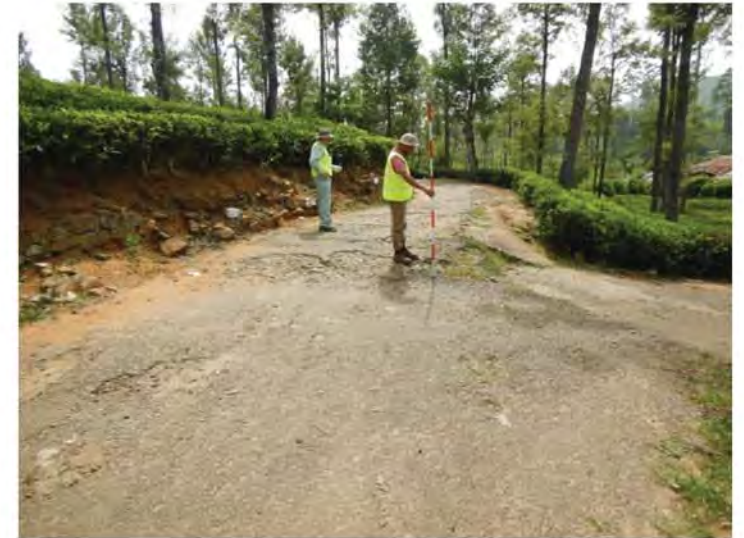
P6 Deformation and upheaval situation of the village road around the the toe of landslide
