表6.2.1 排水測量成果（右岸）（1/30）

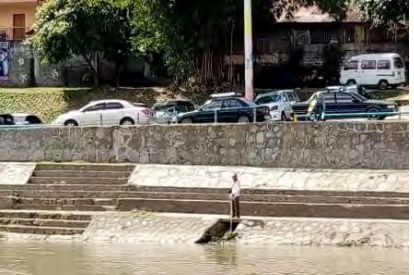
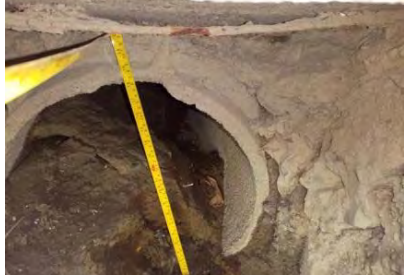
<p>NEW OUTLET</p> <p>Drainage Outlet No.= MR001A                      Northing= 1618661.915                      Easting= 509853.144                      Elevation= 11.606                      Dimension= D450mm T50mm                      Type= RC                      Date= 2020/1/8                      Station no.= 13+327</p> <p>REMARKS: CLOGGED                      RC inside BC                      BC dimensions: H: 550mm W: 800mm                      Distance from mouth of BC to RC: 2 meters</p>
<p>Photo (distant view)</p>

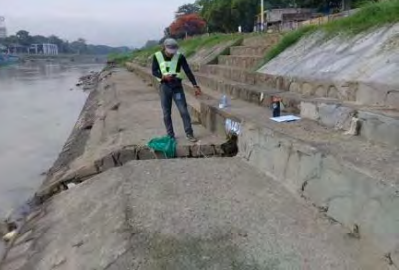
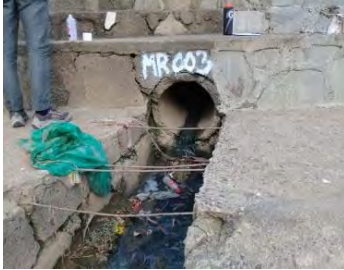
<p>Drainage Outlet No.= MR003                      Northing= 1618572.76                      Easting= 509873.784                      Elevation= 11.931                      Dimension= D450mm T80mm                      Type= RC                      Date= 2019/10/8                      Station no.= 13+236</p>
<p>Photo (distant view)</p>

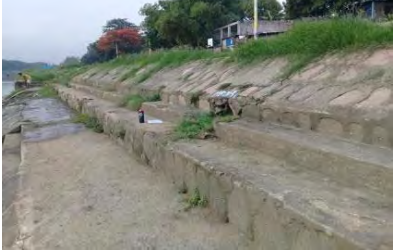
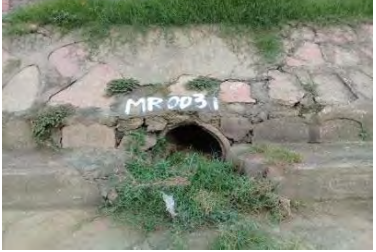
<p>NEW OUTLET</p> <p>Drainage Outlet No.= MR003.1                      Northing= 1618552.032                      Easting= 509877.448                      Elevation= 12.254                      Dimension= D570mm T70mm                      Type= RC                      Date= 2019/6/18                      Station no.= 13+215</p>
<p>Photo (distant view)</p>

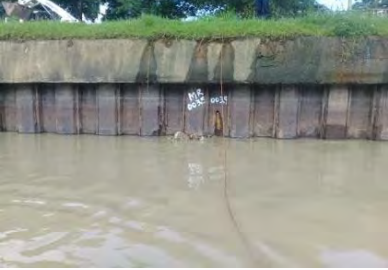
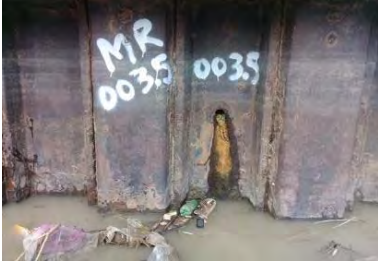
<p>NEW OUTLET</p> <p>Drainage Outlet No.= MR003.5                      Northing= 1618497.537                      Easting= 509892.562                      Elevation= 11.485                      Dimension= D50mm                      Type= PVC                      Date= 2019/10/18                      Station no.= 13+158</p>
<p>Photo (distant view)</p>

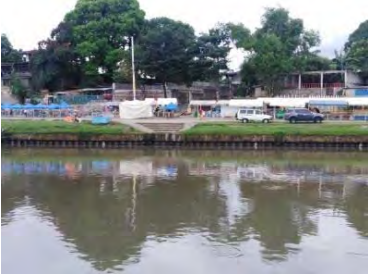
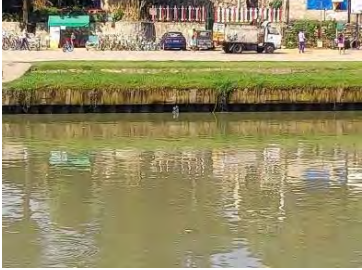
<p>NEW OUTLET</p> <p>Drainage Outlet No.= MR003.6                      Northing=                      Easting=                      Elevation=                      Dimension=                      Type=                      Date=                      Station no.=</p> <p>Remarks: Underwater during observation                      Photo will be added when water level decreases</p>

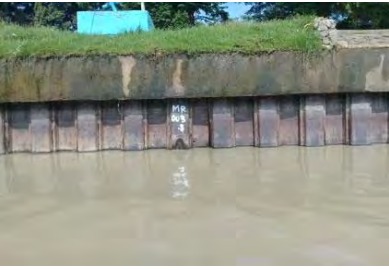
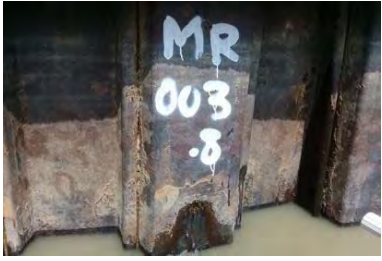
<p>NEW OUTLET</p> <p>Drainage Outlet No.= MR003.8                      Northing= 1618480.047                      Easting= 509896.832                      Elevation= 10.746                      Dimension= D50mm                      Type= PVC                      Date= 2019/6/17                      Station no.= 13+140</p>
<p>Photo (distant view)</p>

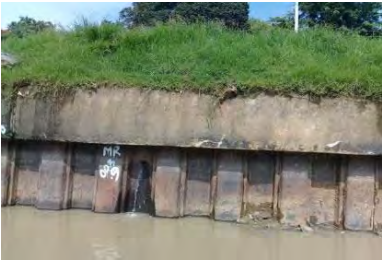
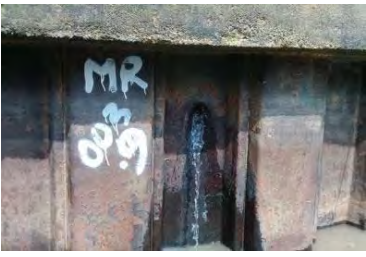
<p>NEW OUTLET</p> <p>Drainage Outlet No.= MR003.9                      Northing= 1618470.153                      Easting= 509898.61                      Elevation= 11.701                      Dimension= D50mm                      Type= PVC                      Date= 2019/10/18                      Station no.= 13+130</p>
<p>Photo (distant view)</p>

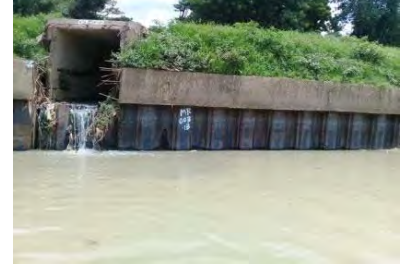
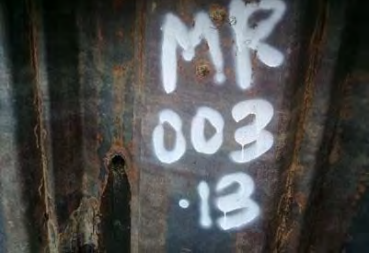
<p>NEW OUTLET</p> <p>Drainage Outlet No.= MR003.13                      Northing= 1618384.794                      Easting= 509911.758                      Elevation= 11.012                      Dimension= D50mm                      Type= PVC                      Date= 2019/6/17                      Station no.= 13+043</p>
<p>Photo (distant view)</p>

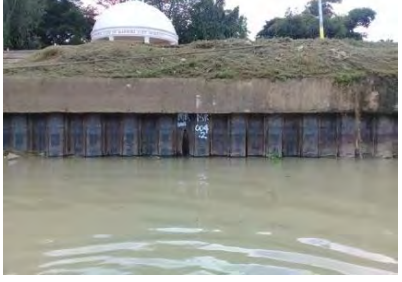
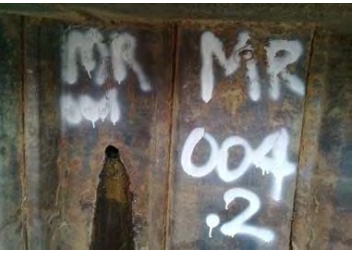
<p>NEW OUTLET</p> <p>Drainage Outlet No.= MR004.2                      Northing= 1618363.443                      Easting= 509913.62                      Elevation= 11.167                      Dimension= D50mm                      Type= PVC                      Date= 2019/6/17                      Station no.= 13+021</p>
<p>Photo (distant view)</p>

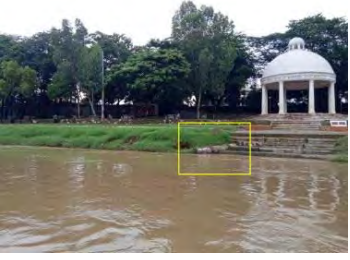
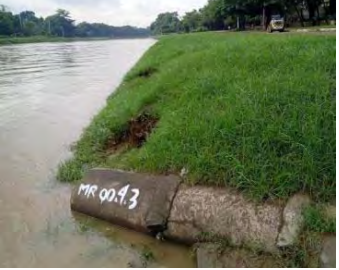
<p>NEW OUTLET</p> <p>Drainage Outlet No.= MR004.3                      Northing= 1618352.055                      Easting= 509914.629                      Elevation= 12.611                      Dimension= D450mm T80mm                      Type= RC                      Date= 2019/6/17                      Station no.= 13+010</p>

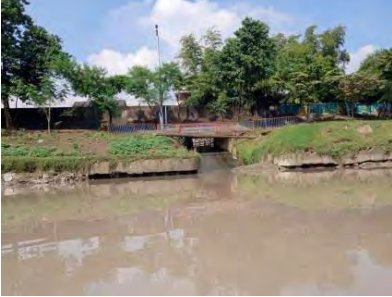
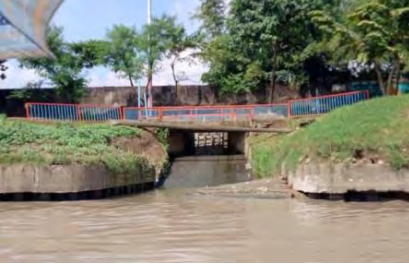
<p>CROSS SECTION</p> <p>Drainage Outlet No.= MR005                      Northing= 1618079.924                      Easting= 509923.546                      Elevation= 13.807                      Dimension= W1900mm H12050mm                      Type= BC                      Date= 2019/10/19                      Station no.= 12+739</p>

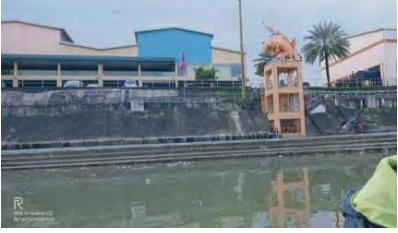
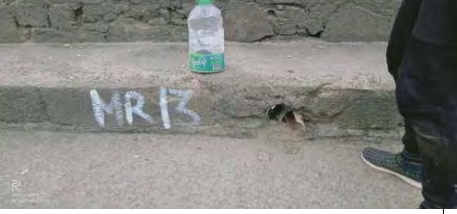
<p>Drainage Outlet No.= MR013                      Northing= 1617959.021                      Easting= 508780.528                      Elevation= 11.94                      Dimension= D80mm                      Type= PVC                      Date= 2019/10/20                      Station no.= 10+645</p>
<p>Photo (distant view)</p>

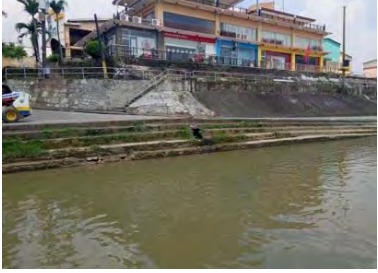
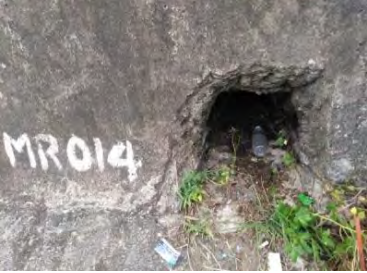
<p>Drainage Outlet No.= MR014                      Northing= 1617929.173                      Easting= 508756.44                      Elevation= 16.017                      Dimension= H470mm W470mm                      Type= BC                      Date= 2019/6/13                      Station no.= 10+610</p>
<p>Photo (distant view)</p>

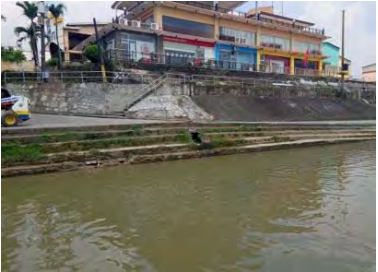
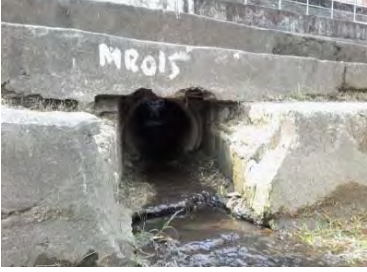
<p>NEW OUTLET                      Drainage Outlet No.= MR015A                      Northing= 1617886.822                      Easting= 508755.923                      Elevation= 12.548                      Dimension= D700mm T100mm                      Type= RC                      Date= 2019/10/11                      Station no.= 10+569</p>

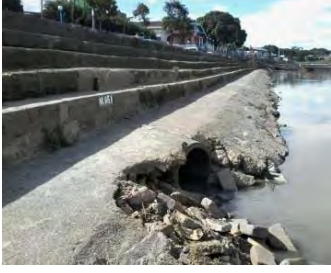
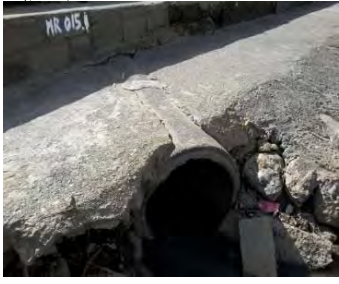
<p>NEW OUTLET                      Drainage Outlet No.= MR015.1                      Northing= 1617738.032                      Easting= 508711.6787                      Elevation= 10.643                      Dimension= D700mm T100mm                      Type= RC                      Date= 2019/6/13                      Station no.= 10+414</p>
<p>Photo (distant view)</p>

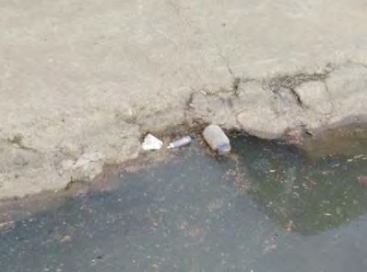
<p>NEW OUTLET                      Drainage Outlet No.= MR015.101                      Northing= 1617853.686                      Easting= 508748.428                      Elevation= 10.5622                      Dimension= D700mm T100mm                      Type= RC                      Date= 2019/6/13                      Station no.= 10+536</p>
<p>Photo (distant view)</p>

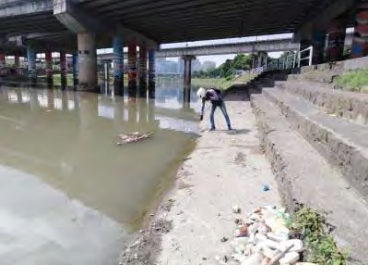
<p>NEW OUTLET                      Drainage Outlet No.= MR015.2                      Northing= 1617700.773                      Easting= 508699.2339                      Elevation= 10.9142                      Dimension= D700mm T100mm                      Type= RC                      Date= 2019/6/13                      Station no.= 10+375</p>

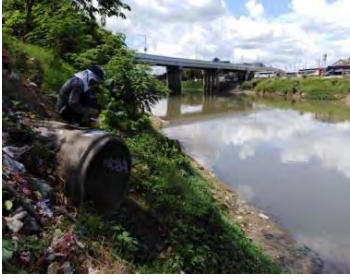
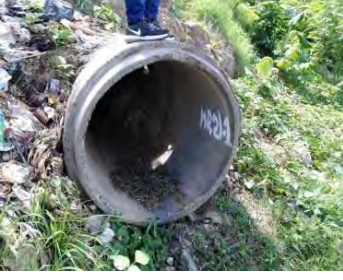
<p>NEW OUTLET</p> <p>Drainage Outlet No.= MR021.1                      Northing= 1617101.156                      Easting= 508620.834                      Elevation= 13.189                      Dimension= D1020mm T80mm                      Type= RC                      Date= 2019/8/13                      Station no.= 9+774</p>
<p>Photo (distant view)</p>

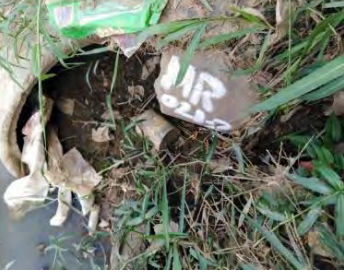
<p>NEW OUTLET</p> <p>Drainage Outlet No.= MR021.2                      Northing= 1616989.49                      Easting= 508590.312                      Elevation= 12.4522                      Dimension= D800mm T100mm                      Type= RC                      Date= 2019/7/19                      Station no.= 9+638</p>
<p>Photo (distant view)</p>

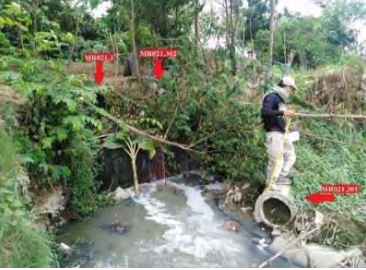
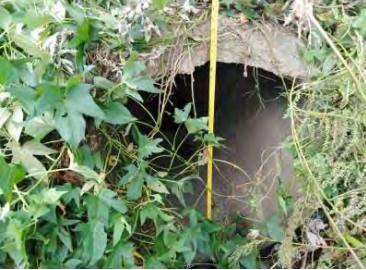
<p>NEW OUTLET</p> <p>Drainage Outlet No.= MR021.3                      Northing= 1616944.141                      Easting= 508548.098                      Elevation= 12.3185                      Dimension= D900mm T100mm                      Type= RC                      Date= 2019/7/19                      Station no.= 9+569</p>

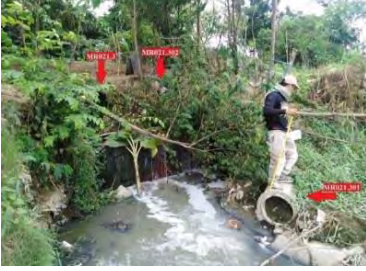
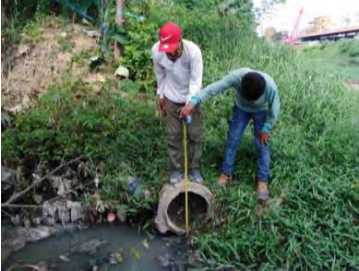
<p>NEW OUTLET</p> <p>Drainage Outlet No.= MR021.301                      Northing= 1616941.041                      Easting= 508551.6347                      Elevation= 11.2985                      Dimension= D390mm T90mm                      Type= RC                      Date= 2019/7/19                      Station no.= 9+570</p>
<p>Photo (distant view)</p>

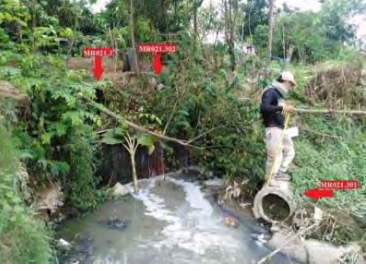
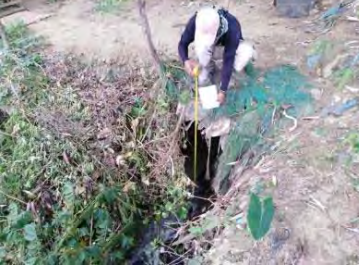
<p>NEW OUTLET</p> <p>Drainage Outlet No.= MR021.302                      Northing= 1616945.609                      Easting= 508549.0274                      Elevation= 12.4522                      Dimension= D900mm T80mm                      Type= RC                      Date= 2019/7/19                      Station no.= 9+571</p>
<p>Photo (distant view)</p>

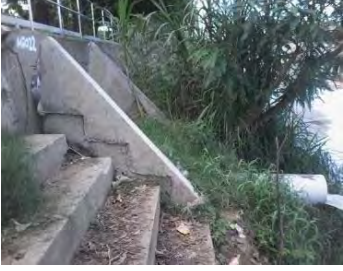
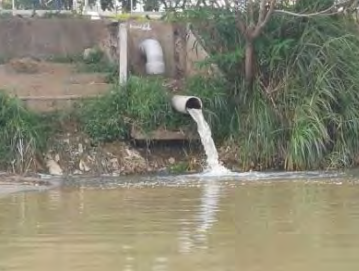
<p>NEW OUTLET</p> <p>Drainage Outlet No.= MR022                      Northing= 1616885.908                      Easting= 508468.563                      Elevation= 12.855                      Dimension= D350mm T25mm                      Type= RC                      Date= 2019/10/20                      Station no.= 9+471</p>

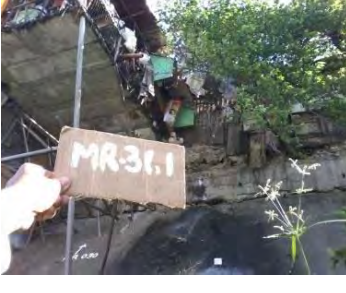
<p>NEW OUTLET</p> <p>Drainage Outlet No.= MR031.1                      Northing= 1616107.939                      Easting= 508400.392                      Elevation= 19.042                      Dimension= D25.4mm                      Type= PVC                      Date= 2019/8/14                      Station no.= 8+657</p>
<p>Photo (distant view)</p>

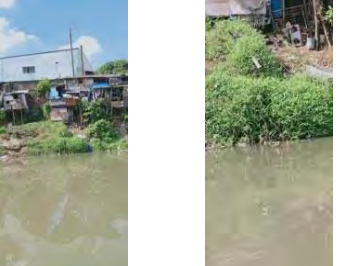
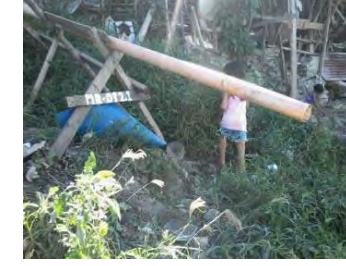
<p>NEW OUTLET</p> <p>Drainage Outlet No.= MR032.1                      Northing= 1616099.465                      Easting= 508411.644                      Elevation= 13.301                      Dimension= D25.4mm                      Type= PVC                      Date= 2019/8/14                      Station no.= 8+646</p>

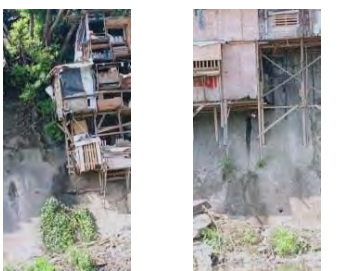
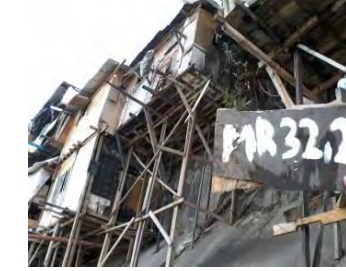
<p>NEW OUTLET</p> <p>Drainage Outlet No.= MR032.2                      Northing= 1616075.288                      Easting= 508422.353                      Elevation= 17.491                      Dimension= D25.4mm                      Type= PVC                      Date= 2019/8/14                      Station no.= 8+621</p>
<p>Photo (distant view)</p>

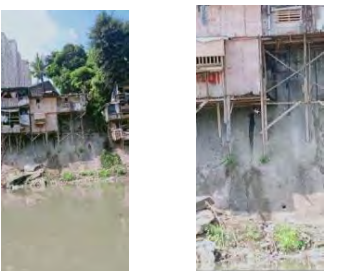
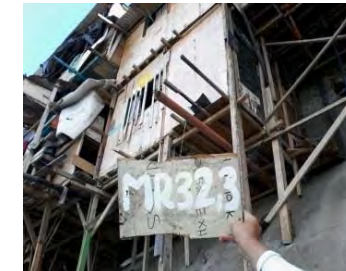
<p>NEW OUTLET</p> <p>Drainage Outlet No.= MR032.3                      Northing= 1616071.237                      Easting= 508426.66                      Elevation= 16.27                      Dimension= D25.4mm                      Type= PVC                      Date= 2019/8/14                      Station no.= 8+615</p>
<p>Photo (distant view)</p>

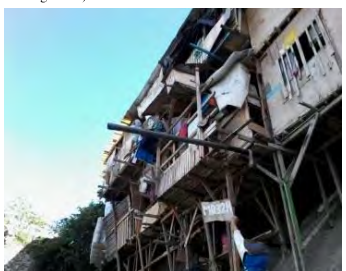
<p>NEW OUTLET</p> <p>Drainage Outlet No.= MR032.4                      Northing= 1616070.32                      Easting= 508430.242                      Elevation= 16.385                      Dimension= D25.4mm                      Type= PVC                      Date= 2019/8/14                      Station no.= 8+612</p>

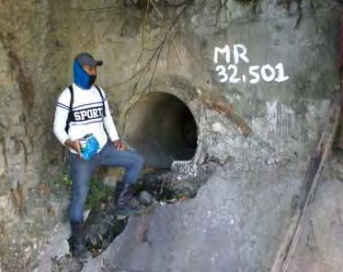
<p>NEW OUTLET</p> <p>Drainage Outlet No.= MR032.501                      Northing= 1616058.14                      Easting= 508435.754                      Elevation= 16.927                      Dimension= D1000mm T100mm                      Type= RC                      Date= 2019/8/14                      Station no.= 8+603</p>
<p>Photo (distant view)</p>

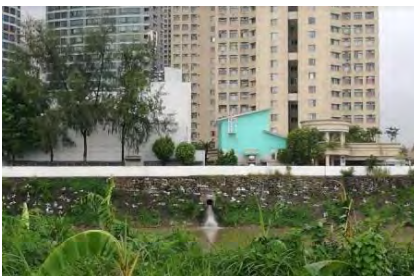
<p>Drainage Outlet No.= MR043.39                      Northing= 1616039.949                      Easting= 508476.088                      Elevation= 14.642                      Dimension= D920mm T100mm                      Type= RC                      Date= 2019/10/23                      Station no.= 8+563</p>

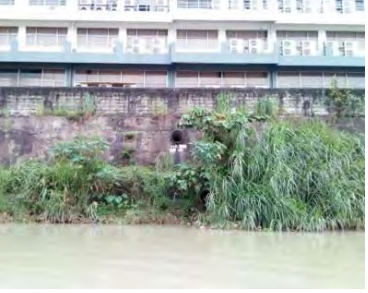
<p>Drainage Outlet No.= MR047.3                      Northing= 1615999.104                      Easting= 508527.843                      Elevation= 17.321                      Dimension= D100mm                      Type= PVC                      Date= 2019/9/10                      Station no.= 8+597</p>
<p>Photo (distant view)</p>

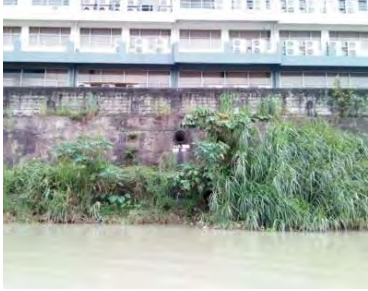
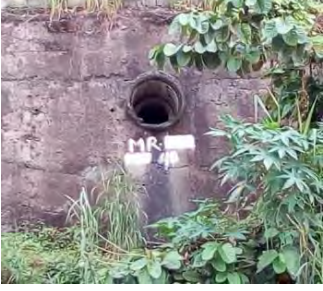
<p>Drainage Outlet No.= MR048                      Northing= 1615996.443                      Easting= 508532.262                      Elevation= 15.926                      Dimension= D630mm T500mm                      Type= RC                      Date= 2019/7/27                      Station no.= 8+492</p>
<p>Photo (distant view)</p>

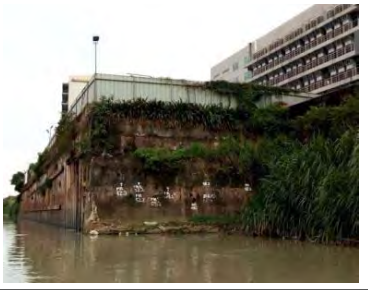
<p>Drainage Outlet No.= MR048.1                      Northing= 1615973.439                      Easting= 508568.664                      Elevation= 16.232                      Dimension= D160mm                      Type= RC                      Date= 2019/9/29                      Station no.= 8+449</p>

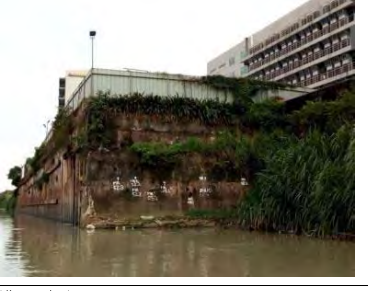
<p>Drainage Outlet No.= MR048.2                      Northing= 1615972.899                      Easting= 508567.108                      Elevation= 14.588                      Dimension= D150mm                      Type= RC                      Date= 2019/9/29                      Station no.= 8+450</p>
<p>Photo (distant view)</p>

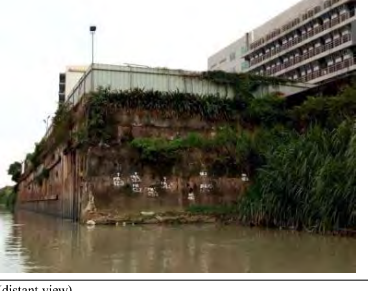
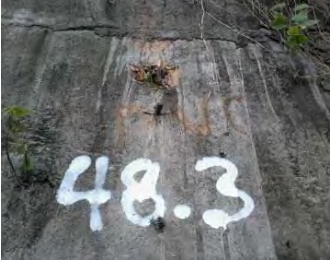
<p>Drainage Outlet No.= MR048.3                      Northing= 1615974.69                      Easting= 508568.851                      Elevation= 14.788                      Dimension= D80mm                      Type= PVC                      Date= 2019/9/29                      Station no.= 8+450</p>
<p>Photo (distant view)</p>

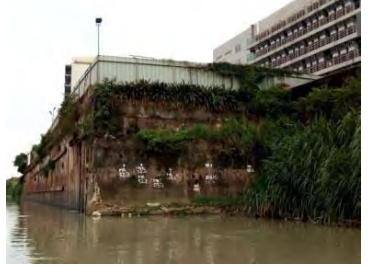
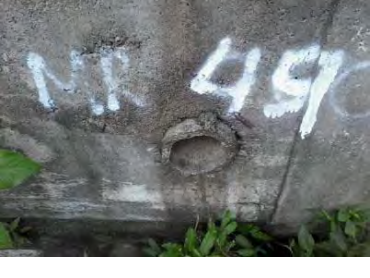
<p>Drainage Outlet No.= MR049                      Northing= 1615975.179                      Easting= 508570.83                      Elevation= 16.25                      Dimension= D160mm                      Type= RC                      Date= 2019/8/14                      Station no.= 8+449</p>

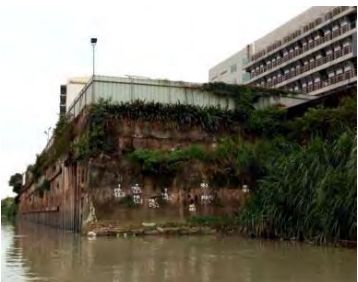
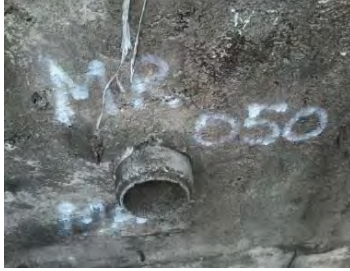
<p>Drainage Outlet No.= MR050                  Northing= 1615977.129                  Easting= 508572.661                  Elevation= 16.281                  Dimension= D160mm                  Type= RC                  Date= 2019/8/14                  Station no.= 8+448</p>
<p>Photo (distant view)</p>

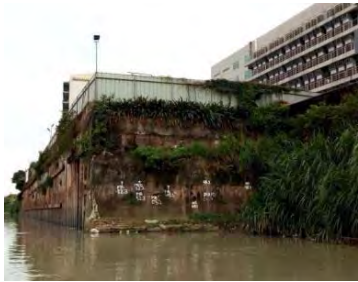
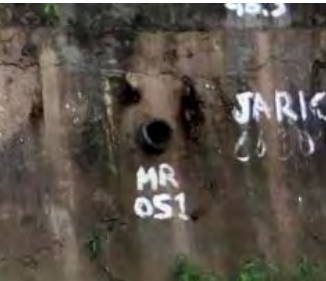
<p>Drainage Outlet No.= MR051                  Northing= 1615975.337                  Easting= 508569.301                  Elevation= 13.408                  Dimension= D160mm                  Type= RC                  Date= 2019/8/14                  Station no.= 8+450</p>
<p>Photo (distant view)</p>

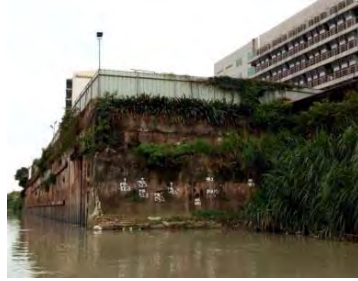
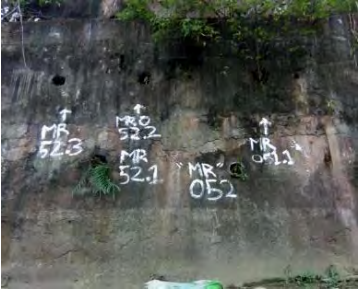
<p>Drainage Outlet No.= MR051.1                  Northing= 1615976.199                  Easting= 508570.457                  Elevation= 14.707                  Dimension= D160mm                  Type= RC                  Date= 2019/8/14                  Station no.= 8+450</p>

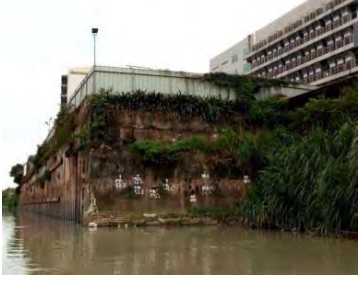
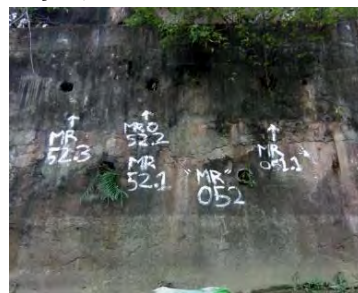
<p>Drainage Outlet No.= MR052.1                  Northing= 1615977.92                  Easting= 508571.712                  Elevation= 13.592                  Dimension= D150mm                  Type= RC                  Date= 2019/10/21                  Station no.= 8+450</p>
<p>Photo (distant view)</p>

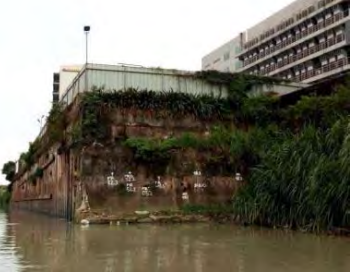
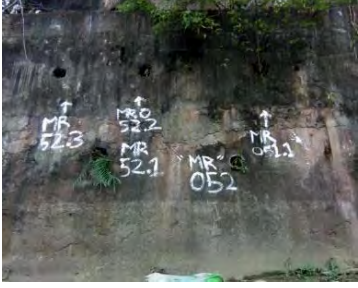
<p>Drainage Outlet No.= MR052.2                  Northing= 1615977.42                  Easting= 508571.568                  Elevation= 14.741                  Dimension= D160mm                  Type= RC                  Date= 2019/10/21                  Station no.= 8+450</p>

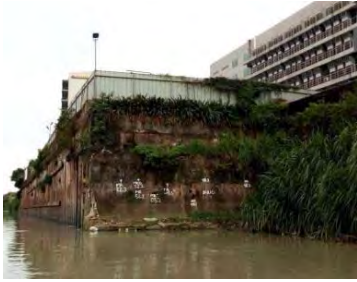
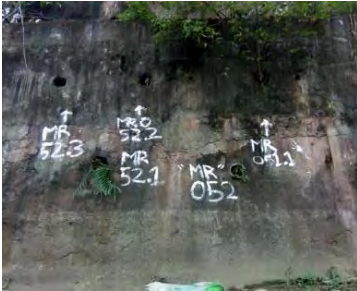
<p>Drainage Outlet No.= MR052.3                      Northing= 1615978.246                      Easting= 508572.366                      Elevation= 14.777                      Dimension= D160mm                      Type= RC                      Date= 2019/10/21                      Station no.= 8+450</p> <p>REMARKS Old coordinates were off</p>
<p>Photo (distant view)</p>

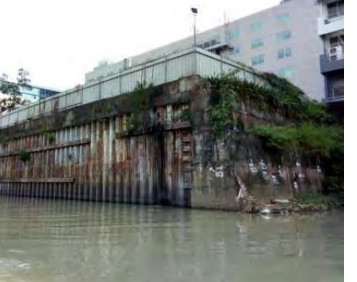
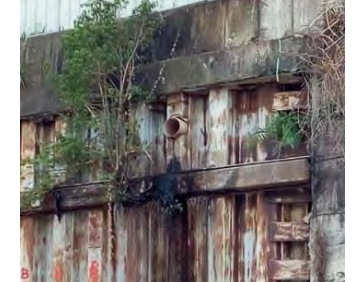
<p>Drainage Outlet No.= MR053                      Northing= 1615976.368                      Easting= 508577.192                      Elevation= 17.172                      Dimension= D300mm                      Type= PVC                      Date= 2019/10/21                      Station no.= 8+443</p>
<p>Photo (distant view)</p>

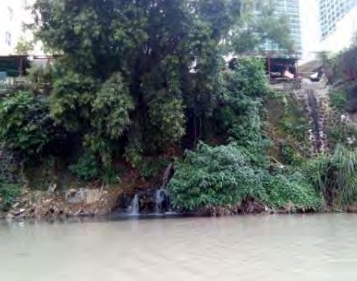
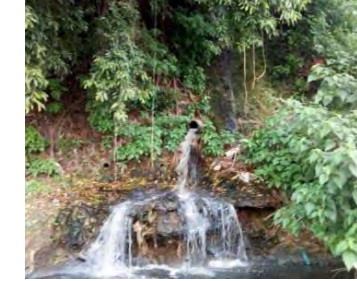
<p>Drainage Outlet No.= MR054                      Northing= 1615899.742                      Easting= 508665.035                      Elevation= 14.632                      Dimension= D250mm                      Type= RC                      Date= 2019/9/29                      Station no.= 8+328</p>

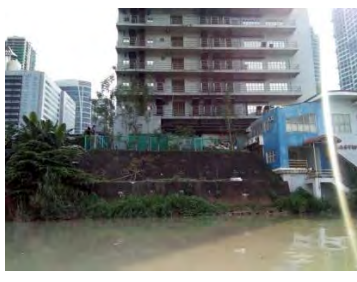
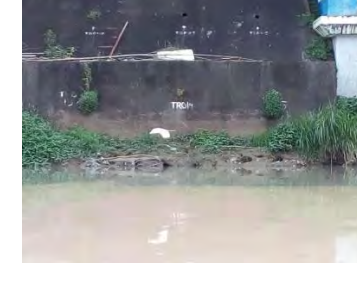
<p>NEW OUTLET</p> <p>Drainage Outlet No.= MR055.1                      Northing=                      Easting=                      Elevation=                      Dimension=                      Type=                      Date=                      Station no.=</p> <p>Remarks: Underwater during survey</p>
<p>Photo (distant view)</p>

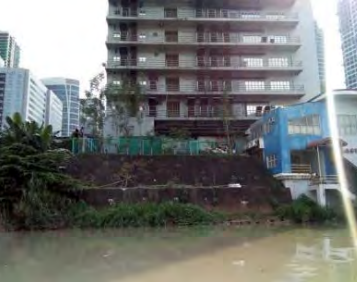
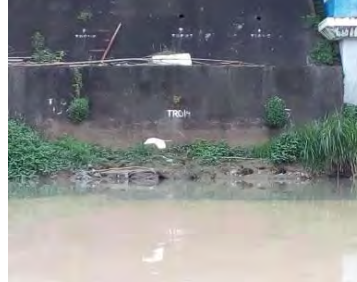
<p>NEW OUTLET</p> <p>Drainage Outlet No.= MR055.2                      Northing=                      Easting=                      Elevation=                      Dimension=                      Type=                      Date=                      Station no.=</p> <p>Remarks: Underwater during survey</p>

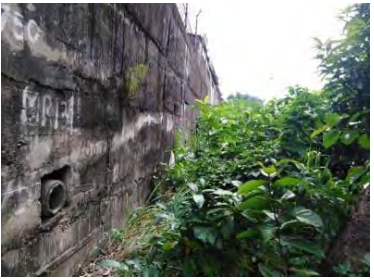
<p>Drainage Outlet No.= MR131                      Northing= 1615057.235                      Easting= 509095.785                      Elevation= 15.569                      Dimension= D200mm                      Type= RC                      Date= 2019/10/26                      Station no.= 5+985</p>

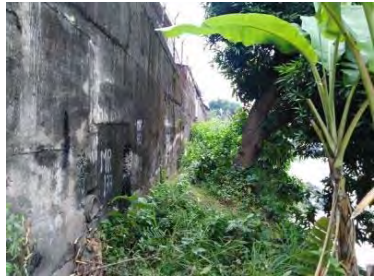
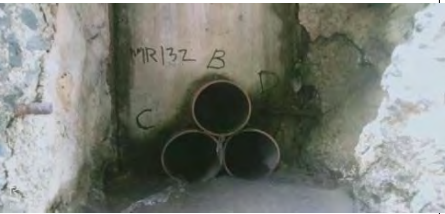
<p>Drainage Outlet No.= MR132B                      Northing= 1615060.042                      Easting= 509092.496                      Elevation= 16.025                      Dimension= D100mm                      Type= PVC                      Date= 2019/11/6                      Station no.= 5+981</p> <p>REMARKS: 3 PVC inside BC</p>
<p>Photo (distant view)</p>

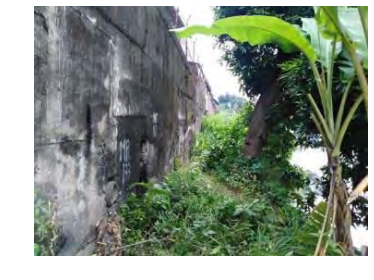
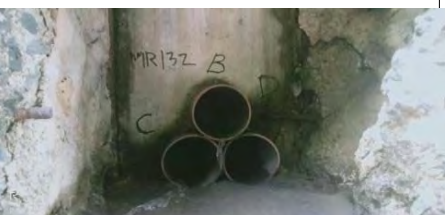
<p>Drainage Outlet No.= MR132C                      Northing= 1615060.084                      Easting= 509092.455                      Elevation= 15.938                      Dimension= D100mm                      Type= PVC                      Date= 2019/11/6                      Station no.= 5+981</p> <p>REMARKS: 3 PVC inside BC</p>
<p>Photo (distant view)</p>

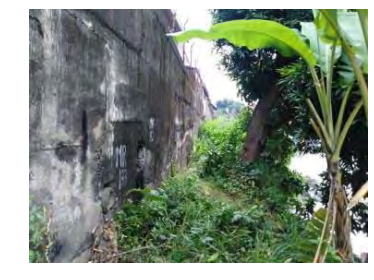
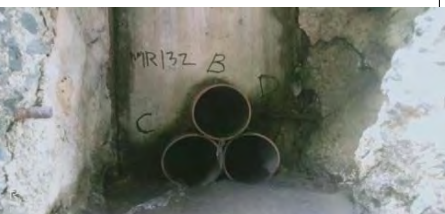
<p>Drainage Outlet No.= MR132D                      Northing= 1615060.016                      Easting= 509092.534                      Elevation= 15.938                      Dimension= D100mm                      Type= PVC                      Date= 2019/11/6                      Station no.= 5+981</p> <p>REMARKS: 3 PVC inside BC</p>

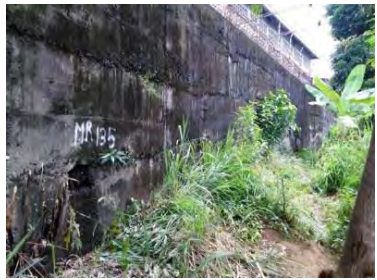
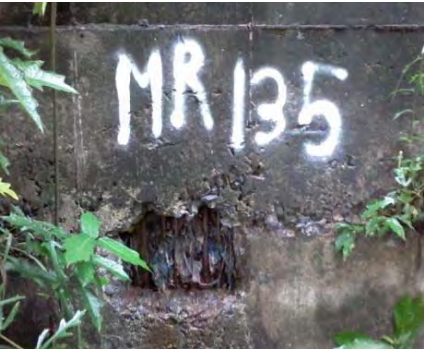
<p>Drainage Outlet No.= MR135A                      Northing= 1615066.791                      Easting= 509082.476                      Elevation= 15.821                      Dimension= H200mm W200mm                      Type= RC                      Date= 2019/10/26                      Station no.= 5+969</p>

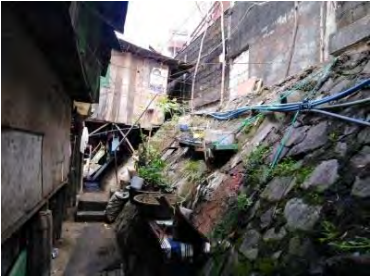
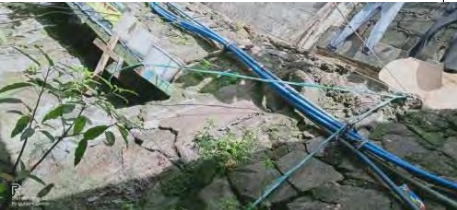
<p>Drainage Outlet No.= MR145                      Northing= 1615117.599                      Easting= 508976.764                      Elevation= 16.363                      Dimension= D260mm T50mm                      Type= RC                      Date= 2019/10/26                      Station no.= 5+861</p>

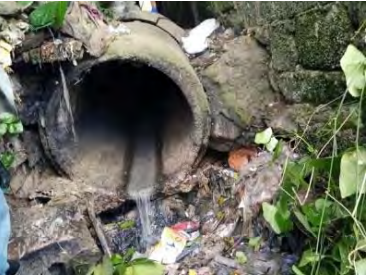
<p>Drainage Outlet No.= MR151C                      Northing= 1614891.907                      Easting= 508698.134                      Elevation= 11.326                      Dimension= D600mm T80mm                      Type= RC                      Date= 2019/10/25                      Station no.= 5+513</p>
<p>Photo (distant view)</p>

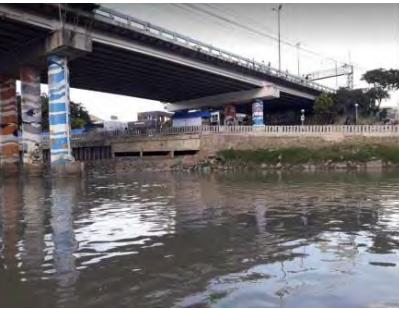
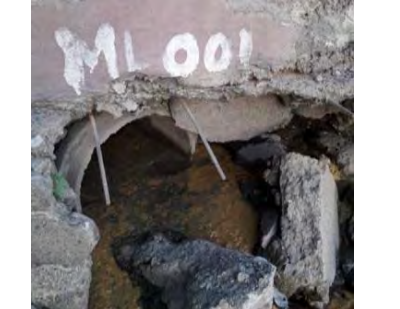
<p>Drainage Outlet No.= ML001                      Northing= 1618684.931                      Easting= 509912.44                      Elevation= 12.463                      Dimension= D450mm T50mm                      Type= RC                      Date= 2019/9/6                      Station no.= 13+340</p>	
<p>Photo (distant view)</p>

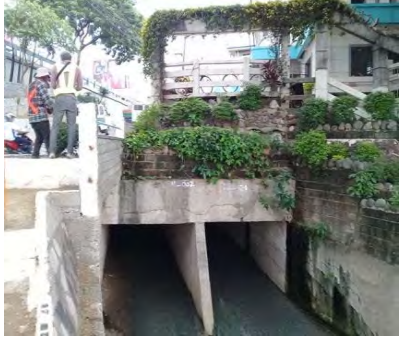
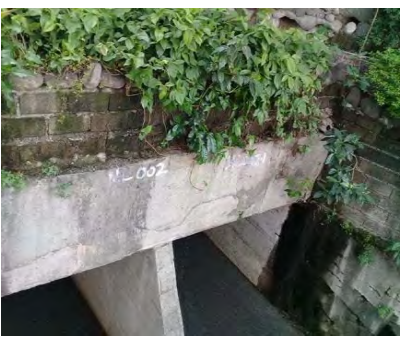
<p>Drainage Outlet No.= ML002                      Northing= 1618666.309                      Easting= 509949.276                      Elevation= 13.413                      Dimension= H2300mm W3100mm                      Type= BC                      Date= 2019/10/16                      Station no.= 13+315</p> <p>Drainage Outlet No.= ML002.1                      Northing= 1618663.583                      Easting= 509950.105                      Elevation= 13.399                      Dimension= H2300mm W3100mm                      Type= BC                      Date= 2019/10/16                      Station no.= 13+312</p>

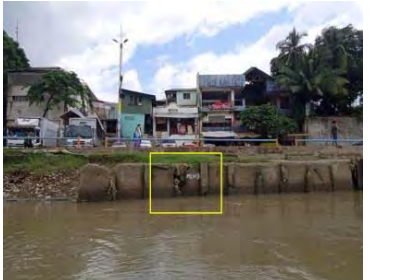
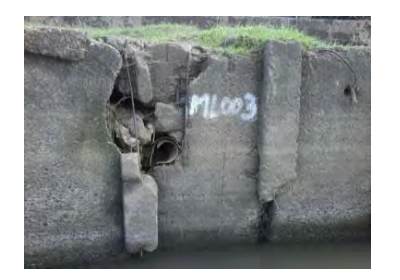
<p>Drainage Outlet No.= ML003                      Northing= 1618626.036                      Easting= 509923.704                      Elevation= 12.507                      Dimension= D180mm T100mm                      Type= PVC                      Date= 2019/10/16                      Station no.= 13+280</p>	
<p>Photo (distant view)</p>

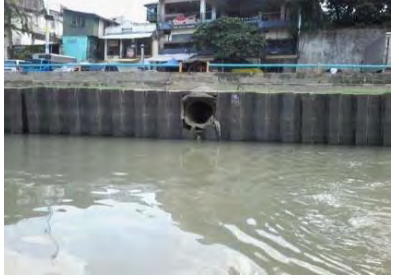
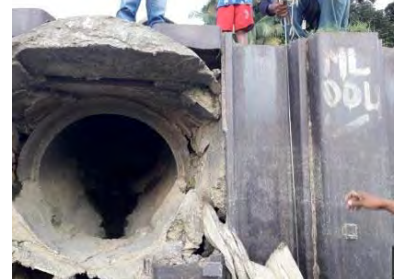
<p>Drainage Outlet No.= ML004                      Northing= 1618608.07                      Easting= 509926.963                      Elevation= 12.163                      Dimension= D900mm T100mm                      Type= RC                      Date= 2019/10/8                      Station no.= 13+261</p>	
<p>Photo (distant view)</p>

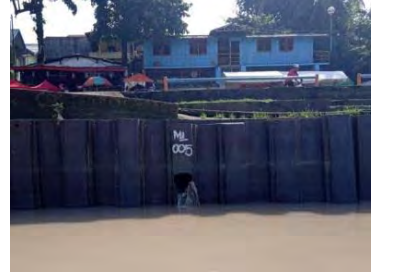
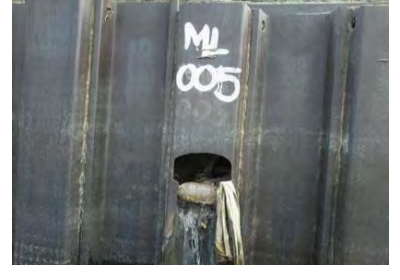
<p>Drainage Outlet No.= ML005                      Northing= 1618553.36                      Easting= 509935.943                      Elevation= 11.788                      Dimension= H1000mm W720mm T200mm                      Type= BC                      Date= 2019/9/28                      Station no.= 13+206</p>

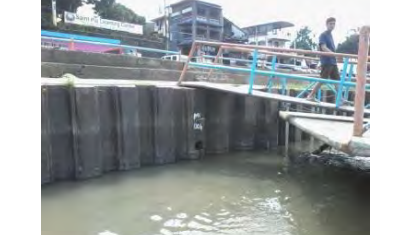
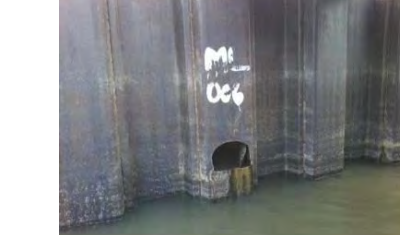
<p>Drainage Outlet No.= ML006                      Northing= 1618532.699                      Easting= 509938.925                      Elevation= 11.829                      Dimension= H180mm W250mm                      Type= BC                      Date= 2019/10/8                      Station no.= 13+185</p>

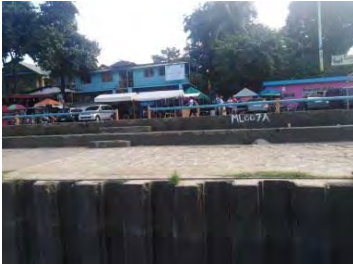
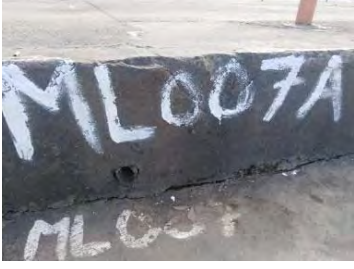
<p>Drainage Outlet No.= ML007A          Northing= 1618535.034          Easting= 509943.517          Elevation= 13.830          Dimension= D50mm T5mm          Type= PVC          Date= 2019/8/25          Station no.= 13+187</p>	<p>Remarks: Old outlet (ML007) has been cut down and the remaining portion has been surveyed.</p>
<p>Photo (distant view)</p>

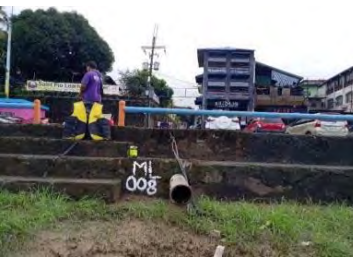
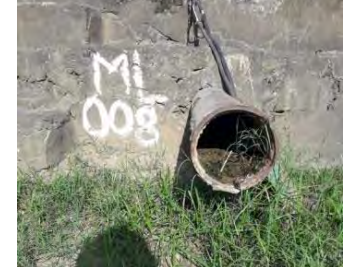
<p>Drainage Outlet No.= ML008          Northing= 1618507.370          Easting= 509946.135          Elevation= 13.473          Dimension= D150mm T10mm          Type= SP          Date= 2019/10/8          Station no.= 13+159</p>	
<p>Photo (distant view)</p>

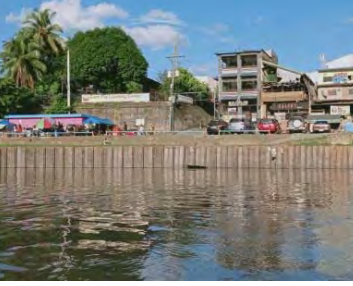
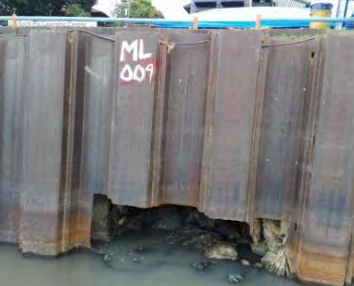
<p>Drainage Outlet No.= ML009          Northing= 1618499.037          Easting= 509944.855          Elevation= 11.599          Dimension= H1550mm W1500mm T150mm          Type= BC          Date= 2019/10/16          Station no.= 13+151</p>	<p>Remarks: The drainage was still underwater during the observation today so the dimensions were not confirmed. Photos of the dimension will be added as proof.</p>

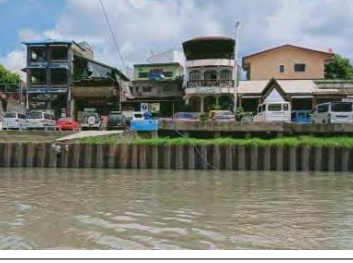
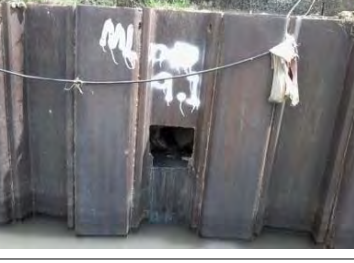
<p>Drainage Outlet No.= ML009.1          Northing= 1618493.160          Easting= 509945.886          Elevation= 12.011          Dimension= D250mm T50mm          Type= RC          Date= 2019/9/25          Station no.= 13+145</p>	<p>NEW OUTLET</p>
<p>Photo (distant view)</p>

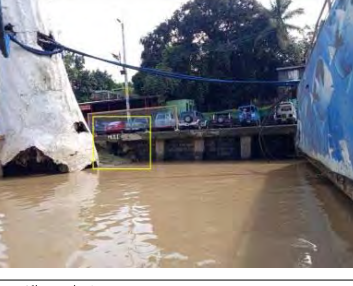
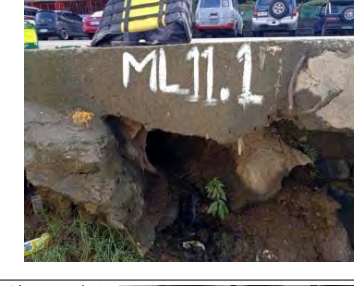
<p>Drainage Outlet No.= ML011.1          Northing= 1618422.518          Easting= 509970.920          Elevation= 13.525          Dimension= D450mm T50mm          Type= RC          Date= 2019/9/6          Station no.= 13+073</p>	<p>NEW OUTLET</p>
<p>Photo (distant view)</p>

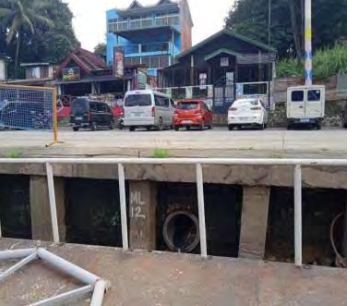
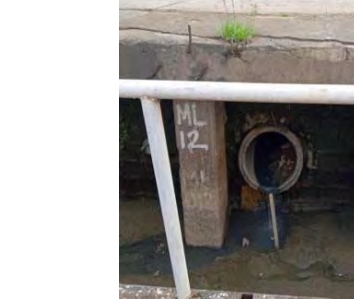
<p>Drainage Outlet No.= ML012          Northing= 1618387.516          Easting= 509976.771          Elevation= 13.155          Dimension= D600mm T80mm          Type= RC          Date= 2019/6/17          Station no.= 13+037</p>

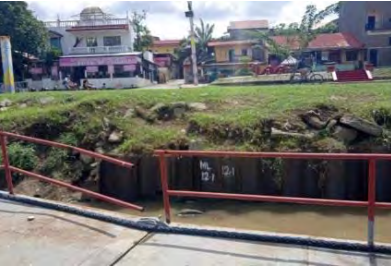
<p>Drainage Outlet No.= Northing= Easting= Elevation= Dimension= Type= Date= Station no.=</p>	<p>NEW OUTLET  ML012.1 1618338.351 509970.233 10.862 D700mm T70mm RC 2019/6/17 12+989</p>
<p>Photo (distant view)</p>

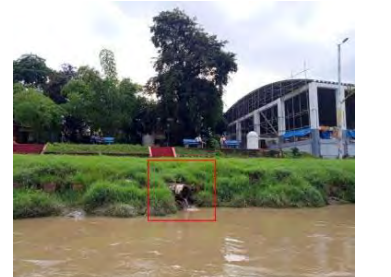
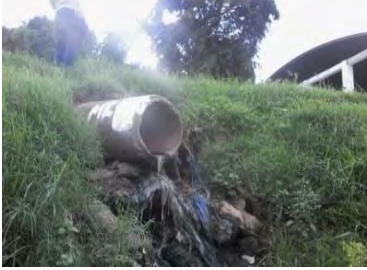
<p>Drainage Outlet No.= Northing= Easting= Elevation= Dimension= Type= Date= Station no.=</p>	<p>NEW OUTLET  ML012.2 1618291.53 509974.618 12.973 D400mm T50mm RC 2019/6/17 12+942</p>
<p>Photo (distant view)</p>

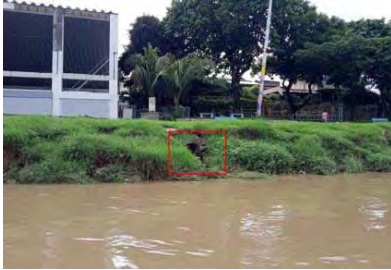
<p>Drainage Outlet No.= Northing= Easting= Elevation= Dimension= Type= Date= Station no.=</p>	<p>NEW OUTLET  ML012.201 1618227.750 509981.290 13.138 D490mm T60mm RC 2019/6/17 12+878</p>
<p>Photo (distant view)</p>

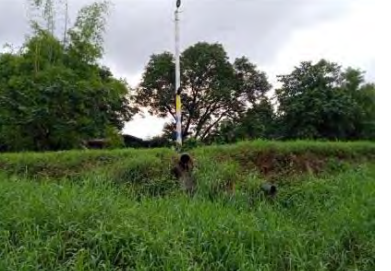
<p>Drainage Outlet No.= Northing= Easting= Elevation= Dimension= Type= Date= Station no.=</p>	<p>NEW OUTLET  ML012.3 1618173.373 509991.87 14.461 D200mm T40mm RC 2019/6/17 12+823</p>

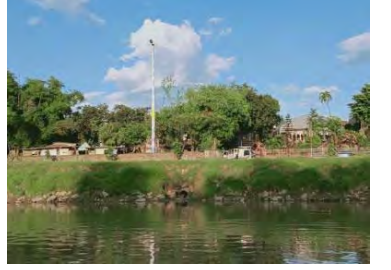
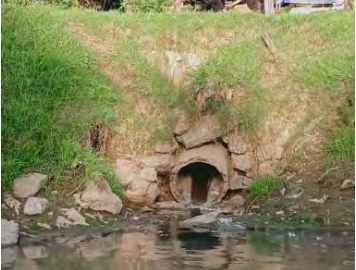
<p>Drainage Outlet No.= Northing= Easting= Elevation= Dimension= Type= Date= Station no.=</p>	<p>NEW OUTLET  ML013 1618114.509 509998.443 12.435 D900mm T50mm RC 2019/10/16 12+764</p>
<p>Photo (distant view)</p>

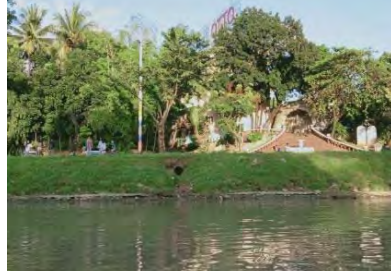
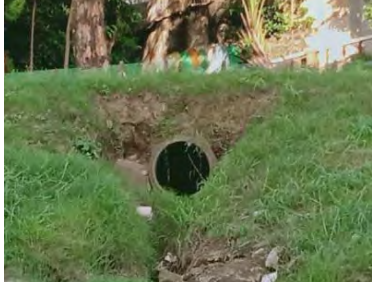
<p>Drainage Outlet No.= Northing= Easting= Elevation= Dimension= Type= Date= Station no.=</p>	<p>NEW OUTLET  ML015 1618019.477 510012.264 13.177 D600mm T80mm RC 2019/10/16 12+668</p>

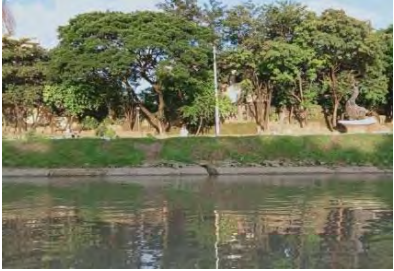
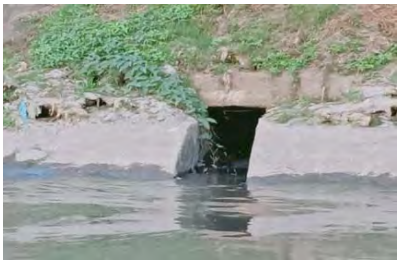
Drainage Outlet No.= Northing= Easting= Elevation= Dimension= Type= Date= Station no.=	ML016 1617923.490 510021.853 11.576 H630mm W750mm T200mm BC 2019/9/25 12+572  Remarks: There is an RC inside this drainage which is about 2 meters from the opening making it hard for measuring the dimension of the RC
Photo (distant view)

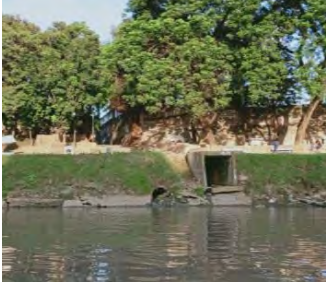
Drainage Outlet No.= Northing= Easting= Elevation= Dimension= Type= Date= Station no.=	ML017 1617891.291 510025.929 11.955 D920mm T10mm RC 2019/6/3 12+542
Photo (distant view)

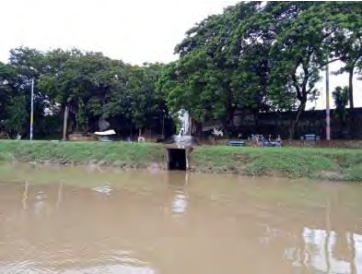
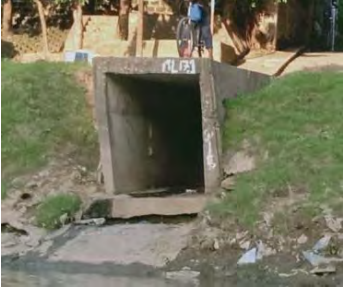
Drainage Outlet No.= Northing= Easting= Elevation= Dimension= Type= Date= Station no.=	NEW OUTLET ML017.1 1617887.885 510025.850 12.564 H2430mm W1950mm T1230mm BC 2019/6/3 12+539
Photo (distant view)

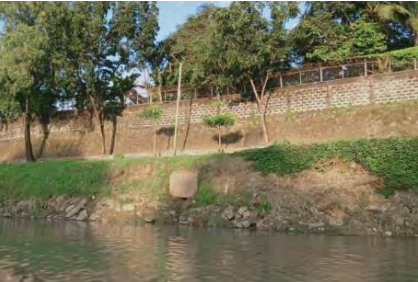
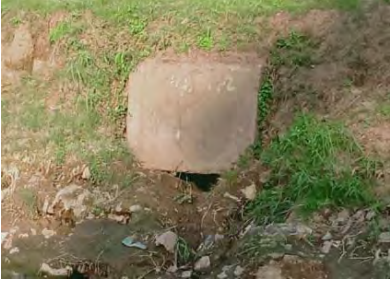
Drainage Outlet No.= Northing= Easting= Elevation= Dimension= Type= Date= Station no.=	NEW OUTLET ML017.2 1617733.464 510011.600 12.325 H450mm W550mm RC inside BC 2019/9/25 12+388  Remarks: RC inside cannot be measured because area is covered in soil.

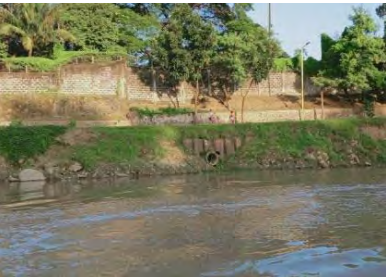
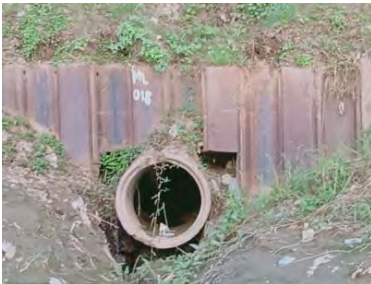
Drainage Outlet No.= Northing= Easting= Elevation= Dimension= Type= Date= Station no.=	ML018 1617710.141 510010.440 12.209 D800mm T80mm RC 2019/10/9 12+365
Photo (distant view)

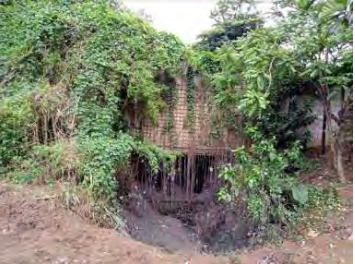
Drainage Outlet No.= Northing= Easting= Elevation= Dimension= Type= Date= Station no.=	ML019 1617588.389 510007.673 14.898 D1200mm T130mm RC 2019/10/9 12+251  Remarks Outlets ML19 and ML19.1 are not of the same/equal elevation as shown in the picture

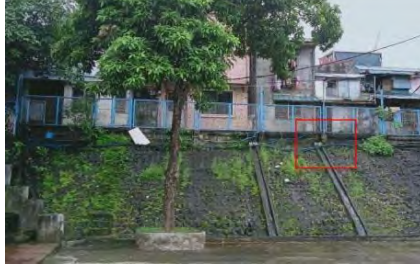
<p>Photo (short range view)</p>  	<p>Drainage Outlet No.= ML025                      Northing= 1617345.334                      Easting= 509826.147                      Elevation= 20.189                      Dimension= D80mm                      Type= PVC                      Date= 2019/6/13                      Station no.= 11+989</p>	<p>Remarks: PVC is damaged. Photos of the dimension will be added as proof.</p>
<p>Photo (distant view)</p>

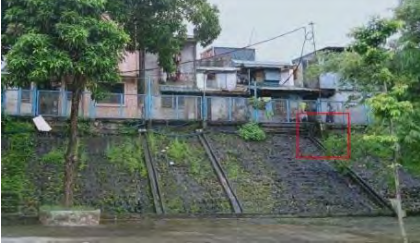
<p>Photo (short range view)</p>  	<p>Drainage Outlet No.= ML026                      Northing= 1617345.327                      Easting= 509819.814                      Elevation= 19.932                      Dimension= D120mm                      Type= PVC                      Date= 2019/6/13                      Station no.= 11+983</p>	<p>Remarks: PVC is damaged.</p>

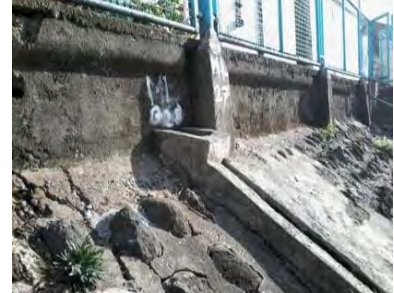
<p>Drainage Outlet No.= ML027                      Northing= 1617345.359                      Easting= 509809.984                      Elevation= 19.754                      Dimension= D180mm                      Type= PVC                      Date= 2019/10/9                      Station no.= 11+974</p>	<p>Remarks: PVC is damaged.</p>
<p>Photo (distant view)</p>  	<p>Photo (short range view)</p>  	<p>Drainage Outlet No.= ML028                      Northing= 1617345.232                      Easting= 509799.915                      Elevation= 19.628                      Dimension= D200mm                      Type= PVC                      Date= 2019/10/9                      Station no.= 11+968</p>	<p>Remarks: PVC is damaged.</p>
<p>Photo (distant view)</p>

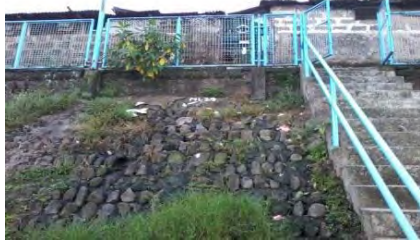
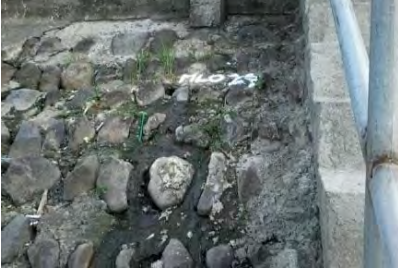
<p>Drainage Outlet No.= ML029A                      Northing= 1617345.580                      Easting= 509789.628                      Elevation= 19.275                      Dimension= D50mm                      Type= PVC                      Date= 2019/10/9                      Station no.= 11+959</p>	<p>Remarks: Old outlet ML029 was damaged because of the new constructed stairs. It was relocated to a new drainage located in the wall. The drainage type is hard to be determined since there is no outlet but it is PVC from before and water flows from the outlet.</p>

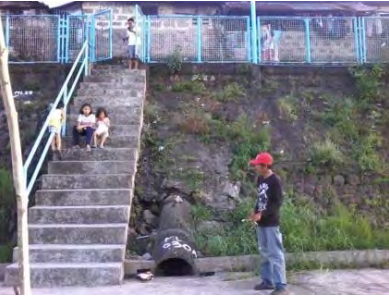
<p>Photo (short range view)</p>  	<p>Drainage Outlet No.= ML030A                      Northing= 1617349.876                      Easting= 509784.858                      Elevation= 15.437                      Dimension= D600mm T80mm                      Type= RC                      Date= 2019/10/9                      Station no.= 11+956</p>	<p>Remarks:                      Old outlet ML030 was extended for about 50 cm. The extended drainage was constructed and relocated adjacent to the stairs.</p>
<p>Photo (distant view)</p>  	<p>Photo (short range view)</p>  	<p>Drainage Outlet No.= ML031                      Northing= 1617344.936                      Easting= 509771.587                      Elevation= 20.092                      Dimension= D100mm                      Type= PVC                      Date= 2019/6/13                      Station no.= 11+945</p>	<p>Remarks:                      PVC is damaged.</p>
