表6.2.1 排水測量成果（右岸）（1/30）

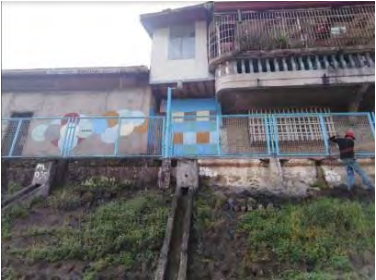
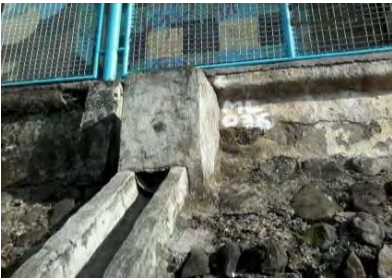
<p>Drainage Outlet No.=                      Northing=                      Easting=                      Elevation=                      Dimension=                      Type=                      Date=                      Station no.=</p>	<p>ML036                      1617343.892                      509727.978                      20.283                      D150mm T50mm                      RC                      2019/10/15                      11+906</p>
<p>Photo (distant view)</p>

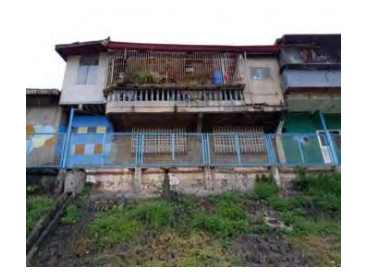
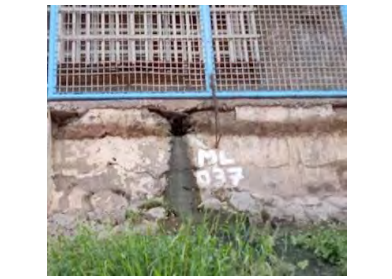
<p>Drainage Outlet No.=                      Northing=                      Easting=                      Elevation=                      Dimension=                      Type=                      Date=                      Station no.=</p>	<p>ML037                      1617343.779                      509724.343                      20.354                      D50mm                      PVC                      2019/10/9                      11+903</p>

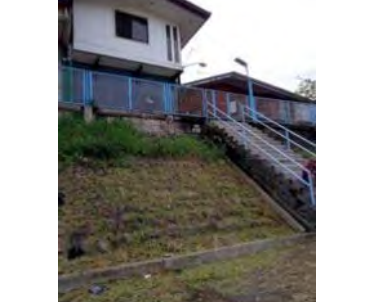
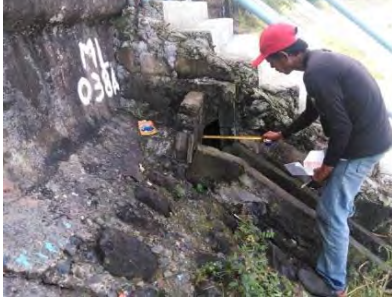
<p>Drainage Outlet No.=                      Northing=                      Easting=                      Elevation=                      Dimension=                      Type=                      Date=                      Station no.=</p>	<p>ML038A                      1617343.797                      509708.596                      19.258                      D120mm                      UD                      2019/10/15                      11+890</p> <p>Remarks:                      Old outlet ML.038 was destroyed because of the constructed stairs. It was then diverted to a new drainage adjacent to the stairs.</p>
<p>Photo (distant view)</p>

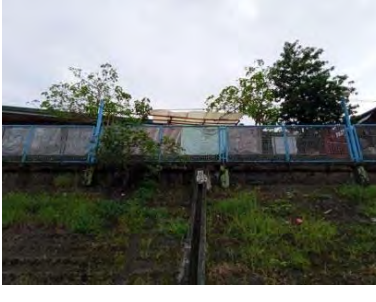
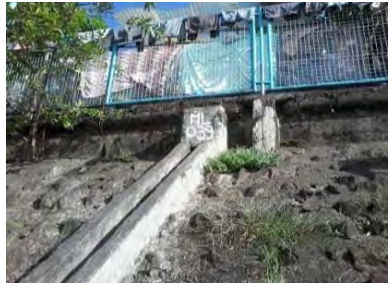
<p>Drainage Outlet No.=                      Northing=                      Easting=                      Elevation=                      Dimension=                      Type=                      Date=                      Station no.=</p>	<p>ML039                      1617343.252                      509693.412                      19.714                      D140mm                      PVC                      2019/6/13                      11+878</p> <p>Remarks:                      PVC is damaged.</p>

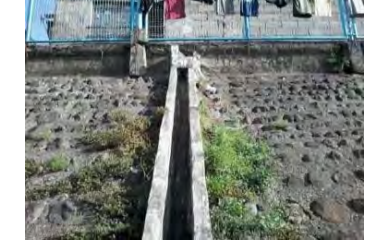
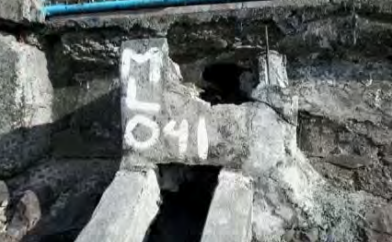
<p>Drainage Outlet No.=                      Northing=                      Easting=                      Elevation=                      Dimension=                      Type=                      Date=                      Station no.=</p>	<p>ML041                      1617343.212                      509679.002                      20.399                      D160mm                      PVC                      2019/10/15                      11+864</p> <p>Remarks:                      PVC is damaged.</p>

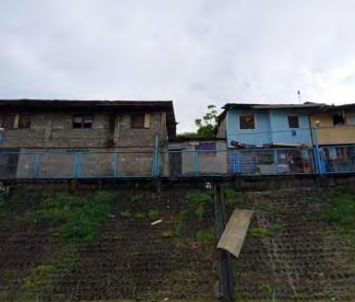
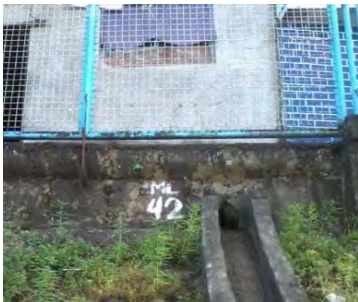
<p>Drainage Outlet No.= ML042                      Northing= 1617343.410                      Easting= 509668.165                      Elevation= 19.825                      Dimension= D100mm                      Type= PVC                      Date= 2019/6/13                      Station no.= 11+856</p> <p>Remarks: PVC is damaged.</p>	
<p>Photo (distant view)</p>

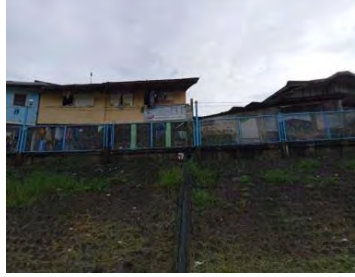
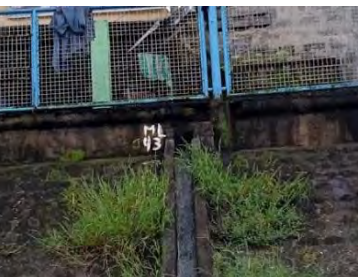
<p>Drainage Outlet No.= ML043                      Northing= 1617345.389                      Easting= 509654.465                      Elevation= 20.142                      Dimension= D130mm                      Type= PVC                      Date= 2019/10/15                      Station no.= 11+843</p> <p>Remarks: PVC is damaged.</p>	
<p>Photo (distant view)</p>

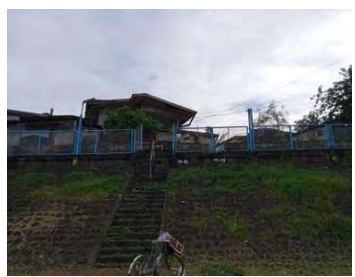
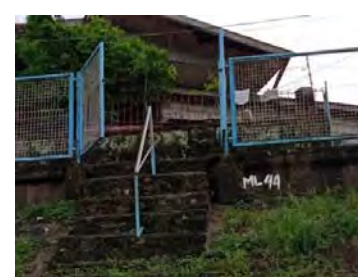
<p>Drainage Outlet No.= ML044                      Northing= 1617349.516                      Easting= 509640.776                      Elevation= 19.649                      Dimension= D130mm                      Type= PVC                      Date= 2019/6/13                      Station no.= 11+832</p> <p>Remarks: PVC is damaged.</p>

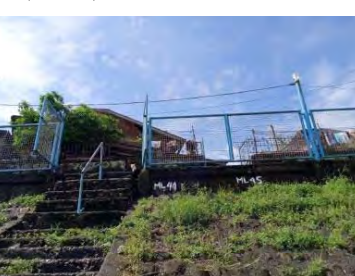
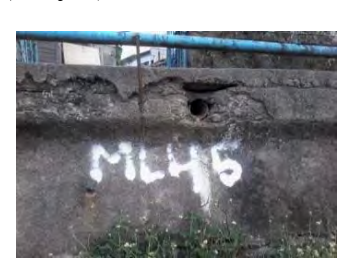
<p>Drainage Outlet No.= ML045                      Northing= 1617350.029                      Easting= 509638.466                      Elevation= 20.344                      Dimension= D80mm                      Type= PVC                      Date= 2019/10/10                      Station no.= 11+829</p> <p>Remarks: PVC is damaged.</p>	
<p>Photo (distant view)</p>

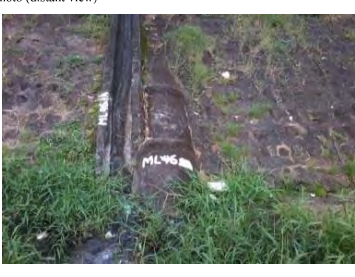
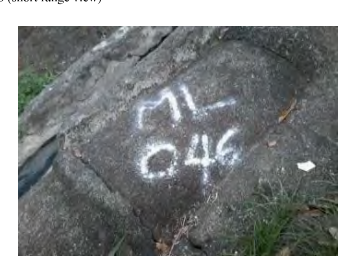
<p>Drainage Outlet No.= ML046                      Northing= 1617358.714                      Easting= 509633.207                      Elevation= 14.925                      Dimension= D800mm T100mm                      Type= RC                      Date= 2019/10/10                      Station no.= 11+822</p> <p>Remarks: Dimension cannot be measured properly because drainage is submerged. The dimension above are estimated measurements.</p>

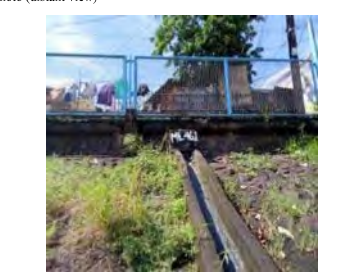
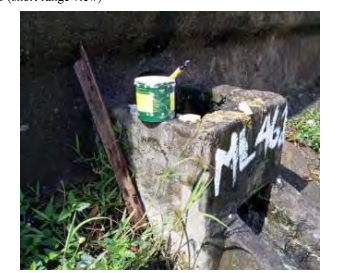
<p>Drainage Outlet No.= ML046.1                      Northing= 1617352.196                      Easting= 509631.931                      Elevation= 20.042                      Dimension= D150mm                      Type= PVC                      Date= 2019/9/20                      Station no.= 11+823</p>	<p>NEW OUTLET</p>

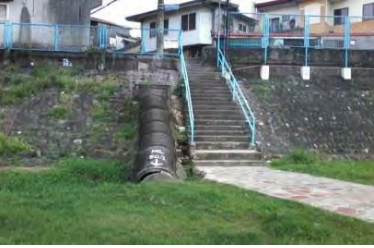
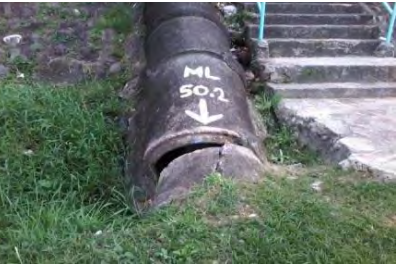
<p>Drainage Outlet No.=                      Northing=                      Easting=                      Elevation=                      Dimension=                      Type=                      Date=                      Station no.=                      Remarks:</p>	<p>NEW OUTLET                      ML050.2                      1617389.187                      509597.199                      12.726                      D800mm T100mm                      RC                      2019/9/20                      11+782                      The drainage is submerged into the land area so it is hard to measure the dimension. The dimension will be estimated from what is visible. 80 cm for the diameter and 10 cm for the thickness on both sides.</p>
<p>Photo (distant view)</p>

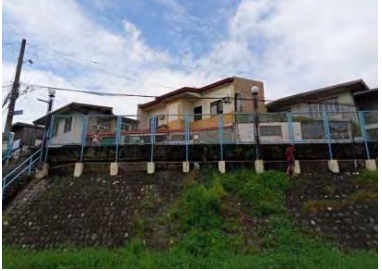
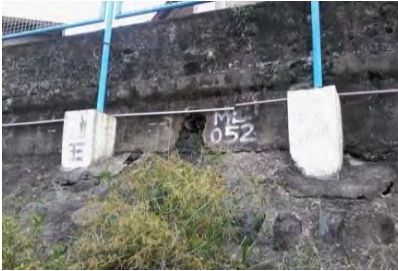
<p>Drainage Outlet No.=                      Northing=                      Easting=                      Elevation=                      Dimension=                      Type=                      Date=                      Station no.=</p>	<p>ML052                      1617373.851                      509576.291                      20.160                      D100mm                      PVC                      2019/10/10                      11+771</p>

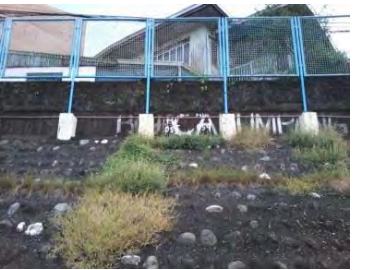
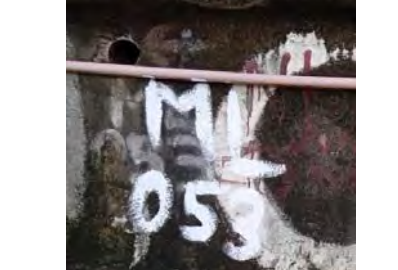
<p>Drainage Outlet No.=                      Northing=                      Easting=                      Elevation=                      Dimension=                      Type=                      Date=                      Station no.=                      Remarks:</p>	<p>ML053                      1617378.577                      509568.070                      20.384                      D90mm T10mm                      SP                      2019/10/10                      11+763</p>
<p>Photo (distant view)</p>

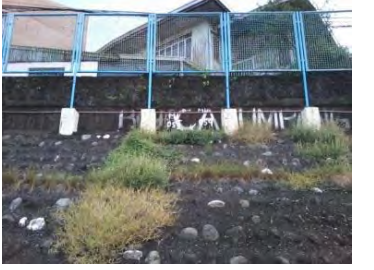
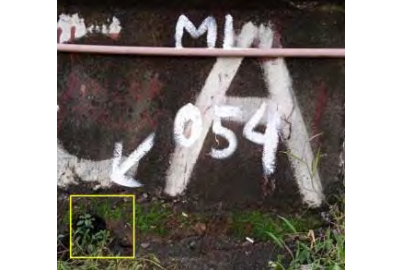
<p>Drainage Outlet No.=                      Northing=                      Easting=                      Elevation=                      Dimension=                      Type=                      Date=                      Station no.=</p>	<p>ML054                      1617378.872                      509567.672                      19.638                      D100mm                      PVC                      2019/9/20                      11+763</p>

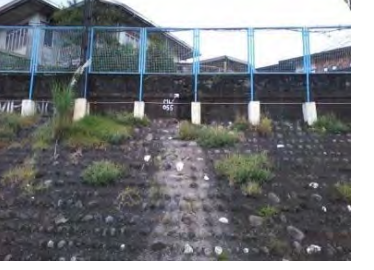
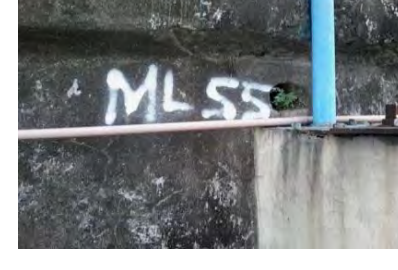
<p>Drainage Outlet No.=                      Northing=                      Easting=                      Elevation=                      Dimension=                      Type=                      Date=                      Station no.=</p>	<p>ML055                      1617383.212                      509560.159                      20.801                      D100mm                      PVC                      2019/6/13                      11+754</p>
<p>Photo (distant view)</p>

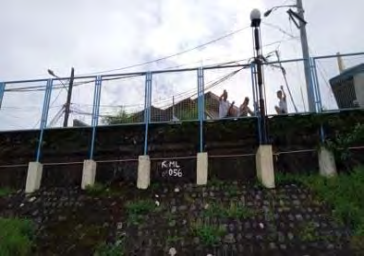
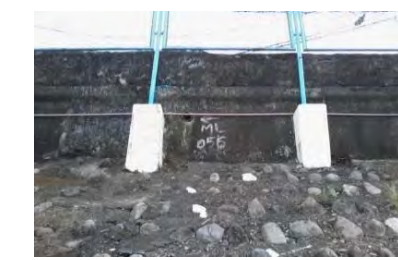
<p>Drainage Outlet No.=                      Northing=                      Easting=                      Elevation=                      Dimension=                      Type=                      Date=                      Station no.=</p>	<p>ML056                      1617392.829                      509546.334                      20.435                      D120mm T20mm                      SP                      2019/6/13                      11+741</p>

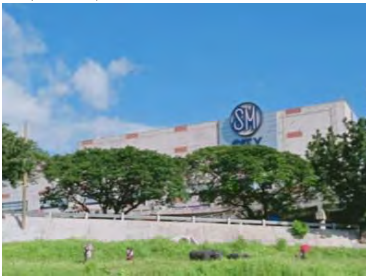
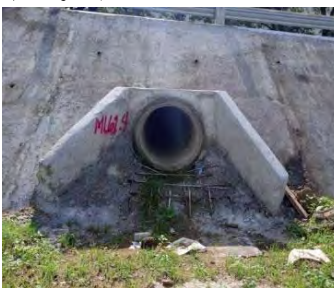
<p>Drainage Outlet No.=                      Northing=                      Easting=                      Elevation=                      Dimension=                      Type=                      Date=                      Station no.=</p>	<p>NEW OUTLET                      ML061.4                      1617708.694                      508779.481                      15.851                      D910mm T100mm                      RC                      2019/10/28                      10+405</p>
<p>Photo (distant view)</p>

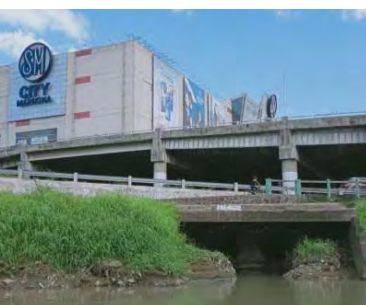
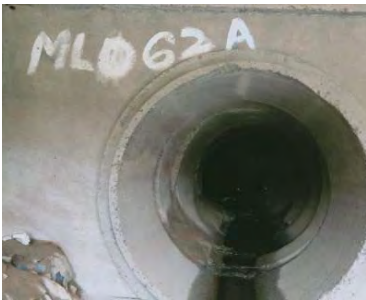
<p>Drainage Outlet No.=                      Northing=                      Easting=                      Elevation=                      Dimension=                      Type=                      Date=                      Station no.=</p>	<p>ML062A                      1617669.324                      508757.802                      11.867                      D1200mm T100mm                      RC                      2019/9/25                      10+361</p> <p>Remarks:                      Old outlet ML062 was a box culvert before and the drainage improvement resulted to three drainage outlets (ML062A, ML062.1B, ML062.2C) which were surveyed here.</p>

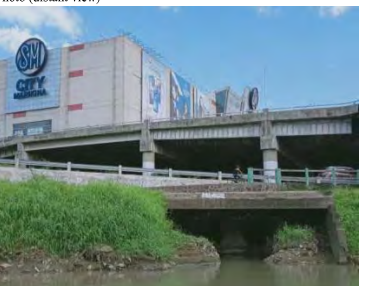
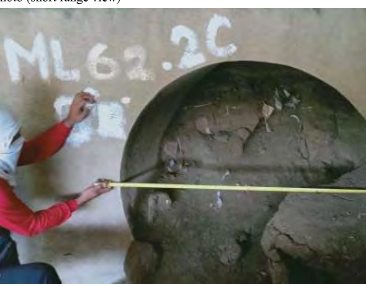
<p>Drainage Outlet No.=                      Northing=                      Easting=                      Elevation=                      Dimension=                      Type=                      Date=                      Station no.=</p>	<p>NEW OUTLET                      ML062.2C                      1617666.075                      508755.634                      11.895                      D1200mm T100mm                      RC                      2019/9/25                      10+358</p>

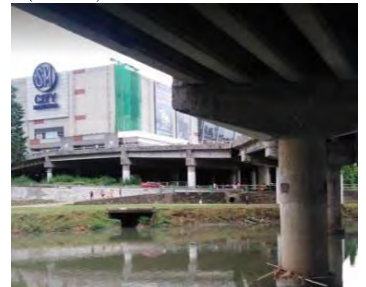
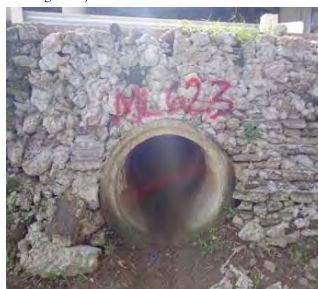
<p>Drainage Outlet No.=                      Northing=                      Easting=                      Elevation=                      Dimension=                      Type=                      Date=                      Station no.=</p>	<p>NEW OUTLET                      ML062.3D                      1617650.387                      508763.454                      13.976                      D1200mm T100mm                      RC                      2019/10/28                      10+345</p>
<p>Photo (distant view)</p>

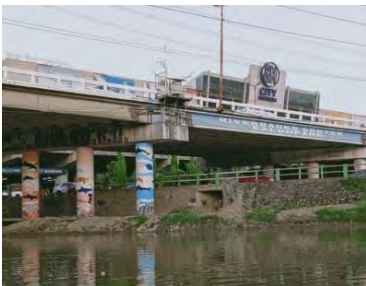
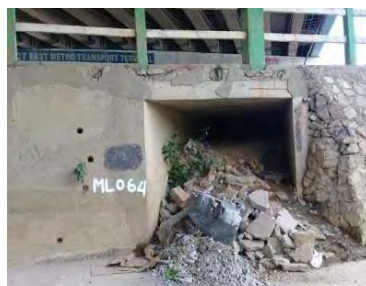
<p>Drainage Outlet No.=                      Northing=                      Easting=                      Elevation=                      Dimension=                      Type=                      Date=                      Station no.=</p>	<p>ML064                      1617601.725                      508749.523                      13.412                      H1640mm W2750mm                      T300mm (Top)                      BC                      2019/10/17                      10+292</p>

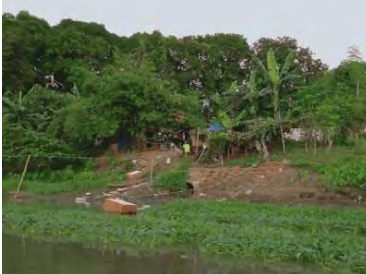
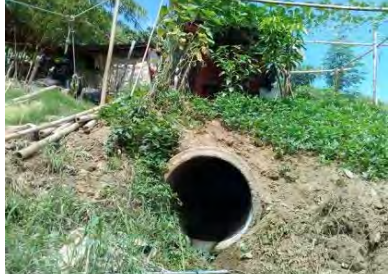
<p>Drainage Outlet No.= Northing= Easting= Elevation= Dimension= Type= Date= Station no.=</p>	<p>ML068.1 1616603.216 508367.068 11.660 D900mm T100mm RC 2019/10/12 9+177</p>
<p>Photo (distant view)</p>

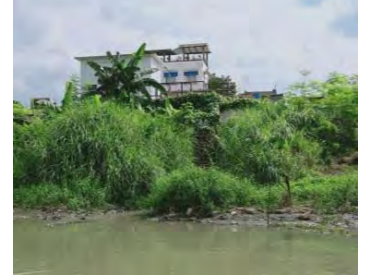
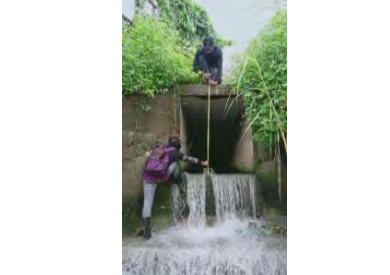
<p>Drainage Outlet No.= Northing= Easting= Elevation= Dimension= Type= Date= Station no.=</p>	<p>ML069 1616445.355 508349.732 13.127 H1440mm W1310mm T200mm BC 2019/10/12 9+002</p>
<p>Photo (distant view)</p>

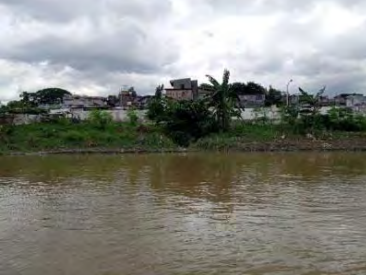
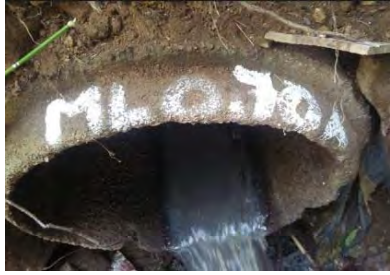
<p>Drainage Outlet No.= Northing= Easting= Elevation= Dimension= Type= Date= Station no.=</p>	<p>ML070A 1616313.703 508386.943 12.085 D600mm T80mm RC 2019/10/12 8+848</p> <p>Remarks Old outlet (ML070) was destroyed and was part of a road construction located along the centerline. A new drainage was relocated and constructed.</p>

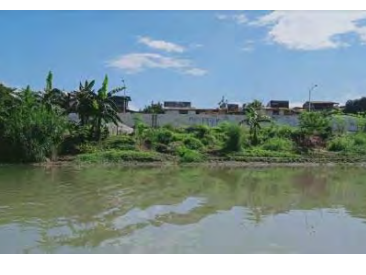
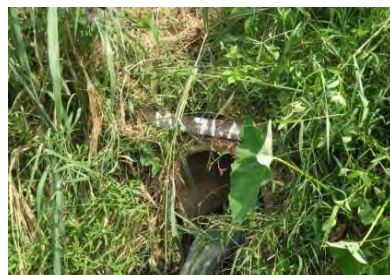
<p>Drainage Outlet No.= Northing= Easting= Elevation= Dimension= Type= Date= Station no.=</p>	<p>ML071A 1616263.343 508400.069 12.397 D600mm T80mm RC 2019/10/12 8+791</p> <p>Remarks Old outlet (ML071) was destroyed and was part of a road construction located along the centerline. A new drainage was relocated and constructed.</p>
<p>Photo (distant view)</p>

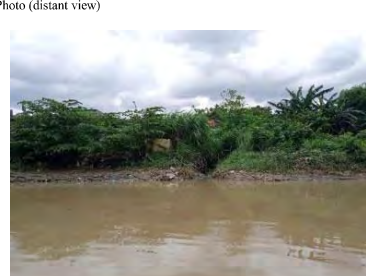
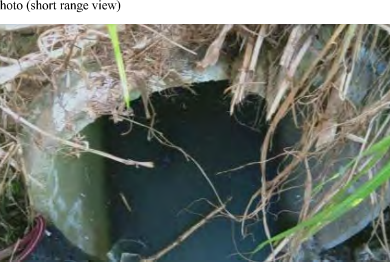
<p>Drainage Outlet No.= Northing= Easting= Elevation= Dimension= Type= Date= Station no.=</p>	<p>ML072A 1616137.448 508500.447 14.443 D900mm T100mm RC 2019/10/14 8+611</p> <p>Remarks Old outlet (ML072) was destroyed and was part of a road construction located along the centerline. A new drainage was relocated and constructed.</p>

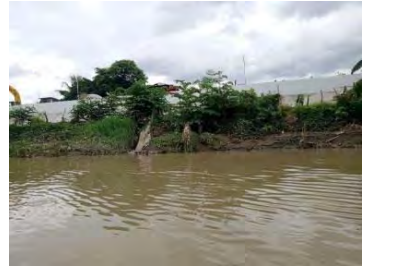
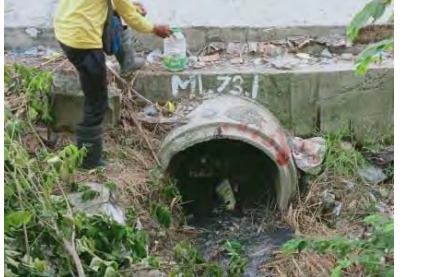
<p>Drainage Outlet No.=                      Northing=                      Easting=                      Elevation=                      Dimension=                      Type=                      Date=                      Station no.=</p>	<p>NEW OUTLET                      ML073.1                      1615977.314                      508705.867                      13.066                      D900mm T100mm                      RC                      2019/9/24                      8+341</p>

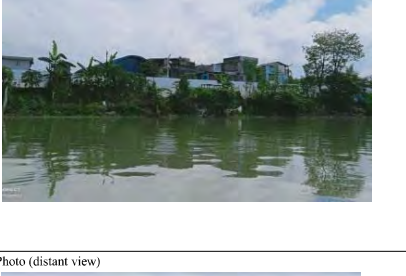
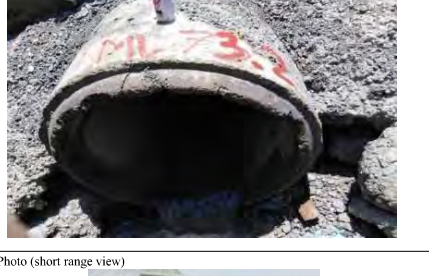
<p>Drainage Outlet No.=                      Northing=                      Easting=                      Elevation=                      Dimension=                      Type=                      Date=                      Station no.=</p>	<p>NEW OUTLET                      ML073.2                      1615918.695                      508781.463                      12.804                      D900mm T100mm                      RC                      2019/9/24                      8+245</p>
<p>Photo (distant view)</p>

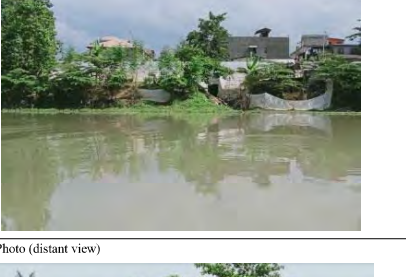
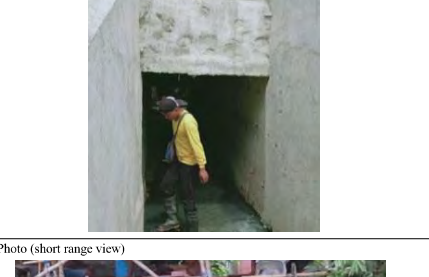
<p>Drainage Outlet No.=                      Northing=                      Easting=                      Elevation=                      Dimension=                      Type=                      Date=                      Station no.=</p>	<p>NEW OUTLET                      ML073.3                      1615854.395                      508869.071                      13.122                      H1810mm W1430mm                      BC                      2019/9/24                      8+137</p>

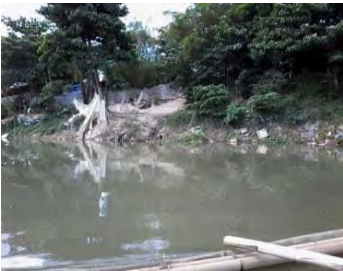
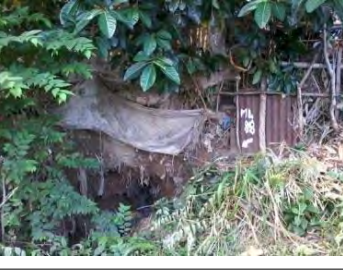
Photo (short range view)  	Drainage Outlet No.= Northing= Easting= Elevation= Dimension= Type= Date= Station no.=	NEW OUTLET  ML087.2 1615660.764 509110.377 10.808 H400mm W400mm BC 2019/7/17 7-827
Photo (distant view)

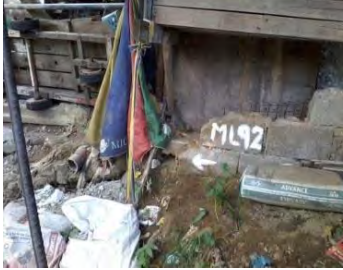
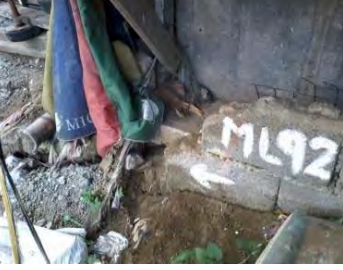
Drainage Outlet No.= Northing= Easting= Elevation= Dimension= Type= Date= Station no.=	ML092 1615647.895 509137.023 13.436 D100mm PVC 2019/7/17 7-798
Photo (distant view)

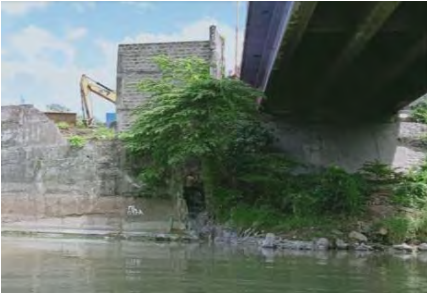
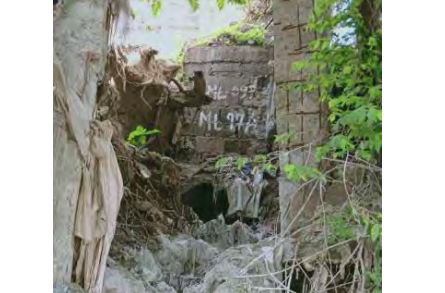
<p>Drainage Outlet No.=                  Northing=                  Easting=                  Elevation=                  Dimension=                  Type=                  Date=                  Station no.=</p>	<p>ML097A                  1615168.637                  509480.304                  12.511                  D770mm, T120mm                  RC                  2019/10/16                  7-216</p> <p>Remarks:                  Old outlet (ML097) has been cut down and the remaining portion has been surveyed.</p>
<p>Photo (distant view)</p>

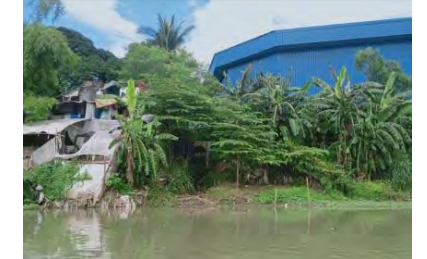
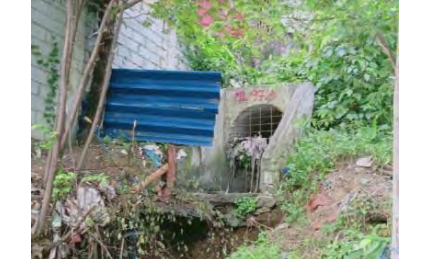
<p>Drainage Outlet No.=                  Northing=                  Easting=                  Elevation=                  Dimension=                  Type=                  Date=                  Station no.=</p>	<p>NEW OUTLET                  ML097.3                  1615564.777                  509252.930                  15.009                  D1180mm                  RC                  2019/10/14                  7-658</p>

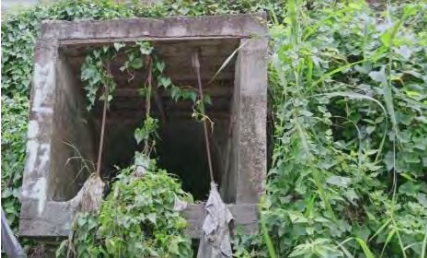
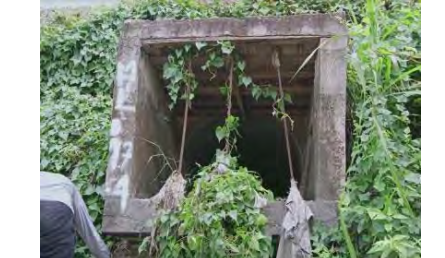
<p>Drainage Outlet No.=                  Northing=                  Easting=                  Elevation=                  Dimension=                  Type=                  Date=                  Station no.=</p>	<p>NEW OUTLET                  ML097.4                  1615335.585                  509390.223                  13.665                  D1200mm T50mm                  RC                  2019/8/15                  7-406</p>
<p>Photo (distant view)</p>

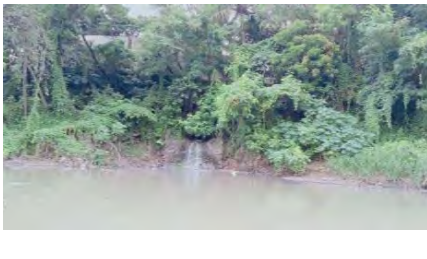
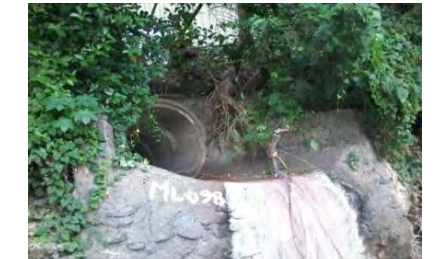
<p>Drainage Outlet No.=                  Northing=                  Easting=                  Elevation=                  Dimension=                  Type=                  Date=                  Station no.=</p>	<p>ML098                  1615139.331                  509507.087                  13.508                  D1520mm T160mm                  RC                  2019/8/30                  7-178</p>

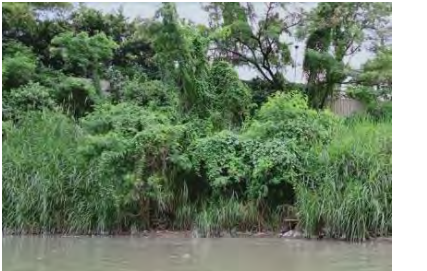
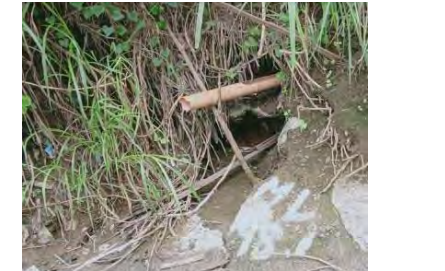
<p>Drainage Outlet No.=                  Northing=                  Easting=                  Elevation=                  Dimension=                  Type=                  Date=                  Station no.=</p>	<p>NEW OUTLET                  ML098.1                  1615036.696                  509562.793                  14.073                  D80mm T4mm                  PVC                  2019/7/19                  7-061</p> <p>Remarks                  During site visit, no RC was found behind or nearby this PVC.</p>
<p>Photo (distant view)</p>

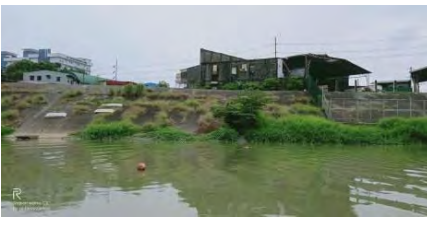
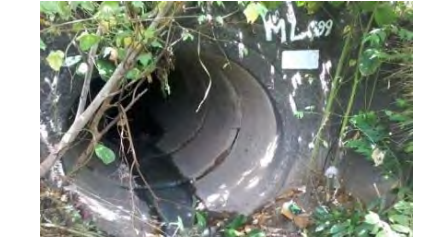
<p>Drainage Outlet No.=                  Northing=                  Easting=                  Elevation=                  Dimension=                  Type=                  Date=                  Station no.=</p>	<p>ML099                  1614709.381                  509646.645                  11.995                  D1840mm T170mm                  RC                  2019/10/12                  6-758</p>
