**Ex-Post Project Evaluation 2019:
Package I – 6 (Tanzania, Zambia)**

“The Project for Improvement of Rural Water Supply in Tabora Region”

External Evaluator: Hisae Takahashi, Ernst & Young ShinNihon LLC

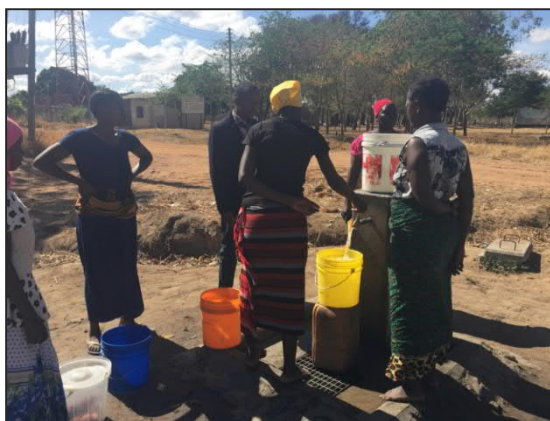
Piped Water Supply Scheme (Uyui District)

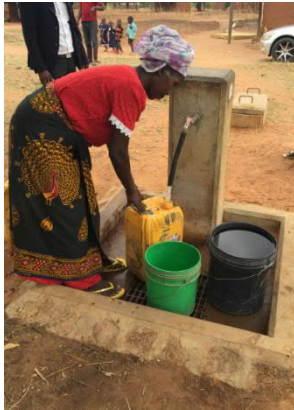
Level 2 water supply facility
(Tabora municipality)

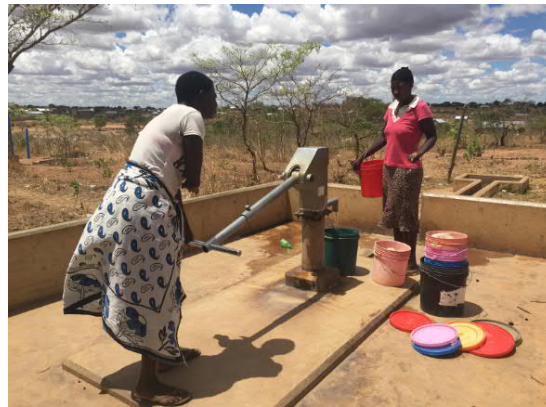
Level 1 water supply facility
(Sikonge district)

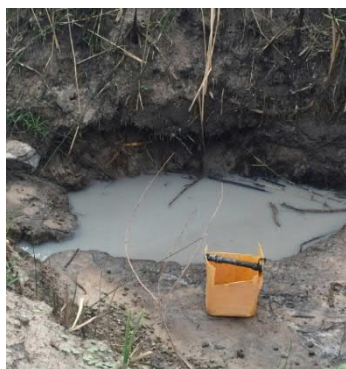
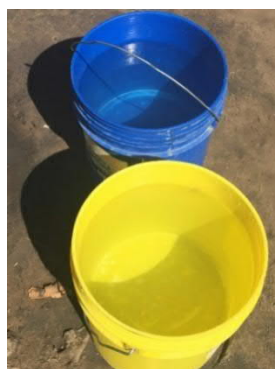
(Photo: Left)
Traditional water source

(Photo: Right)
Water from the water supply facility installed under this Project

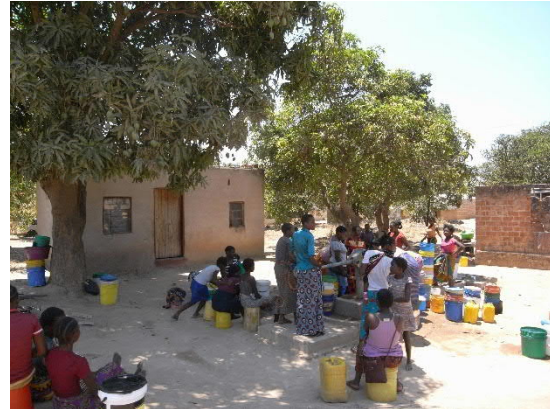
Photo 1. Many women and children gathering at a deep well in the morning to fetch water (Chabala Village, Mansa District)

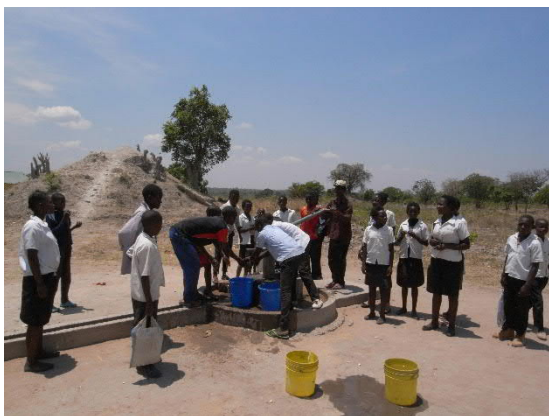
Photo 2. Deep wells with hand pumps installed at schools have contributed to improving learning opportunities and the study environment (Kafuula Community School, Mansa District)

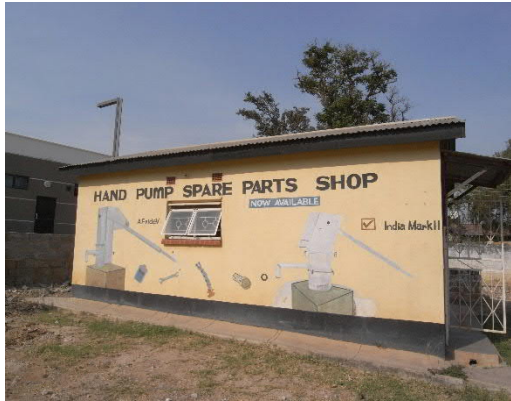
Photo 3. Spare parts shop constructed through the SOMAP 3 technical cooperation project
