Ex-Post Project Evaluation 2019 :
Package I-7 (Nicaragua)

“The Project for Construction of Paso Real Bridge” (hereinafter referred to as “the Project”) was implemented with the aim of achieving safe and smooth river-crossing traffic over Matagalpa River on National Route 21 by replacing the existing Paso Real Bridge (temporary bridge) located in Matagalpa Department of Nicaragua with a permanent one, thereby contributing to the facilitation of the smooth flow of goods. At the time of both planning and ex-post evaluation, the Project is highly consistent with the development policy/plan and development needs of Nicaragua. As the Project is also consistent with Japan’s assistance policy for Nicaragua at the time of appraisal, the relevance of the Project is high. The outputs of the Project are as planned with both the project cost and project period being within the planned ranges. Therefore, the efficiency of the Project is high. Since the implementation of the Project, there has been no traffic suspensions due to an increased river water level or other reasons at Paso Real Bridge, and the river-crossing time has been shortened. Moreover, the danger posed by over-loaded vehicles ab

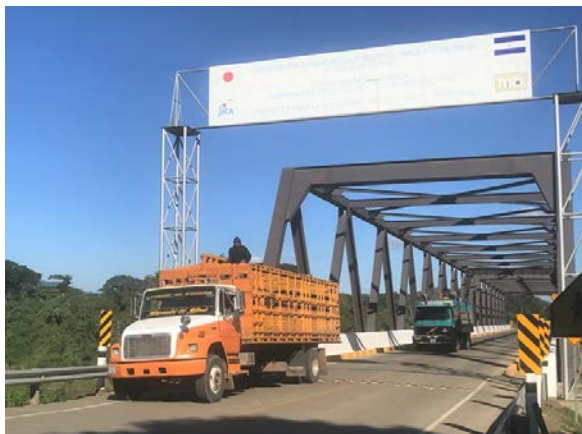
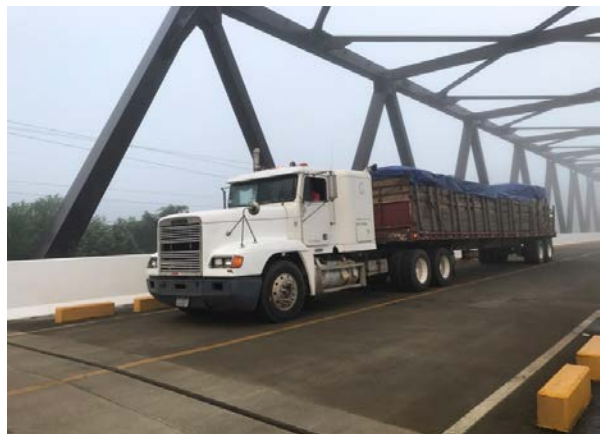
Trucks crossing the bridge (left: transporting cattle towards Managua; right: transporting building materials towards the Caribbean Sea)

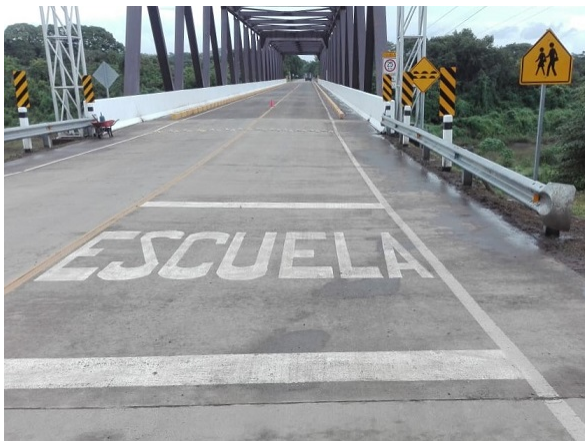
The existence of a primary school at the side of Paso Real Bridge makes the nearby road section, including the bridge, a school zone where the maximum speed is restricted to 25 km/hr. Because of this, the target average travelling speed across the bridge site was set at 25 km/hr at the time of planning and road signs and speed cushions were introduced. In Nicaragua, however, such speed limit for a school zone is routinely ignored and the actual average travelling speed exceeds 25 km/hr. According to local residents living near the bridge, no uniformed policeman is present most of the time. Based on the actual measurement results described above, it is concluded that most vehicles using Paso Real Bridge travel at a speed above the design speed.

Traffic sign for the school zone

- There is a need for the introduction of speed bump to ensure the safety of children using Paso Real Bridge to go to school and to reduce the number of speeding vehicles above the design speed limit of 40 km/hr under the Project. The preferable design of the speed bump is to achieve a sufficient deceleration effect even for large vehicles while limiting damage to passing vehicles (smooth surface of 2 – 3 m in width and 0.1 – 0.2 m in height). These zones should be painted yellow or black, etc. to ensure sufficient visibility. In view of the possibility of vehicles rapidly accelerating after passing the deceleration zone, the introduction of four such bumps is recommended, consisting of two bumps at two entry points of the bridge and on both access road at the some 70 – 100 m point from the bridge.

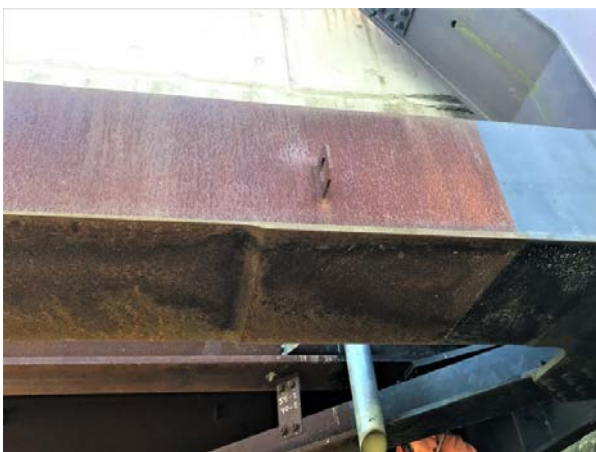
The access roads for Paso Real Bridge are concrete-paved roads and no advanced skills are required for their maintenance. The actual bridge section uses low alloy steels which are designed to form protective rust over the steel surface and this weather-resistant material can maintain its weather-resistant performance for a long time without anti-rust coating using organic solvent-based paint. Engineers of the MTI have basic knowledge of the maintenance of weather-resistant steel and no technical problems have occurred so far with the maintenance of the bridge section.

Weather-resistant steel (the right-hand side is painted for aesthetic purposes)

surface. Although a state of uneven rust is observed in some parts, the consultant for the Project has judged this to be normal based on photographs of the uneven rust. As such, this rust does not pose any problem.

- There is a need for MTI to enhance its technical competence for the inspection and maintenance of a bridge constructed with weather-resistant steel. The Rio Blanco-Siuna Bridges and National Road Construction Project (ODA loan project; 2017 –) which targets NR-21 plans the construction of bridges using weather-resistant steel. The organization of training on the inspection and maintenance of weather-resistant steel is recommended using the bridges constructed with such steel under the Project and the Project for Reconstruction of Bridges on Managua-El Rama Road (grant aid project; 2010 – 2013) as field training sites.

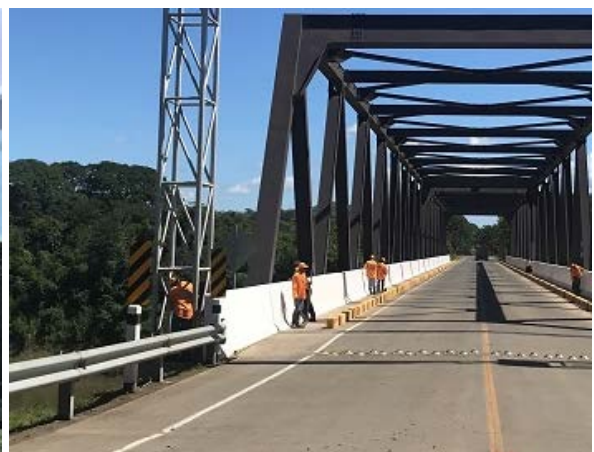
Regular maintenance work in progress

The on-site visit as part of the ex-post evaluation found that routine maintenance by the contractor outsourced by FOMAV appears to have been adequately conducted. Such work is conducted approximately once a month to control vegetation, clean the water distribution facility, clear rubbish, manage trees, clean traffic signs and the road surface. Based on the above, no special problems are observed regarding the operation and maintenance situation of the Project although the cracks on the surface of the access roads require urgent repair.

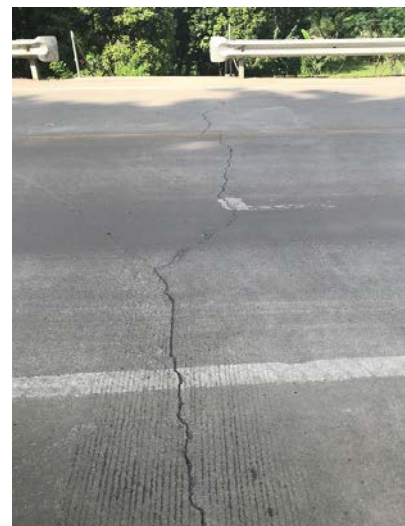
As part of the ex-post evaluation, the evaluator visited the project-related facilities together with an MTI engineer and found new cracks in more than 10 places on the concrete pavement of the access roads. Some of these had a surface opening of approximately 2 mm in width and more than 15 cm in depth, causing concern in regard to damage of the roadbed by infiltrating water. These cracks were previously found by the inspection conducted by the MTI in July, 2019 and the repair cost was estimated. MTI intends to finalize its response on receiving recommendations in the ex-post evaluation report. The cracks which were sealed by epoxy resin at the time of defect inspection show no special development. Meanwhile, the weather-resistant steels at the bridge section have developed protective rust on its

A crack on pavement

- There is a need for the urgent and appropriate repair of cracks on the pavements of the access roads for Paso Real Bridge. Moreover, the said pavements should be inspected approximately once

a year in the future and any new cracks should be quickly repaired to prevent any adverse impact on the roadbed.
