**Ex-Post Project Evaluation 2019: Package III - 7
(Indonesia)**

“The Project for Enhancement of Vessel Traffic System in Malacca and Singapore Straits”

“The Project for Enhancement of Vessel Traffic System in Malacca and Singapore Straits (Phase 2)”

External Evaluator: Masumi Shimamura, Mitsubishi UFJ Research and Consulting Co., Ltd.

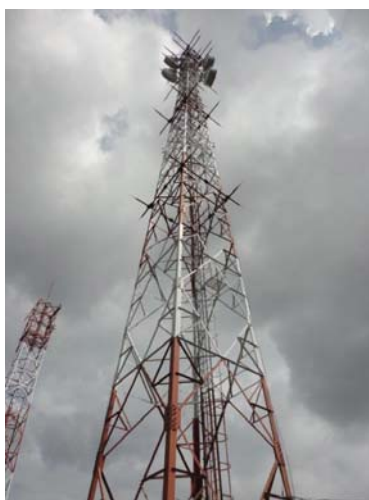
Radar Scanners and Multiple Transmission Parabolic Antennas at Dumai VTS Center

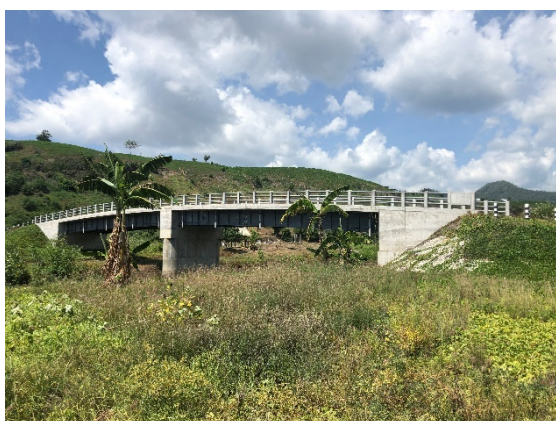
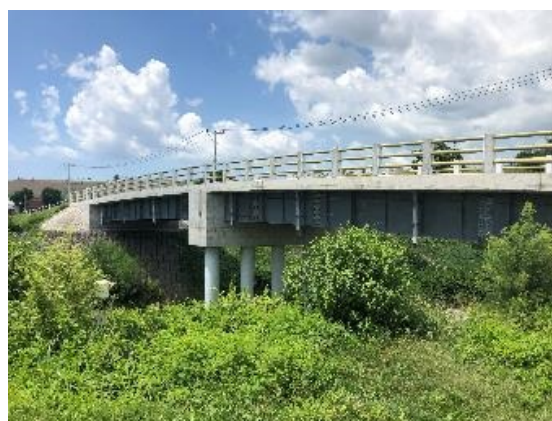
Project Bridges (Left: Lamar Bridge; Right: Emang Bridge)

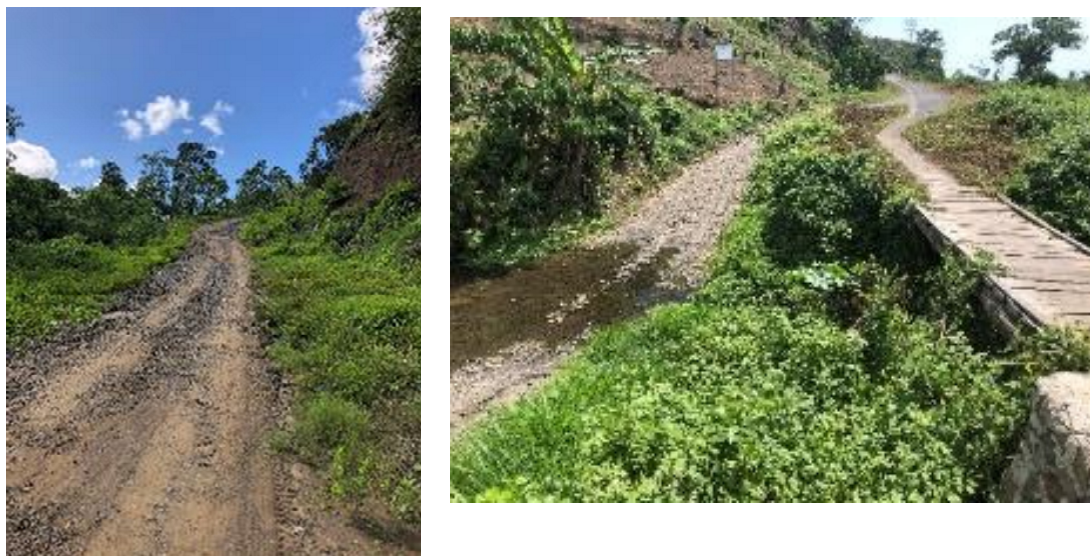
On the other hand, some of the construction works by the Indonesian side are yet to be completed at the time of the ex-post evaluation. During the field study, we have confirmed that the pavement of roads and construction of small bridges, which should be borne by NTB, have generally been completed, but there are still some unpaved roads and temporary bridges in the Phase II and III sectors. In detail, there are one unpaved section between Negene and Tatar Loka bridges in the Phase II sector and another unpaved section near the end of the Phase II sector (on the Tatar side), and two sites in the Phase II sectors and three sites in the Phase III sector where permanent small bridges are to be constructed. According to NTB, to complete a construction at these sites, tenders for the construction are to open in 2020 and the construction work is expected to be completed in 2022. With regard to land acquisition by Sumbawa Regency and West Sumbawa Regency, we have been unable to obtain direct

Unpaved Sector and Small Bridge Construction Site

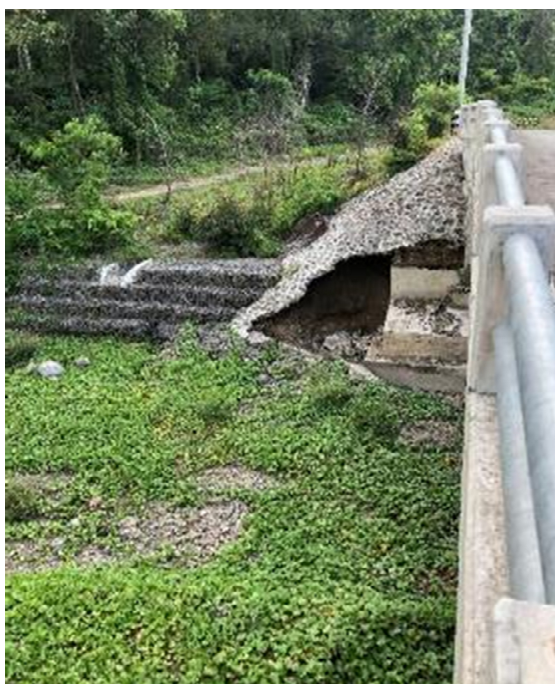
Through interviews with the Technical Road Planning Section, we have heard that no major problems had happened in the project bridges by the time of the ex-post evaluation, and accordingly, there were no plans to repair the bridges. In contrast, we have checked the condition of each project bridge through the field study and found abutment protections

collapsed and road surface deteriorated in some of the bridges. We then asked back the Technical Road Planning Section about these matters, and they answered that they had not been aware of the problems but would carry out repair works on the said bridges within the scope of the FY2020 budget. One of the reasons for their overlooking could be attributed to a lack of bridge inspection/assessment manual. The criteria for assessing the condition of bridges and the items to be inspected are not clearly defined, so even if a bridge was in a condition that an inspector should report as “repairs required,” it might have been overlooked by the inspector due to his/her subjective judgment. Additionally, inspection results are not necessarily recorded on paper or electronic media, suggesting there is a need for improving the way of information management. The Technical Road Planning Section is also aware of the need to develop the bridge inspection/assessment manual and seeks a support for establishing such manual.

Collapsed Abutment Protection (Mone I)

As for the maintenance of bridges, criteria for assessing conditions of the bridges and items to be inspected are not clearly defined and are largely left to the subjectivity of individual inspectors. As a result, bridges in a condition that the inspector should report as “repairs required” may be overlooked due to his/her subjective judgment. Therefore, NTB should establish a bridge inspection/assessment manual and have objective criteria for the assessment, and then conduct such inspections/assessments. It is also important to secure every year a budget for the maintenance of roads and bridges so as to ensure that the inspections and repairs are carried out steadily.

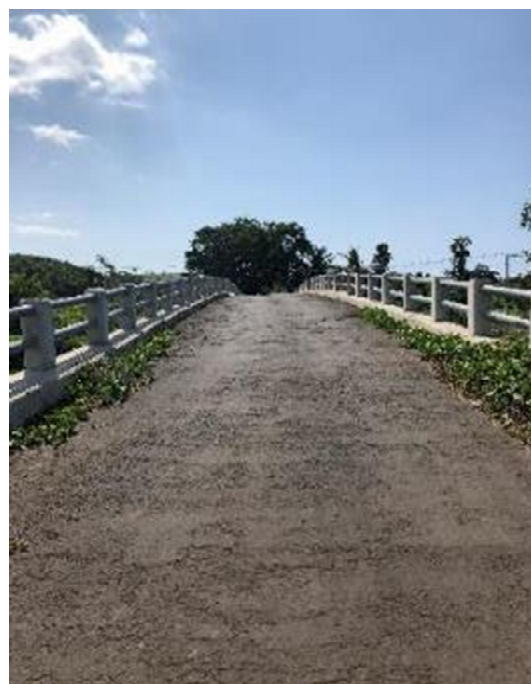
Deteriorated Road Surface (Telonang I)

project bridges by the time of the ex-post evaluation. The Implementation of Maintenance Section located in the Sumbawa Island cleans the bridges, briefly checks their conditions and reports to the Technical Road Planning Section if any problems are found. The frequency of inspection and cleaning was assumed to be once a year at the time of the project planning, so they are carried out as planned. On the other hand, repairs such as sealing of pavement cracks and patching of pavement pot holes were expected to be carried out twice a year at the time of the project planning, but they do not seem to be carried out as planned, judging from the deteriorated road surface of some bridges confirmed through the field study.
