**REPUBLIC OF ZIMBABWE
DATA COLLECTION SURVEY
ON
IRRIGATION AND AGRICULTURE
DEVELOPMENT**

FINAL REPORT

February 2022

**JAPAN INTERNATIONAL COOPERATION AGENCY (JICA)
SANYU CONSULTANTS INC.**

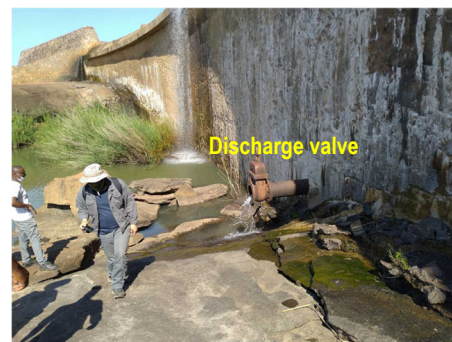
Figure 1.4.8 A Sample of Dams which Stored Water has not been Utilized

* Stored water has not been utilized since there are no irrigation facilities after a discharge valve.

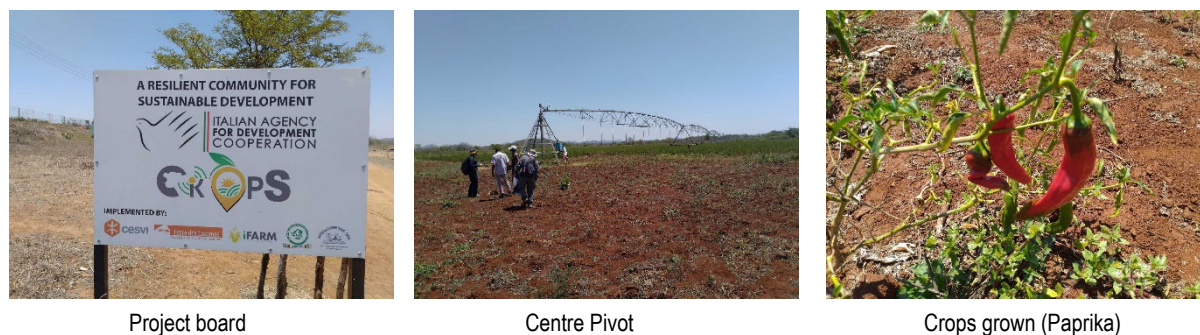
Figure 2.3.3 Situation of CESVI Project Site (Murove Irrigation Scheme)

Centre pivots have been installed in the Murove Irrigation Scheme, one of the CESVI project areas, where mainly sugar bean and paprika are grown. From the interviews with the beneficiary farmers, it is confirmed that 1) they have received guidance and manuals from CESVI on O&M of the centre pivot, but 2) they have only received verbal explanation on O&M of the pumps and canals. It is also confirmed that IMC has sold paprika two times but has not set aside any part of the proceeds as O&M expenses. The beneficiaries intend to start setting aside a portion of the proceeds from the next sale.

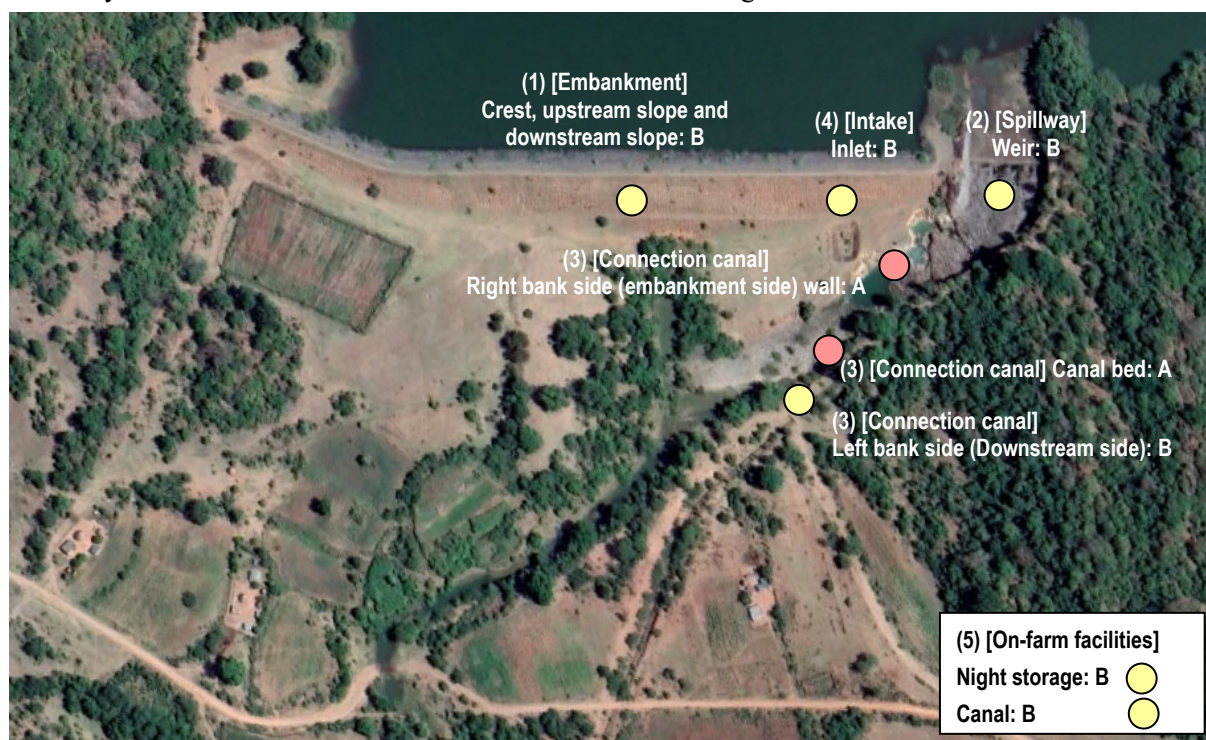
Figure 5.3.1 Locations of Deteriorations/Damages on Magudu Dam

The locations of deteriorations/damages found on Magudu Dam are shown in Figure 5.3.1, and the summary of the evaluation results of each deteriorations/damages are shown in Table 5.3.1

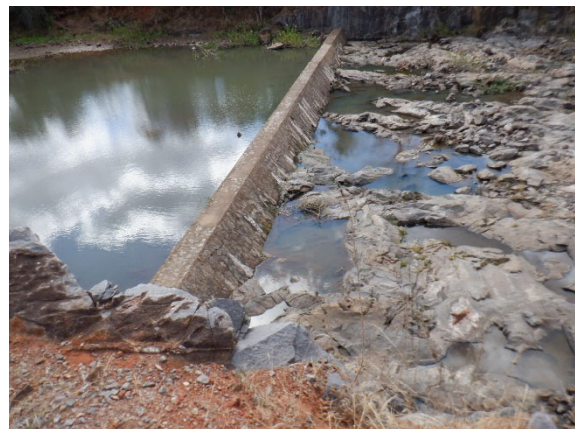
Figure 5.3.7 Panoramic View of Weir

The concrete peeling at crest of the weir may have been caused by deterioration of mortar concrete and removal of stone masonries by flood.

As for the peeling at the edge of downstream slope, its factors may be 1) Washing away of the rocks around the edge by flood, and 2) disposure and damage of the edge of slope.

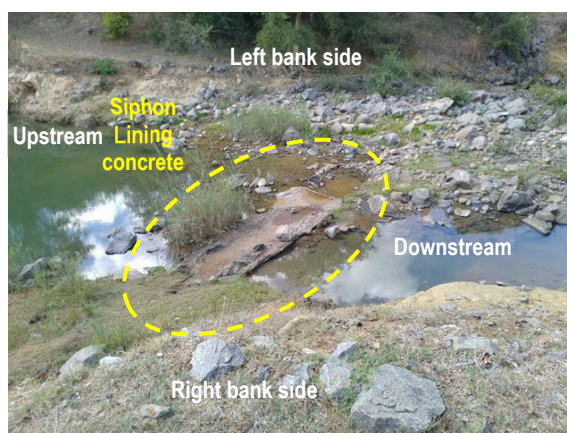
The bridge point is located just downstream of the section where the canal slope changes from steep to gentle, which is a point where flow is disturbed. Additionally, geological feature of left bank side is sandy and relatively soft compared to the scattered rocks on the right side. And therefore, the erosion caused by the flood might concentrate on the left side after the bridge was washed away.

Figure 5.3.11 Exposure of Siphon Lining Concrete

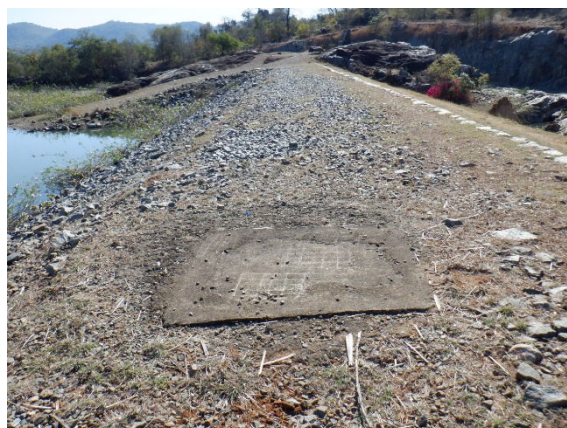
Figure 5.3.14 Disappearance of the Intake Gate Operation Facilities

[Inlet] Disappearance of the gate operation facilities (see Figure 5.3.14)

All of the intake gate operation facilities (wires and wire winches) are disappeared. They may have been removed due to time-related deterioration or stolen. The intake gate is open at all times and water can be taken.

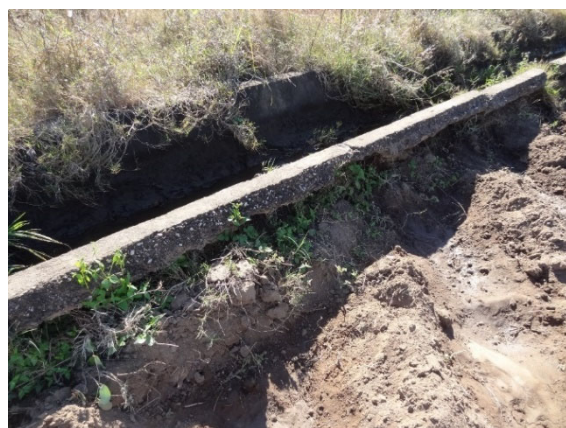
Figure 5.3.16 Spilling Out of Canal Back Side Soil

[Canal] Spilling out of back side soil (see Figure 5.3.16)

When the construction was completed, the elevation of the top of canal wall and farmland surface may have been same, however the back side soil may have spilled out due to the tillage near the canal.

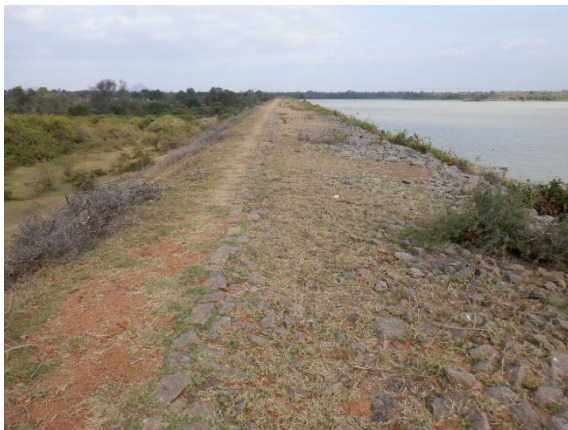
Originally, the downstream slope might be covered with grass. However, it might disappear due to eating and trampling by livestock, and caused the dam body exposure. Finally, gully erosion might occur due to years of rainfall. The depth of erosion is about 20 cm.

Figure 5.3.22 Disturbance of Riprap, Dam Body Exposure, and Erosion (Crest and Upstream Slope)

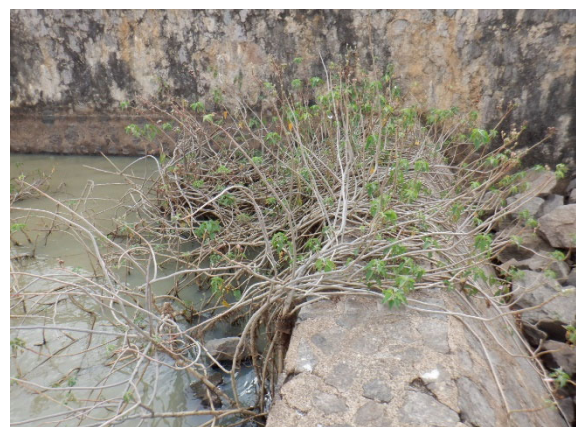
Figure 5.3.27 Plants on the Left Side

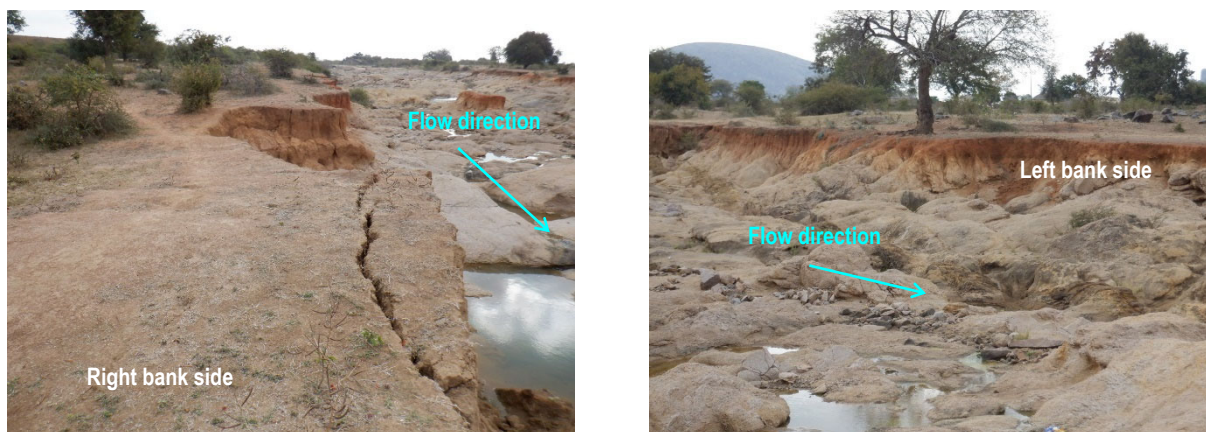
While, there are no houses or other structures in the surrounding area which would be affected by the progress of the collapse.

Figure 5.3.28 Collapse of Side Walls on Both Bank Sides

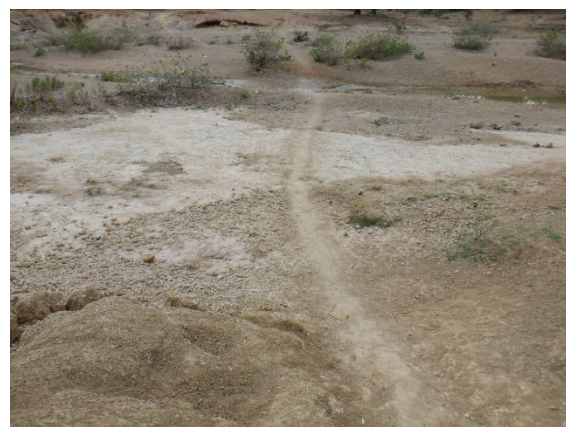
Figure 5.3.29 Crossing Road

[Other] Crossing road across canal (see Figure 5.3.29)

The reason why people pass the canal may be that there are no bridges that can safely cross the canal.

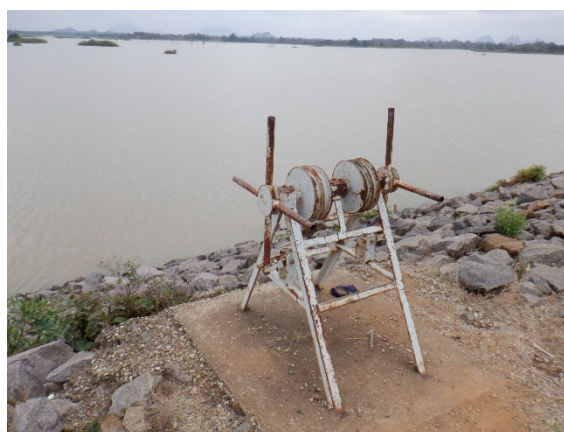
Figure 5.3.30 Winch for Intake Gate Operation

[Inlet] Rusting all over (see Figure 5.3.30)

This may be due to the insufficient maintenance after the wire disappeared.

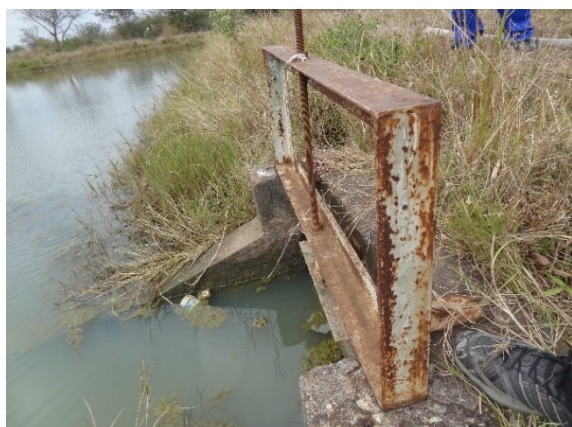
A sluice valve was added in front of original sluice valve by IMC in 2020, and the sluice valve on the rear side is the original one installed 30 years ago and discharge volume cannot be controlled. The front side sluice valve has some leakage and missing parts, however, it may have been left unsolved because there is almost no water leakage.

Figure 5.3.31 Broken of the Discharge Gate

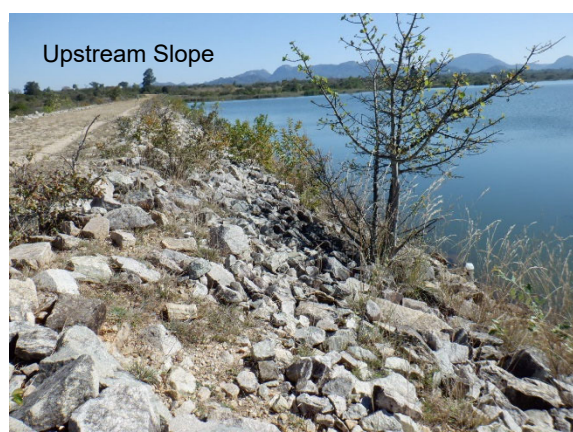
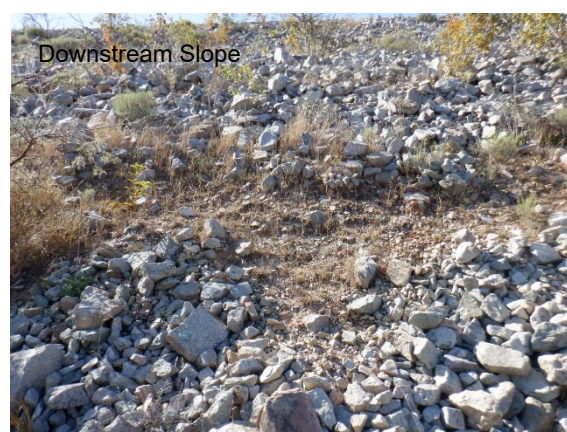
Under the riprap, there may be erosion due to rainfall, and the eroded portions are filled with riprap materials. In addition, the disturbance of the riprap and dam body exposure may be caused by the intrusion of people and livestock. Further, the overgrowth of plants implies the insufficient regular maintenance.

Figure 5.3.38 Upstream and Downstream Slope

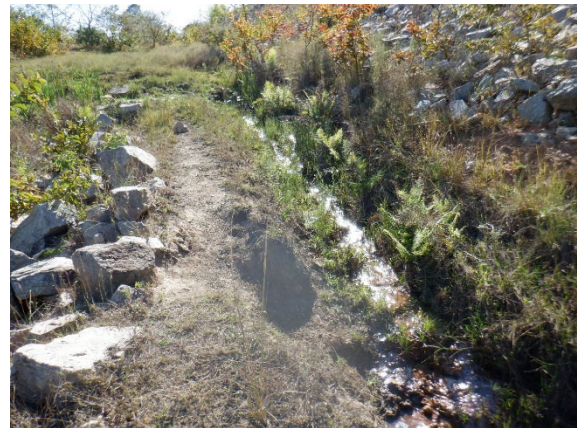
Seepage is observed at the edge of downstream slope. Since there is no wetness on the slope surface, The seepage water may come out from the boundary between the abutment and the natural ground.

Figure 5.3.39 Downstream Slope Edge of the Right Side Abutment

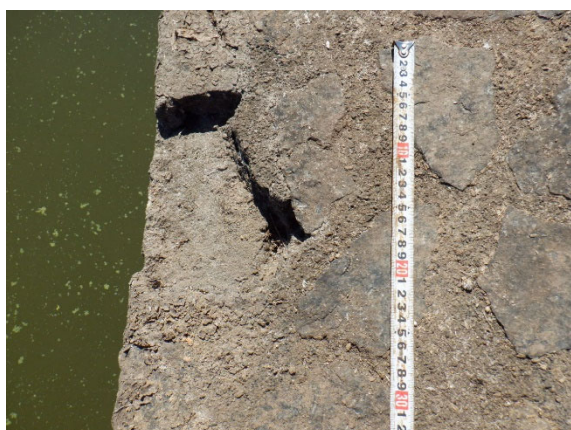
Figure 5.3.41 Slight Damage on the Crest

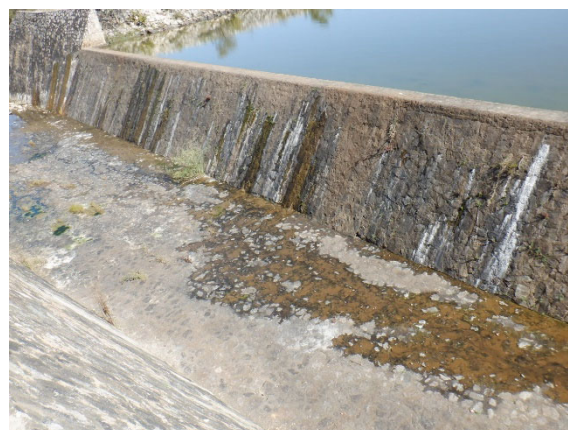
Figure 5.3.42 Leakage from Downstream Slope

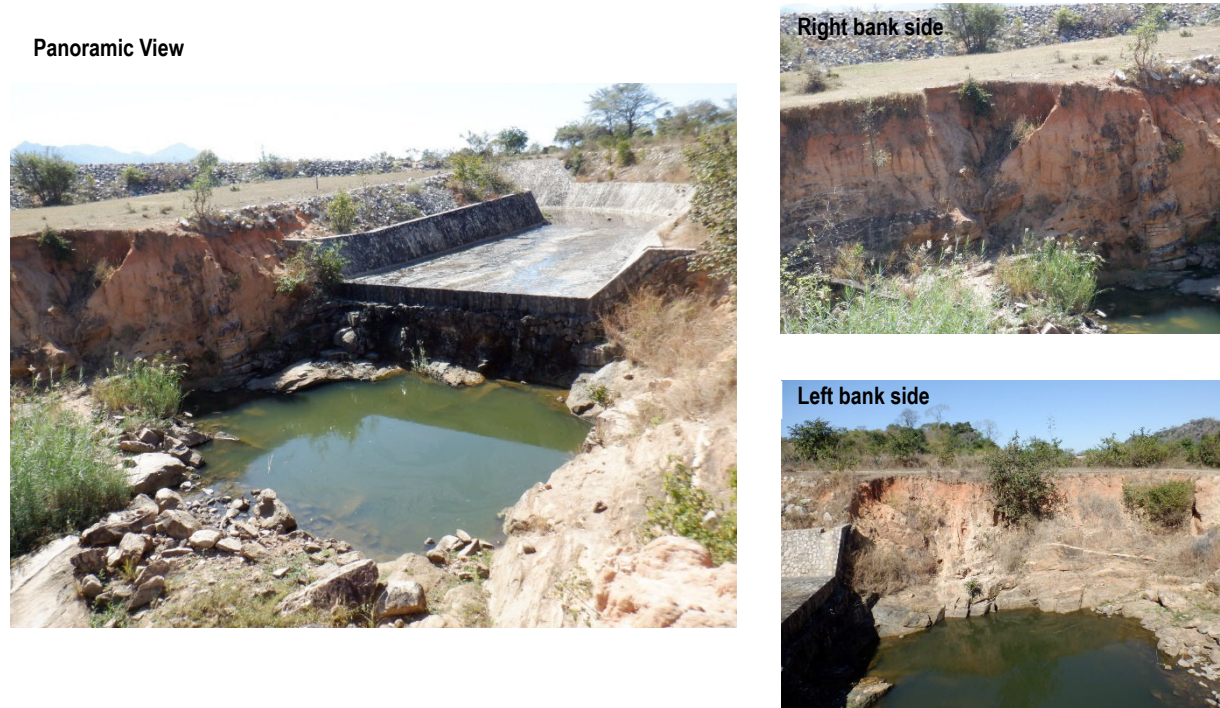
There is no basket mat work at the end of the spillway channel, and it is formed like a drop-off. During the floods, disturbance of the flow may occur at this drop-off, eroded both bank sides walls and caused the collapse.

Figure 5.3.43 Collapse of Side Walls on Both Bank Sides at the End of the Spillway Channel

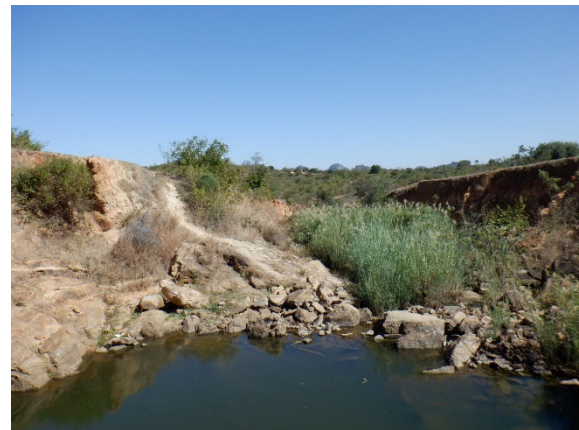
The reason why people pass the canal may be that there are no bridges that can safely cross the canal.

Figure 5.3.44 Crossing Road

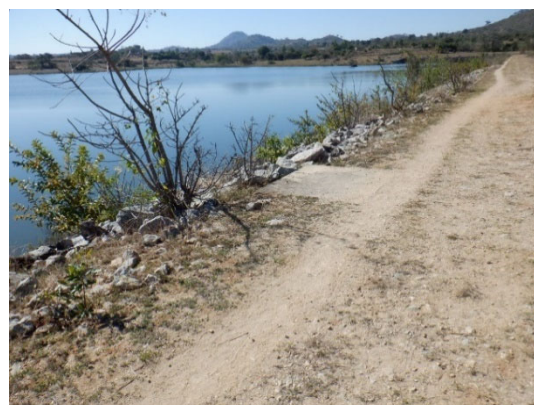
Figure 5.3.45 Disappearance of the Intake Gate Operation Facilities

[Inlet] Disappearance of the gate operation facilities
(see Figure 5.3.45)

All of the intake gate operation facilities (wires and wire winches) are disappeared. They may have been removed due to time-related deterioration or stolen. The intake gate is open at all times and water can be taken.

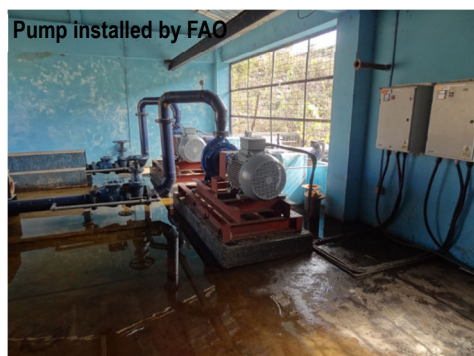
Figure 5.3.46 Situation of Pumps

[Pump] Insufficient supply volume

The pumps installed by FAO were not in operation at the start of this Survey, but it was confirmed to be in operation by replacing the breaker. Although the pump became operational, the electricity current value of the pumps was less than the planned one and the pump was not able to deliver the planned flow. The reason why the planned electricity current flow is not achieved is that the transformer is located about 500m away from the pump facility, and the required current volume cannot be supplied due to transmission loss. Although the planned flow rate has not been achieved to the planned one, it has been possible to fill the night storage by taking 1.5 times longer than planned.

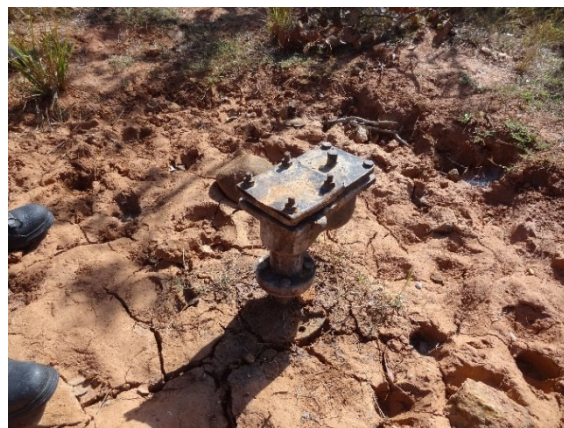
Figure 5.3.47 Mark of Water Leakage from Air Valve

[Air valve] Small amount of water leakage (see Figure 5.3.47)

The condition of the air valves was confirmed by FAO in 2018, but this leakage may happen due to initial failure, use of low quality parts, and low assembly accuracy.

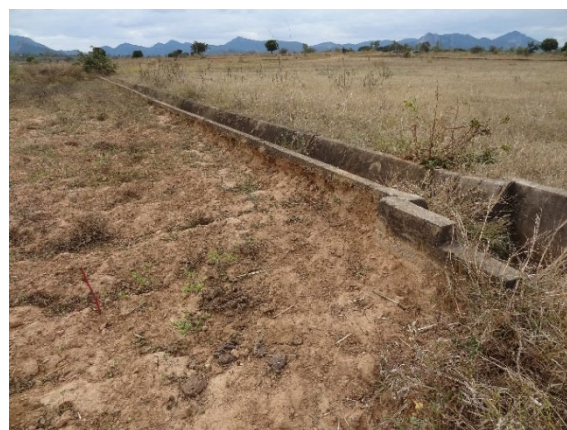
When the construction was completed, the elevation of the top of canal wall and farmland surface may have been same, however the back side soil may have spilled out due to the tillage near the canal.

Figure 5.3.48 Silling Out of Back Side Soil

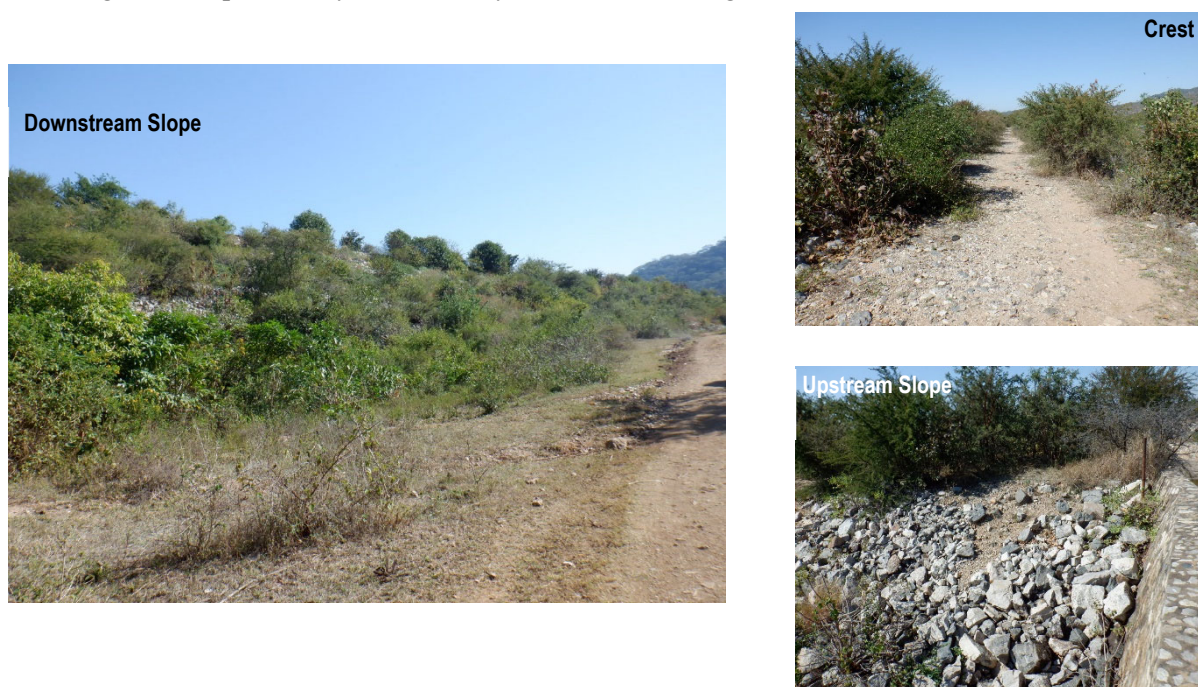
The overgrowth of plants may be caused by the insufficient regular maintenance.

Figure 5.3.54 Partial Disturbance of Riprap, Dam Body Exposure, and Many Trees

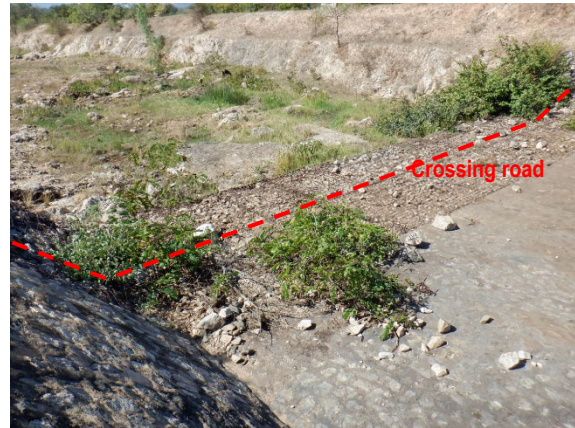
The reason why people pass the channel may be that there are no bridges that can safely cross the channel.

Figure 5.3.55 Crossing Road across the Channel

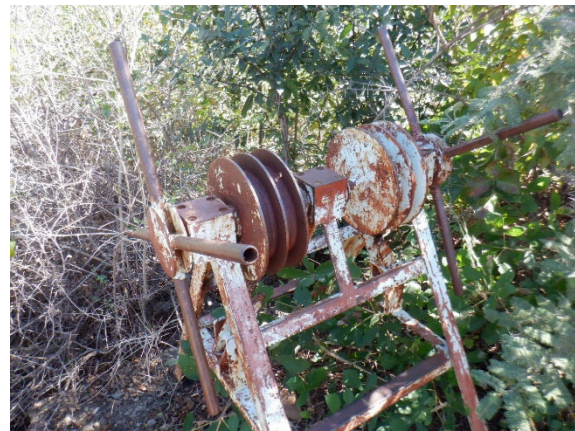
This may be due to the insufficient maintenance after the wire disappeared.

Figure 5.3.56 Winch for Intake Gate Operation

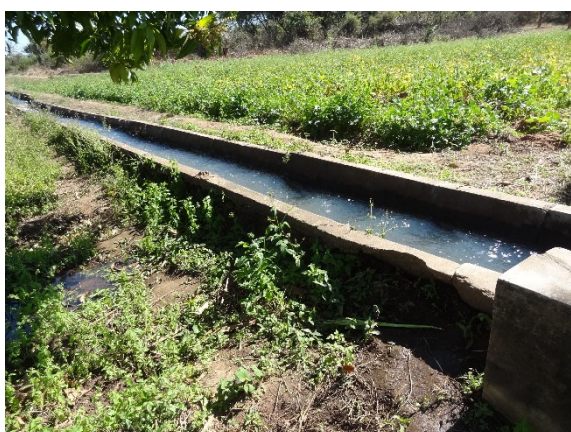
Figure 5.3.57 Spilling Out of Back Side Soil

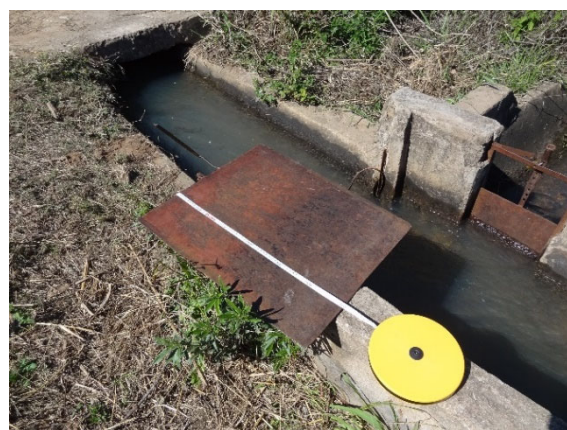
Figure 5.3.58 Broken of Sluice Gate

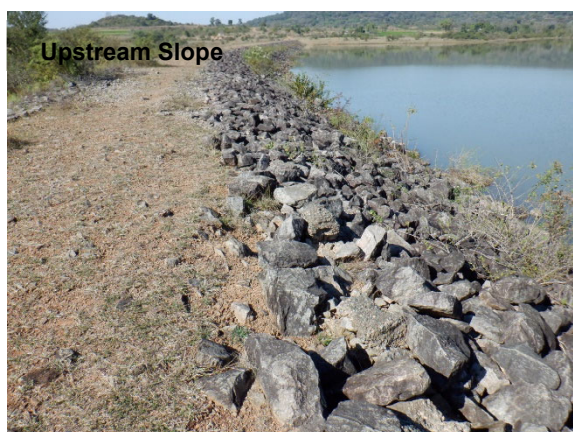
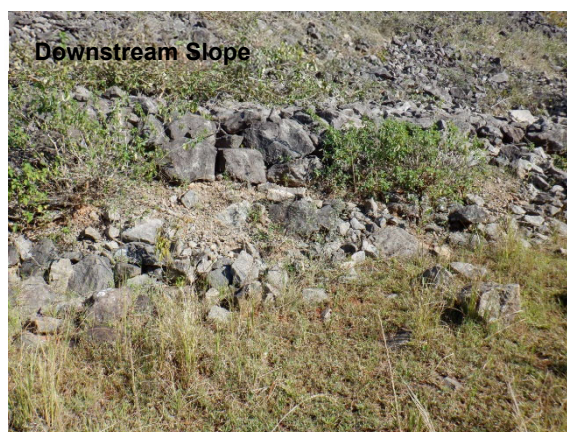
Figure 5.3.64 Upstream and Downstream Slope

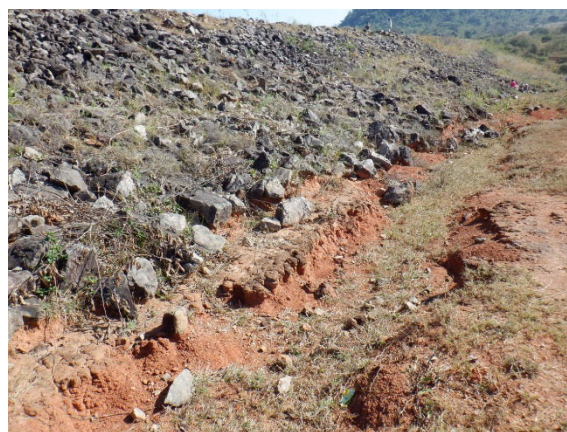
Figure 5.3.65 Downstream Slope Edge

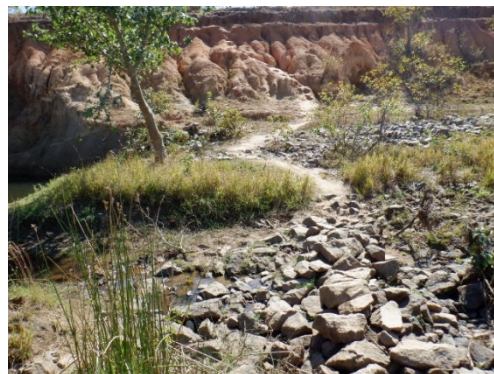
Figure 5.3.67 Crossing Road

[Other] Crossing road across the canal (see Figure 5.3.67)

The reason why people pass the canal may be that there are no bridges that can safely cross the channel.

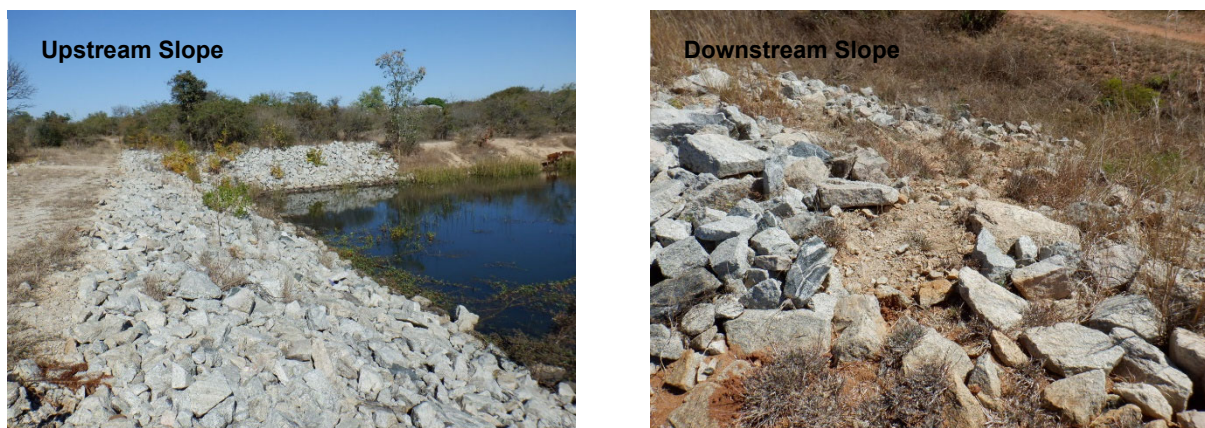
Figure 5.3.72 Upstream and Downstream Slope

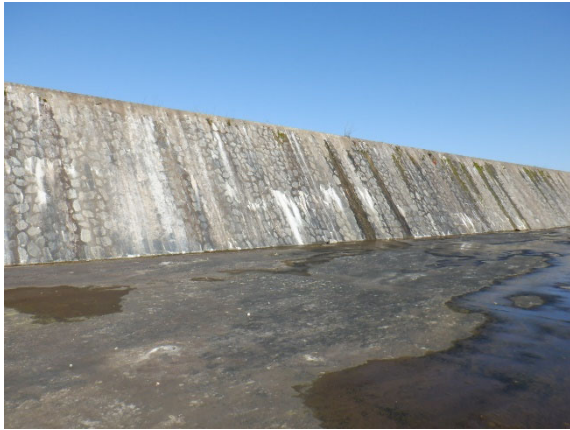
Figure 5.3.73 Leakage from Downstream Slope

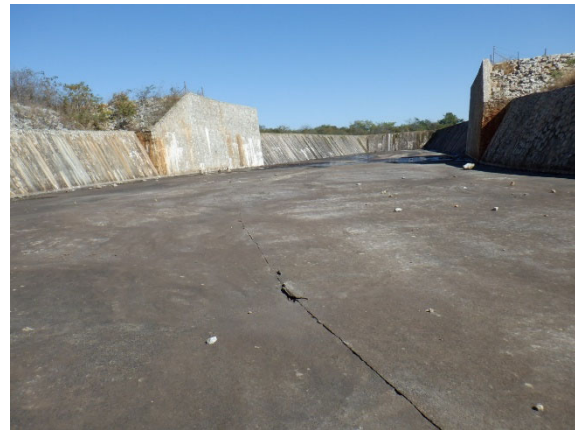
Open and damage of the joints may be caused by damage and detachment of the joint material by flood.

Figure 5.3.74 Joints of the Apron

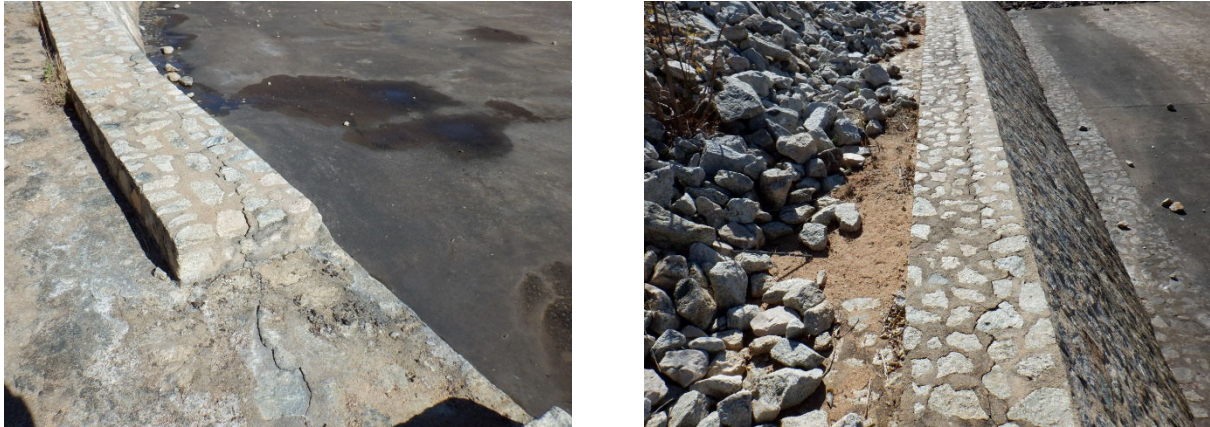
Figure 5.3.75 Cracks at the Top of Retaining Walls

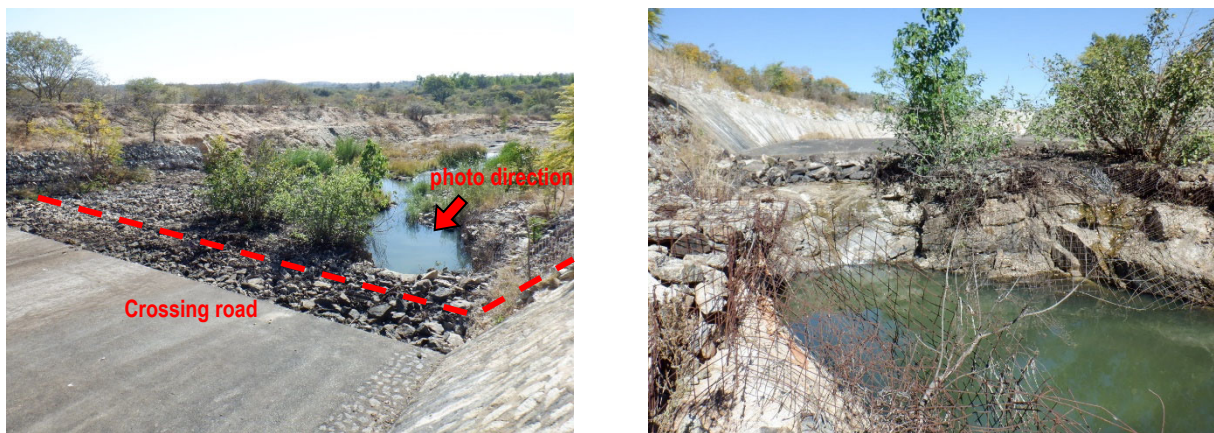
Figure 5.3.76 Spilling Out of Basket Mat at the Right Bank Side

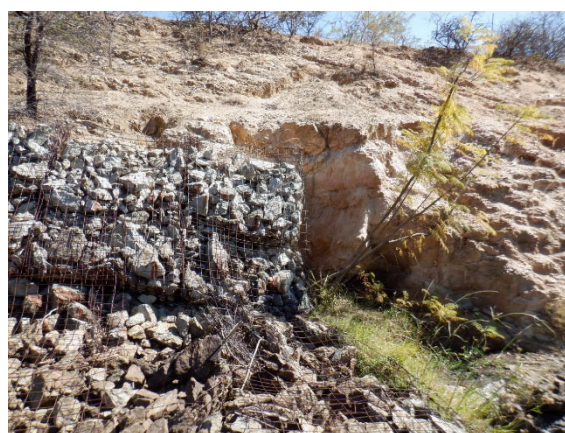
Figure 5.3.77 Collapse of Left Side Bank

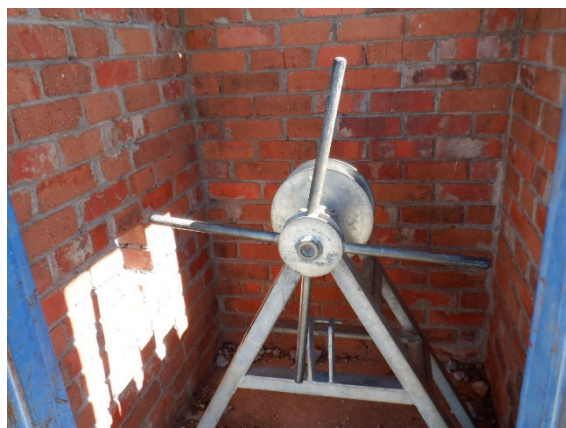
Figure 5.3.78 Winch on the Crest

[Inlet] Missing of the wires (see Figure 5.3.78)

The wires may have been removed due to time-related deterioration or stolen. The intake gate is open at all times and water can be taken.

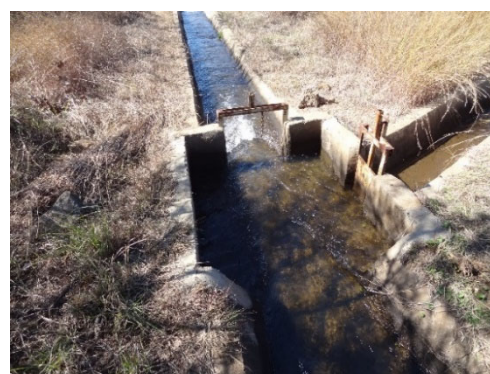
Figure 5.3.79 Broken Sluice Gate

[Diversion] Broken of sluice gate (see Figure 5.3.79)

The sluice gate may have been broken due to time-related deterioration or un-repairing for 30 years after installation.

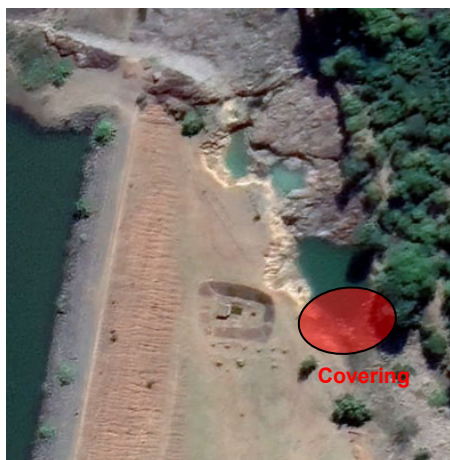
Figure 5.4.3 Outline of Emergency Repairing Measure for Exposure of Siphon Lining Concrete on the Connection Canal Bed

0.5 m covering thickness in consideration of workability

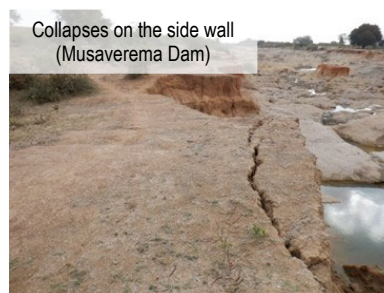
Figure 5.5.3 Deteriorations/Damages on the Connection Canal to be Treated by Zimbabwean Side

* In respect for the erosion and collapse of the sidewalls found in the connection canal of the Musaverema Dam, as the impact on other facilities and the surrounding environment cannot be measured at this time even if it progresses, the Zimbabwean side will conduct continuous monitoring to determine whether or not countermeasures are necessary.

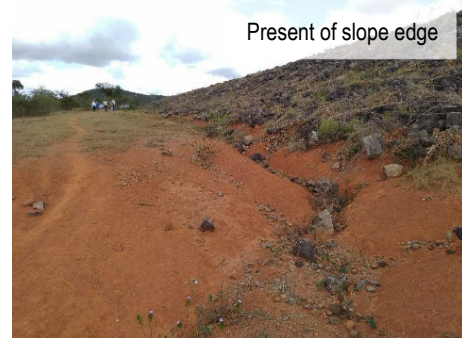
Figure 5.5.6 Present of Slope Edge and Example of Installing a Drainage Canal

iv) Seepage and erosion at slope edge are assumed to be caused by the absence of a drainage canal at the embankment slope edge where surface water arising from rainfall tends to be collected. Therefore, a drainage canal is installed at the edge of the embankment to quickly remove the surface water and prevent erosion (see Figure 5.5.6). Since this damage may occur in all dams in the long term, measures should be taken in all dams together with the above-mentioned repair of embankments.

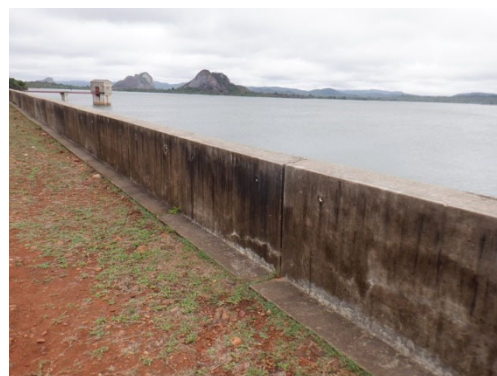
Figure 5.5.10 Example of Parapets (Mundi Mataga Dam)

Although there are some cases in Zimbabwe where retaining walls (parapets) are laid on the crest to secure a freeboard, in this Survey, raising the embankment is adopted because it can be implemented together with the above-mentioned deteriorations/damages rehabilitation.

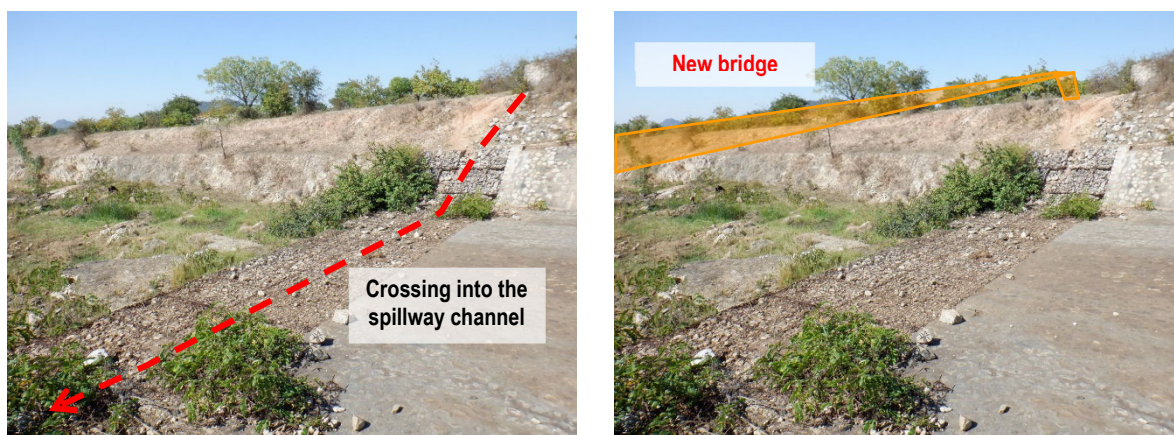
Figure 5.5.15 Model of Installing of New Bridge (Left: Present, Right: Installed)

It is thought that the reason why the inside of the channel is used as a road is that there is no crossing bridge nearby. Since the crossing into the spillway channel, especially during the rainy season, is very dangerous and must be definitely prevented, a bridge for the crossing is installed at an appropriate point in the section between the spillway channel and the connection canal.

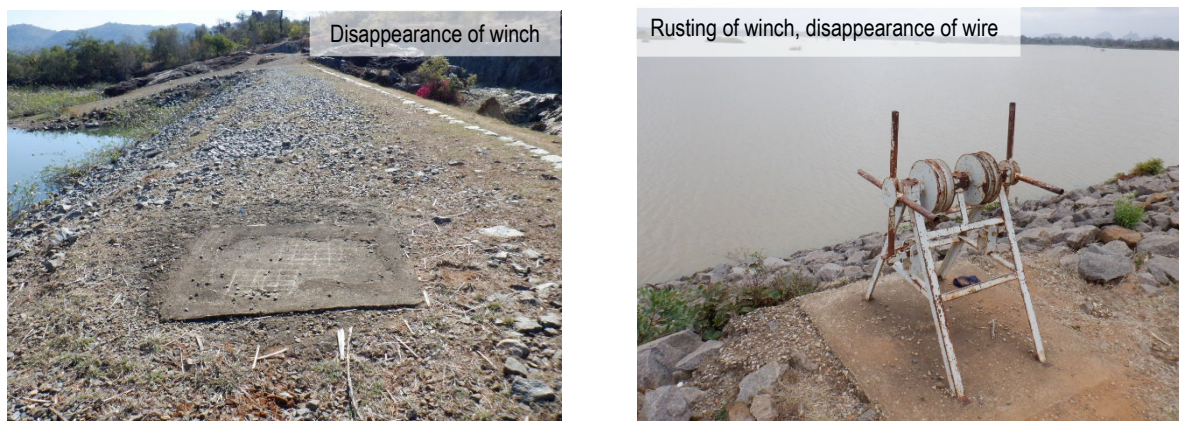
Figure 5.5.18 Status of Intake Structures

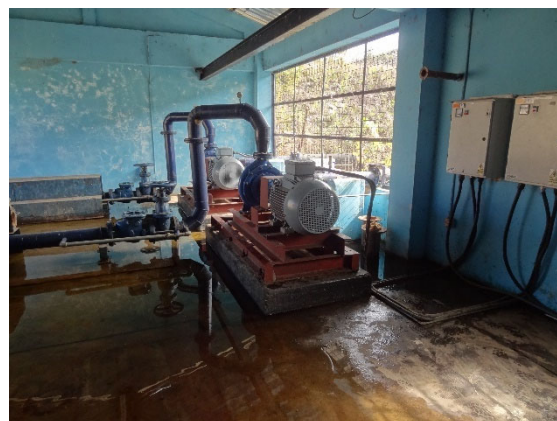
Figure 5.5.20 Status of the Pump Facility (Chinyamatumwa Dam)

Insufficient supply volume found on the pumps at Chinyamatumwa Dam might be caused by insufficient electricity current volume since the transformer is about 500 m away from the pump facility and the required amount of current cannot be supplied due to transmission loss. To cope with this problem, the transformer is replaced.
