**THE REPUBLIC OF KENYA  
WATER RESOURCES AUTHORITY**

**THE REPUBLIC OF KENYA  
KENYA WATER RESOURCES EXPERT  
PROJECT**

**COMPLETION REPORT**

**OCTOBER 2024**

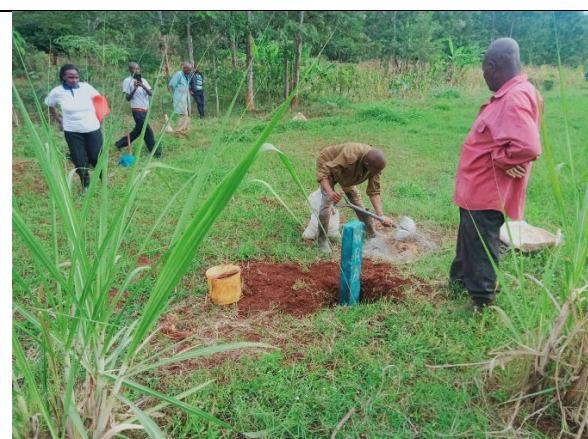
During an interview at the Muranga Sub-basin Office of the Tana Basin Area on January 27, 2023, the JICA Expert Team learned that the office is promoting “riparian marking” activities to prevent flood damage. By marking the highest flood level in the past with concrete posts, the office aims to warn people not to cultivate or build houses below the flood level. These riparian marking activities are described in Attachment 5: Site Work Reports, based on the results of a field survey conducted from January 25 to 27, 2023, along with photos. A representative photo is shown on the right.

Riparian marking activities in the Muranga Sub-basin Office. Under the guidance of WRA staff, residents are installing concrete posts indicating the maximum water level during floods.

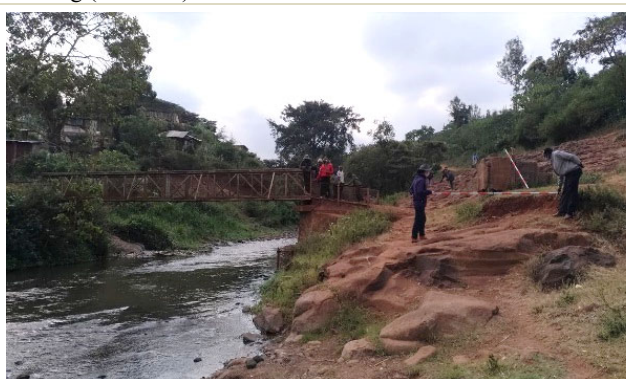
Candidate Gauging Station for Discharge Measurement Practices, 4AC04 New Chania in Muranga SBO (2021/7/7)

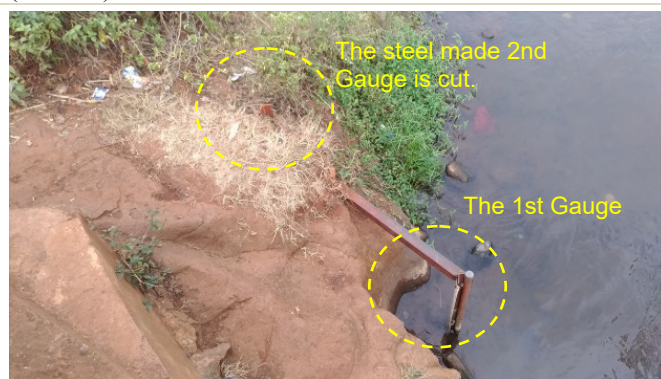
Status of Staff Gauges at 4AC04 New Chania (2021/7/7)

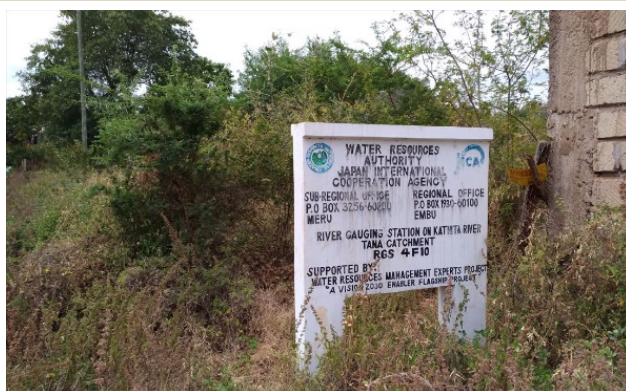
Candidate Gauging Station for Discharge Measurement Practices, 4F10 Kathita in Meru SBO. This Station was rehabilitated in the Previous Advisory Service. (2021/7/8)

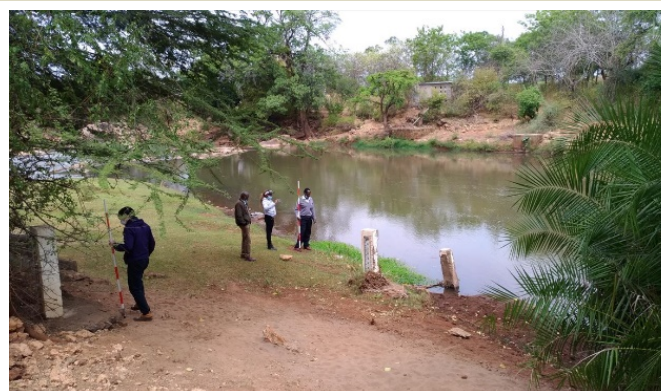
Candidate Gauging Station for Discharge Measurement Practices, 4F10 Kathita in Meru SBO. Staff Gauges in the Left Bank (2021/7/8)

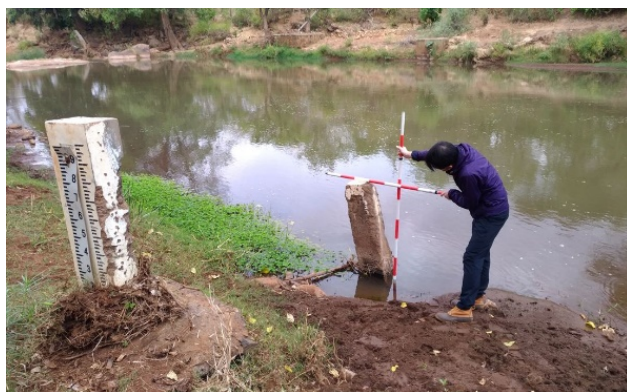
Candidate Gauging Station for Discharge Measurement Practices, 4F10 Kathita in Meru SBO. The first staff gauge is slightly leaning. (2021/7/8)

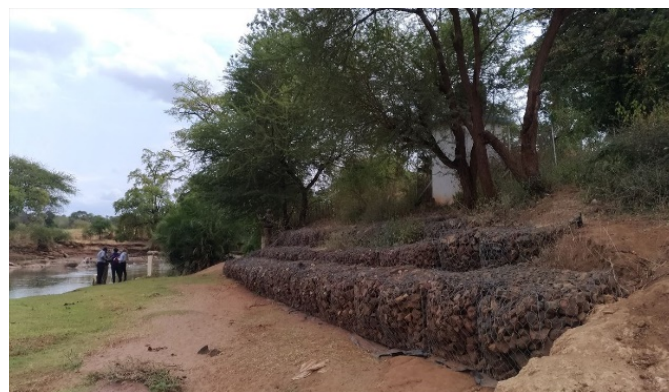
Candidate Gauging Station for Discharge Measurement Practices, 4F10 Kathita in Meru SBO. Gabion mattress installed in the Previous Advisory Activities. (2021/7/8)

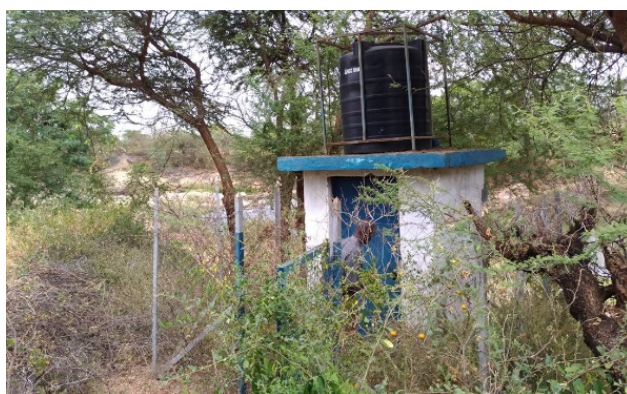
Candidate Gauging Station for Discharge Measurement Practices, 4F10 Kathita in Meru SBO. A small building for accommodating data logger system. (2021/7/8)

A Japanese-made Hioki data logger is in operation at the 4F10 (Kathita) Regular Gauging Station at the Meru Sub-basin Office, which was installed during the previous advisory work. When this data logger was checked in May 2023 during the sixth fieldwork, it was confirmed that the observation hut had been pried open and the data logger had been taken away. As of February 2024, there are no plans for repair or restoration.

| No. | Sub-basin Office | Status |
|---|---|---|
| 1 | Meru | The data logger was installed at the Kathita Gauging Station (4F10) and was in operation. However, on May 18, 2023, it was confirmed that the observation hut had been broken into and the data logger was removed. |

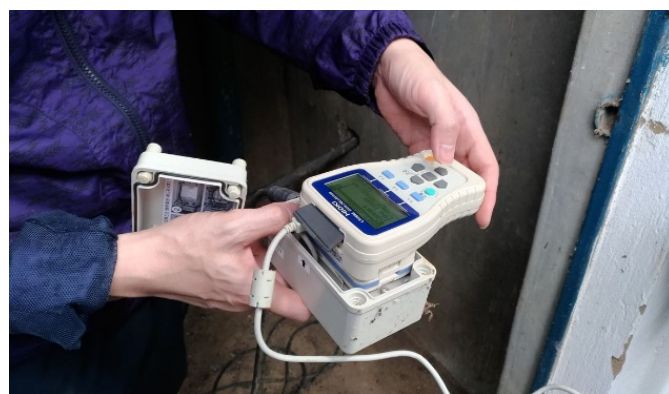
Candidate Gauging Station for Discharge Measurement Practices, 4F10 Kathita in Meru SBO. Data retrieval work The logger is being operated in good condition. (2021/7/8)

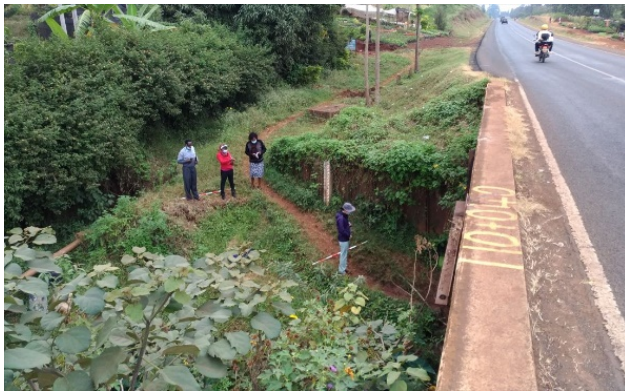
Candidate Gauging Station for Discharge Measurement Practices, 4BF01 Saba Saba in Muranga SBO. (2021/7/9)

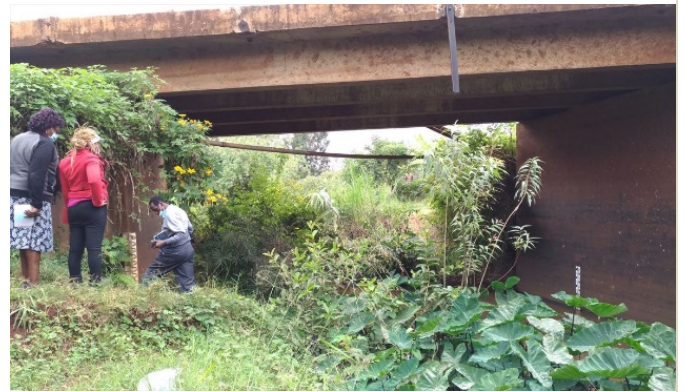
Candidate Gauging Station for Discharge Measurement Practices, 4BF01 Saba Saba in Muranga SBO. (2021/7/9)

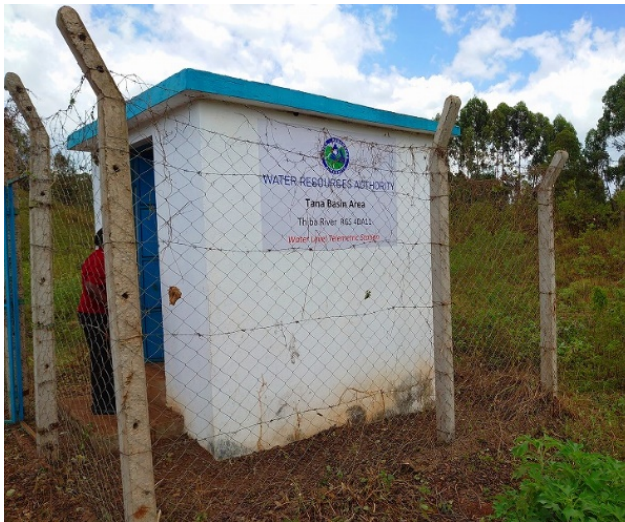
Site visit to Telemetering Station at 4DA11 Thiba. Outer view of the station building. (2021/10/26)

On October 26 and 27, 2021, the JICA experts in charge of "Team Leader/Water Resources Management" and "Communications/Innovation Technology" inspected five telemetering stations in the upper reaches of the Tana River. Among these, three stations (4DA11, 4BB01, and 4CC08) were found to be functioning normally. However, one station (4BE01) had stopped operation due to theft or destruction and another station (4DD02) had stopped observations due to equipment malfunction. The telemetering equipment (data loggers) used consist of three types: SEBA, ISODAQ, and Campbell. The three stations that were functioning normally use SEBA (made in Germany). The malfunctioning station (4DD02) used ISODAQ (made in the United Kingdom) equipment, and it appeared that creatures were building nests in the container in which the equipment was stored. Detailed information is available in Attachment 5, "Site Works Reports."

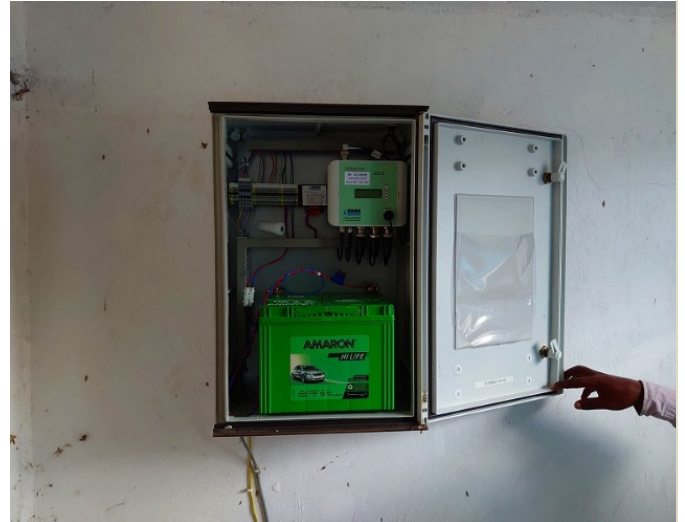
Site visit to Telemetering Station at 4DA11 Thiba. Telemetering Panel (up) and a car battery for power supply. (2021/10/26)

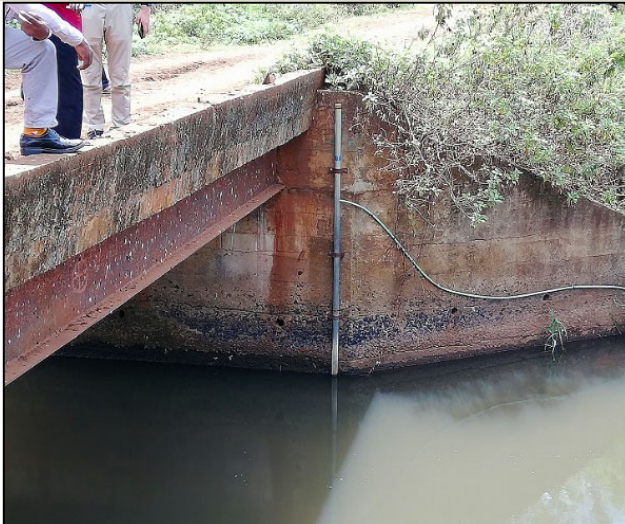
Site visit to Telemetering Station at 4DA11 Thiba. Outer view of the station building. Pressure sensor and cable. (2021/10/26)

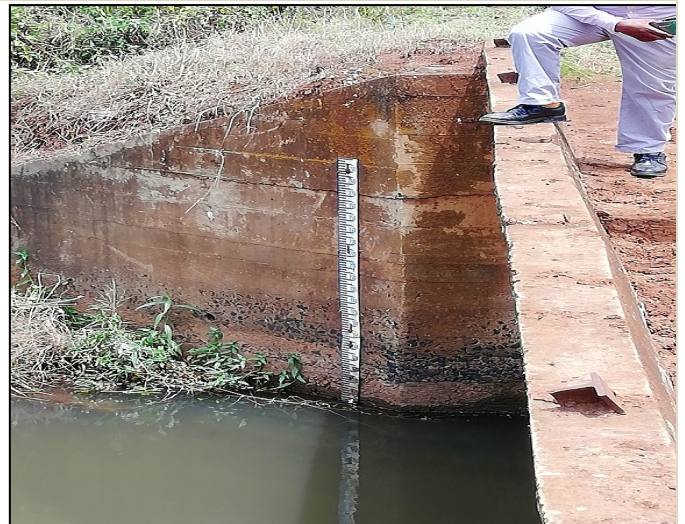
Site visit to Telemetering Station at 4DA11 Thiba. Staff Gauge for manual reading. (2021/10/26)

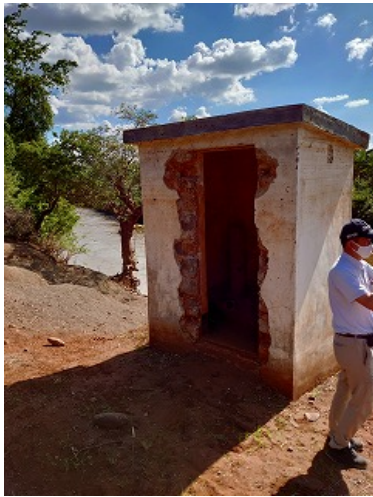
Telemetry Station in Tana Basin, 4BE10 Tana Rukanga. The door is broken with its concrete base and all the equipments are taken away. (2021/10/26)

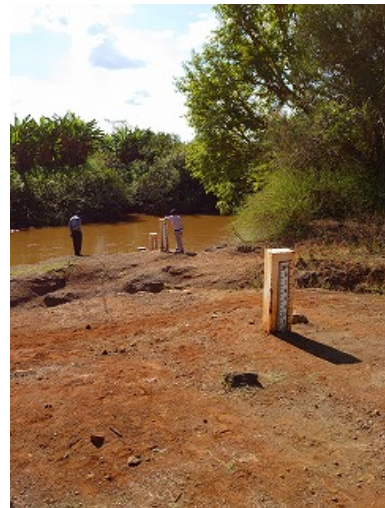
Telemetry Station in Tana Basin, 4BE10 Tana Rukanga. 4BE10 Tana Rukanga. Staff Gages located in the left bank (2021/10/26)

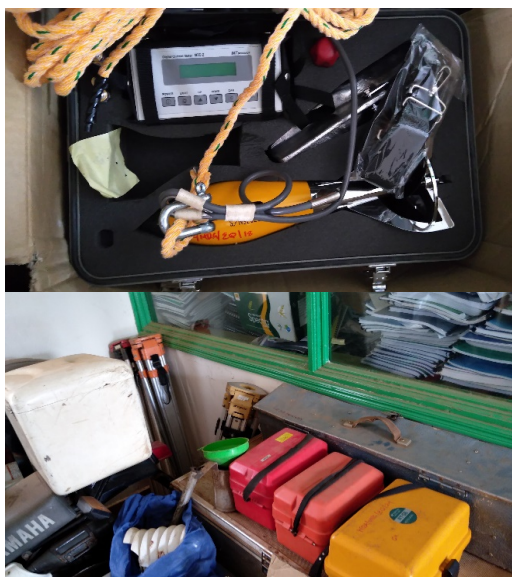
Status of Observation Equipment in Muranga SBO. Current Meter (up) and Surge Equipment (low). They are well maintained. (2022/6/10)

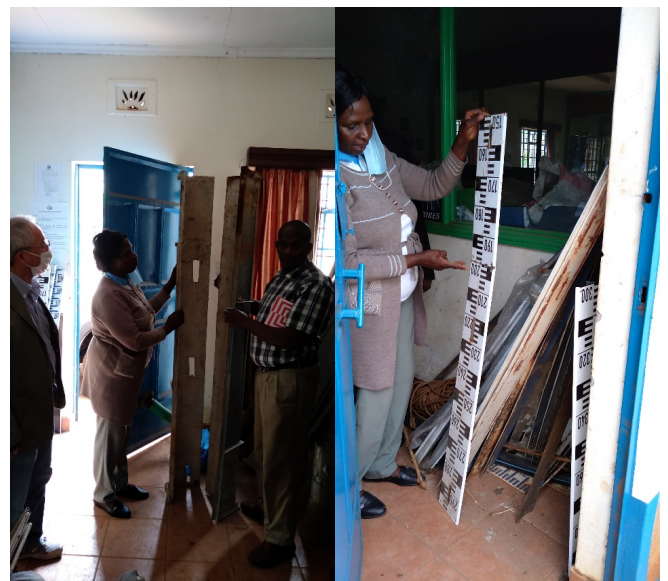
Status of Observation Equipment in Muranga SBO. A Form Work for Gauging Post (left) and Gauge Plates (right). (2022/6/10)

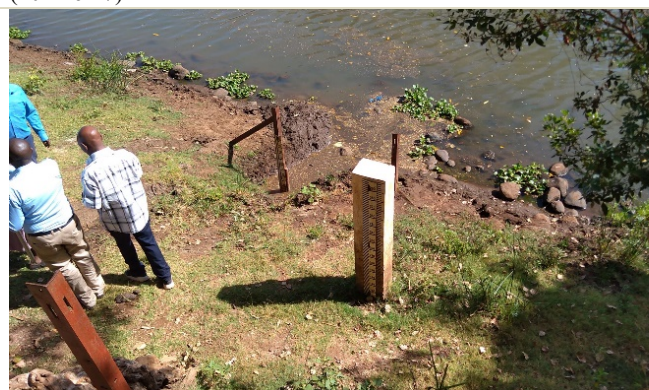
Site Reconnaissance to Regular Gauging Station 4DD02 Thiba. The 1<sup>st</sup> and the 2<sup>nd</sup> Staff Gauges. (2023/1/25)

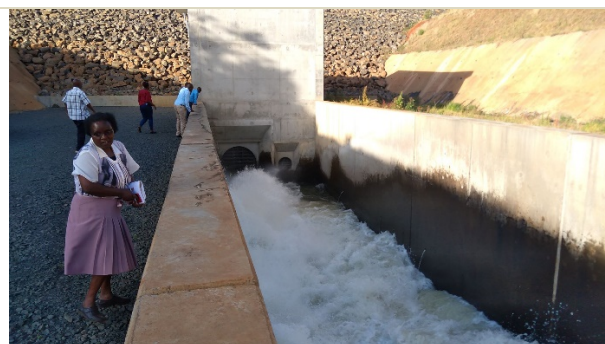
Irrigation Outlet of Thiba Dam. Flow Release of 5 m<sup>3</sup>/s implemented. (2023/1/26)

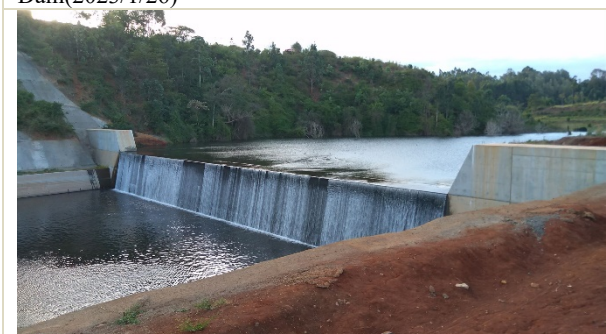
A Check Dam located at the upstream part of Thiba Dam (2023/1/26)

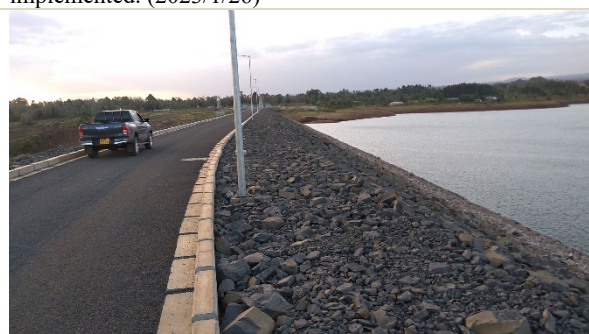
Thiba Dam Body looking from the left bank side. (2023/1/26)

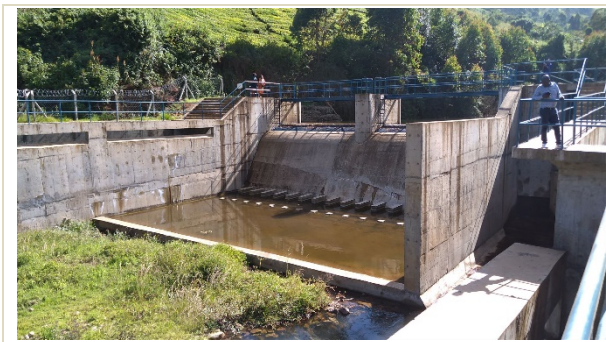
| <p>An Intake Facility for Water Supply to Nairobi, Maragua Intake (2023/1/27)</p> | <p>A Group Photo of Participants at Maragua Intake (2023/1/27)</p> |

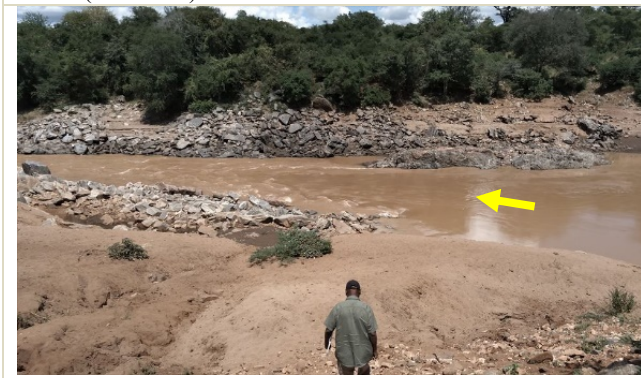
| <p>Site Reconnaissance to Flood Forecast &amp; Warning System Candidate, 4F13 Tana Grandfalls (2023/5/22)</p> | <p>Site Reconnaissance to Flood Forecast &amp; Warning System Candidate, 4F13 Tana Grandfalls. Outcrops are observed on the left bank. (2023/5/22)</p> |

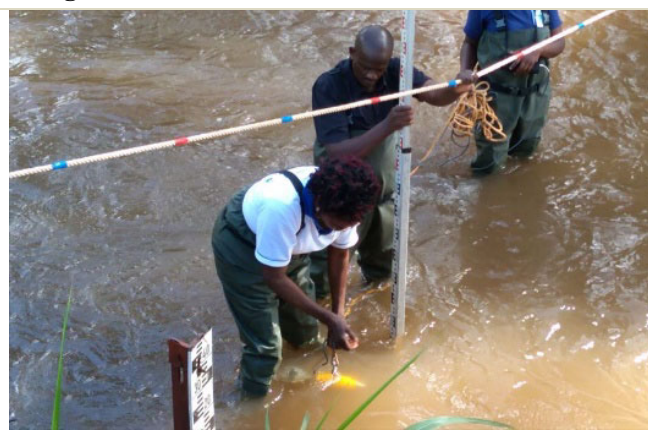
Exercises of Discharge Measurement at 4AC03 Sagana (2024/2/7)

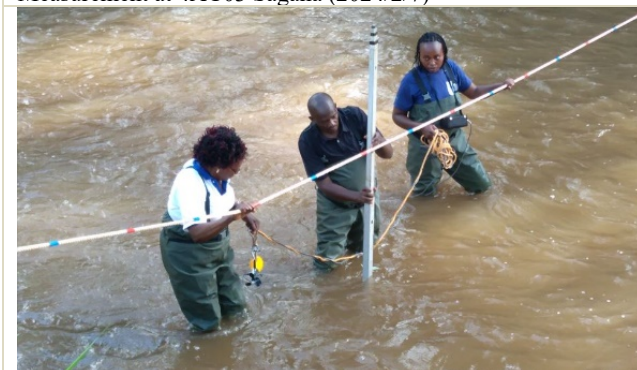
Exercises of Discharge Measurement at 4AC03 Sagana (2024/2/7)

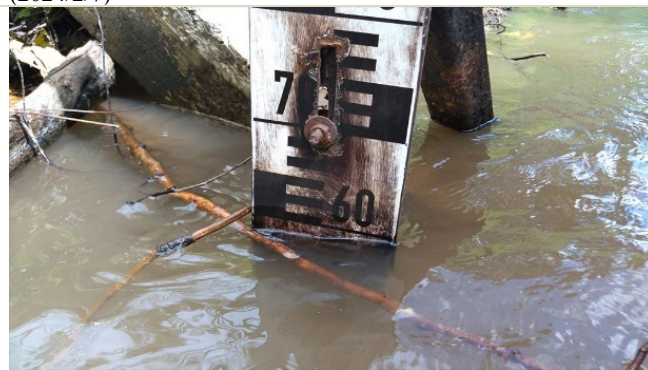
Exercises of Discharge Measurement at 4AC03 Sagana. The Water Level at 0.59 m. (2024/2/7)

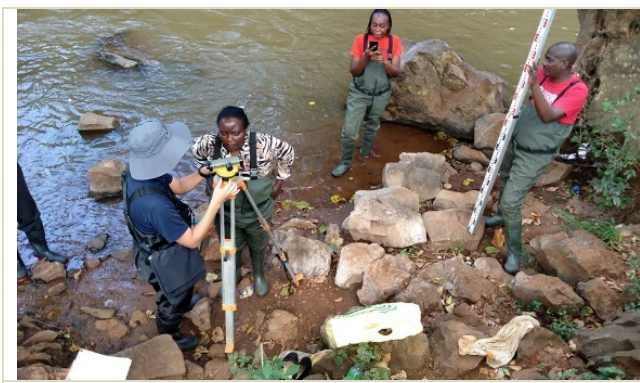
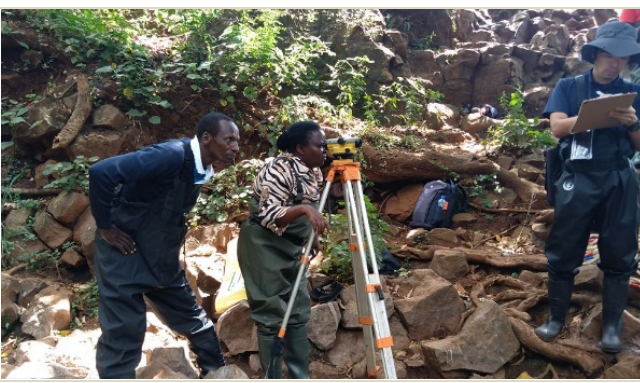
| <p>Exercise of River Cross-Section Survey at 4DC03 Rupingazi (2024/2/8)</p> | <p>Exercise of River Cross-Section Survey at 4DC03 Rupingazi (2024/2/8)</p> |

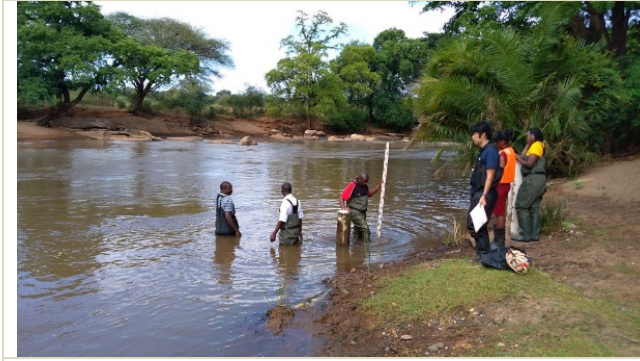
| <p>Exercises of River Cross-Section Survey and Discharge Measurement at 4F10 Kathita. Preliminary Check of River Water Depth prior to measurement (2024/2/9)</p> | <p>Preparation of a Boat for Observation Works at 4F10 Kathita. (2024/2/9)</p> |

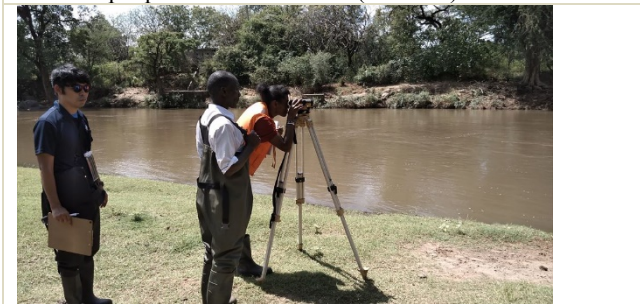
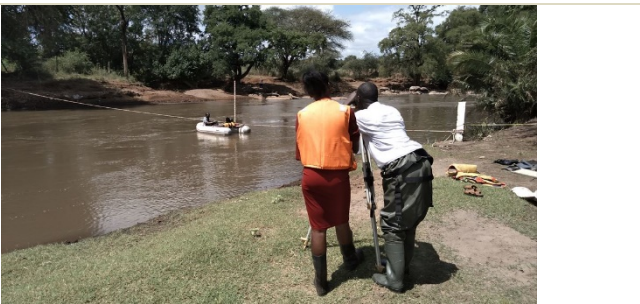
| <p>River Cross-Section Survey at 4F10 Kathita. (2024/2/9)</p> | <p>River Cross-Section Survey at 4F10 Kathita. (2024/2/9)</p> |

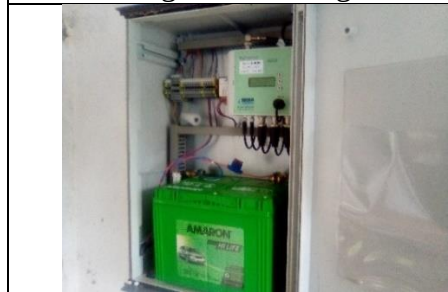
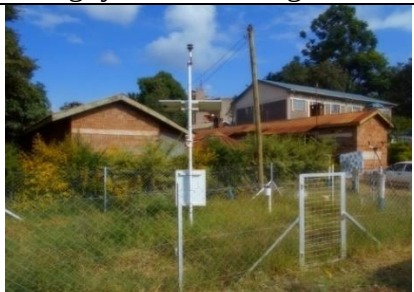
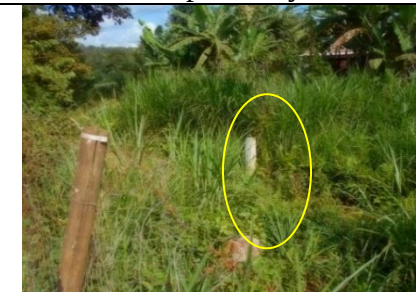
2. SEBA Data Logger in station 4DA11(Thiba). 2&3Newly Installed Telemetric Meteorological station and staff gauge outside Murang'a Sub-Regional Office

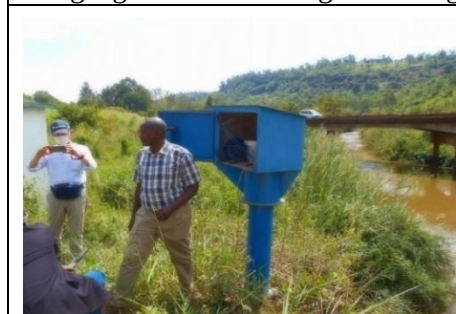
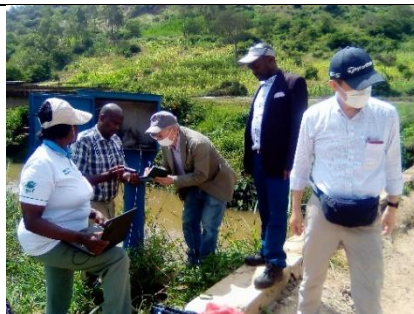
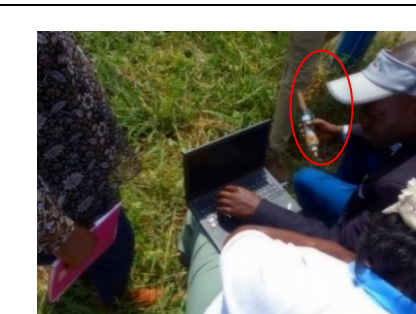
3. The housing structure of HOB0 data logger in 4BE01(Maragua) 2. Checking of the equipment 3. Faith demonstrates data reading from the logger to the PC through the coupler.

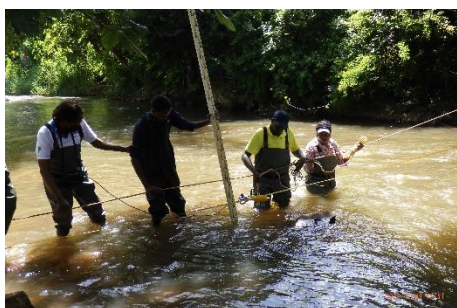
Photo 2: Mr. Masika illustrating the use of a propeller-type current meter during discharge measurement at 4DC03

On 9th December JICA Experts Team together with WRA officers from Embu, Murang'a, and Kerugoya visited Rupingazi 4DC03 and jointly carried out the discharge measurement and cross-section survey. The session was also used to train the surface water officers on the use of a propeller-type current meter supplied by JICA.

This was to take advantage of the idle equipment as an alternative to the ADV. Mr. Kato and Mr. Masika illustrated the use of the dumpy level and the current meter by wading respectively. The exercise was successfully done achieving both discharge measurement and the cross-sectional profile at the station.

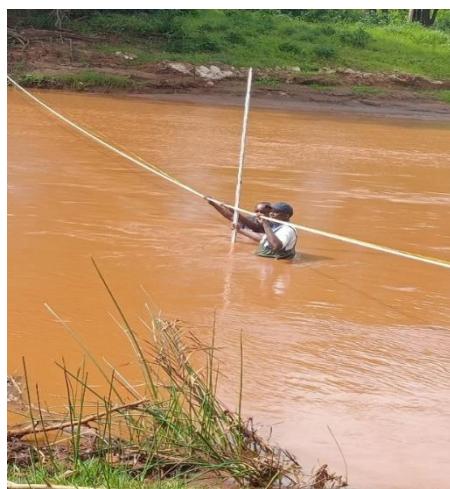
Photo 4: Mr. Masika and a local volunteer wading through the river during the cross-section survey at Kathita 4F10

On 14<sup>th</sup> December 2022, JICA Experts Team visited the Kathita-Mutonga sub-basin to undertake discharge measurement and the river cross-section survey at Kathita 4F10.

A local volunteer was engaged to assist in wading across the river during the survey. However, discharge measurement was not possible due to the high water level (the deepest part was 1.45 m).

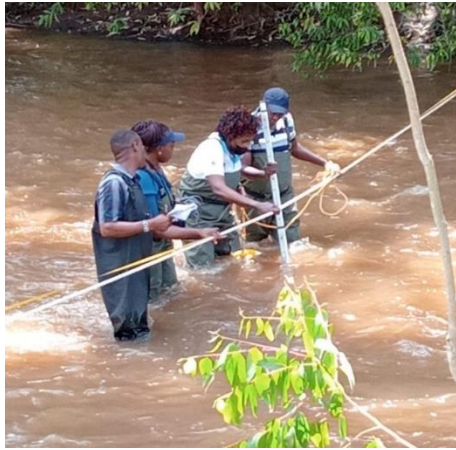
Photo 6:  
Discharge  
measurement in  
progress using  
the propeller-  
type current  
meter at Sagana  
4AC03

On 19th December 2022, the JICA Experts Team visited the Upper Tana sub-basin for the same exercise at Sagana (4AC03). The activity was carried out jointly by JICA Experts Team and the Surface Water Officer from the Murang'a office Ms. Jane Wairimu. Mr. Kato and Mr. Masika took the lead in undertaking the cross-sectional survey and discharge measurement respectively.

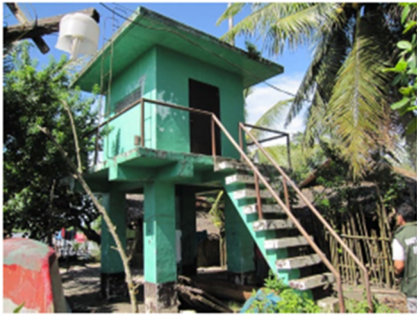
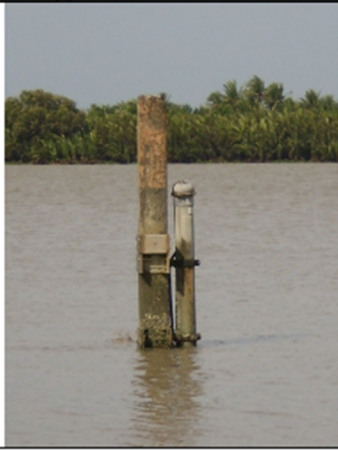
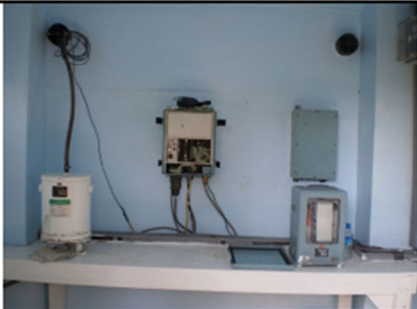
### Installation Example 1: Sensing Pole Type

| Gauging station | Support for water level sensor |
|---|---|
| LeTelecom room | <p>These equipment were constructed in 1980's years and some of the equipment were deteriorated due to expire of equipment life (approx. 20-30 years), however some equipment are still operational after 30 years in 2011 because good and proper maintenance works have conducted by an operator (periodic maintenance works, 3 months interval in a year)</p> |

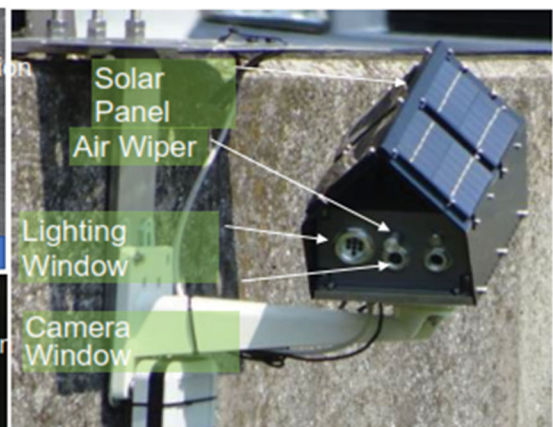
All-in-one  
Easily Setting

- Target price is 1 million JPY (KES907,847)

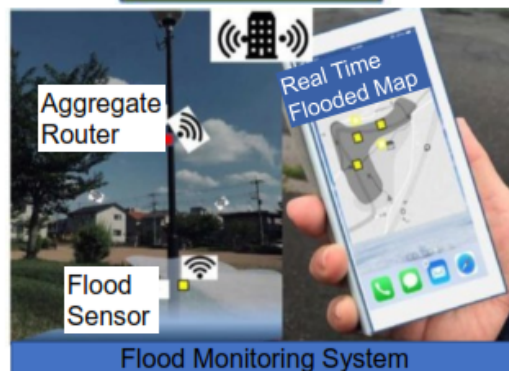
- Flood can be detected through on/off Bluetooth signal in real time (When water touch Bluetooth tip, it become off)
- Browsing on smartphone as well as office PC

- These equipment are developed to aim for cost reduction

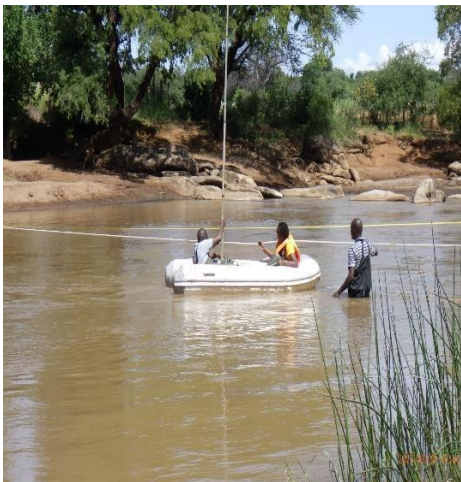
Photo 1: Dr. Masika, Ms. Doreen, and Mr. Gordon carrying out the cross-sectional survey at 4F10 using a boat

On 18<sup>th</sup> May JICA Experts Team together with WRA officers from Meru Sub Region Office visited Kathita 4F10 and jointly carried out the discharge measurement and river cross-section survey. The water levels were high and hence a boat was used to wade across the river. The exercise was successfully done achieving both discharge measurement and the cross-sectional profile at the station.

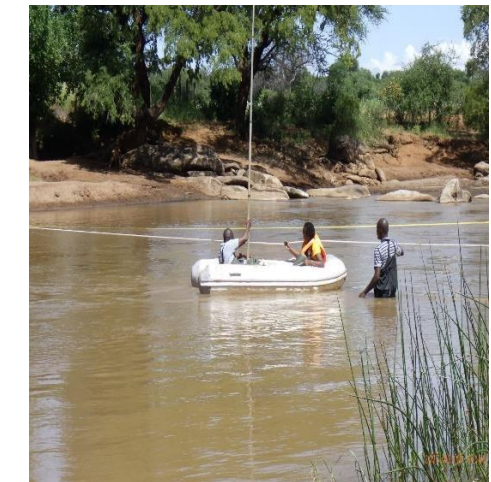
Photo 2: Dr. Masika and Mr. Gordon using the propeller-type current meter during discharge measurement while Ms. Doreen taking the bookings at 4F10

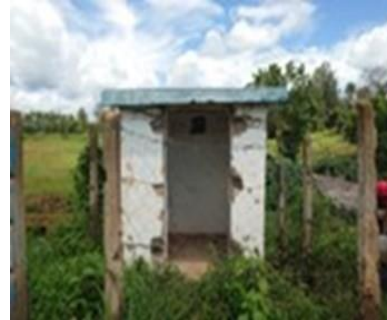
Photo 6: 4BB01 Station found vandalized. Staff gauge reading under the bridge was 1.10M at 1:06PM.

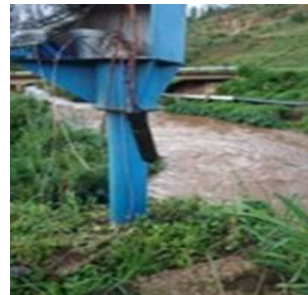
Photo 7: Gauging station 4BE01

(HOBO) on 15/11/2023

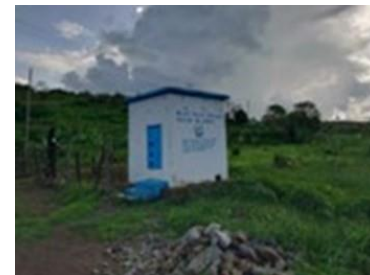
Photo 8: Gauging station 4BE01 (SEBA) on 15/11/2023

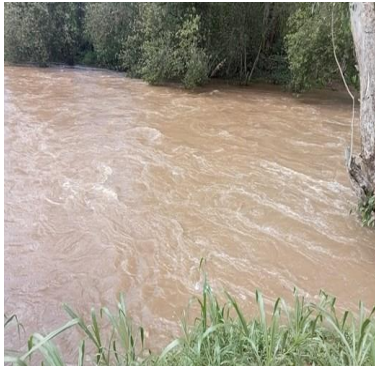
On November 22, 2023, the team attempted to carry out the scheduled activity for the second time at Sagana 4AC03. However, heavy rainfall was still pounding the sub-basin resulting to further increase in river flows. A similar situation was observed in Rupingazi 4DC03 and Kathita 4F10.

Photo 9: Submerged gauge at Sagana 4AC03 on 22/11/2023 at 11:20am. Water level above 1.5M

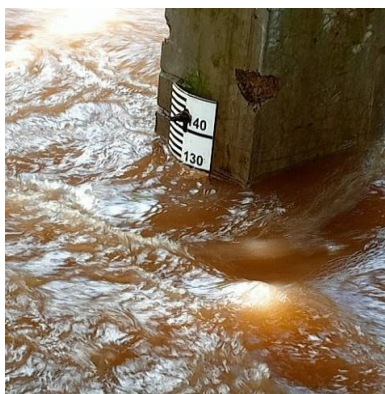
Photo 10: 4DC03 Water level at 1.30M on 22/11/2023 at 1:50pm

In the afternoon, the Team together with Ms Jane from Thiba sub-basin visited Rupingazi 4DC03 to check on its status and the water levels were too high and so was the velocity.

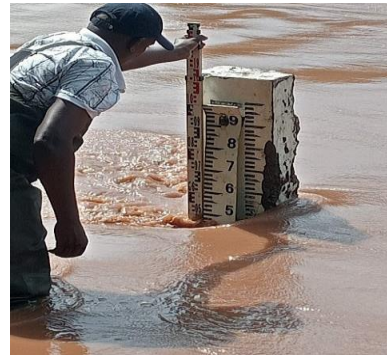
Photo 11: 1st gauge completely submerged. 2nd gauge readings at 1.5M

The activity was postponed for the second time due to safety concerns. On 23rd November 2023, the team together with Mr. Kimotho of Meru sub-basin visited Kathita 4F10 and the situation was the same as the other two stations in Sagana and Rupingazi.

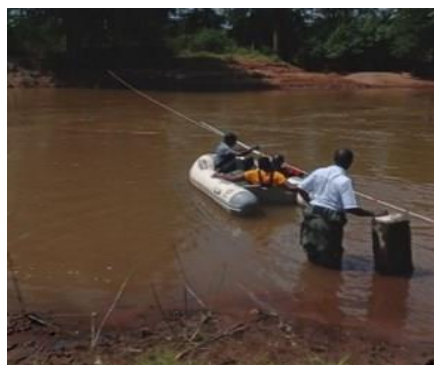
Photo 6: Mr. Gordon, Ms. Doreen, and Dr. Masika carrying out discharge measurement using a propeller-type current meter in a boat at 4F10.

On February 9, 2024, the team and Mr. Kimotho (Surface Water Officer, Meru) went to 4F10 Kathita to conduct the same exercise. River cross-section survey and discharge measurement were conducted jointly. Because the water levels were high (the deepest point being 1.7M), a boat was necessary. Similarly, a local swimmer was engaged to tie the anchorage rope across.

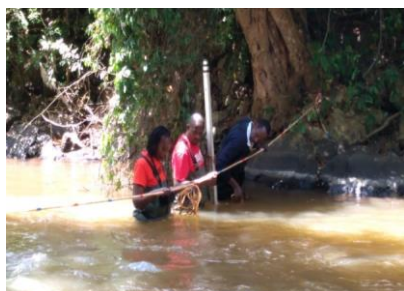
Photo 4: Mr. Ndung'u, Dr. Masika and Ms. Doreen Carrying out discharge measurement at 4DC03
