**Ex-Post Project Evaluation 2023
Package II-2 (Bhutan, Jordan)
Evaluation Reports**

January 2025

The Project for Reconstruction of Bridges on Primary National Highway No. 4

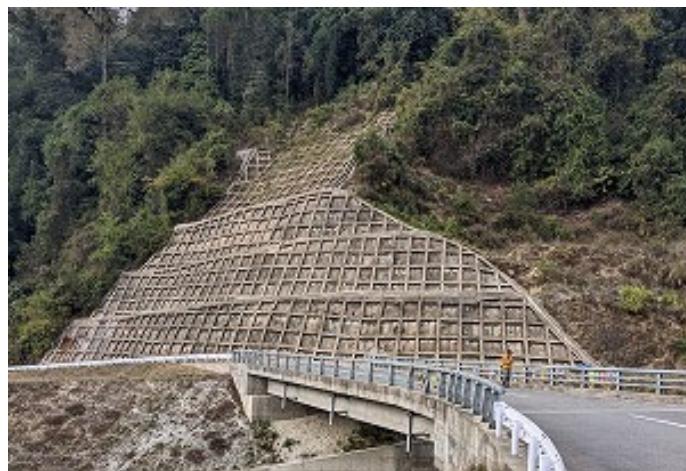
Slope Protection Works at Beteni Bridge
(Source: Photo taken by the evaluator)

When bridges are constructed with the Japanese grant aid, bridge, approach roads and, if the bridge is located in a mountainous area, measures to prevent slopes on the cut surface on the approach roads, are implemented as a set. On the other hand, in bridge construction usually carried out by the Bhutanese side, due to the budget constraints, measures are taken to keep the slope angle within the specified range depending on the soil type of the slope, but not as extensive as the cutting measures work to be carried out through Japanese grant aid. As a result, even after the construction, rockfalls and landslides can occur during the monsoon season. In comparison, in the vicinity of Teleganchu, Samkhara, Beteni bridges, where cutting measures works were implemented in this project, no such accidents have occurred after the project. The bridge reconstructed project funded by Japanese grant aid is a high value-added project that will not only reconstruct bridges but also implement slope protection works in the surrounding area, thereby further increasing safety and effectiveness of the project.

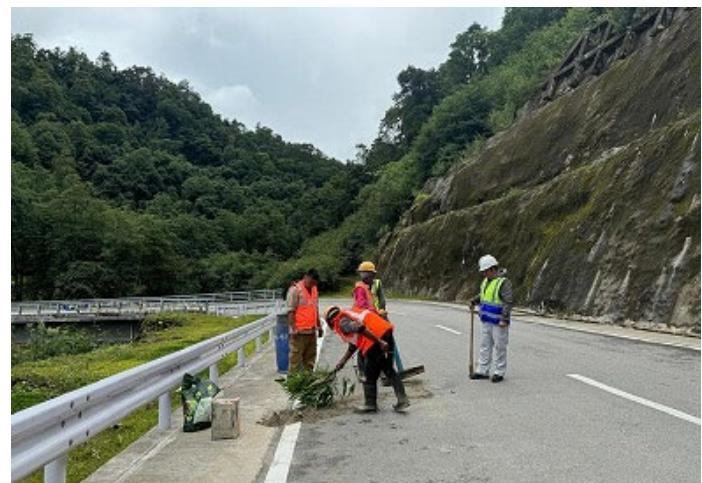
Repair works of potholes of approach road of Teleganchu Bridge (Source: DoR)

Minor damages such as potholes in the approach roads and cracks in the liner plates were identified during the field inspection. Although the repairs have been carried out in response to the finding during the field survey of the ex-post evaluation, even minor damages such as this that does not affect the bridge itself should be addressed as soon as it is discovered, before the damage escalates.

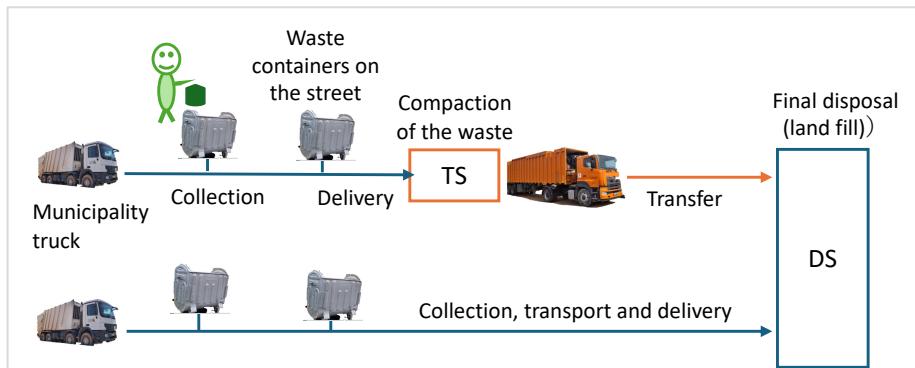
To facilitate understanding of this report, the basic flow of management of municipal waste (hereafter abbreviated as ‘waste’ where appropriate) in Jordan is shown in the figure below.

Figure 2: Waste Management Flow in Jordan

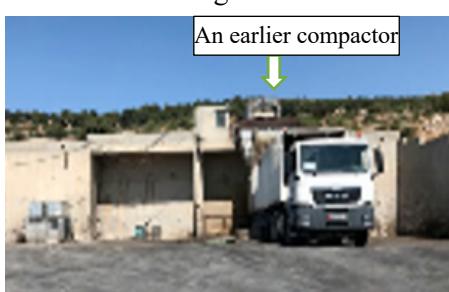
At the time of planning, Aghwar Shamaliyah TS, Rabiet Al-Kura TS, Ajloun TS and Al Shoneh Al Wsta TS only had one hopper and one waste compactor. As a result, when several waste collection vehicles arrived from the municipalities they had to wait for one to one and a half hours to discharge waste into the compactor. This was causing a problem with waste being scattered around, and a bad smell from the waiting vehicles.

Ajloun TS at the Time of Planning

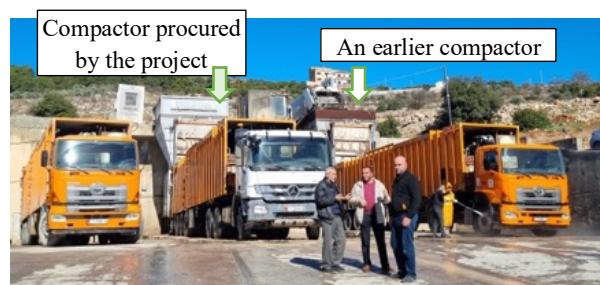
At the time of the ex-post evaluation, waste collection vehicles were discharging waste one after the other into the hopper at the TSs, and there were no vehicles waiting. As a result of the project, there are now two hoppers and two compactors at each DS (see photo below). The number of semi-trailers and tractor heads that transport waste to the DS after compacting has also increased, resulting in an increased capacity for receiving, compacting and transporting waste, with almost no waiting time.

Ajloun TS at the Time of the Ex-post Evaluation

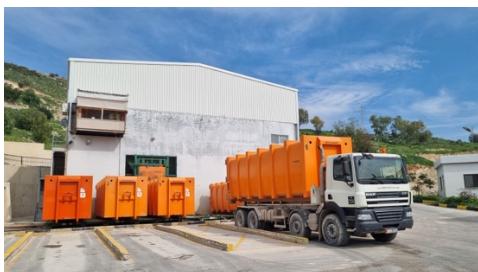
- The TS has a lower environmental impact compared with conventional TSs, because the hopper and compressor are installed indoors and there is a treatment facility for the leachate. In addition, the floor of the building hardly needs to be cleaned, reducing the workload and water consumption (see photo below on the right).
- Compressed waste is automatically loaded into containers, and only a few staff are needed for the loading. The weighing device built into the compressor prevents overloading.
- Waste delivered from municipalities at night can be stored in containers and then transported the next morning, and there is no need for the drivers to work at night (see photo below on the left).

An Arm Roll Truck and Containers at Al Taybeh TS

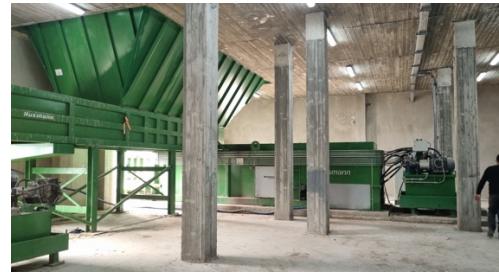
Indoor Hopper and Compressor at Al Taybeh TS

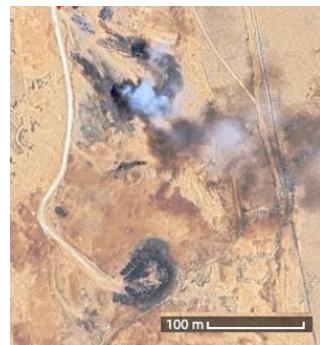
Fire in Al Badiah Al Shamaliyah DS

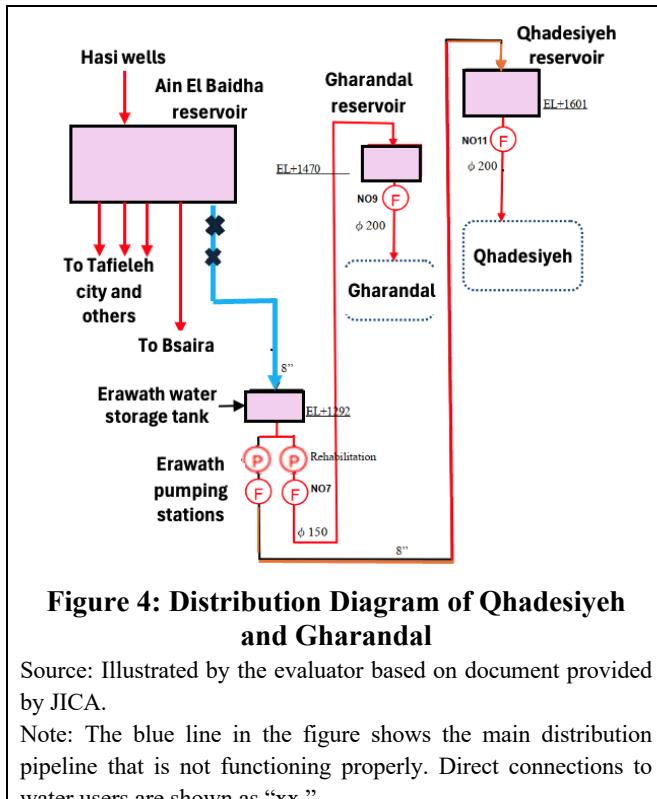
The five distribution zones of the project receive water from the Ain El-Baidha reservoir, and have the same water source. Nevertheless, Qhadesiyeh and Gharandal have water supplied on very few days during the summer. Discussions on the reason for this with the Director of the Tafieleh Water Office revealed that the main reason is that the distribution-main pipeline (blue line in Fig. 4) used to distribute water to these zones is not fully functional.

This distribution-main pipeline is used to distribute water from Ain El-Baidha reservoir to the Erawath water storage tank attached to the Erawath pumping stations

Figure 4: Distribution Diagram of Qhadesiyeh and Gharandal
