CHAPTER 3 . FIELD INVESTIGATION

CHAPTER 3. FIELD INVESTIGATION

3.2 Topographic Survey and Mapping

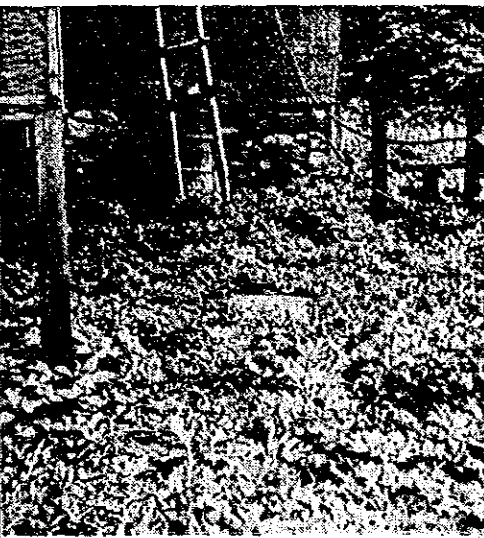
Table 3-1 (1) Point Description

Station No.				Operated by	MR. SHRESTHA
BM 1	survey no. D/ST-1			Checked by	MR. TOYODA
				Date	MAY 25 '86
Zone No.	Coordinates of Station				
45	N	E	H		
Main Point	3048 534.07	529 790.49	808.36		
Eccentric Point	.	.	.		
Supplementary Point	.	.	.		
Sketch-map of Station and Neighborhood				Photograph of Station

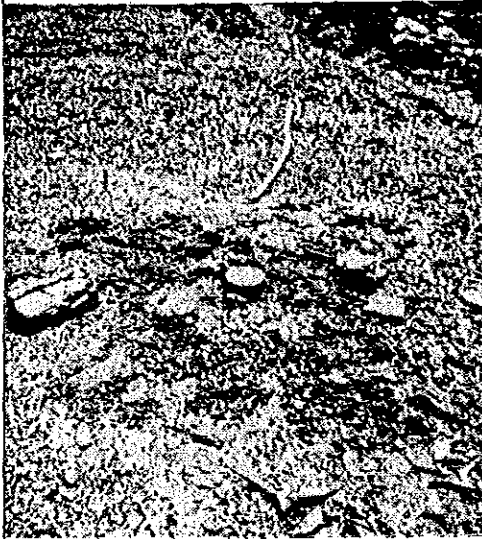
Table 3-1 (2) Point Description

Station No.				Operated by	MR. PRASAIN
BM 2	survey no. P14			Checked by	MR. TOYODA
				Date	MAY 25 '86
Zone No.	Coordinates of Station				
45	N	E	H		
Main Point	-- 3049 971.99	-- 528 622.32	-- 1 330.58		
Eccentric Point	-- .	-- .	-- .		
Supplementary Point	-- .	-- .	-- .		
Sketch-map of Station and Neighborhood				Photograph of Station

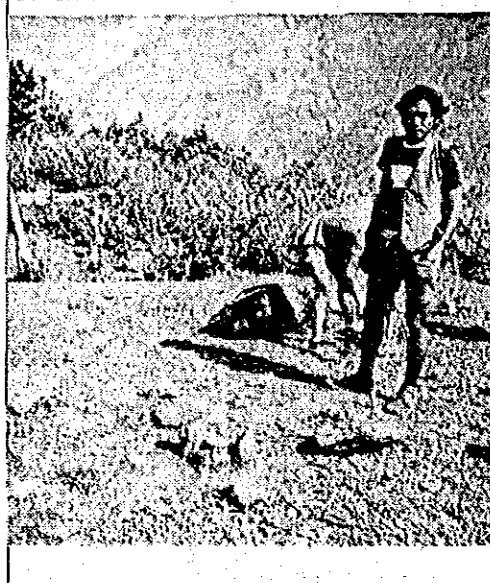
Table 3-1 (4) Point Description

Station No.				Operated by	MR. PRASAIN
BM 4	survey no. P9			Checked by	MR. TOYODA
				Date	MAY 21 '86
Zone No.	Coordinates of Station				
45	N	E	H		
Main Point	3043 332.24	521 408.51	1 566.83		
Eccentric Point	.	.	.		
Supplementary Point	.	.	.		
Sketch-map of Station and Neighborhood				Photograph of Station

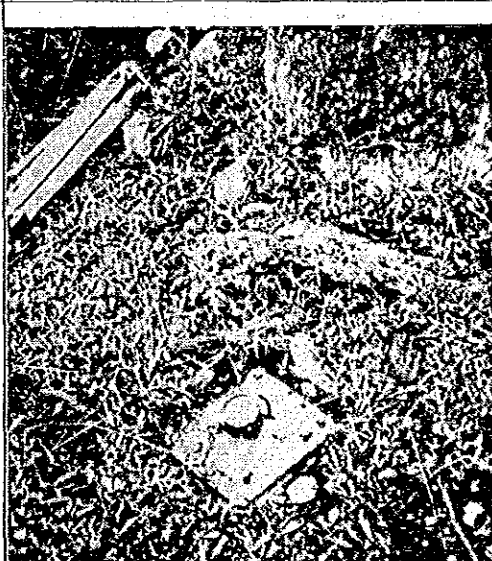
Table 3-1 (5) Point Description

Station No.				Operated by	MR.SHRESTHA
BM 5	survey no. S1			Checked by	MR.TOYODA
				Date	MAY 29 '86
Zone No.	Coordinates of Station				
45	N		E		H
Main Point	-- 3043 748.03 --	-- 519 434.63 --	574.66		
Eccentric Point	-- . --	-- . --	.		
Supplementary Point	-- . --	-- . --	.		
Sketch-map of Station and Neighborhood				Photograph of Station
