## APPENDIX 3. SURVEY ON ENVIRONMENTAL ASPECTS

## Appendix 3.1 Survey of Water Quality (Land)

#### SURVEY OF WATER AND WASTEWATER QUALITY IN PATTAYA

February, 1978

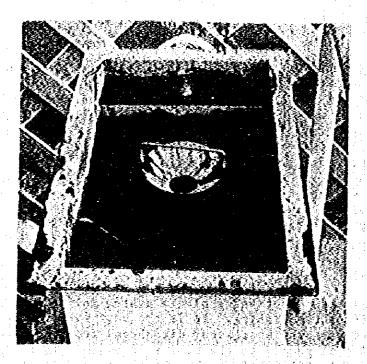
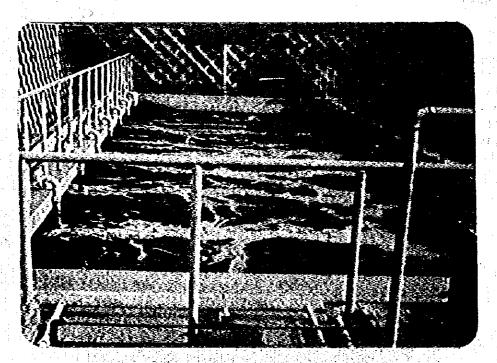
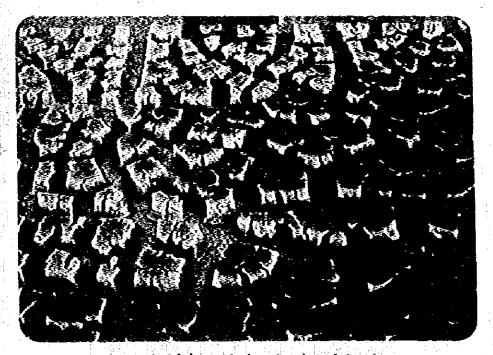
Fig. 2.1 (Cont'd) - Sewage Activated Sludge Plant at Regent Pattaya Rotel

The hotel has an activated sludge system followed by an up-flow sand filter for effluent polishing. It is the best system observed among the hotels in Pattaya. The wastewater discharged from the hotel is received in a pond and then pumped to the activated sludge plant and settled in a clarifier and the effluent from the clarifier is further taken to the sand filter. Sludge dewatering is carried out by sand bed drying system.

Fig. 2.1(a) - Sewage Holding Pond

Fig. 2.1(b) - Flow Measurement (V-Notch Weir)

Fig. 2.1(c) - Activated Sludge System

Fig. 2.1(d) - Effluent from Activated Sludge System

Fig. 2.1(e) - Sludge Sand Bed Drying

Effluent Quality - The quality of the effluent from the activated sludge system is reasonably good and meets the effluent standard imposed by authorities of Thailand. The effluent standard adopted by Ministry of Public Health and Ministry of Industry in Thailand is presented in Table 2.4 and comparing with the effluent characteristics in Table 2.1, it may be observed that the effluent standards are met. Table 2.1 also shows the characteristics of the effluent from the up-flow filter which is far better than the allowable limit by the standards. It appears that there is no need of up-flow filter to produce effluent to meet the standard requirements.

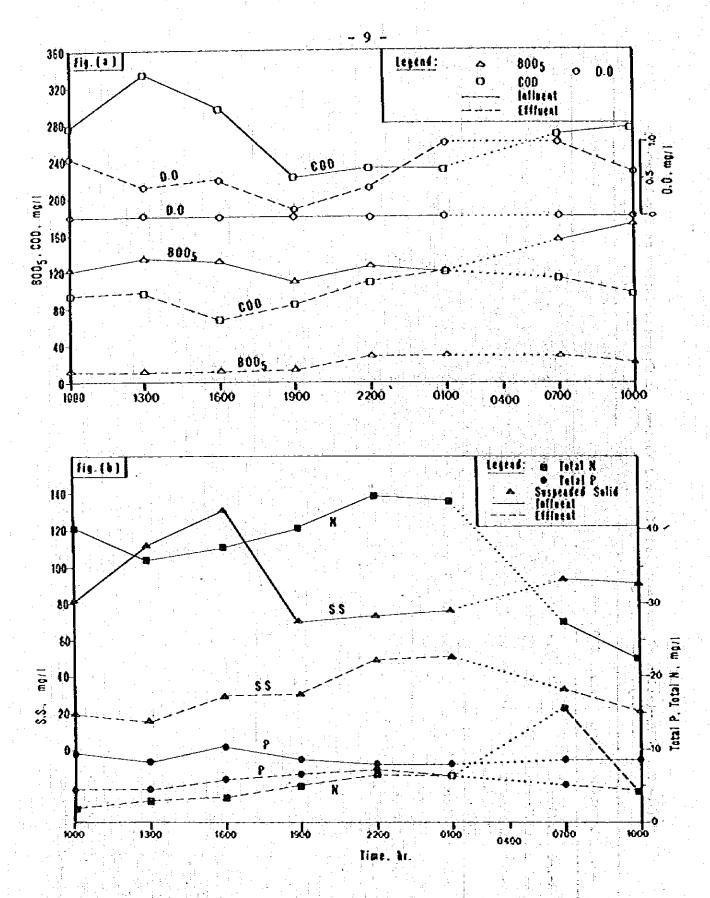
Fig. 2.2 Variation of Wastewater Characteristics at Hotel Regent Pattaya

Wastewater grab samples collected at three-hour intervals over twenty-four hours (January 8-9, 1978) were analysed for the important wastewater parameters. At each time, samples were taken at the influent and effluent of the treatment plant. A summary of the wastewater characteristics of the influent and effluent is given in Table 2.1. The activated sludge plant and the sampling locations are shown in Fig. 2.1. The variation of the wastewater characteristics of all the parameters over the twenty four hourperiod is plotted in Fig. 2.2

Prom Table 2.1, it can be observed that there was no influent from 10 p.m. to 4.00 a.m. and at 4.00 a.m. no effluent was observed. At 7.00 a.m. in the morning the influent pump worked only for two minutes and stopped. Due to the variation of influent wastewater characteristics of some parameters, it was thought useful to present the results of those parameters in the form of cumulative relative frequency diagram as shown in Fig. 2.3. The 50, 70, 80 and 90 percentiles of the wastewater characteristics of the influent to the activated sludge plant is given in Table 2.2. Table 2.3 gives the minimum and maximum values of the wastewater characteristics for the 24 hour study period.

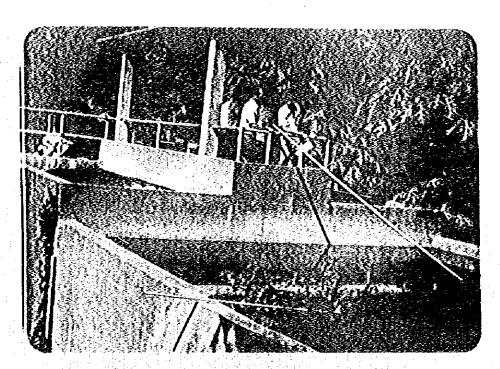
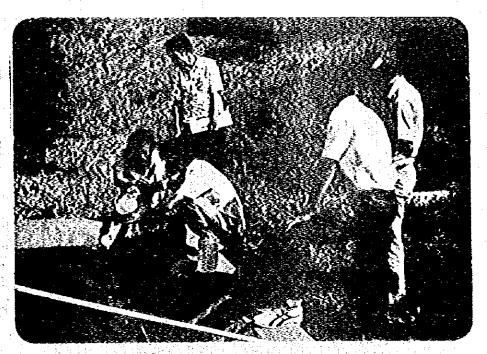
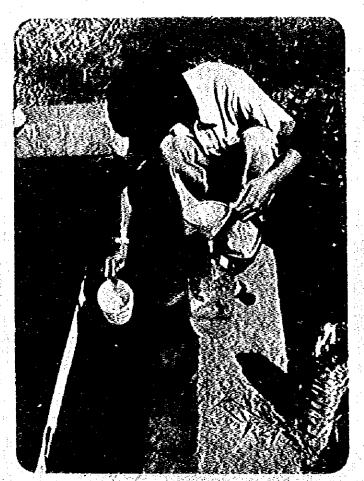
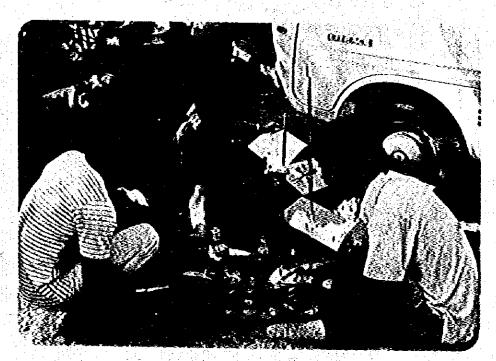
Fig. 2.4 - Sewage Activated Sludge Plant at Orchid Lodge

- 2. Orchid Lodge Another activated sludge plant showing good: performance is at Orchid Lodge, as shown in Fig. 2.4. Samples at the influent and the effluent from the plant were collected and analysed. The results are shown in Table 2.6 under the code 1-1 and 1-2 respectively. The levels of BOD5, COD, SS and pH in the effluent are within the allowable standard limits set by the Ministry of Thailand for sewage and industrial wastes. The ratio of BOD5:N:P of the influent is 100:0.53:1.07. Normally the ratio BOD5:N:P of 100:5:1 is considered as the minimum requirement and in view of this, the concentration of nitrogen in the wastewater is lower. The performance of the activated sludge system might be improved if the level of nitrogen could be increased by adding some nutrients.

Fig. 2.4(a) - Aerator and Sedimentation Basin

Fig. 2.4(c) - Effluent Sampling

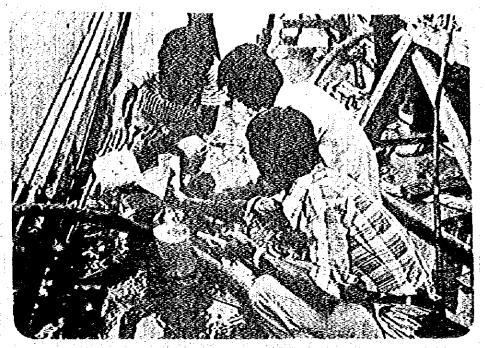
Fig. 2.5 - Sample Collection and DO Determination at Reekender Hotel

- 3. Hotel Weekender This hotel has an activated sludge plant which was not operating at the time of sampling and thus only one sample was collected at the discharge, as shown in Fig. 2.5. The characteristics of the discharge are shown in Table 2.6 under the code 2-1. There is a need that this waste should be treated before discharged in any receiving stream. The ratio of BOD5:COD is 0.75 and the ratio of BOD:N:P is 100:17.1:3.4. There is enough nutrients in the wastewater and the BOD5:COD ratio is well within the desired range of 0.6 to 0.8 for biological treatment of the wastewater.

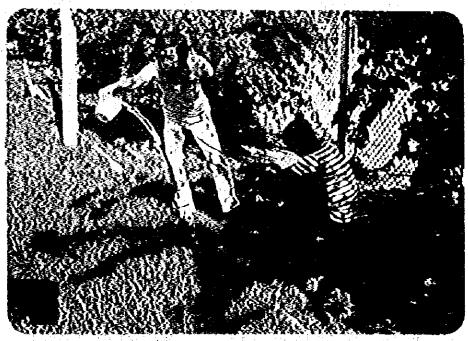
4. Holiday Inn - There is no treatment facility at this hotel. Sewage was simply retained in pond and then used for plants and grass watering through taps and hoses. At night, bad odor could be smelled in the hotel compound, as the result of prevailing anaerobic conditions in the holding pond (zero dissolved oxygen). The BOD5 and COD values of the sewage are respectively 175 mg/l, and 352 mg/l higher than the allowable limits set by the Ministry of Industry, too high to be discharged in any receiving body. The hotel needs to have a better waste treatment facility for meeting effluent standards.

Fig. 2.6(a) - Sewage Holding Pond

Fig. 2.6(b) - Effluent Disposal by Lawn Spraying Fig. 2.6 - Sewage Holding Pond and Effluent Discharge at Holiday Inn

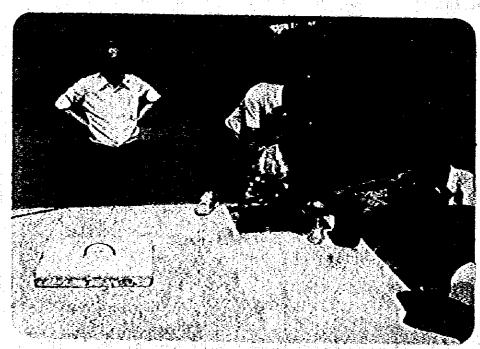
Pig. 2.7 - Septic Tank at Siam Bayshore Hotel

5. Hotel Siam Bayshore — This hotel has a septic tank for the treatment of the wastewater. Samples were collected from the septic tank and analysed. The results of the wastewater characteristics are presented in Table 2.6 (station No. 5) and reveal that the septic tank is not working properly. Added to this, the septic tank effluent is directly discharged into a nearby canal, the Pattaya Canal, which turns black due to the prevailing anaerobic conditions in the canal. The concentration of BODs (257 mg/1) is higher compared to Asia Pattaya. The zero concentration of BO confirms existence of anaerobic conditions.

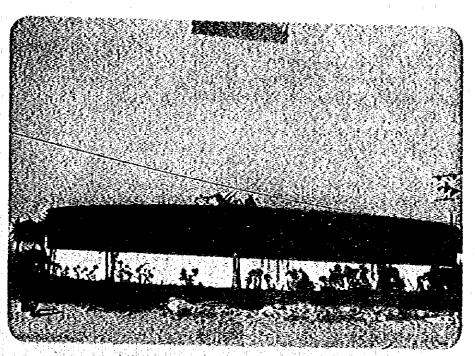
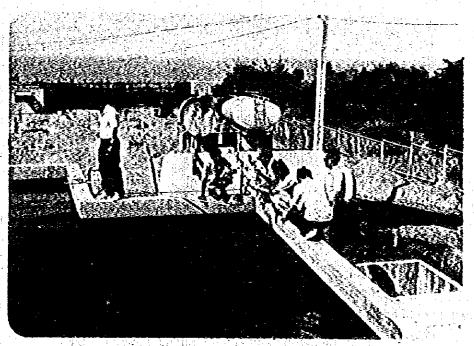
Fig. 2.8 - Activated Sludge Plant at Royal Cliff Hotel

6. Royal Cliff Hotel - This hotel possesses an activated sludge plant, as shown in Fig. 2.8. However, the clarifier was under designed, being ineffective in removing the solids which were washed out in the effluent. The influent and effluent wastewater characteristics are presented in Table 2.6 under the code 6-1 and 6-2. The BODs and COD values of 100 mg/l and 144 mg/l in the effluent is higher than the standards set by the Hinistry of Industry. A better effluent, perhaps meeting the standards, could be achieved by improving the settling conditions in the clarifier.

Fig. 2.8(a) - Covered Activated Sludge Plant

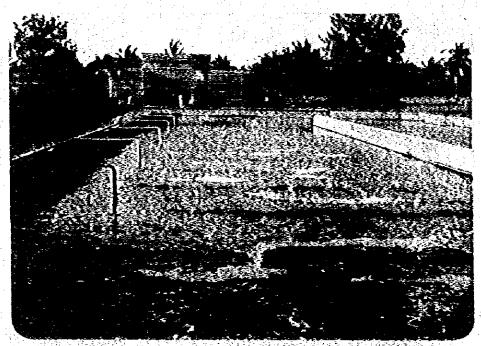
Fig. 2.9 - Aerated Lagoon at Asia Pattaya Hotel

7. Hotel Asia Pattaya — This hotel has an aerated lagoon system as shown in Fig. 2.9. On the day of sampling, it was reported that some KMnO4 was added in the lagoon to prevent the development of odor. The lagoon looked pink and all the biological system was disturbed due to the addition of KMnO4 which could be toxic to the microorganisms. The influent and effluent wastewater characteristics are shown in Table 2.6 under the code 7-1 and 7-2. The BOD5 and COD values of 85 mg/l and 236 mg/l in the effluent do not meet the standards set by Ministry of Thailand. With the better operation of the lagoon system, better effluent could be produced.

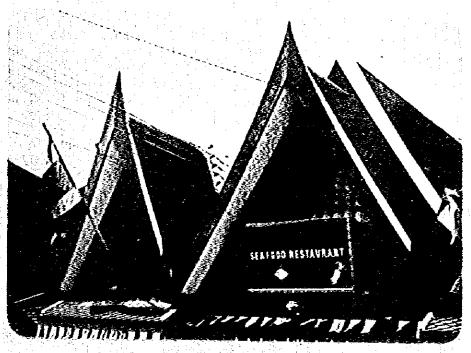
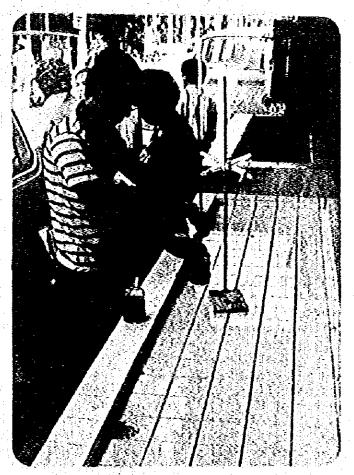
Fig. 2.10 - Nang Nual Restaurant

8. Mang Nual Restaurant - This is one of the best sea food restaurant in Pattaya and at present discharges all the wastewater directly into the sea. Samples near the outfall could not be taken due to high tide period. Samples were, however, taken from the kitchen. The characteristics of the wastewater from the kitchen is presented in Table 2.6 under station 4. It may be observed that the levels of BOD5, COD, SS, N and P (2070, 2280, 1360, 62.7 and 44 mg/l, respectively) were all quite high. This was expected as the waste consisted of mostly waste meat pieces. Due to the presence of high BOD5, COD and suspended solids it is unacceptable to discharge this waste directly into the sea, and some form of treatment seems necessary.

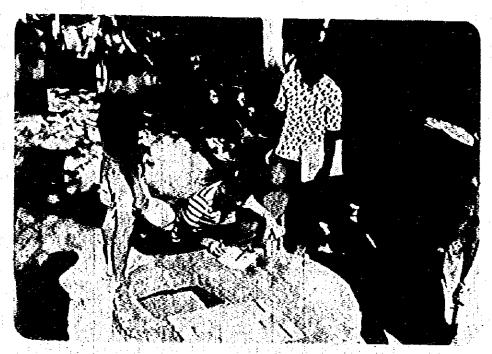
Fig. 3.1 Well in the Naklua Residential Area (Station 22)

Exception to some situations, most of the water quality parameters are within the allowable limits. The concentration of iron (Pe), ranges from 0.08 to 3.36 mg/l with the highest concentration in the water sample from public water supply tap (station 23). Iron in excess of 1.0 mg/l will cause unpleasant taste and reddish brown colour which produces staining of laundry,

fountains and plumbing fixtures. The level of iron (Fe) should normally be kept at about 0.3 mg/l. In view of this, it appears that the water from all the wells and the public water supply tap except at stations 15 and 16 need some form of aeration which will convert iron into its insoluble forms.

Summary: In general, except for the MPN values, turbidity and the concentration of iron (Pe) in the water samples, the water constituents are within the satisfactory levels. It is recommended that the water in the wells and the public tap water should be filtered and disinfected properly so that the water quality is acceptable for drinking and before disinfecting, iron (Pe) level will be reduced to a lower level making it satisfactory for domestic uses.

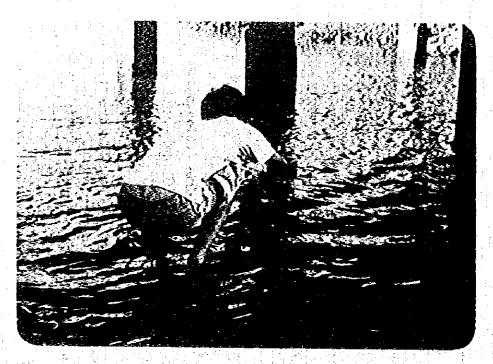
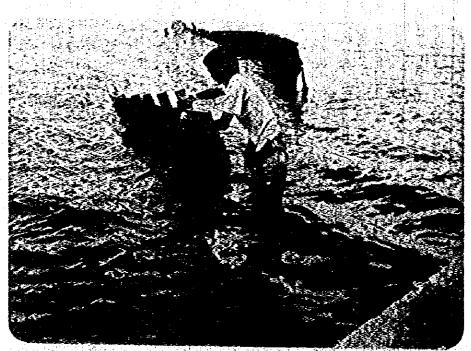
Fig. 4.1 - Na Chom Tiem River.

- 1. Na Chom Tiem River The dissolved oxygen levels, at the river mouth and down below the Sukhumvit Righway underneath the bridge i.e. at stations 10 and 9 respectively, were 8.5 mg/l and 7.2 mg/l which denote the healthy condition of the river. The BOD5, SS, N, P and pH are all within the allowable limits stated in stream standards. As expected, the chloride concentration at the river mouth (to the sea) is quite high and is 17,150 mg/l, slightly lower than the chloride concentration at sea. However, the HPN values of 940 and 2400 per 100 ml at stations 9 and 10 indicate the presence of fecal pollution. Comparing with the stream standards based on stream classification and wastewater treatment given in Table 4.2, the river could be classified as B class and thus suitable for fishing but not suitable for bathing and drinking due to the presence of high density of coliform bacteria.

Fig. 4.1(a) - Underneath the Bridge on Sukhumvit Highway (Station No. 9)

Fig. 4.1(b) - At the River Mouth (Station No. 10)

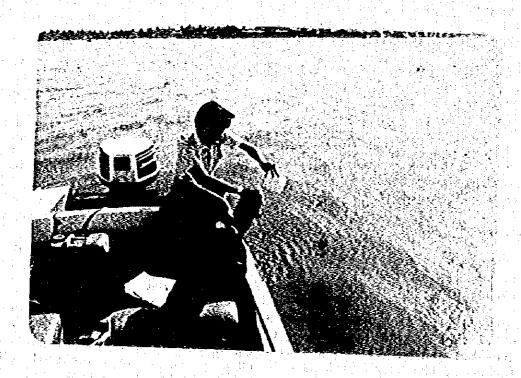
Fig. E. 1 Sample Collection (Station No. 25)
Offshore of Na Klean Village

creation. However, the sea water quality at station 25 which is located offshore of Na Klua pier is not acceptable for sea swimming or bathing purposes, as far as coliform content is concerned. Some undesirable and objectionable objects were seen floating around the area and bad odor could be smelled. The DO level of 1.7 mg/l is quite low and MPN count of 7,500 per 100 ml indicates the presence of fecal contamination. In this present condition, the area around station 25 should be avoided for recreational purposes. In general, the BOD5 concentration in sea water is low at three stations.

Summary: Sea water quality in the popular area i.e. between station 26 and 27 is at present in excellent condition and should be protected from future pollution hazards. The area around station 25 should be improved and care should be taken to stop organic fecal pollution around the area.

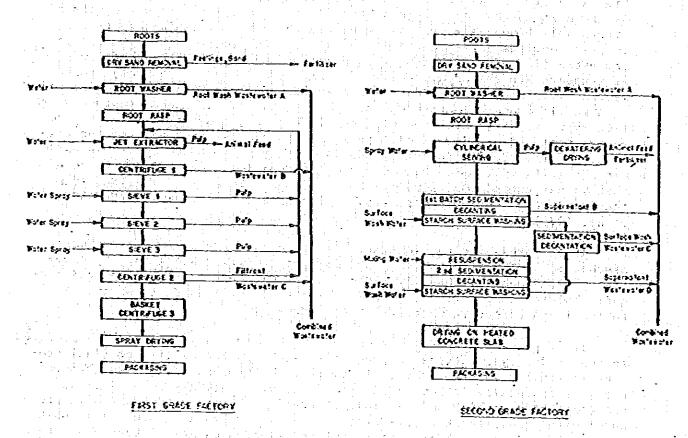
Fig. 1. Topicco Starch Processing In Thoiland

utilized by second-grade starch factories, which are usually small private-enterpirse plants; these installations are not capital intensive but use very simple methods of separation by cloth filtration, gravity settling, decanting and drying on heated concrete slabs. Plow diagrams for both types of process are given in Fig. 6.1 and wastewater streams are shown.

4. Wastewater Emission Rates - The combined wastewater from tapioca starch production is mainly composed of two kinds of wastes, the root washwater and either the starch supernatant decanted from sedimentation basins or the separator wastewater, depending upon whether a second-grade or first-grade starch factory is being considered. First-grade factories process in the order of 200 metric tons of tapioca root per day while second-grade factories commonly process about 30 tons per day. Unit emission rates (UMER Values) for the characteristics of wastewater from first and second-grade factories are shown in Table 6.1. Designations A, B, C and D refer to waste sources shown in Fig. 6.1.

7. Recommended Approach to Treatment - Although tapioca starch is produced in two grades by two different types of processes, both first and second grade factories discharge two major wastewaters. These are washwater, from root washing (wastewater A in Figure 6.1), and separator waste, from jet extraction and channel separation in first-grade factories (wastewaters B and C in Fig. 6.1, 1st grade factory), or starch supernatant decanted from sedimentation basins in second-grade factories (wastewaters B, C, D in Fig. 6.1, 2nd grade factory).
