THE
INVESTIGATION REPORT ON
KRUNG DHEB BRIDGE AND KRUNG DHON BRIDGE

1. Preface	1
2. Conditions of Design	7
3. Floor Slab	12
3.1 Present Condition	12
3.2 Cause of Crack	21
3.3 Countermeasures	21
4. Mechanical and Electrical Equipment of	
Bascule Drive Device	30
4.1 Present Situation	30
4.2 Proposed Measures	32
5. Postscript	36

This report is an investigation report compiled by the said expert team, the investigation of which made between the period of 1 April and 15 April, 1970. The report covers the problem on concrete floor slab and the problem on electrical and mechanical equipment and recommends the respective countermeasures.

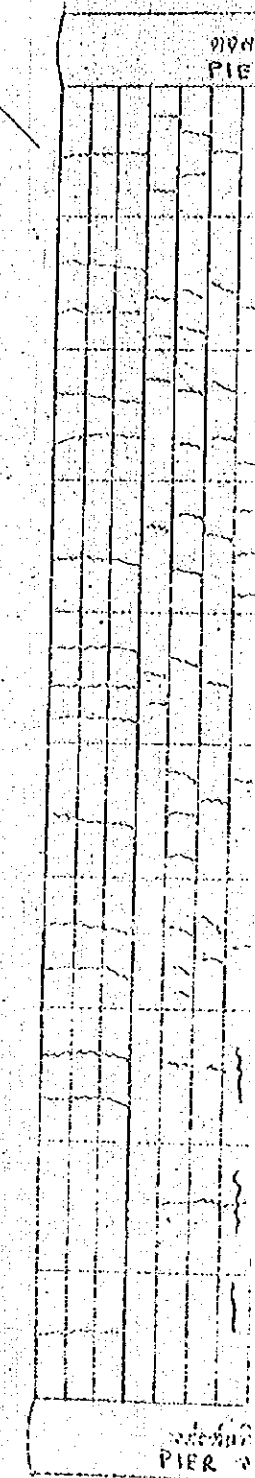
Cracks are seen in the concrete floor slab of these bridges as shown in Fig-5 (investigated by the Public and Municipal Works Dept.) and the photographs: Figs. 6, 7 and 8.

- 1) The direction of crack is wholly perpendicular to the bridge axis with the exception of a part (No. 5 span from Bangkok side) of Krung Shon Bridge.
- 2) It seems that the cracks appeared at the lower surface of floor slab of roadway are minor ones which being about less than 0.2 mm wide.
- 3) On the upper surface of roadway, cracks are seen on the pavement surface of the cross beam position only.
- 4) On the footpath, cracks were seen on both the upper surface and lower surface.
- 5) In Nondhaburi Bridge which is of the same structure as Krung Shon Bridge and the Krung Shon Bridge erected by the same builder at the same period of time, the traffic volume was rather low and the cracks almost none.

Temperature contraction cracks
