**SUPPLEMENTAL MATERIALS ON EXISTING
AIRFIELD FACILITIES (CHAPTER 3,
SUBCHAPTER 3-2)**

LUSAKA INTERNATIONAL AIRPORT DEVELOPMENT PROJECT

FEASIBILITY STUDY, 1985

JAPAN INTERNATIONAL COOPERATION

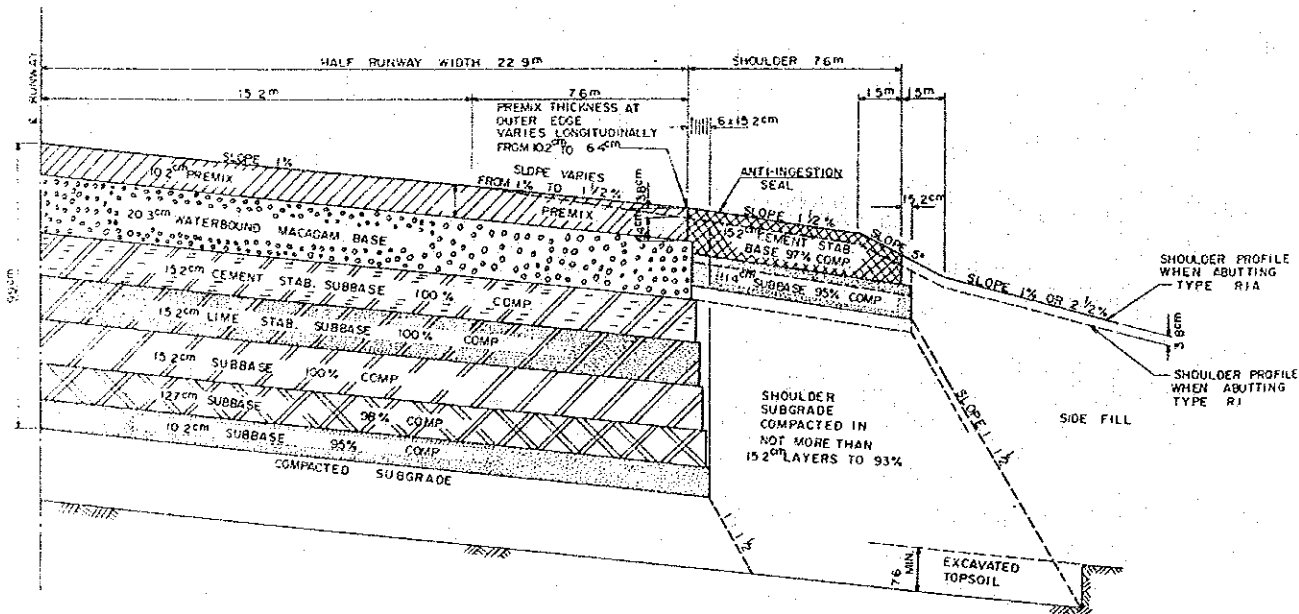
C-4-4 Flexible Pavement of Type R1AB

NOTE THIS IS A PREMIX TRANSITION SECTION BETWEEN TYPES R1 AND R1A

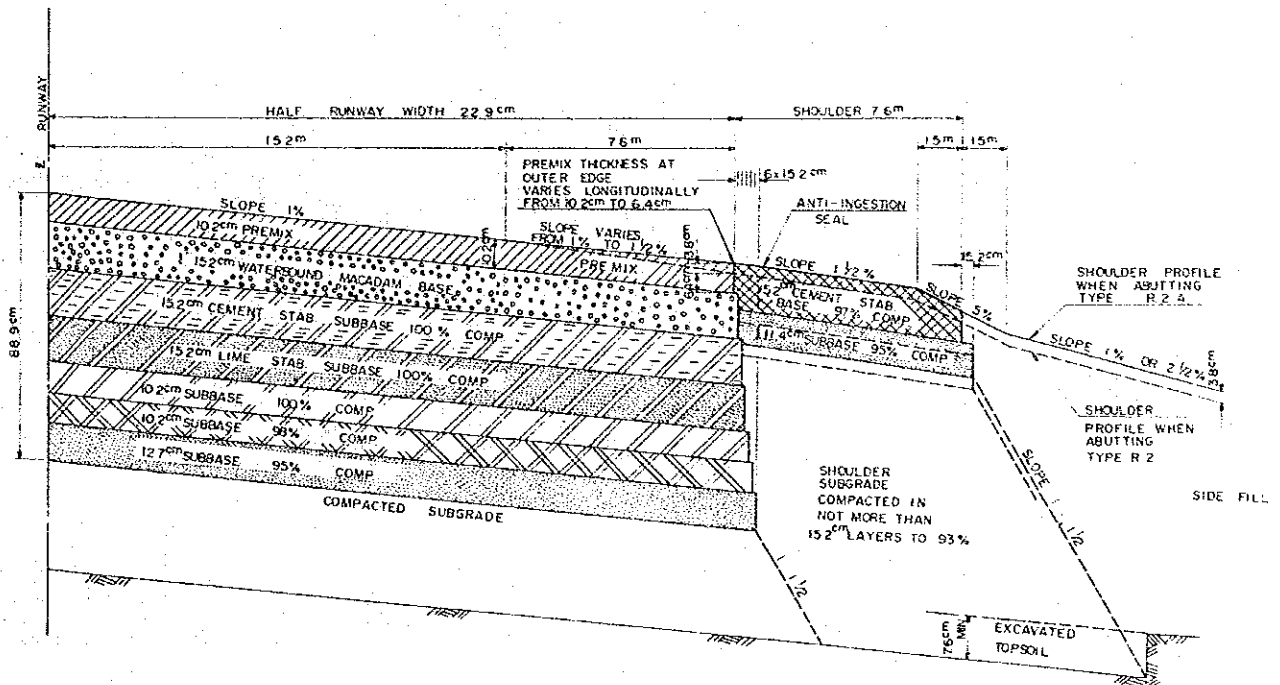
C-4-6 Flexible Pavement of Type R2AB

NOTE THIS IS A PREMIX TRANSITION SECTION BETWEEN TYPES R2 AND R2A

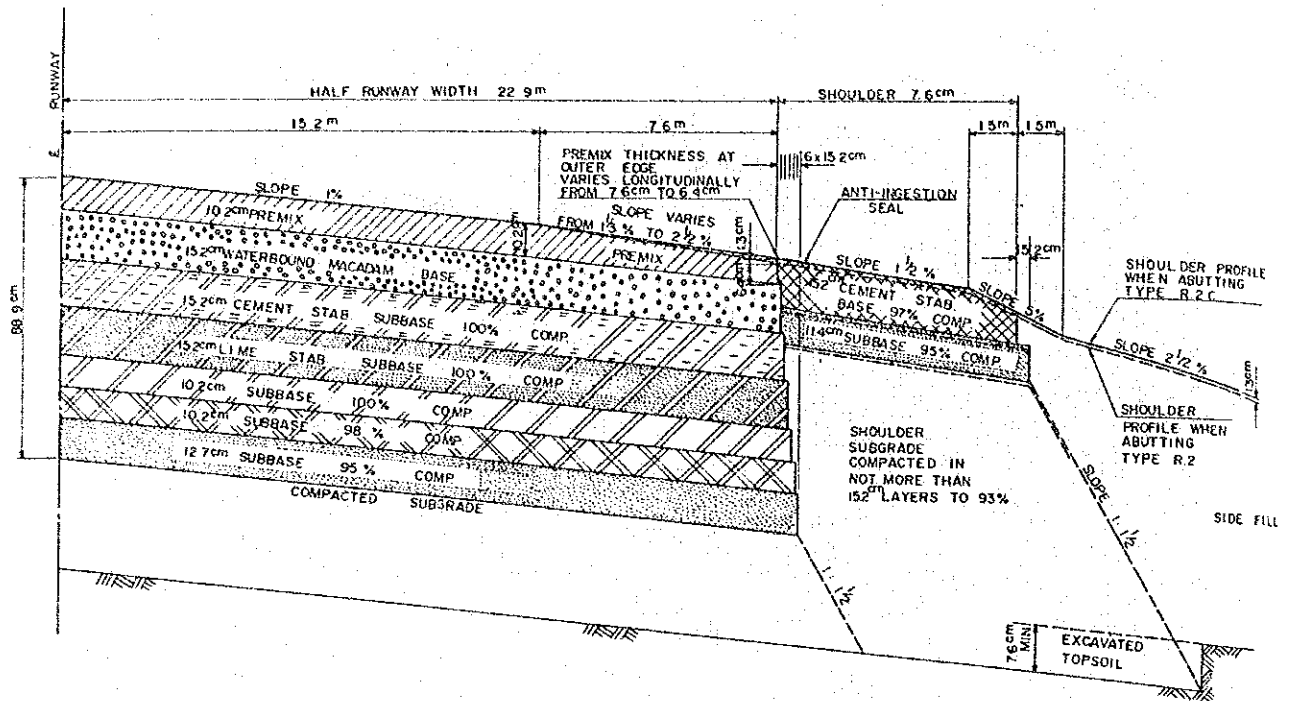
C-4-7 Flexible Pavement of Type R2BC

NOTE THIS IS A PREMIX TRANSITION SECTION BETWEEN TYPES R2 AND R2C

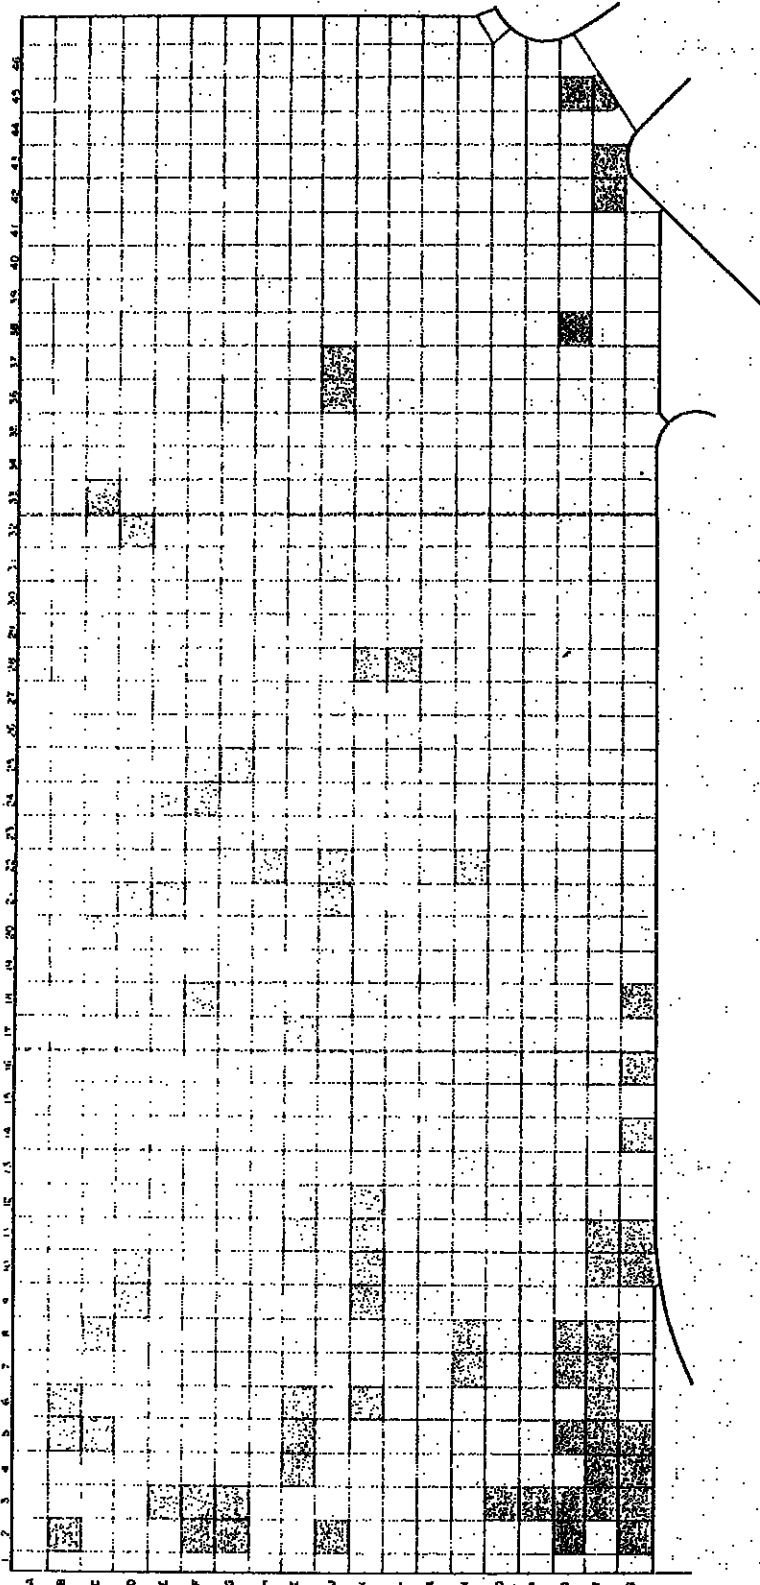
C-5-2-1 Location of Cracked Slabs of Main Apron

Both cement and lime-stabilized soils were granular, of which compressive strength was zero. The locations of cracks of concrete slabs are shown in C-5-2-1 and C-5-2-2, and conditions of cracks at each location are shown in C-5-2-3 to 19.

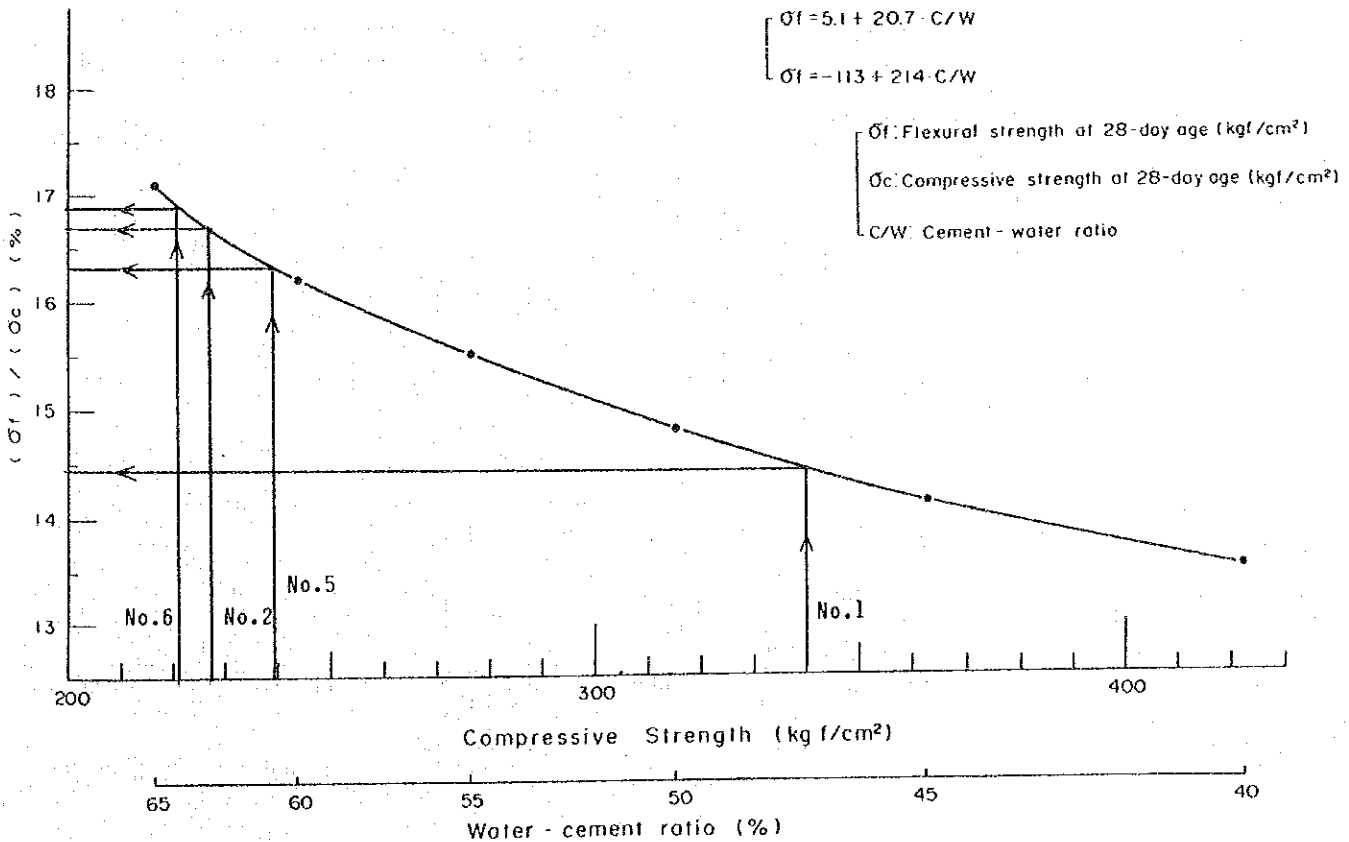
C-5-3-1 Relation between Compressive and Flexural Strengths of Concrete

From C-5-3-1 the flexural strength is estimated as shown in C-5-3-2.

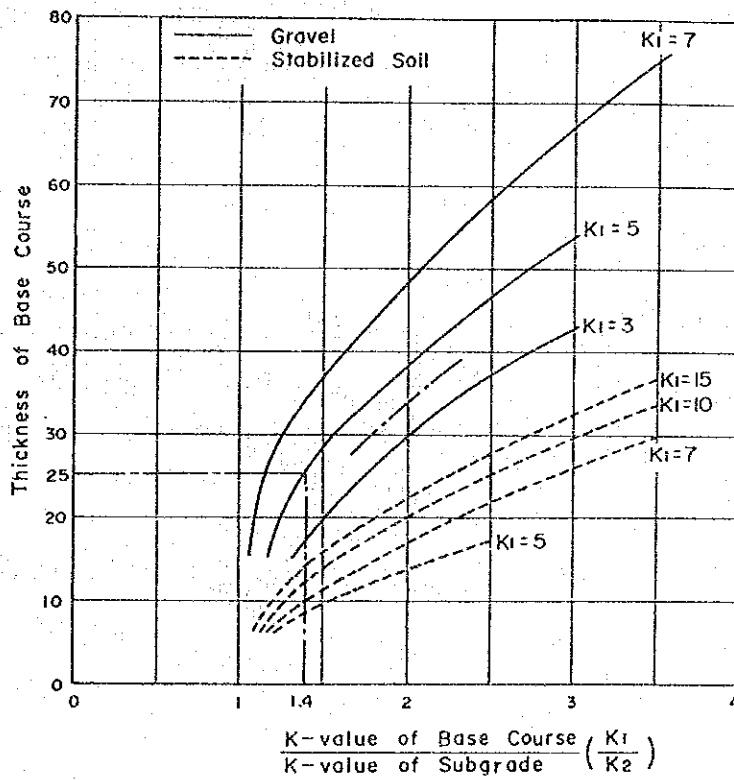
C-5-3-4 Design Curve for Thickness of Base and Subbase Course

Because the thickness of base and subbase courses of rigid pavement is 25cm, the design K-value of base course is estimated to be 5 kgf/cm³ from C-5-3-4.

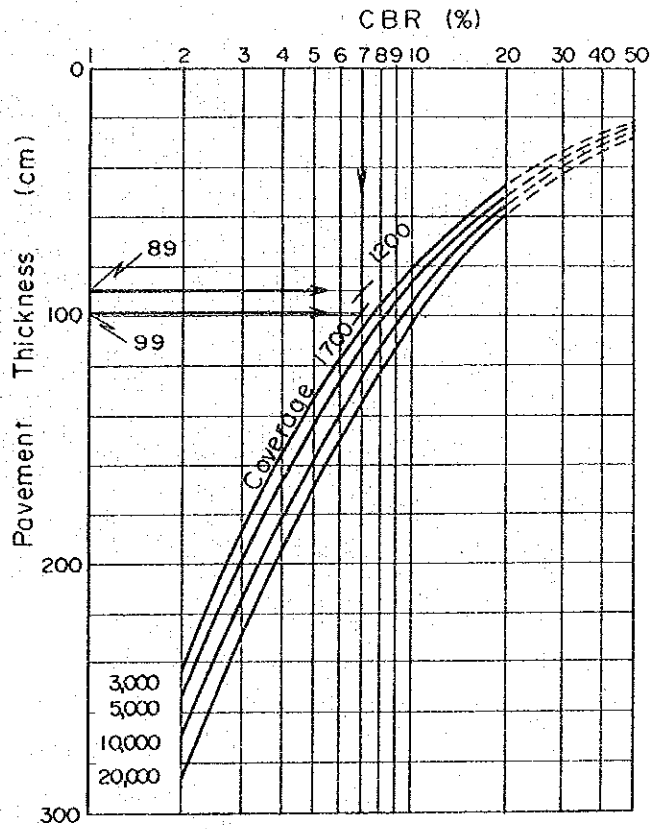
C-6-2-1 Design Curve of Flexible Pavement for B747

The existing runway has flexible pavement of type R2 with the thickness of 89 cm and the CBR of 7%. The relation between the pavement thickness and the CBR of the subgrade is shown in C-6-2-1, which indicates the design coverage of the runway pavement to be 1200 times. On the basis of air transport demand forecast, this coverage is reached in 1992, and, therefore, the existing runway is considered to withstand the forecast aircraft load safely until the end of 1992.

The existing taxiway has flexible pavement of Type T1 with the thickness of 99 cm and the CBR of 7%. C-6-2-1 indicates the design coverage of the taxiway pavement to be 1700 times. As in the case of the runway, this coverage is reached in 1992, and, therefore, the existing taxiway is considered to withstand safely the forecast aircraft load until the end of 1992.

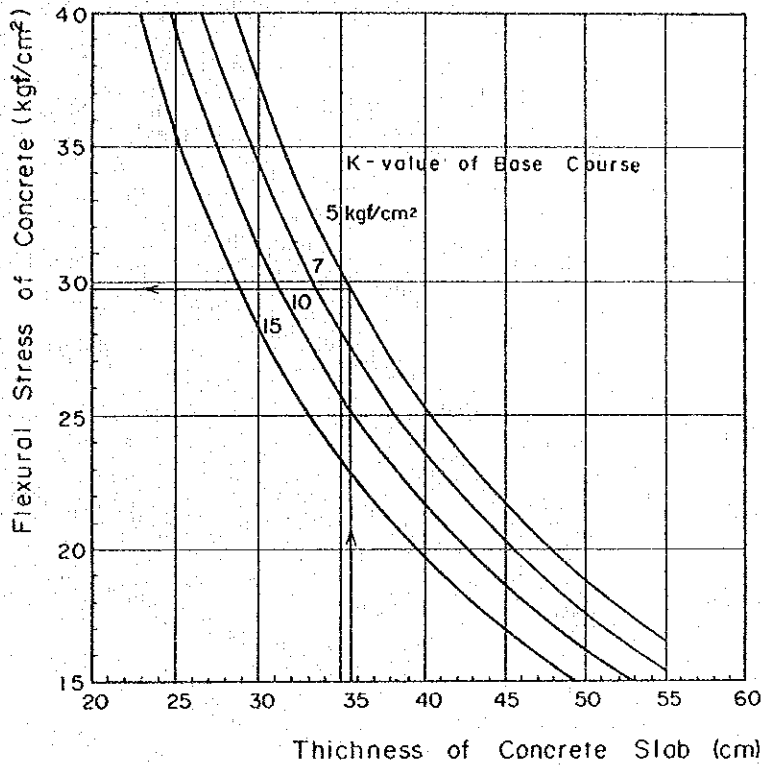
C-6-3-1 Design Curve of Rigid Pavement for B747

The existing apron has rigid pavement with the slab thickness of 35.6 cm, the K-value of 5 kgf/cu.cm and the flexural strength of concrete of 40 kgf/sq.cm. C-6-3-1 indicates the flexural stress of the concrete slab to be 29.8 kgf/sq.cm, and C-6-3-2 shows the design coverage of apron pavement to be 500 times. On the basis of air transport demand forecast, this coverage is reached between the end of 1987 and the end of 1988, and therefore, the existing apron is considered to withstand the forecast aircraft load safely until the middle of 1988.
