3-2 Central District

3-2-1 General Features of Central District

Chapter 4 EXISTING CONDITION OF ROADS AND STREETS

Chapter 5 CURRENT TRAFFIC CONDITIONS

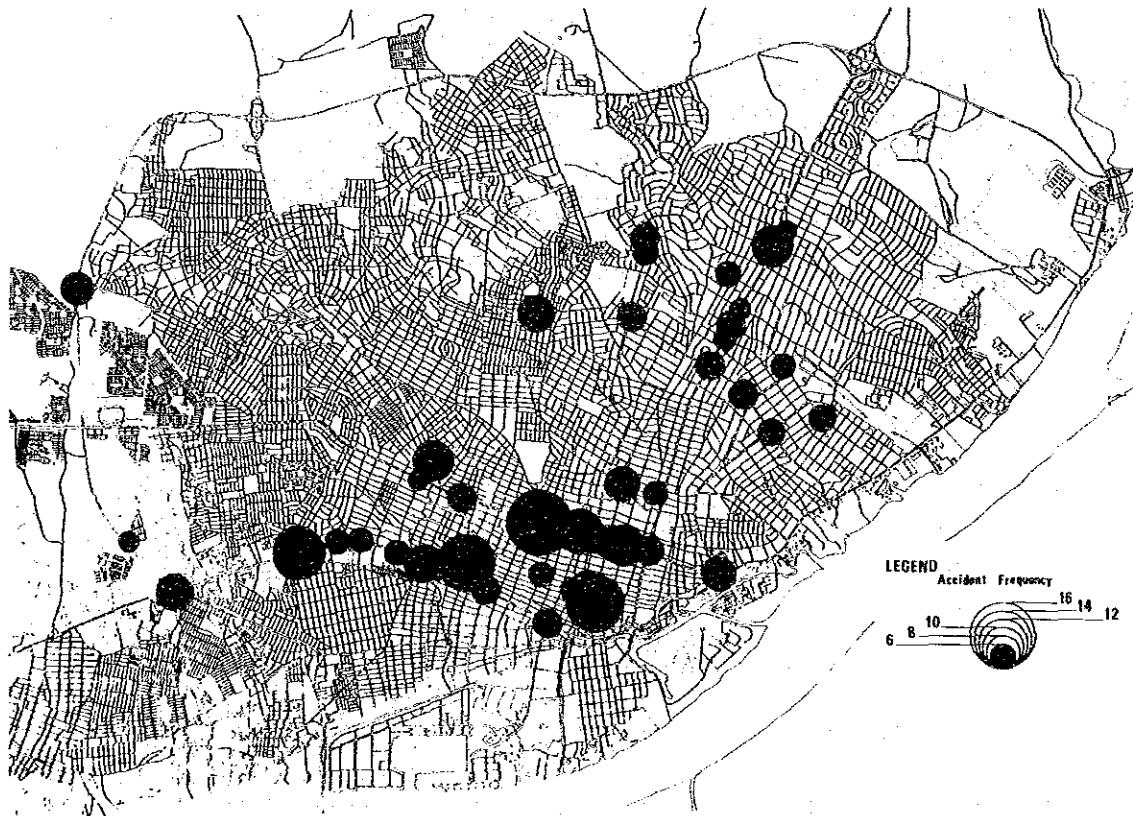
Fig. 5-3-2 High Accident Frequency Points

The locations of high accident frequency are shown in Figure 5-3-2. There was an especially high occurrence of accidents at the following sections: Cras 46-33 on Calle 45 and Cras 38-11 on Calle 30. As shown in Figure 5-3-2, a large number of accidents occurred at intersections of arterial streets, and the biggest concentrations of accidents were located around Cra 38 in the city center and the commercial district in north Barranquilla bordered by Cra 46 and Calles 72 and 76.

The location with the highest accident frequency is the Calle 45–Cra 33 intersection, where 16 accidents were recorded in a year. Other high frequency points are the intersections of Calle 45 and Cra 34, Calle 35 and Cra 27, Calle 30 and Cra 11, Calle 47 and Cra 21, Calle 45 and Cra 44, Calle 64 and Cra 46, and Calle 45 and Cra 38.

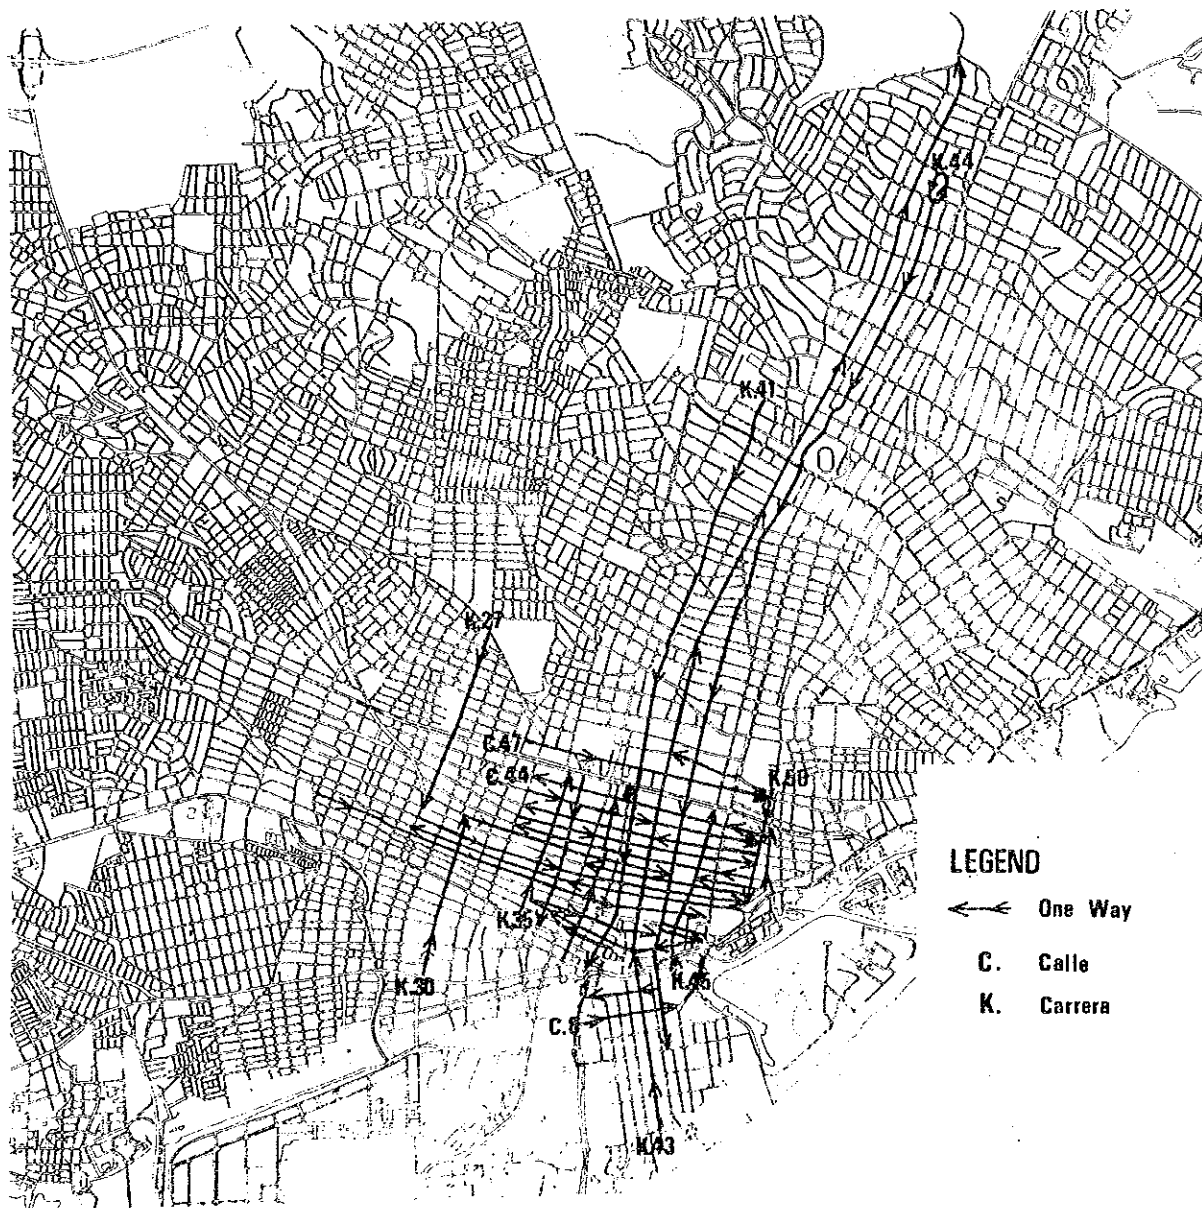
Fig. 5-5-1 One Way Street

As shown in Figure 5-5-1, many streets located in the Centro District and a few major radial streets in the Boston, Colombia and El Porvenir districts are one-way streets. Concentration of one-way streets is especially heavy in the Centro District bordered by Calle 45, Cra 38, Cra 46 and Calle 30. Semi-arterials designated as one way are Cras 41, 43 and 44. Cras 43 and 44 in particular are a pair of one-way arterials that link thae central district of Barranquilla with the northern area.
