#### 2.1.6 Outer water level of planning standard

## 2.2 Topography, Geology and Soils

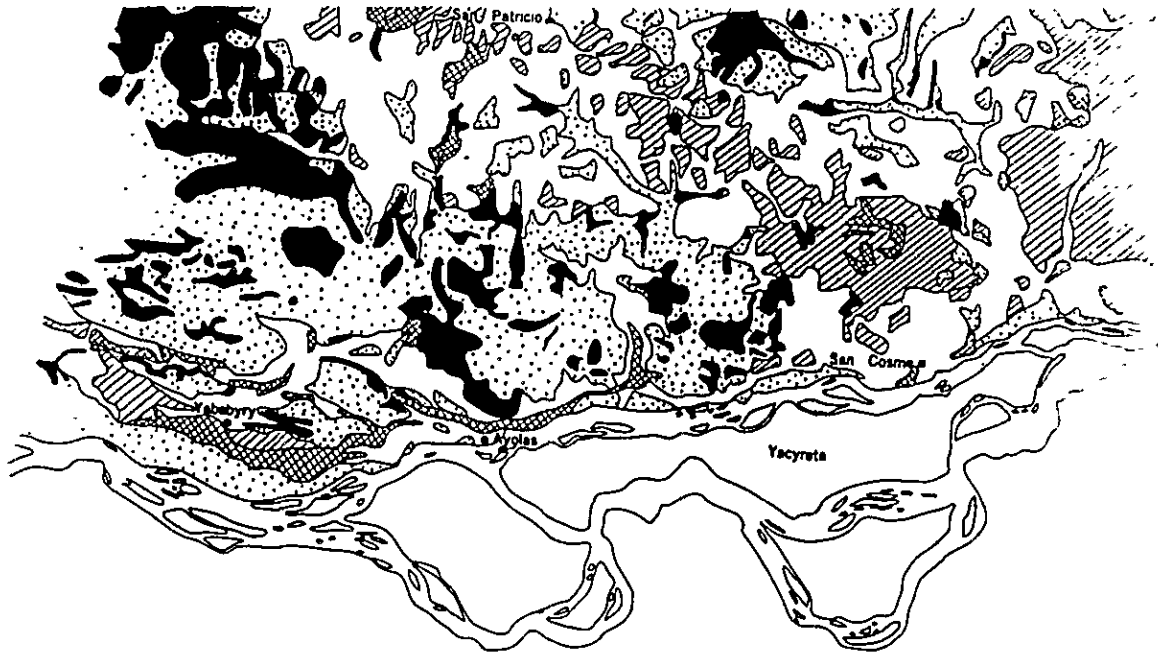
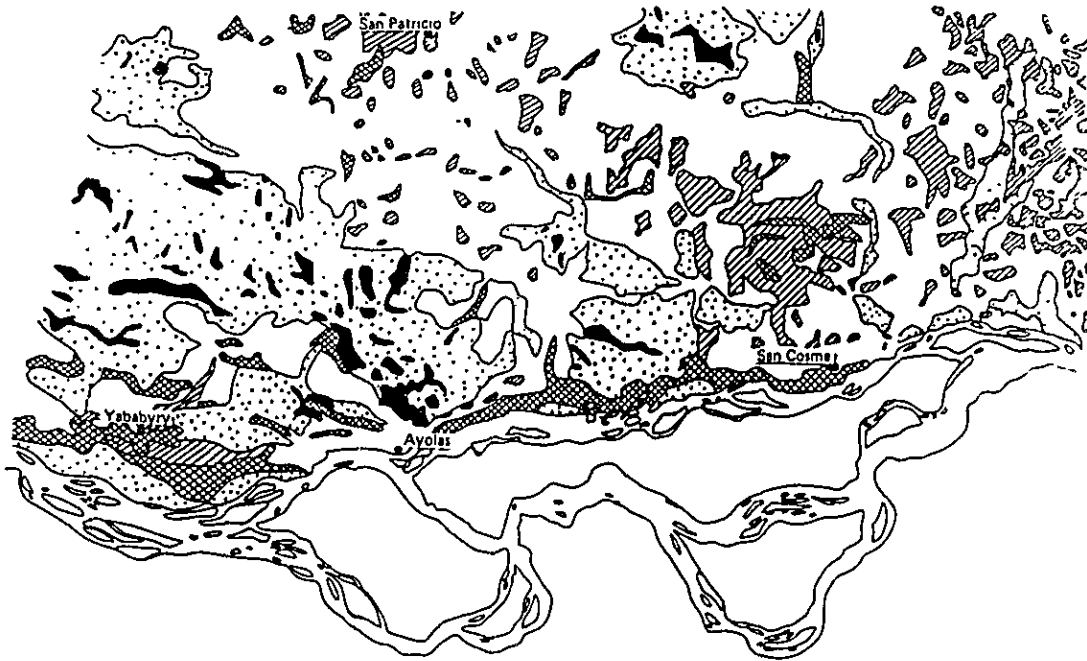
Fig. 2-6-2 Land Flooding Inundation Map 1 (Scale: 1:500,000)

< December 19, 1978 (Rainy season) ->

< August 15, 1978 (Dry season) >

In order to grasp the drainage situations within the survey area, data from LANDSAT was analyzed and the change in the drainage situations by season was analyzed. The results of analysis are shown in the maps of overhead flooding inundation of Figure 2-6-2.

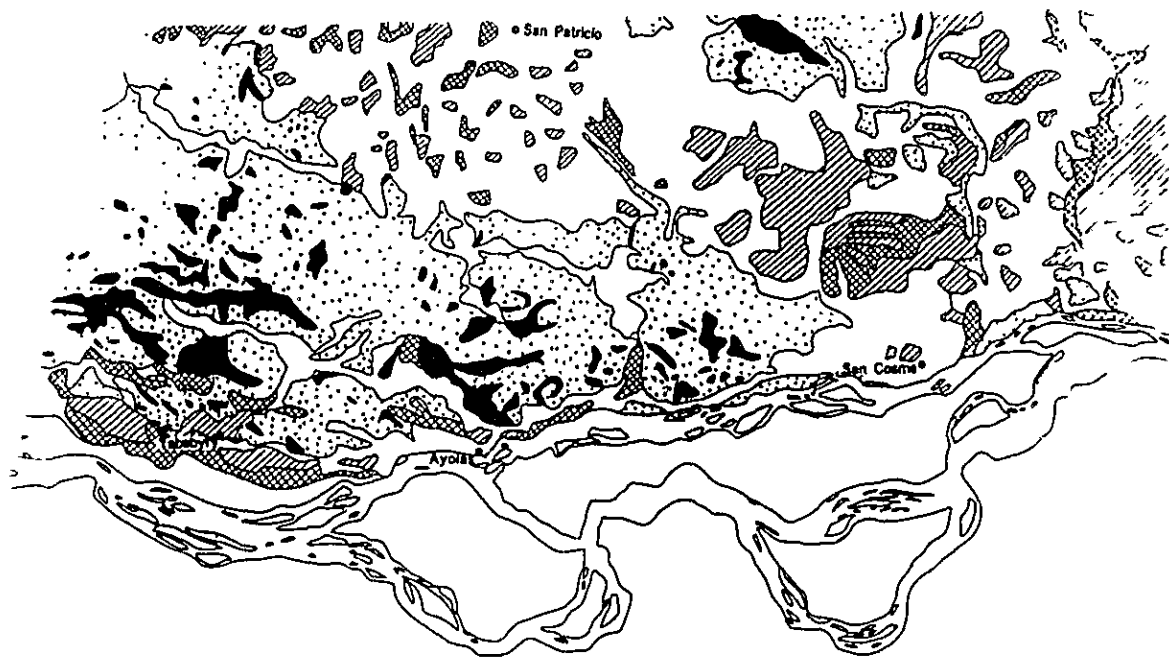
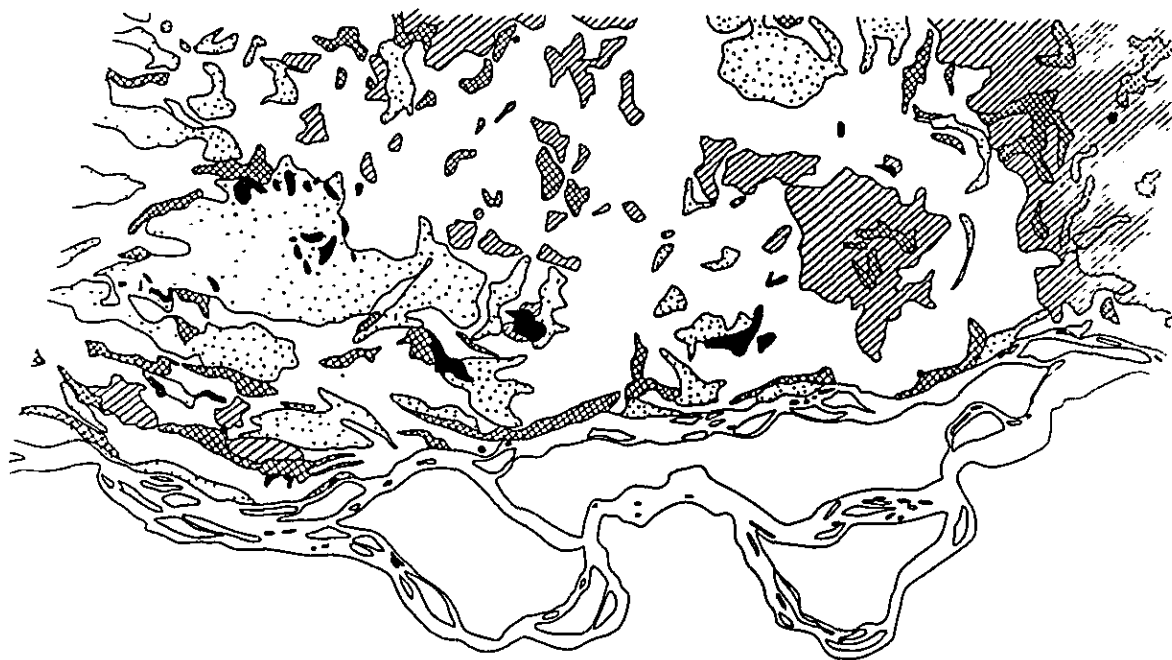
Fig. 2-6-2 Land Flooding Inundation Map 2 (Scale: 1:500,000)

< February 9, 1976 (Rainy season) >

< July 20, 1978 (Dry season) >
