THE PROJECT OF STRENGTHENING AND/OR REPLACEMENT  
OF STEEL BRIDGES ON THE STATE RAILWAY OF THAILAND

A Sub-Project for The Trans-Asian Railway Project  
of The Economic and Social Commission  
for Asia and The Pacific (ESCAP)

13879 646  
338  
JANUARY 1977

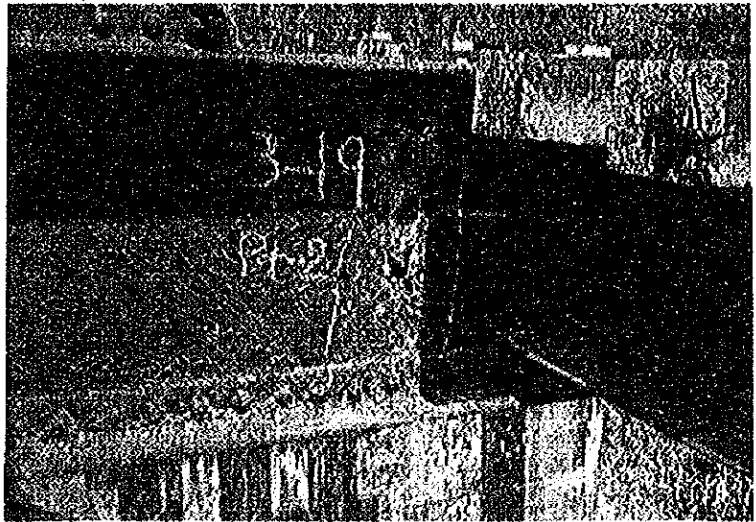
Corrosion of floor beam

Floor beams and lower lateral bracings are locally but severely corroded due to waste and garbage dropped from trains. This kind of corrosion exists on every line, and is an important point for repair and future maintenance (Photo S-3). Corrosion of main trusses and main girders occurs in only a few cases, but local corrosion of lower chord members at the part adjacent to the gusset plates can be observed in many bridges on the Southern Line.

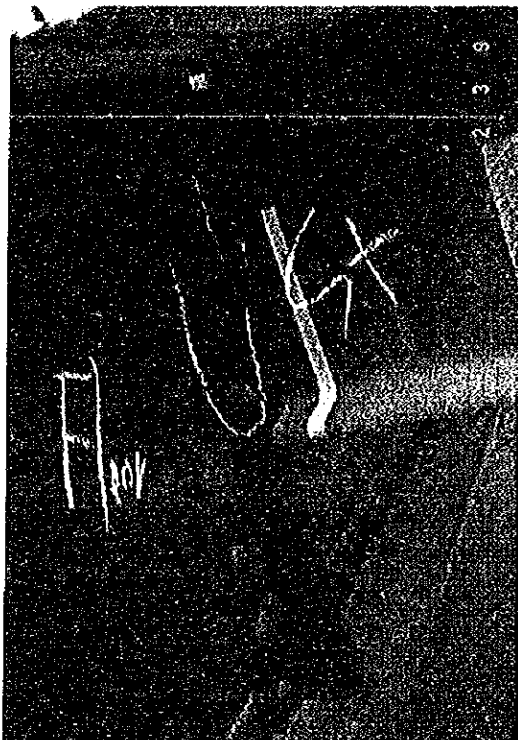
Loose rivets of connection  
for stringer

A considerable number of loose rivets were observed in the connections of principal members such as stringers and main trusses, and in the connections of secondary members such as lateral bracings and stringer struts (Photo S-4). These defects are considered to be mainly due to inadequate design.

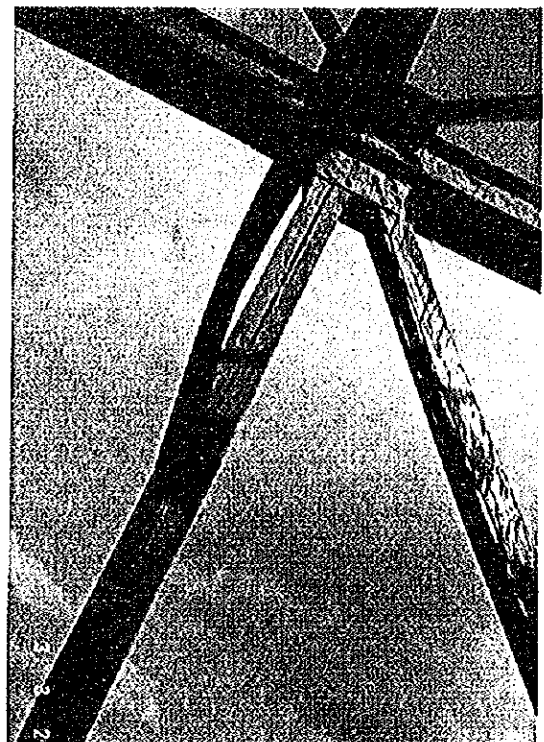
Deformation of sway bracing

Deformation of members was frequently observed in the web plates of lower chord members and lateral members, and likely to have been caused by heavy impacts (Photo S-5) or by improper erection work.

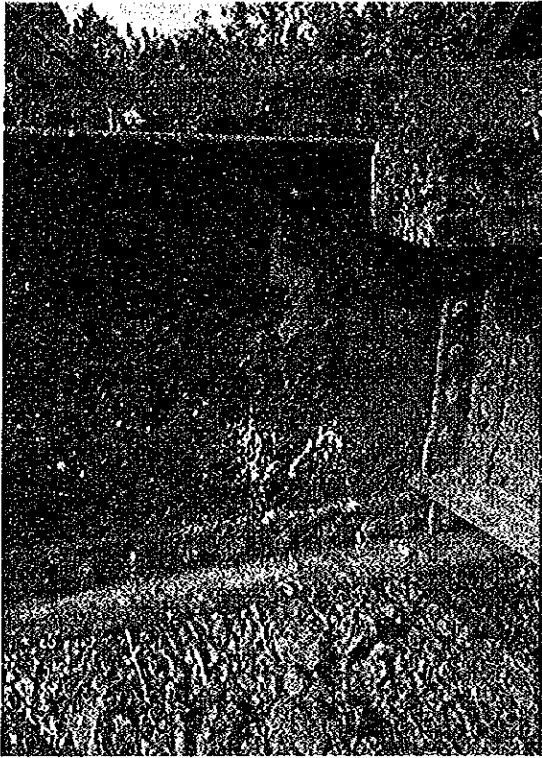
Photo 1  
Corrosion of Web Plate of Floor Beam

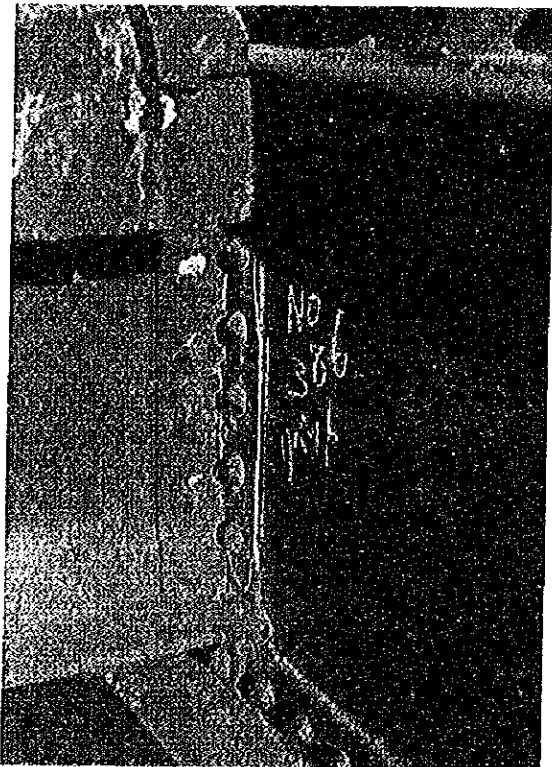
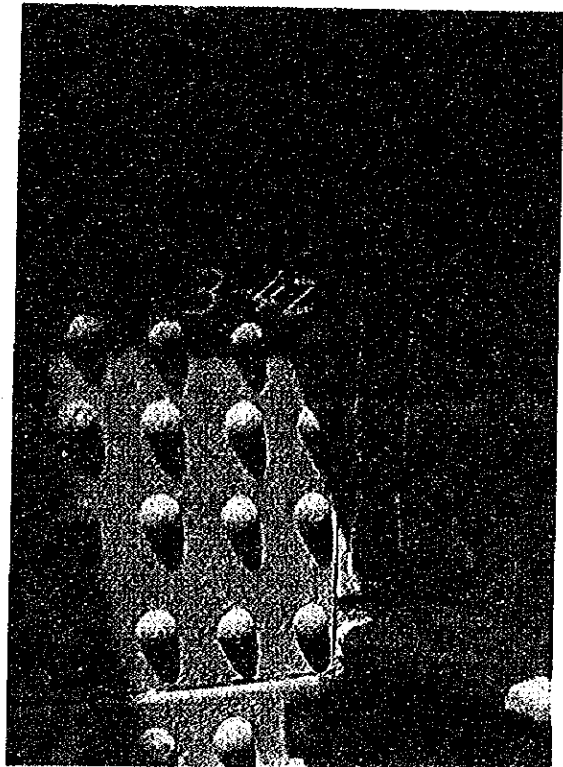
Photo 5  
Loose Rivets for Connection of Stringer with Floor Beam

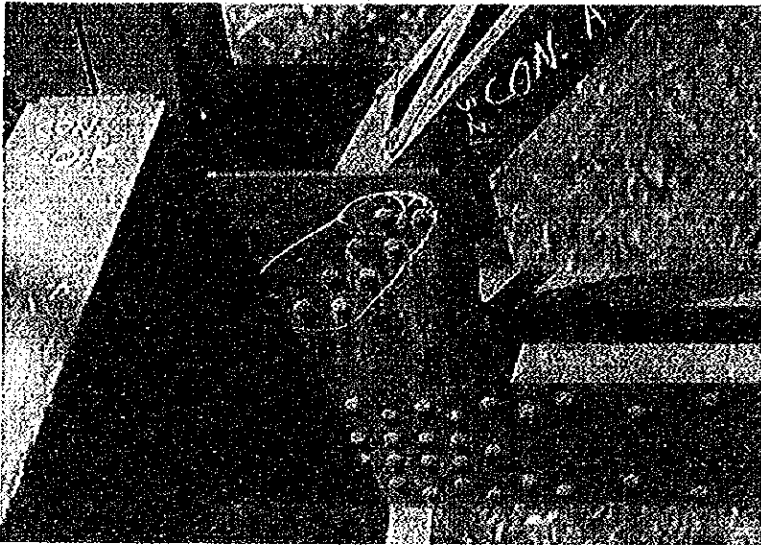
Photo 6, 7  
Loose Rivets for  
Connection of  
Diagonal Members

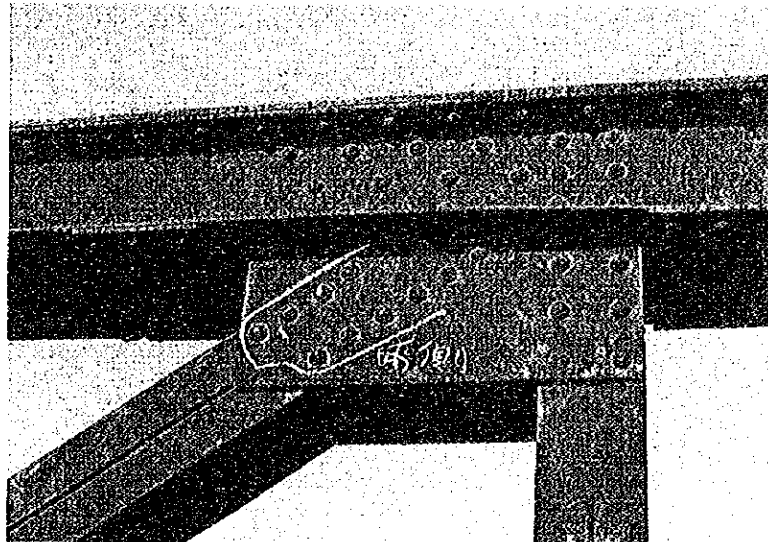
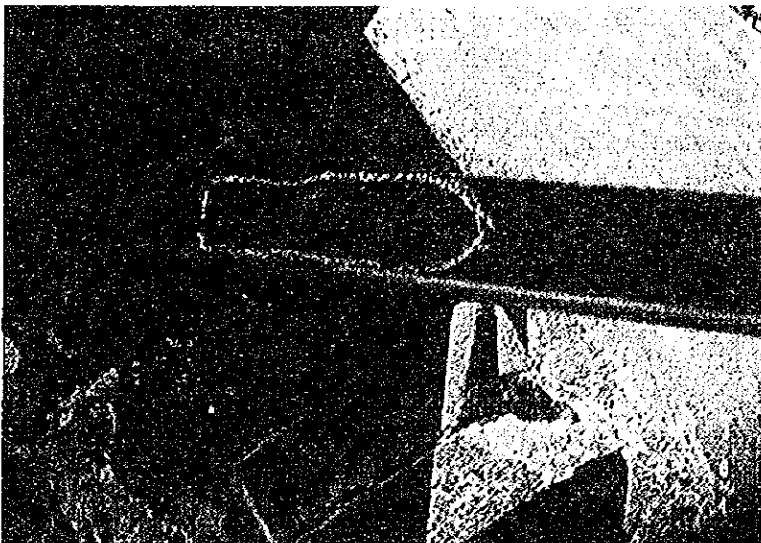
Photo 8  
Loose Rivets for  
Connection of  
Lateral Members

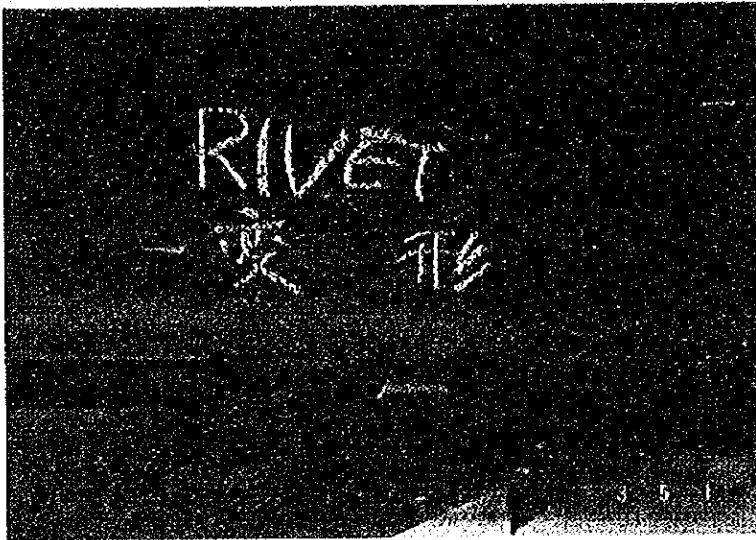
Photo 9

Loose Rivets for  
Connection of Lateral  
Member with Stringer

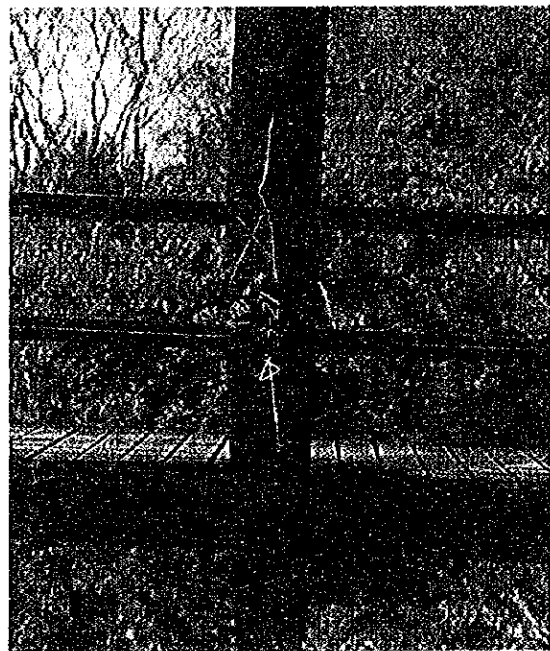
Photo 10

Deformation of  
Vertical Members

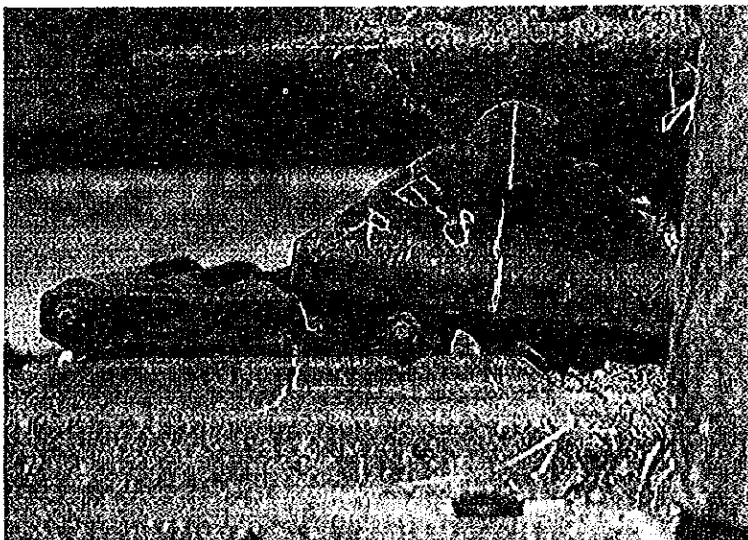
Photo 11

Among them all, the major cause is the horizontal displacement of the abutment which is observed in many places especially on the Eastern Line, where displacement is still in progress. Because of poor concrete under the shoe sole, many shoes have a gap with their bases and some are cracked for which repair is required (Photo 12).

Damage of Shoe  
due to Displace-  
ment of Abutment

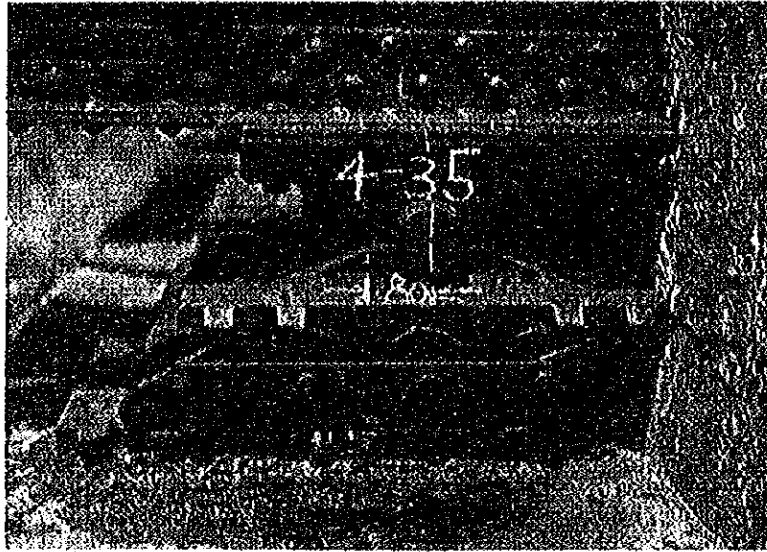
Photo 12  
Damage at the Base of Shoe

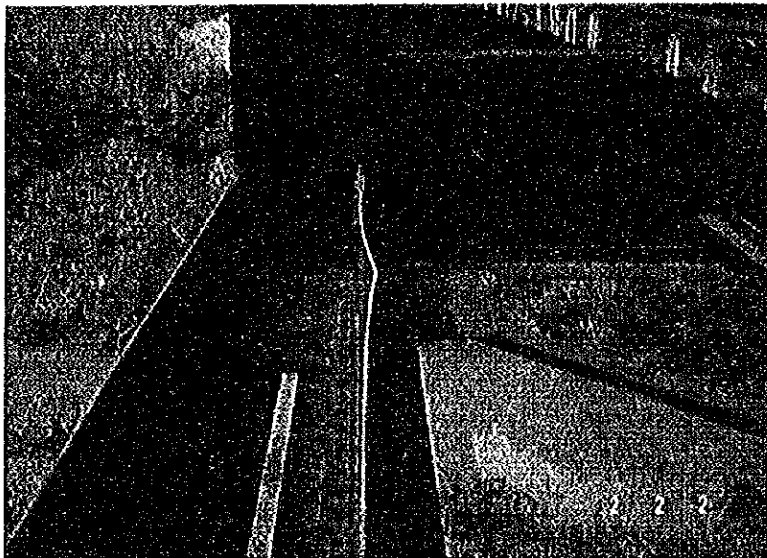
Photo 13  
Deformation of Lower Chord

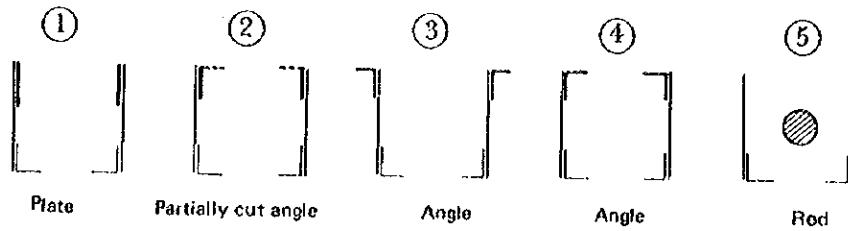
Method ③ presents structural difficulties in relation to floor beams at panel point portion.

Method ⑤ is not employed when the configuration of original section is not adequate. In view of the shape of the original sections, Method ④ is effective as a strengthening method. However, Method 1 should be employed when adding new angles is impossible for structural reasons due to narrow spacing between web plates as in the cases of  $\ell = 30\text{m}$  and  $40\text{m}$  type. Method ②, which uses partially cut angles, should not be employed since it requires a large amount of works for processing angles, although it is better in the final configuration than Method ①. In the case of  $\ell = 48\text{m}$  type, Method ④ should be employed, since there is a sufficient spacing between the web plates.

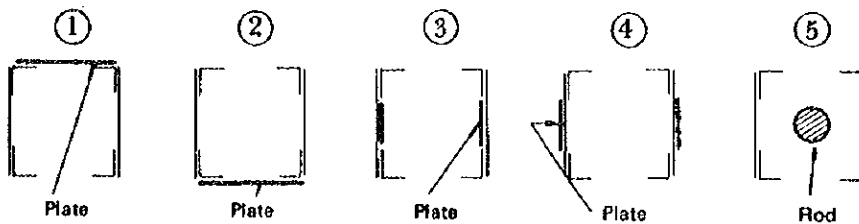
Methods ① and ④ present structural difficulties in relation with other members at panel point portion. Methods ② and ③ may be used if structural conditions of members including gusset plate and splice plate are taken into consideration in an appropriate manner. However, method ⑤ should be employed for the same reasons as stated previously.

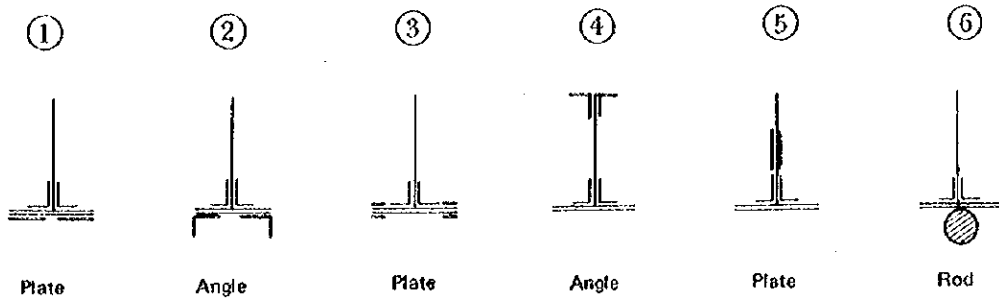
Methods ① and ② should not be used, since they require an increased amount of field works for cutting original rivets.

Method ③ needs original rivet cutting works half the amount of those in Methods ① and ②, but yet the field works in Method ③ are not easy. Method ④ is intended to repair faulty configuration of original sections due to deep outstanding web plates, but continuity of angles to be added is interrupted over a long distance at panel point portion for structural reasons.

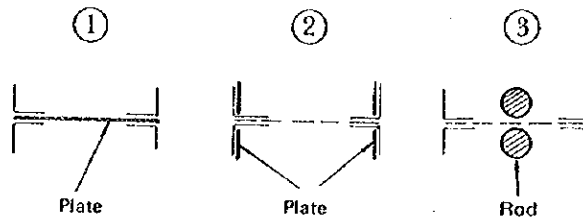
Method ①, which is intended to replace existing tie plates with new plates, is not appropriate since it requires a large amount of field works.

Method ② should not be employed, since it also needs a great amount of field works, although less than in Method ①.

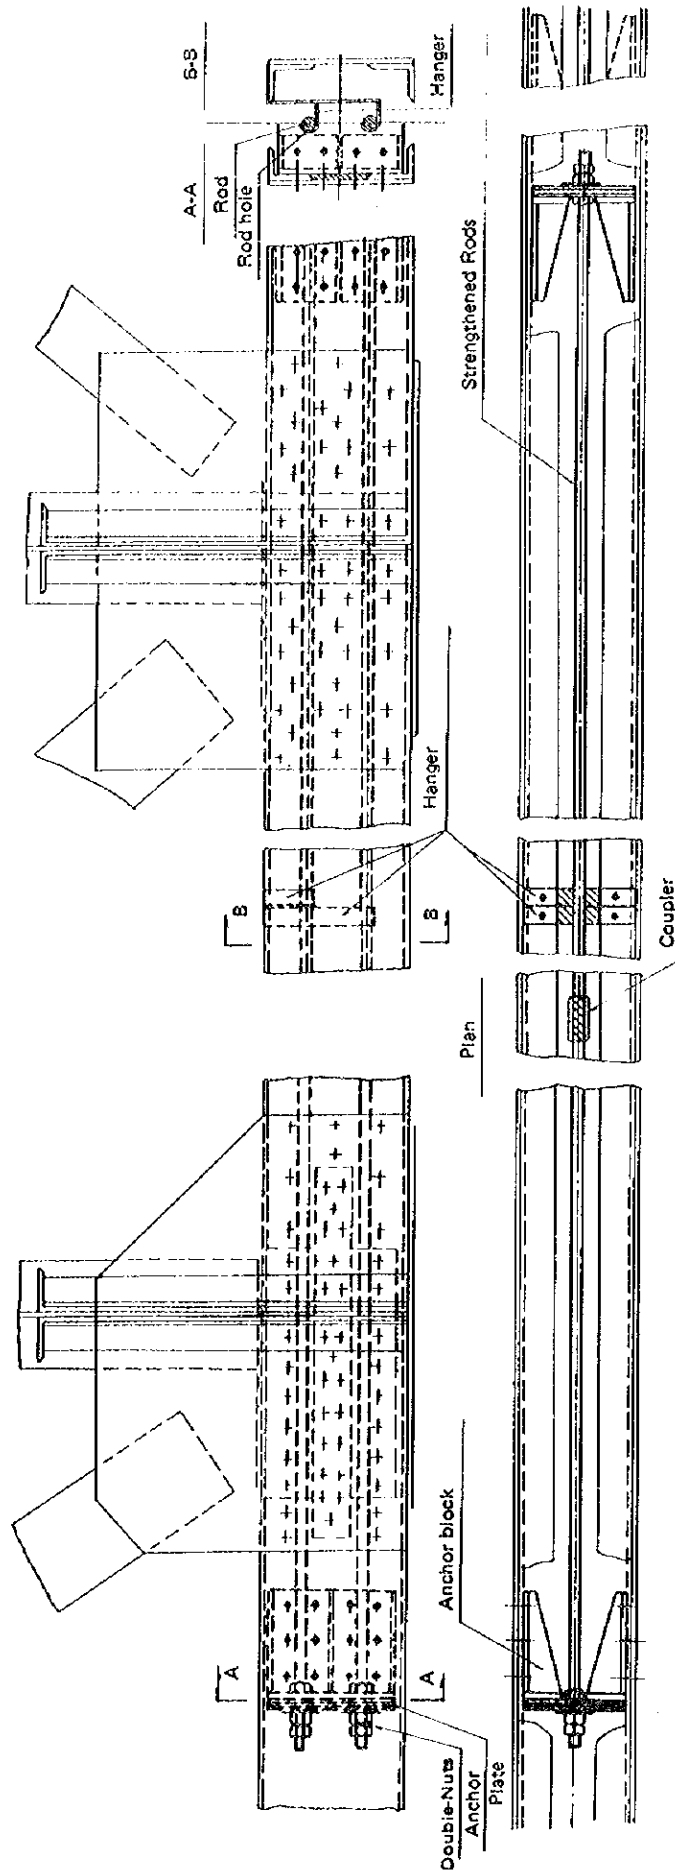
Fig. 6.3

Strengthening of Lower Chord

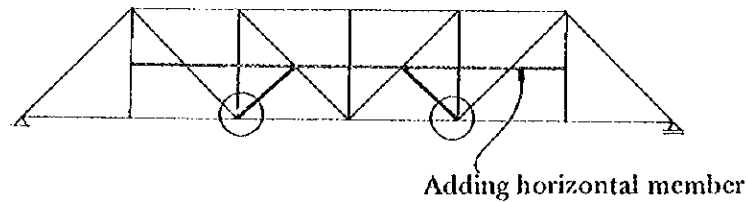
Method ii) should be employed for the following reasons:

- Methods i) and ii) do not much differ from each other in quantity of additional members to be required.
- The field work for Method ii) is far easier than that for Method i).
- In Method iii), some care should be taken of the structural detail at the portions marked by circles in the above figure.

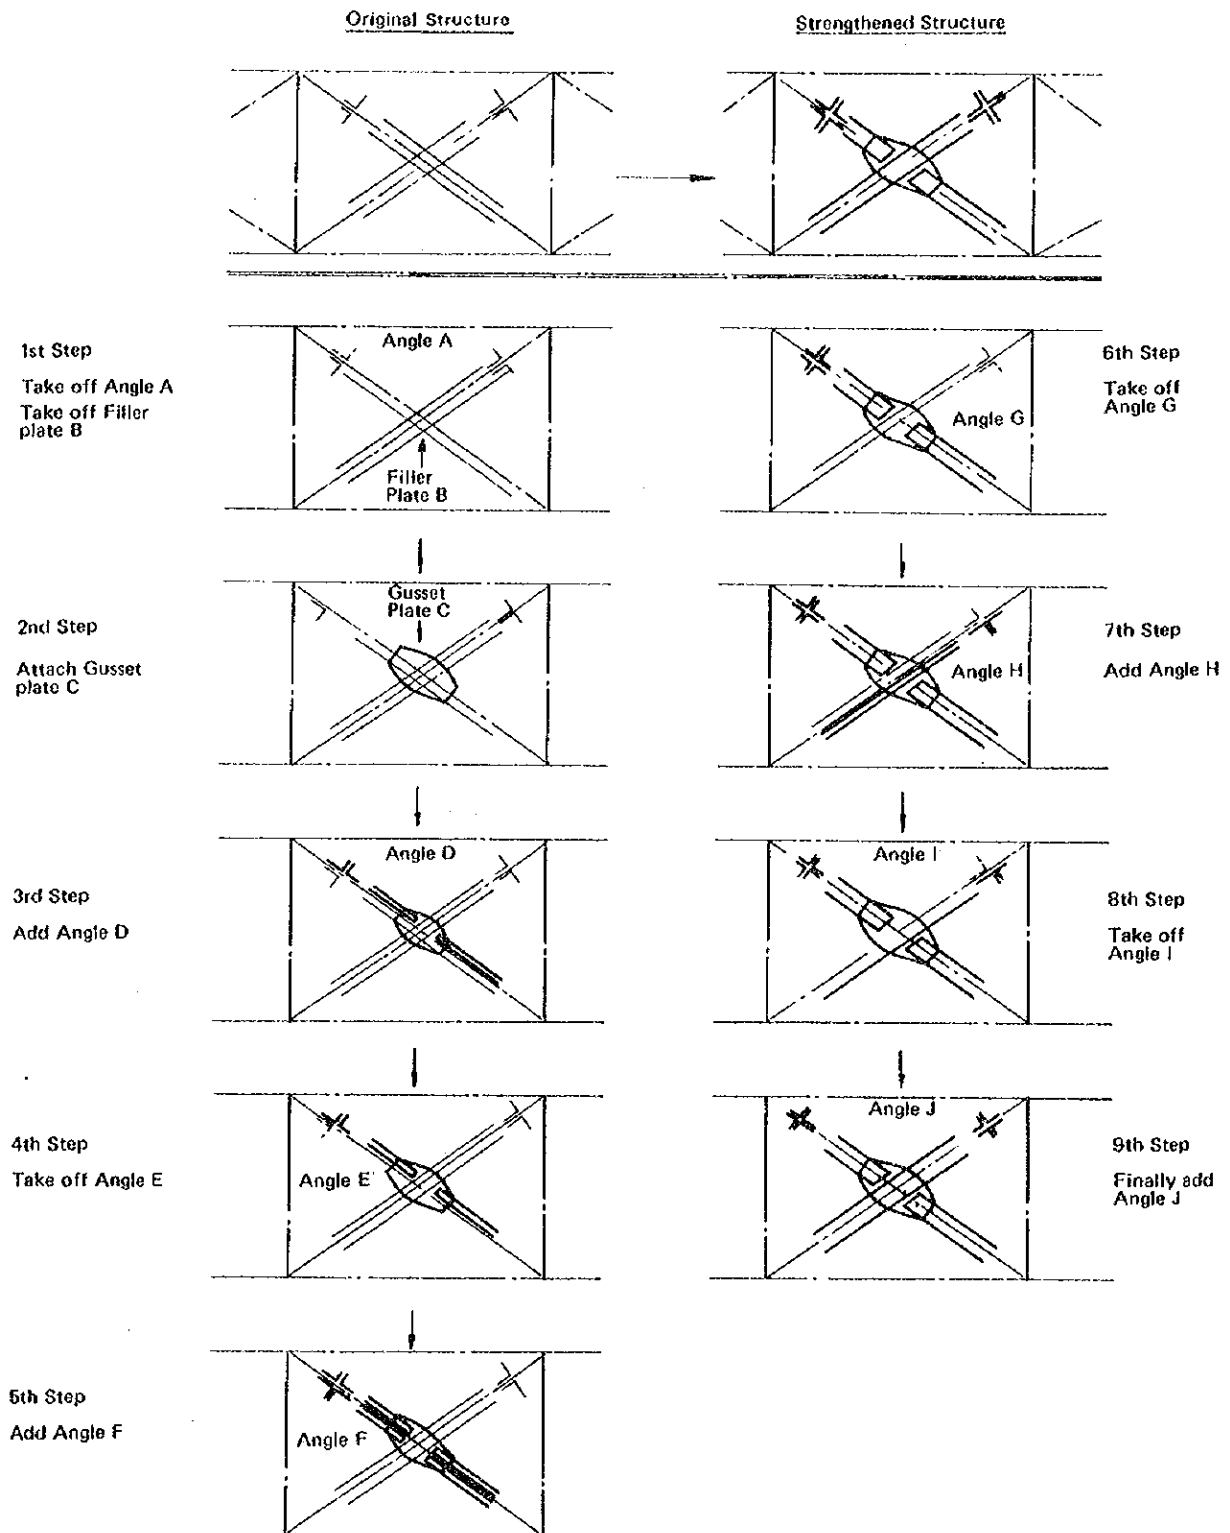
Fig. 6.4 Strengthening of Diagonal members of Daydé Type Double-Warren Trusses

Almost all of the diagonal members have an excessive stress and a considerably excessive slenderness ratio.

As to this type of bridges, studies have been made on the possibility of changing the structural system from Double-Warren truss type to Plat truss type. However, this method does not appear to be a satisfactory method because it requires a great amount of new members and because it may cause unexpected stresses in the members due to changing of the structural system as a whole.

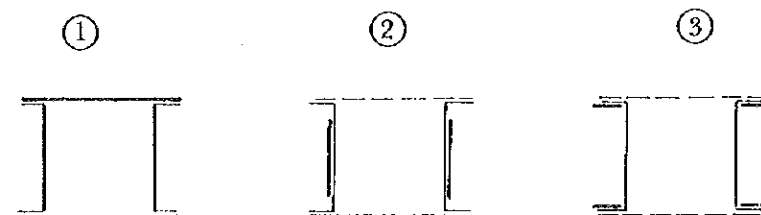
Method ② should be employed, judging from the amount of field work and the amount of excessive stress of the original sections.

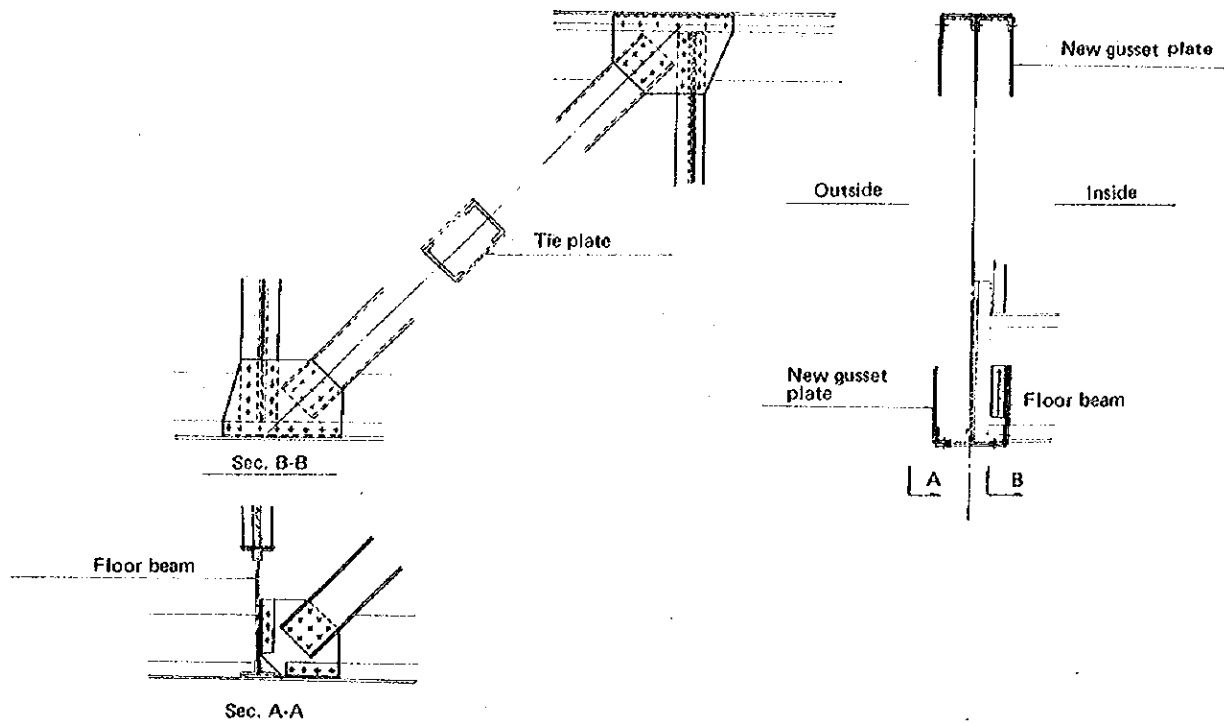
New gusset plates should be added, and new diagonal members should be attached as shown in the figure below since no space for addition of plates or angles is available because of the configuration of the original sections.

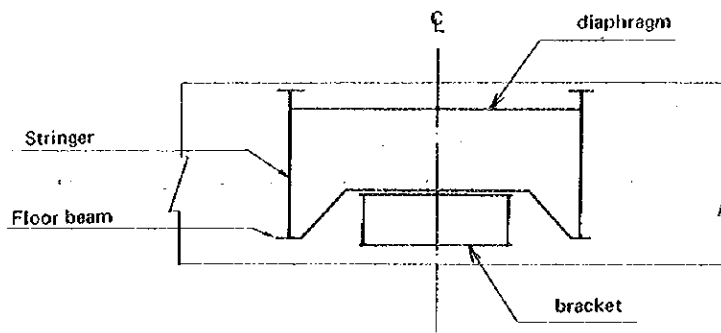
Fig. 6.16

- iii) In case there is no sufficient clearance to install a bracket under the lower flange of stringer, the bracket may be installed on the web of the floor beam between the stringer beams on the right and left sides. In this case, however, a diaphragm must be attached at the end of stringers to support the stringers on the bracket. (see Fig. 6-16)

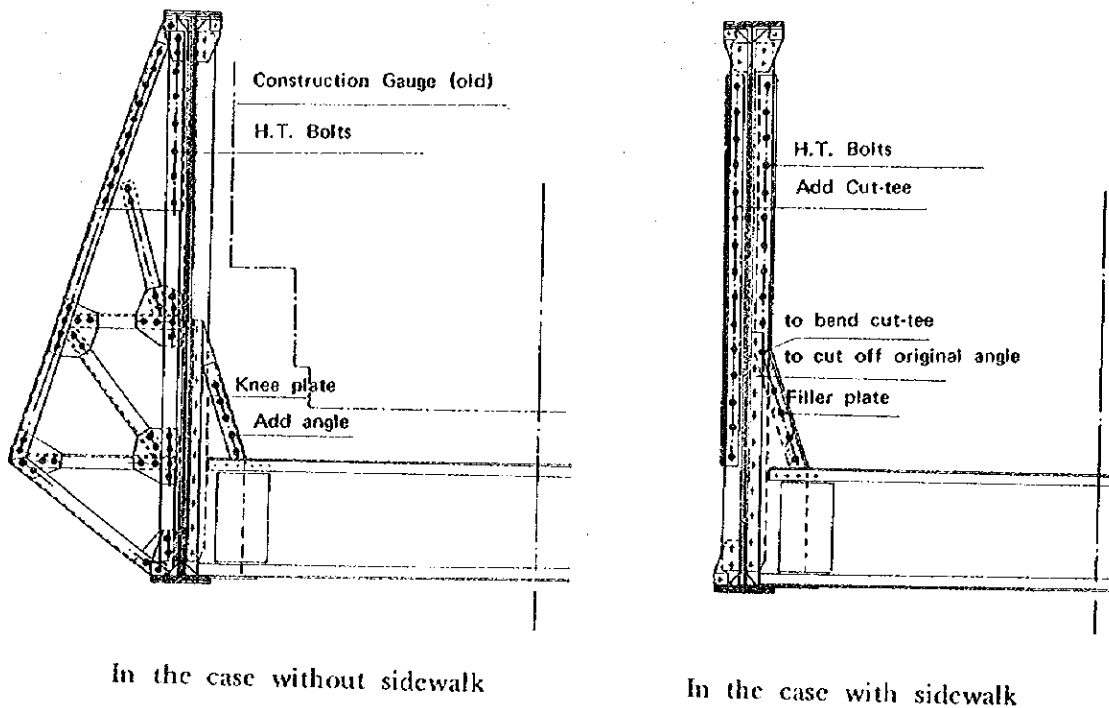
In pony trusses of Daydé type the transverse rigidity is obviously insufficient, so strengthening must be done as shown in Fig. 6-17

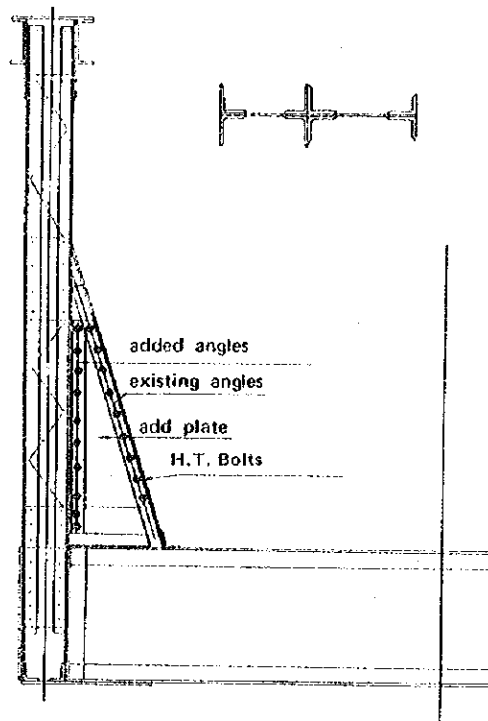
Fig. 6-18

For a pony truss manufactured by Cleveland, a web plate will be added to a knee bracing which consists of angles originally. (see Fig. 6-18)

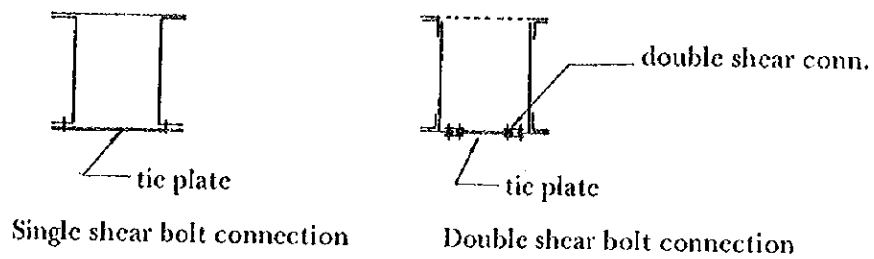
Fig. 6-19

- (1) In principle, end tie plates should be provided for each member in the vicinity of panel points.
- (2) Although lower chord members are subject to tension, intermediate tie plates should be installed at not less than two positions in a panel length.
- (3) When lacing bars attached to compressive members are not strong enough, some of the lacing bars should be replaced by tie plates.
- (4) It is possible to use smaller tie plates by adopting double shear bolt connection, if necessary for the reasons of configuration of original sections. (see 6-19)

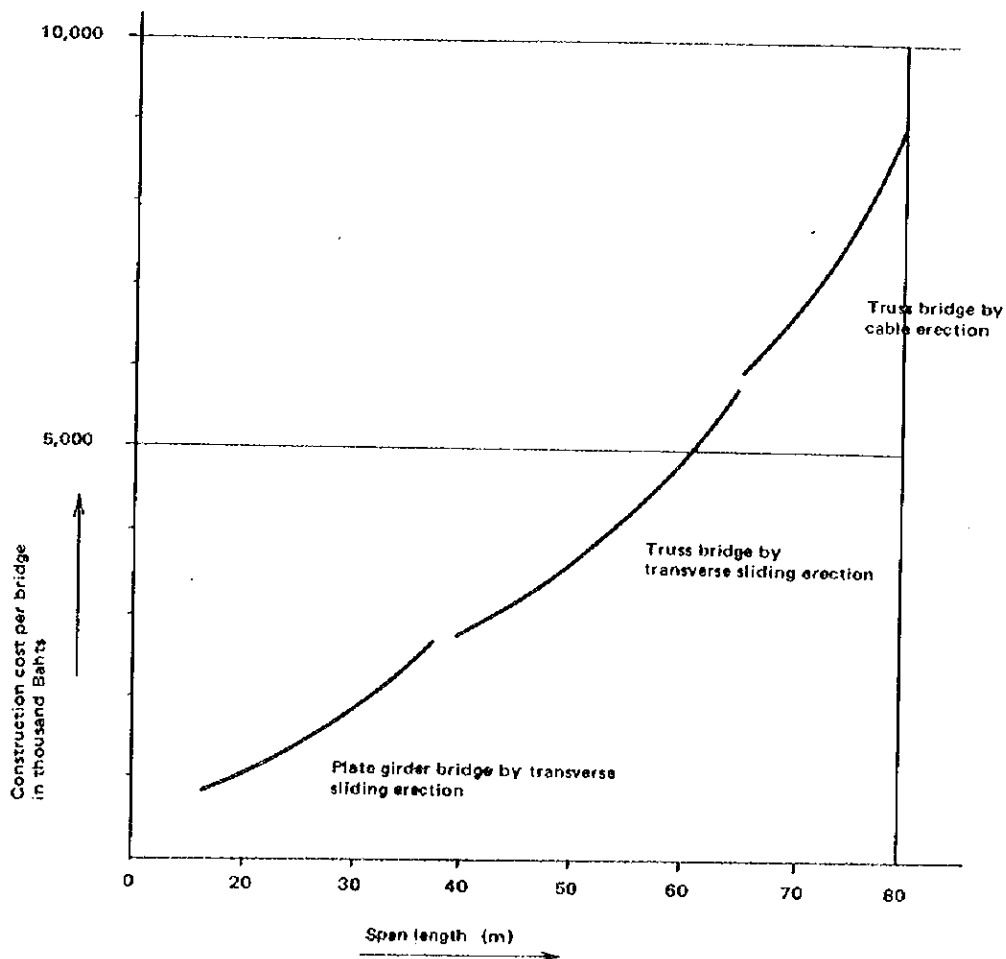
Fig. 9 - 1

This estimation was obtained through the use of a curved graph (Fig. 9-1) that indicated an average relation between the span length of bridge and its cost to be required for it.

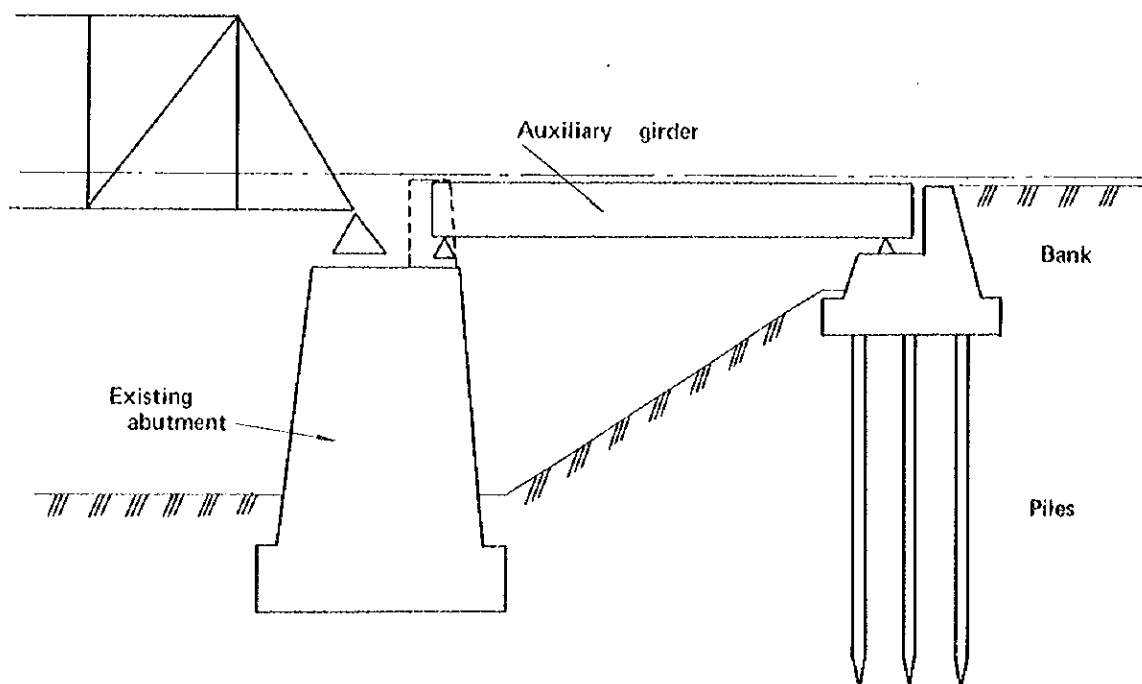
Fig. 10.1 A method to eliminate the earth pressure from the rear of the existing abutment

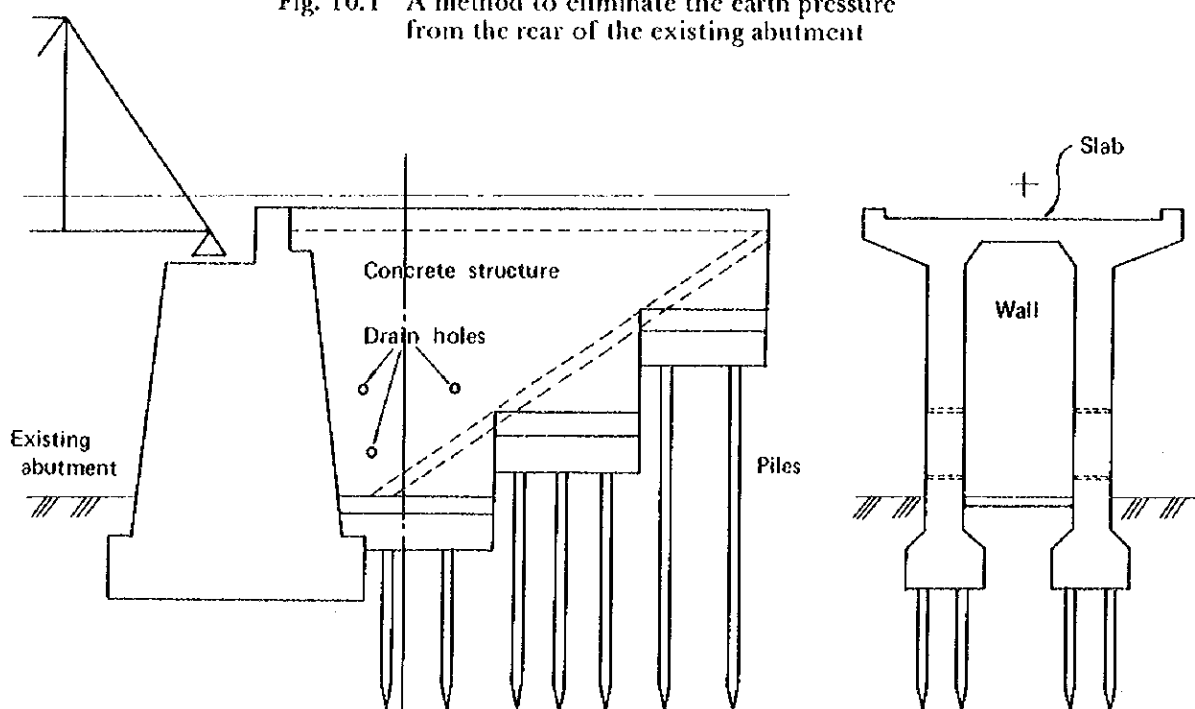
Fig. 10.2 A method to eliminate the water pressure from the rear of the existing abutment
