Appendix 25

Photograph of Seabed

## Appendix 26

### Typical Records of Side Scan Sonar

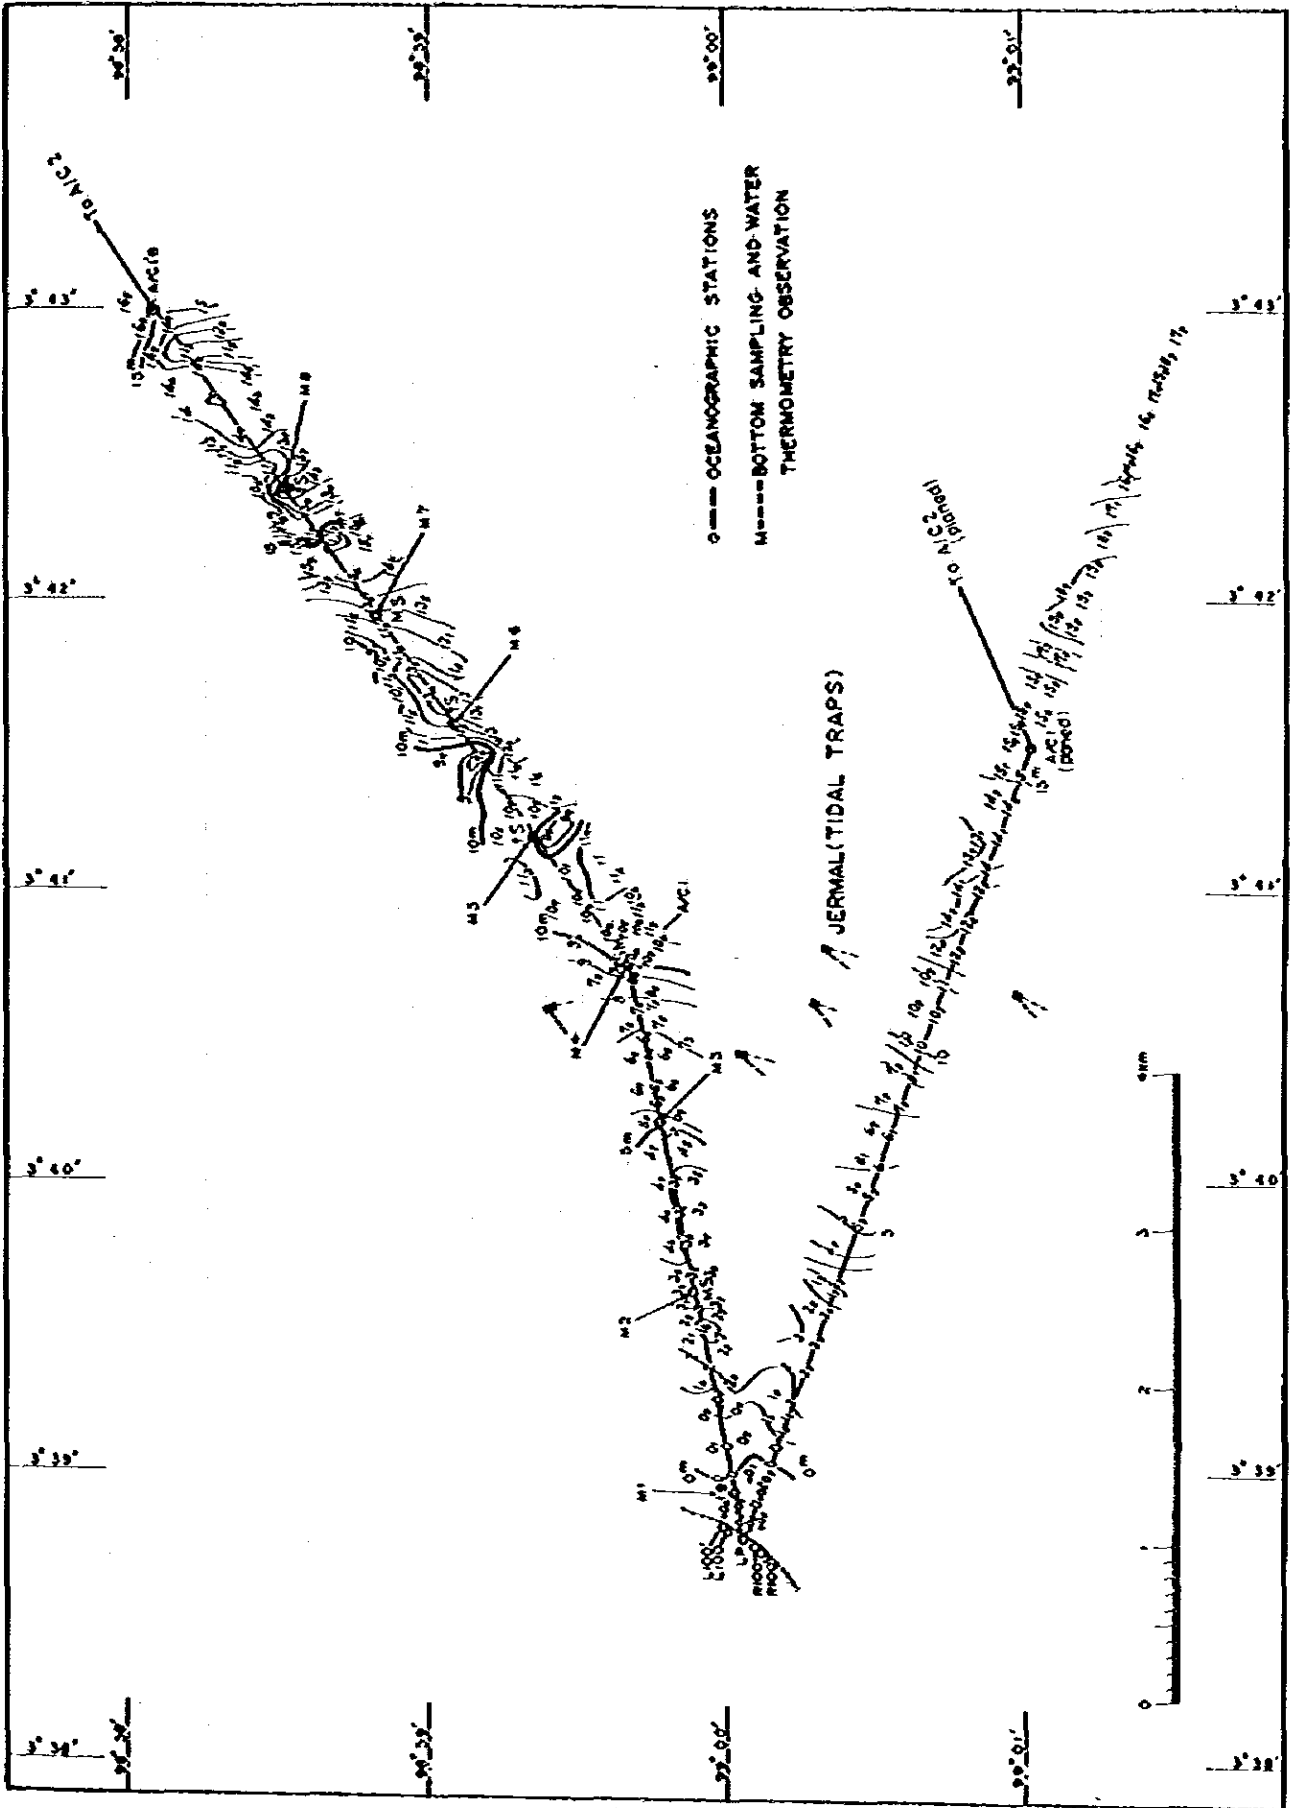
BATHYMETRIC AND CONTOUR CHART (PANTAI GERMIN APPROACH)

sounding in metres

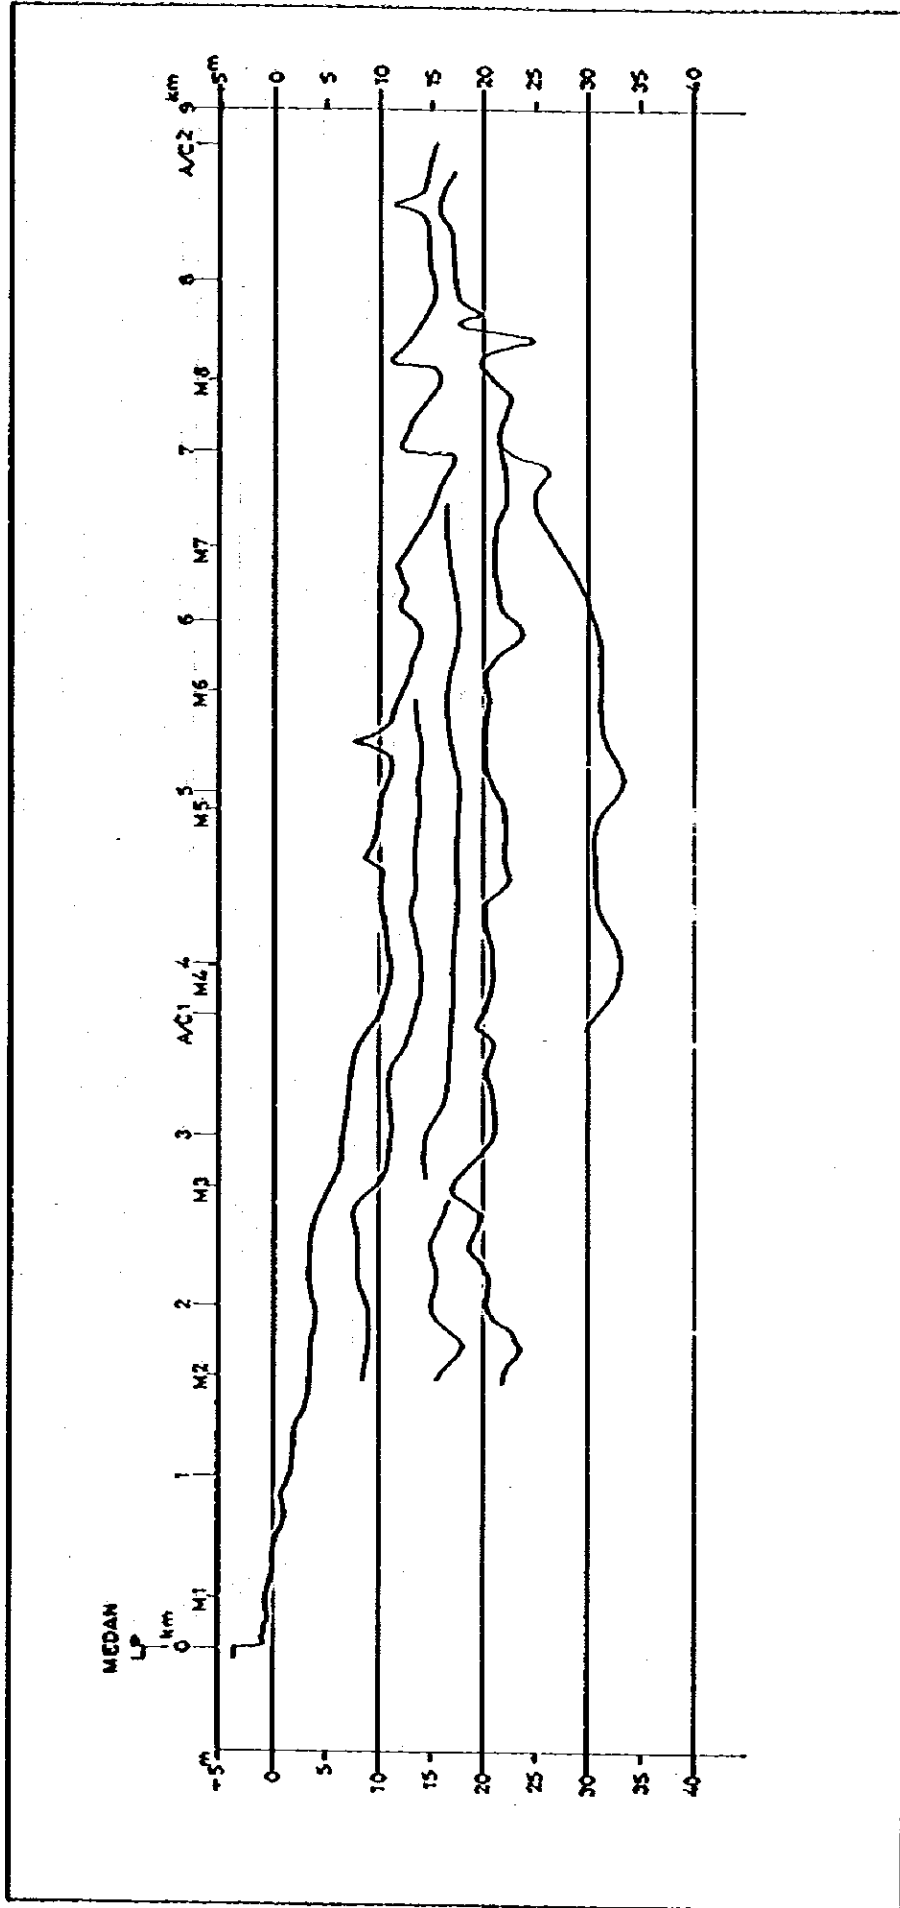
BOTTOM PROFILE AND SUB BOTTOM LAYERS  
(PANTAI CERMIN APPROACH)

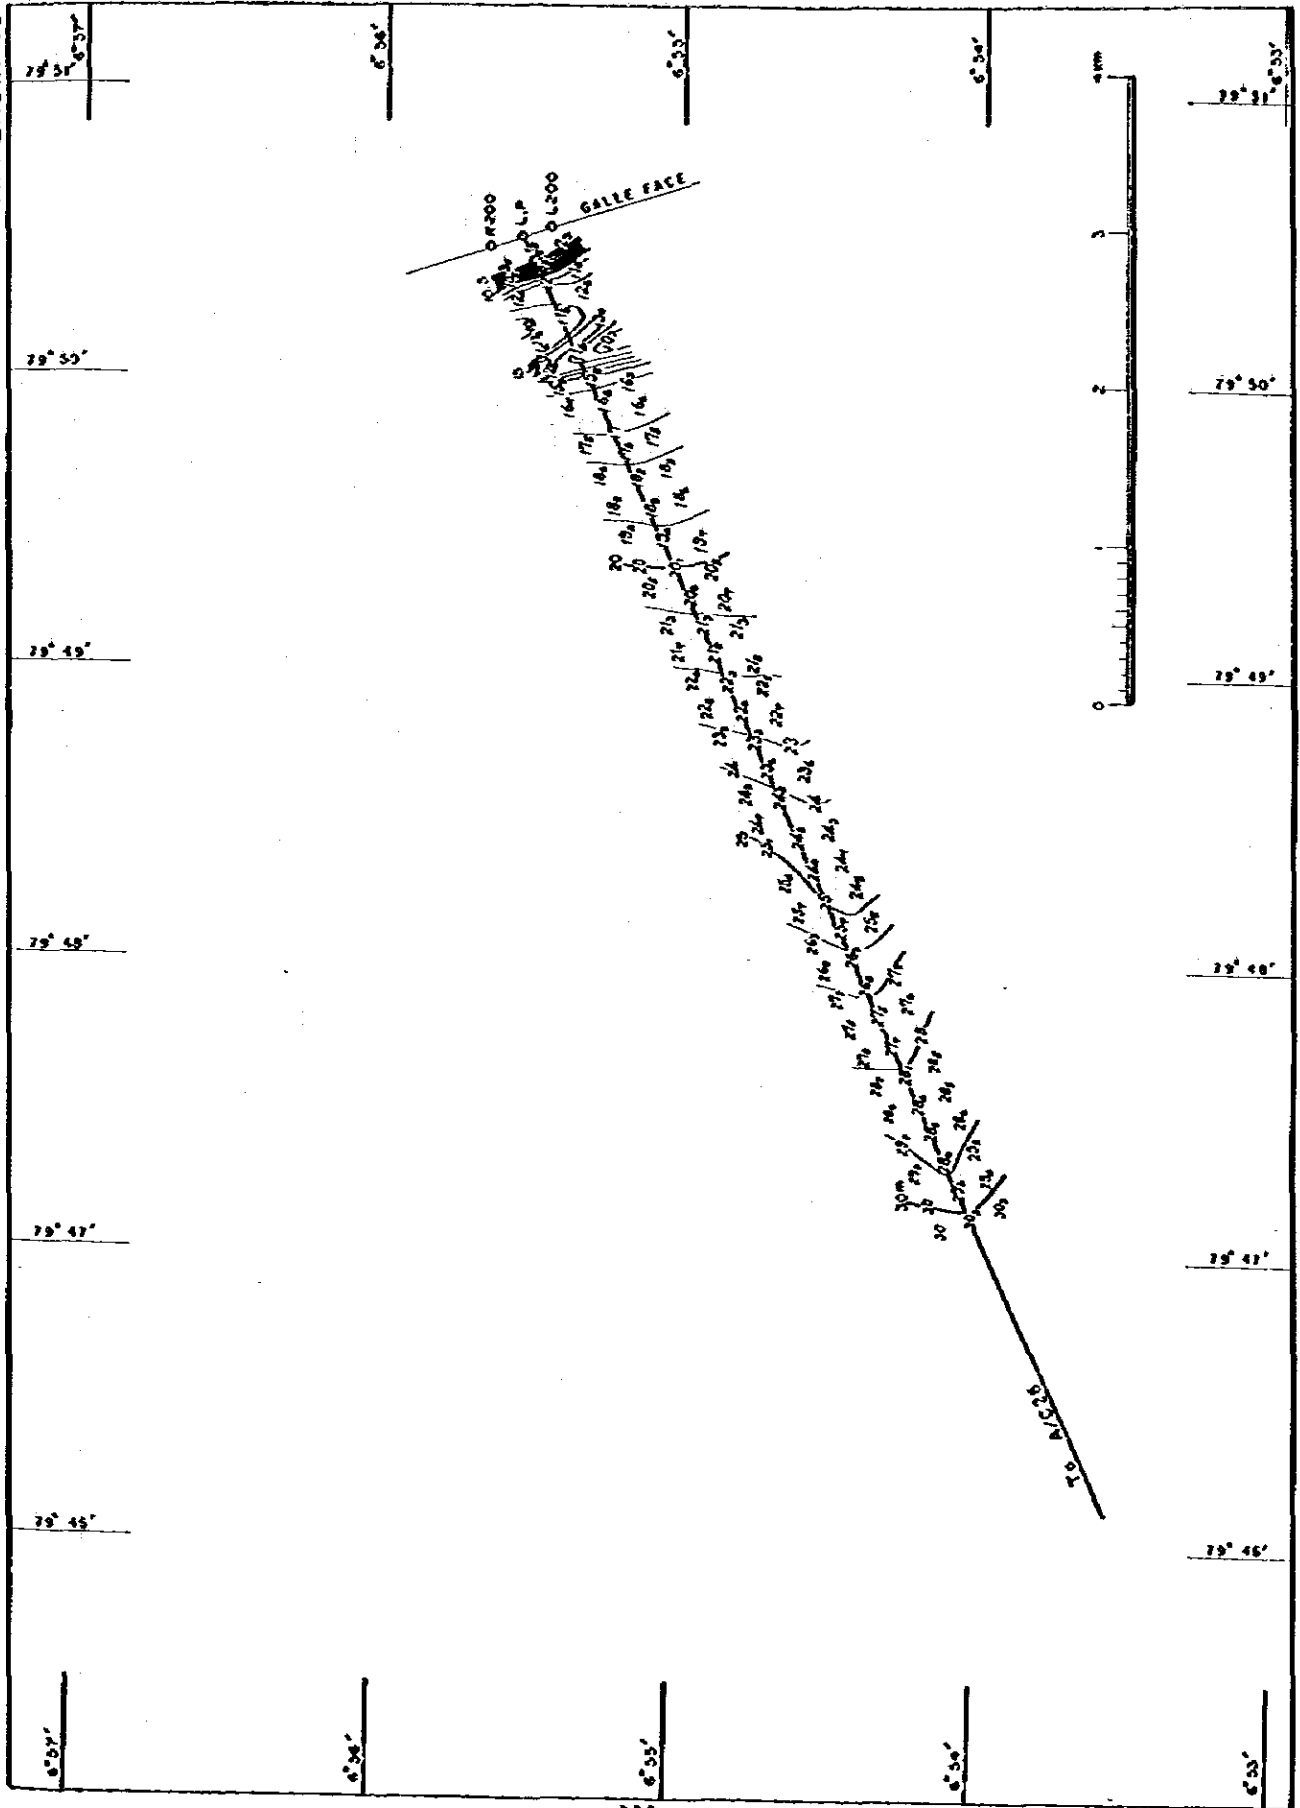
APPENDIX-II

BATHYMETRIC AND CONTOUR CHART (COLOMBO APPROACH)

sounding in metres

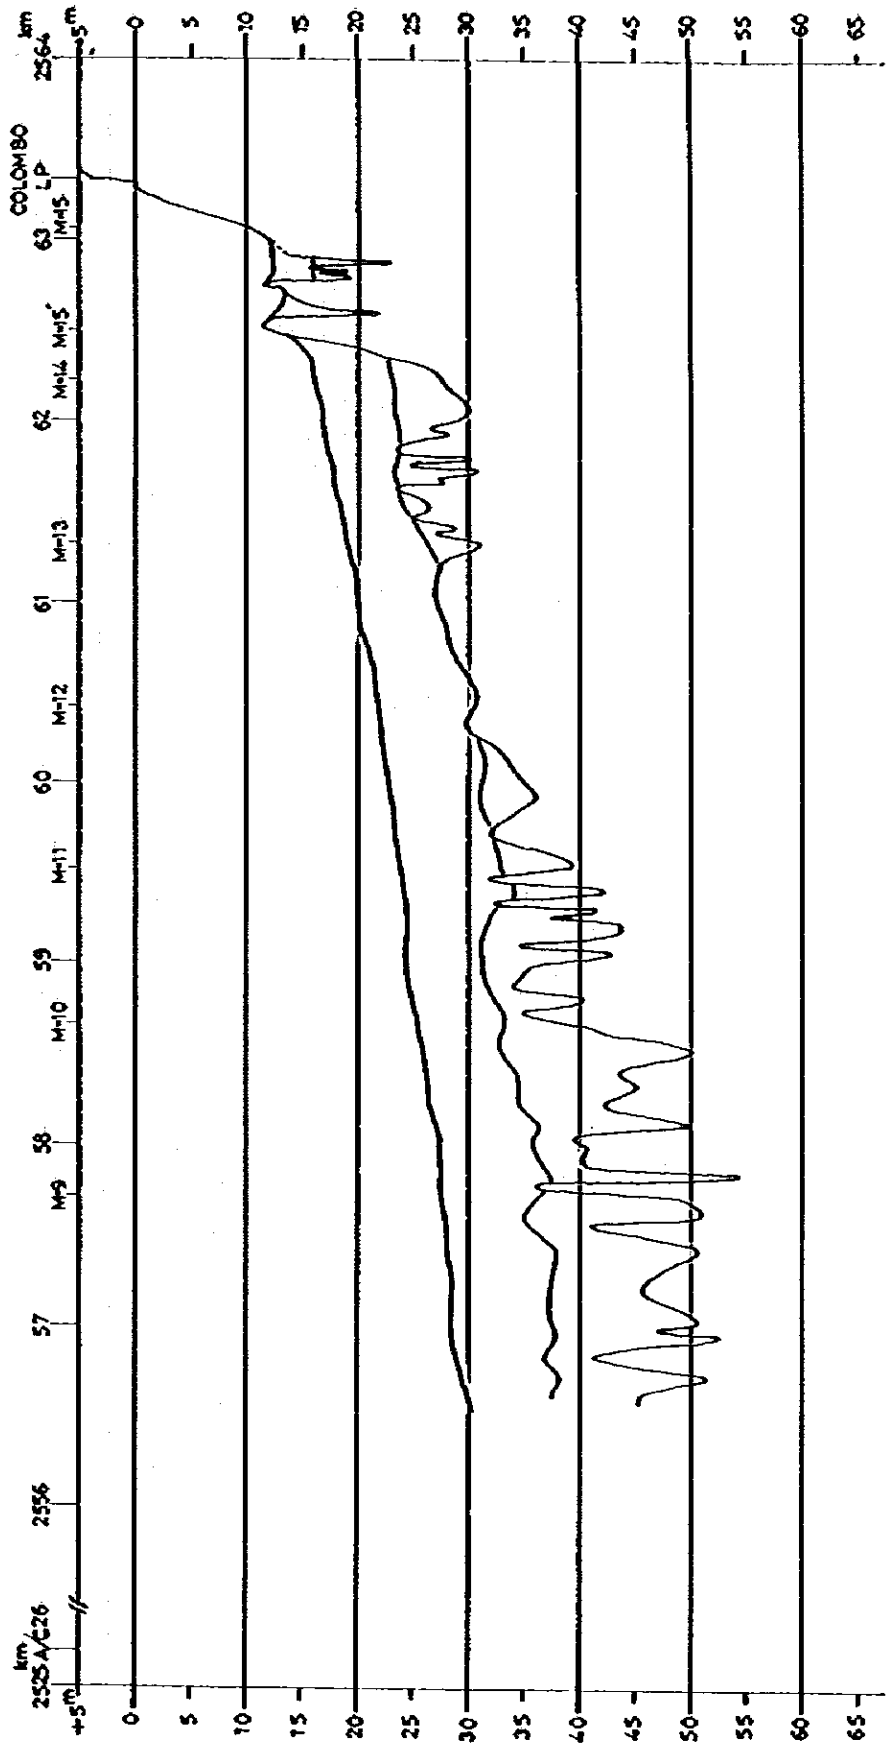
BOTTOM PROFILE AND SUB-BOTTOM LAYERS  
(COLOMBO APPROACH)

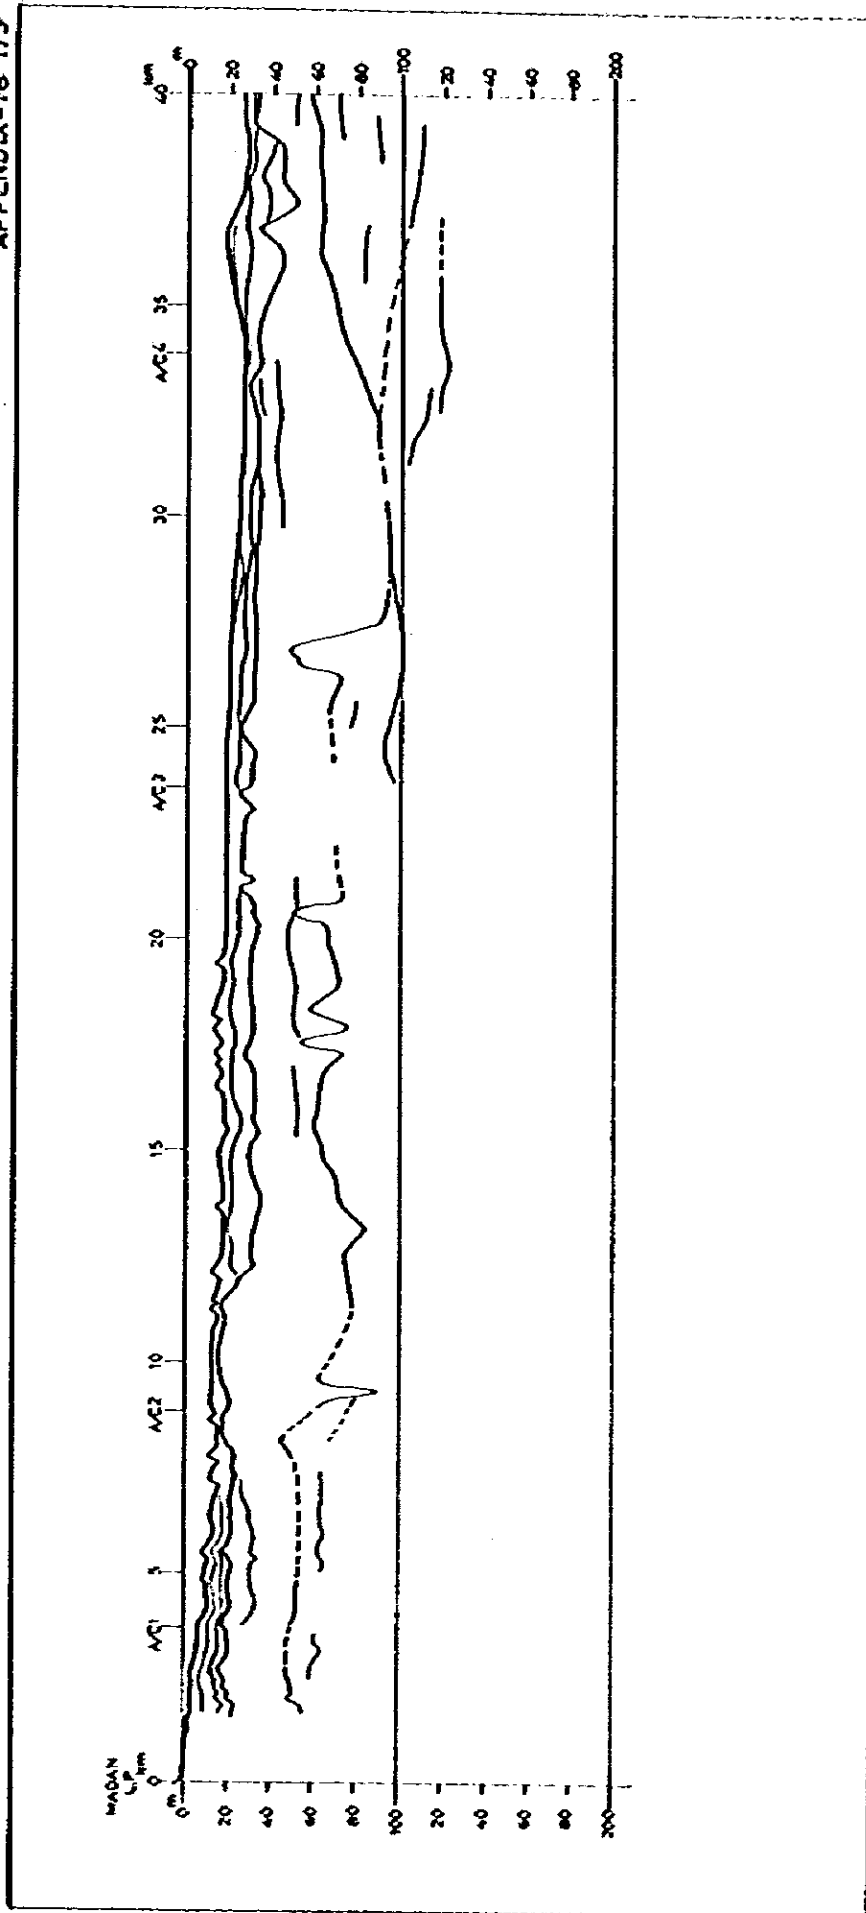
SOTTOM PROFILE AND SUS-SOTTOM LAYERS OF SUNDA SHELF AND SLOPE

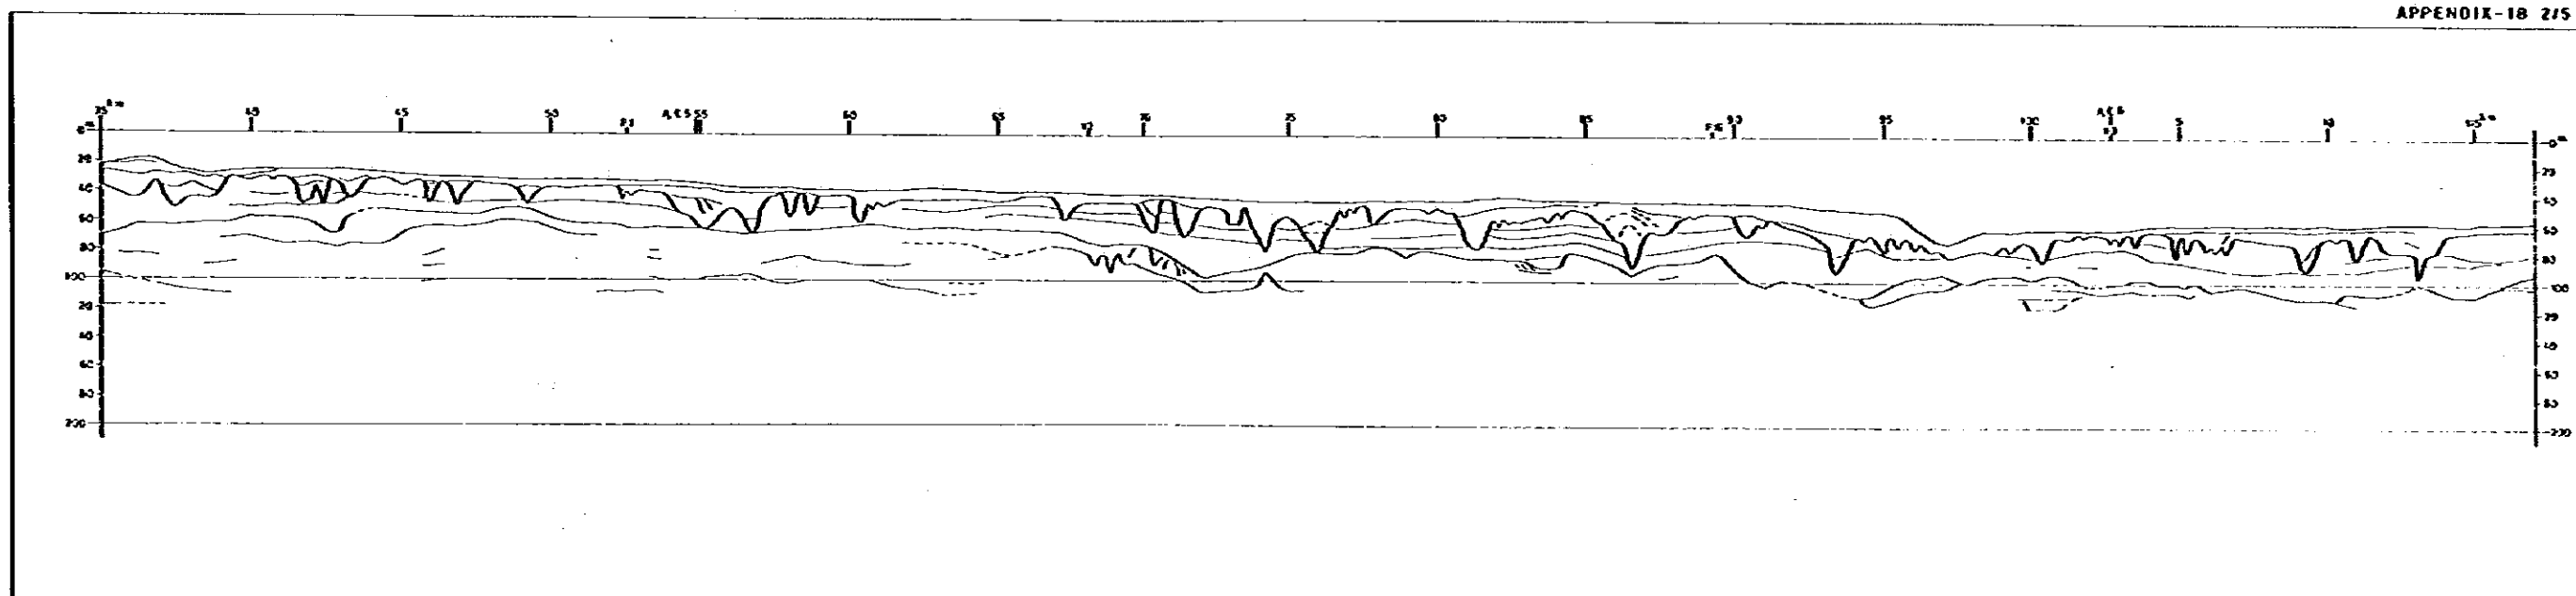
BOTTOM PROFILE AND SUB-BOTTOM LAYERS OF SUNDA SHELF AND SLOPE

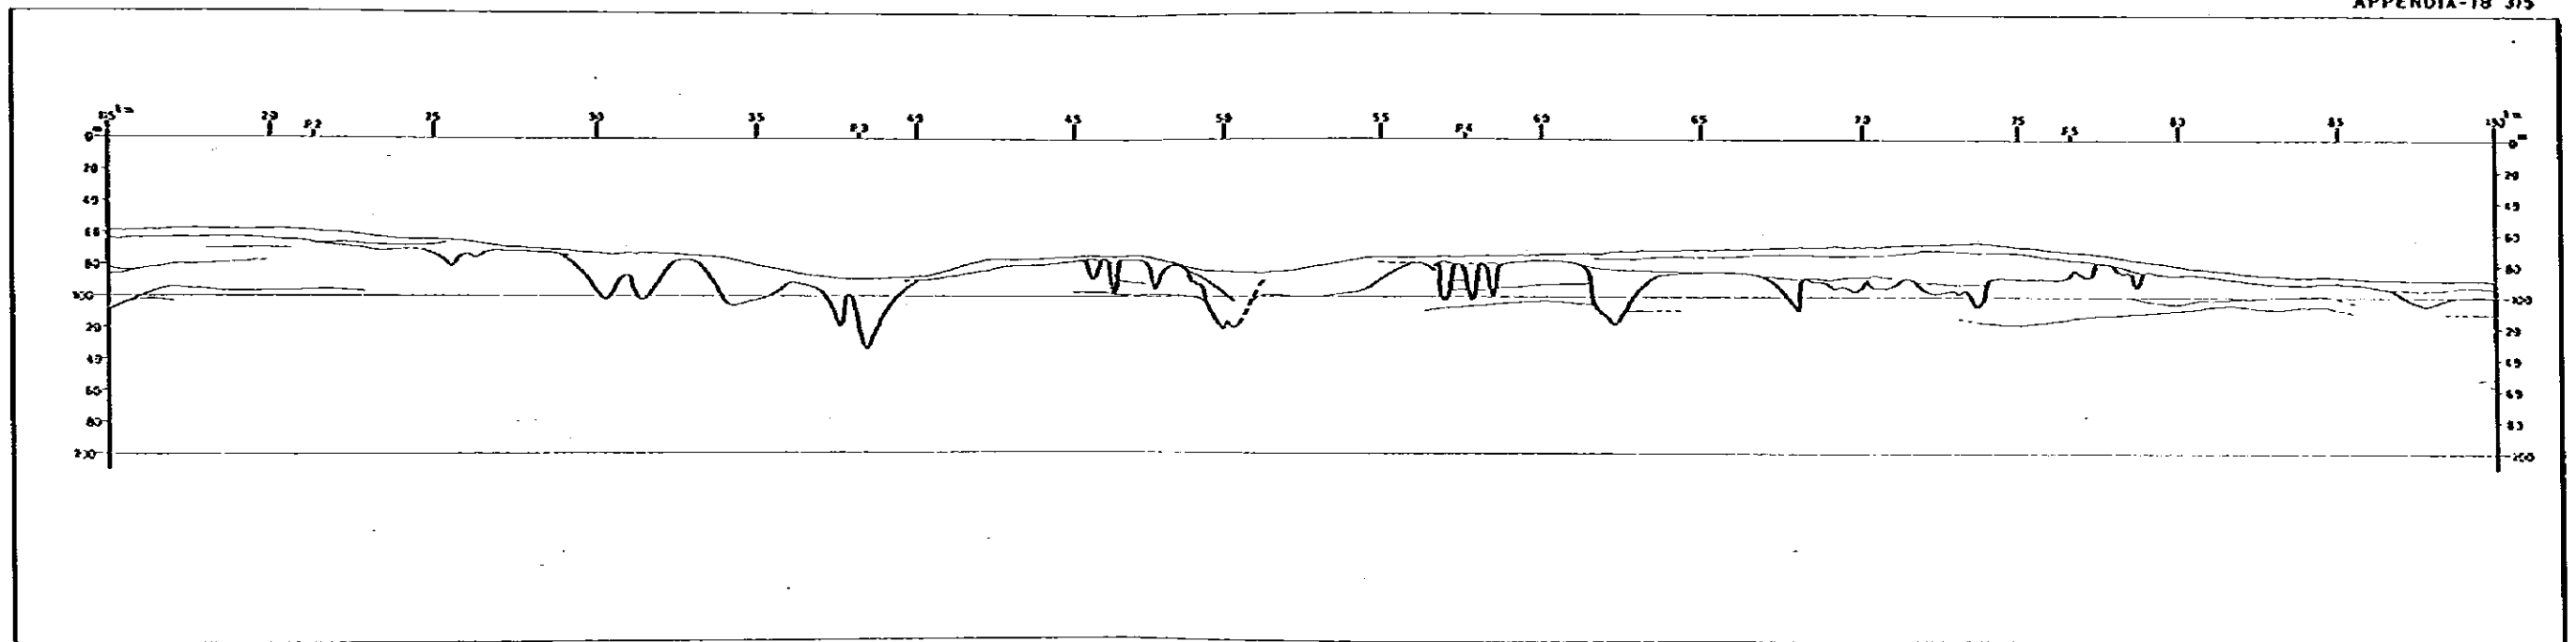
BOTTOM PROFILE AND SUB-BOTTOM LAYERS OF SUNDA SHELF AND SLOPE

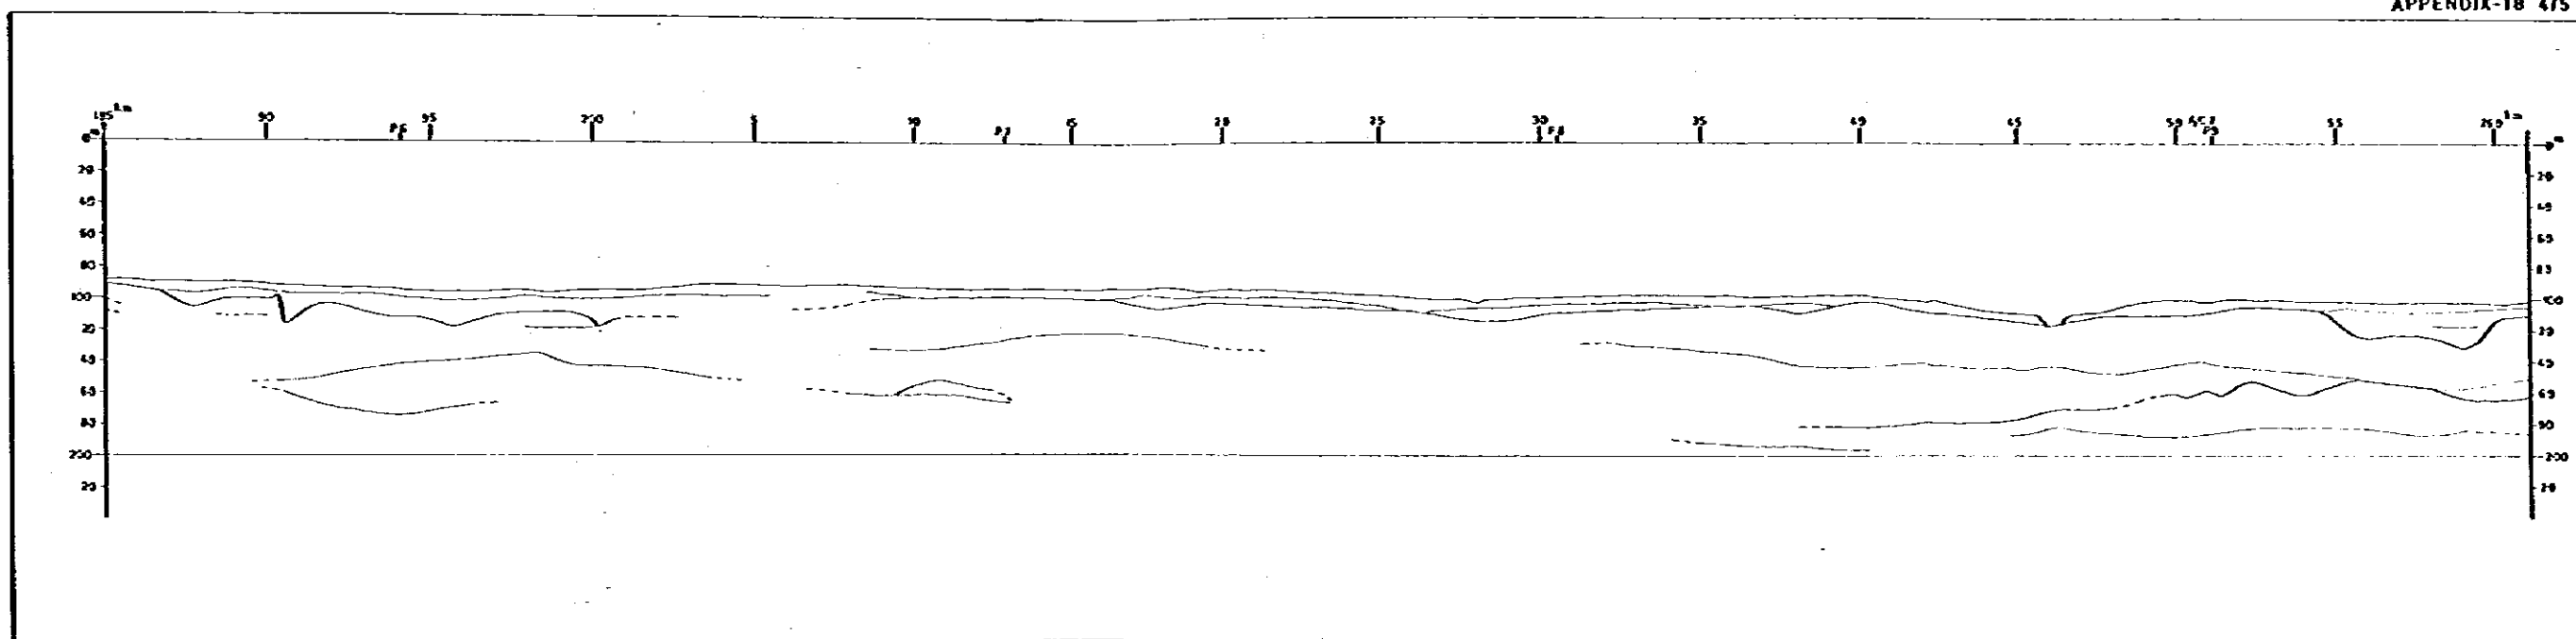
BOTTOM PROFILE AND SUB-BOTTOM LAYERS OF SUNDA SHELF AND SLOPE

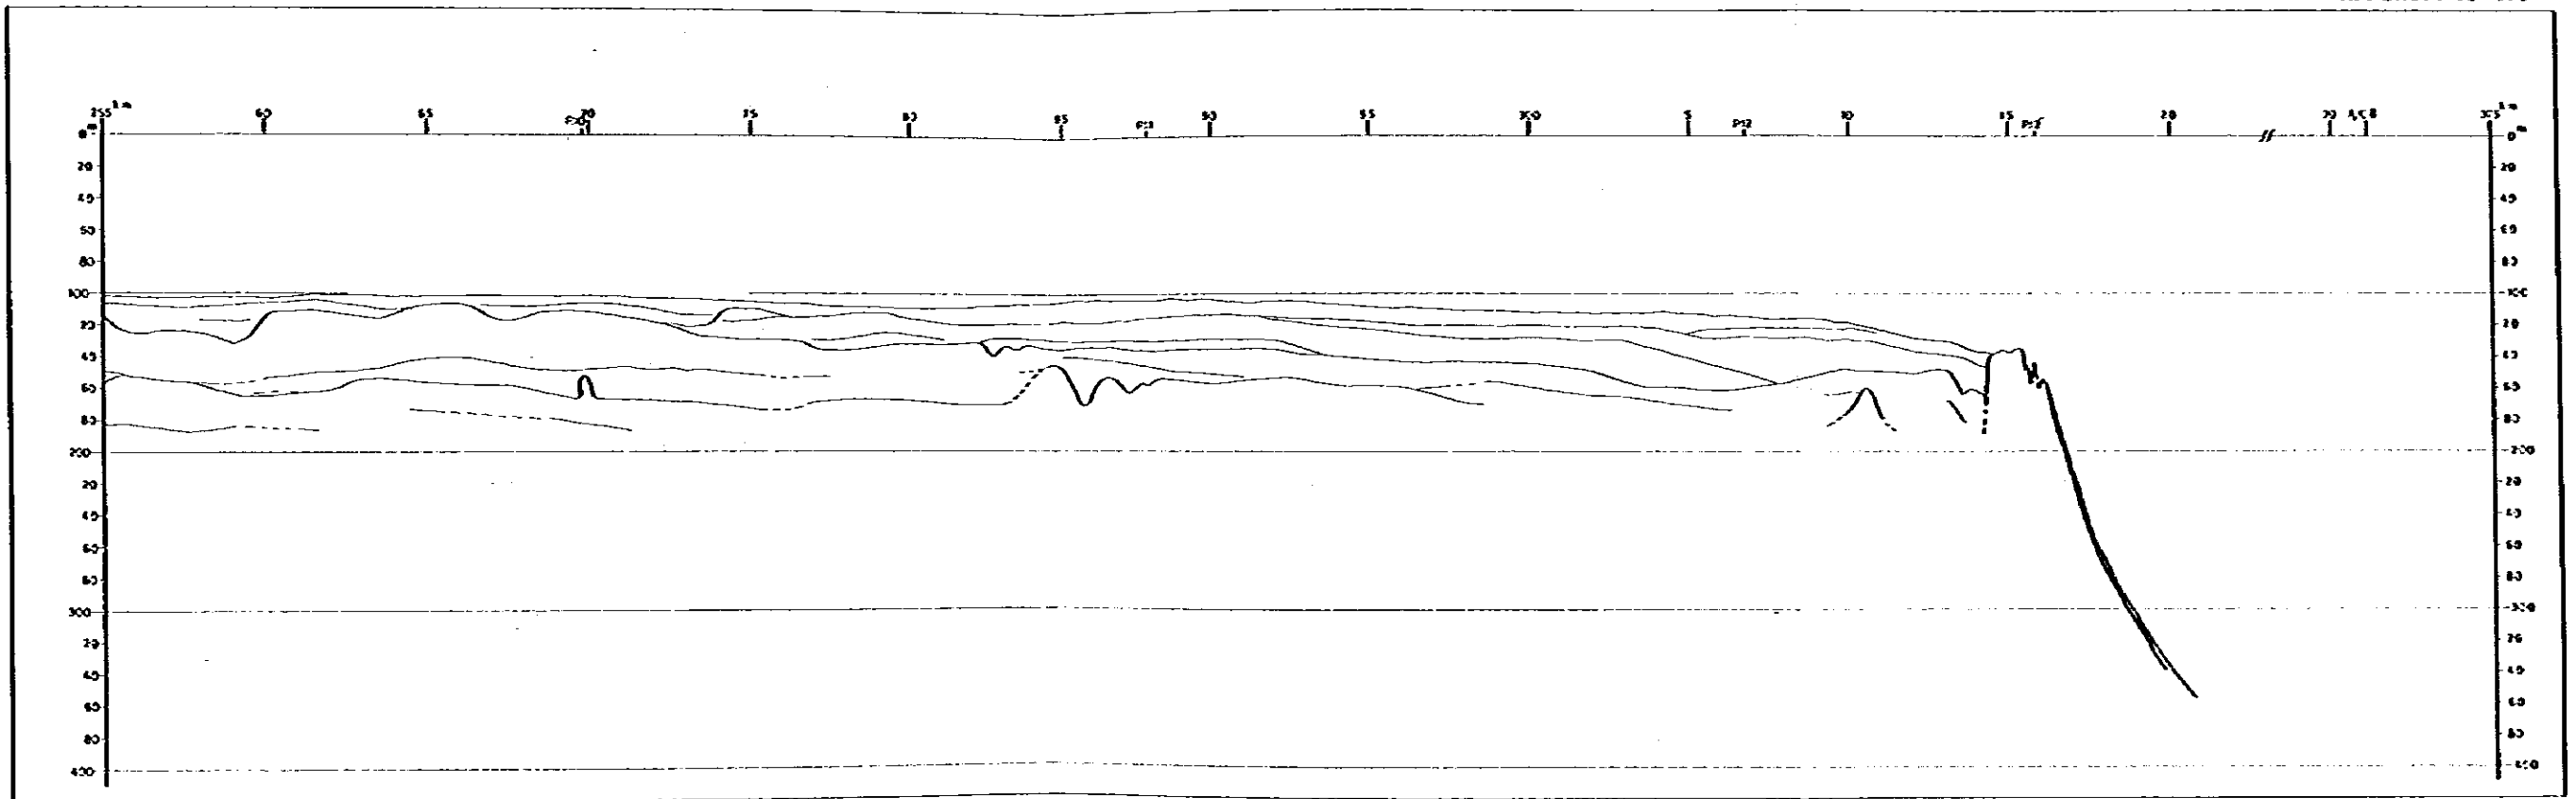
BOTTOM PROFILE AND SUB-BOTTOM LAYERS OF SUNDA SHELF AND SLOPE

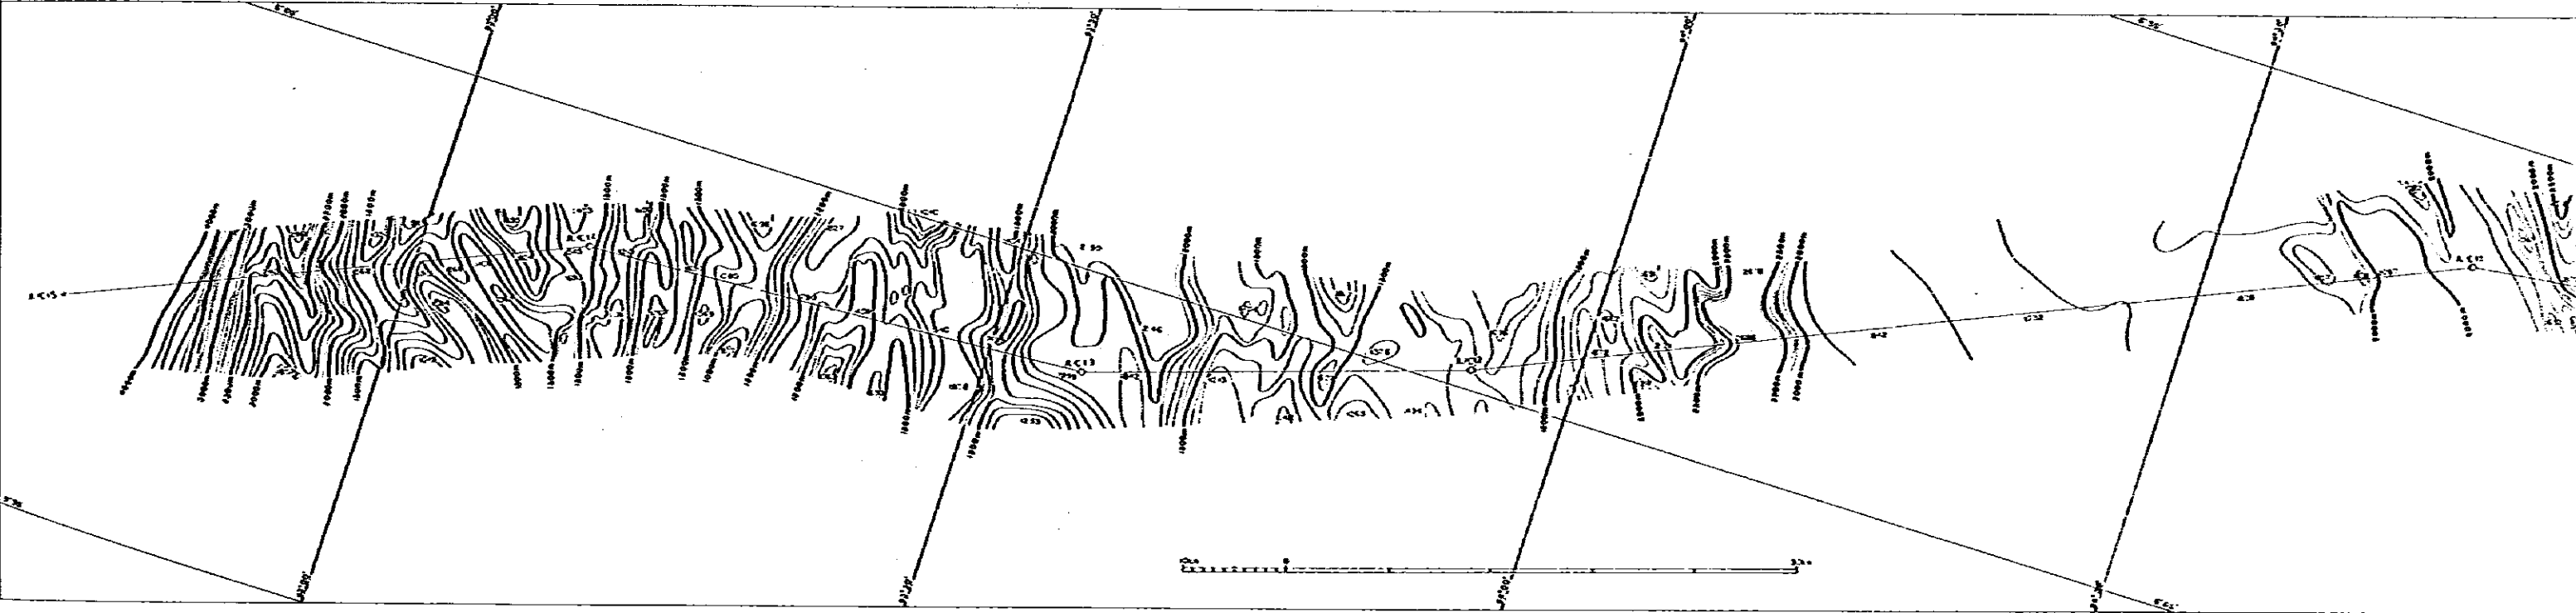
CONTOUR CHART OF GREAT PASSAGE

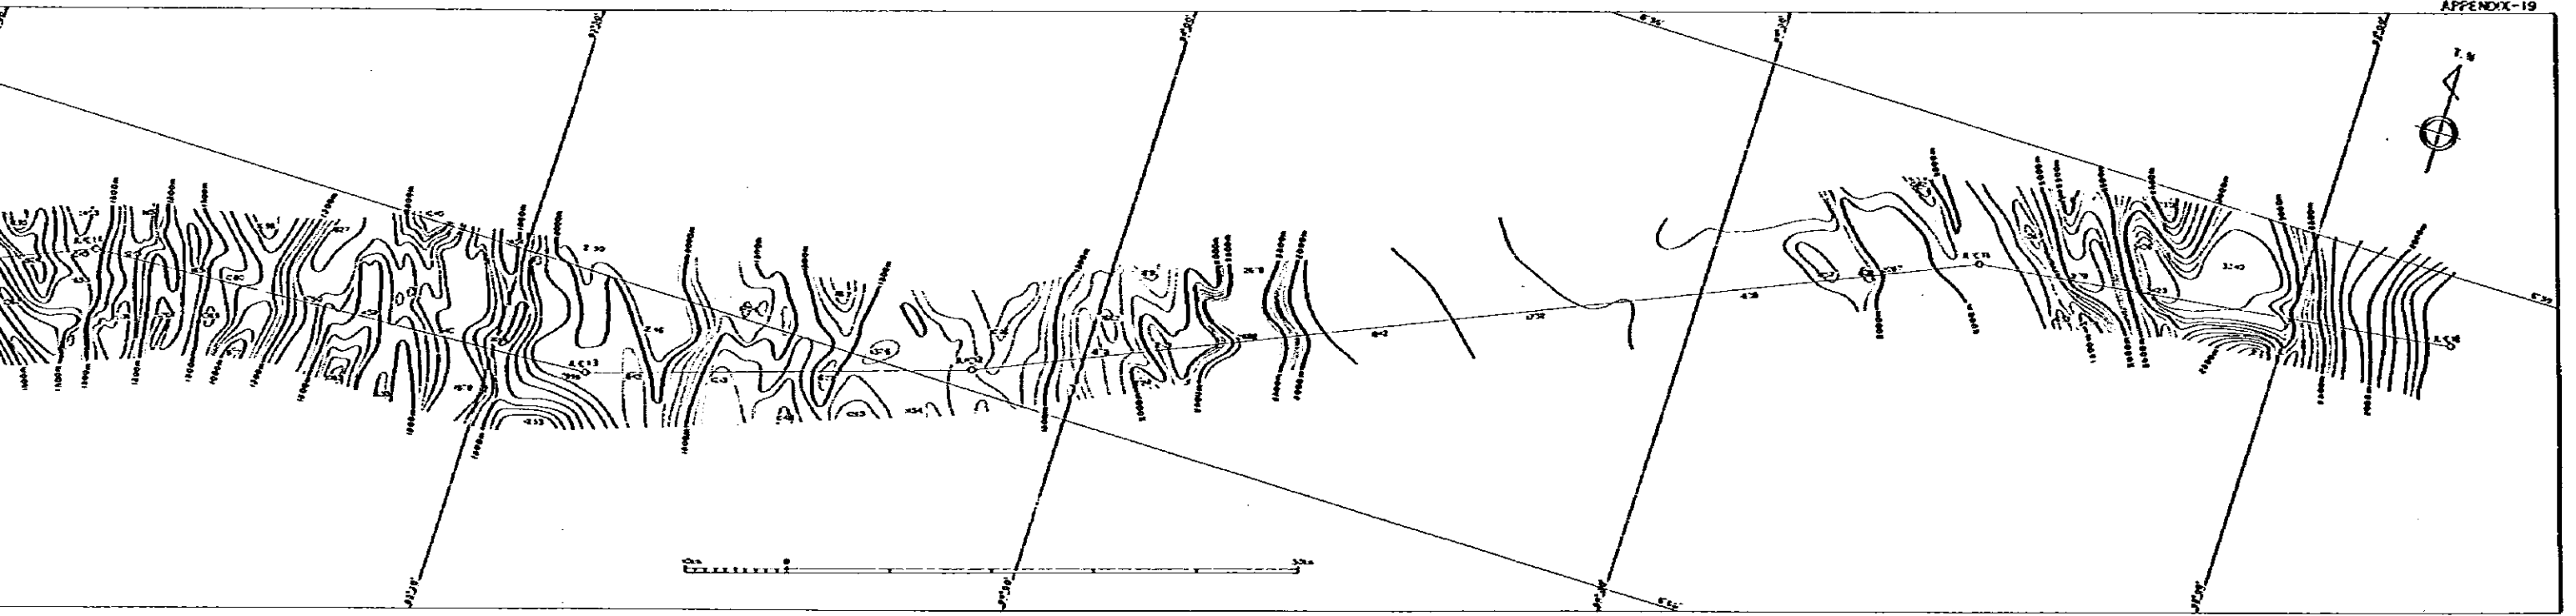
GREAT PASSAGE

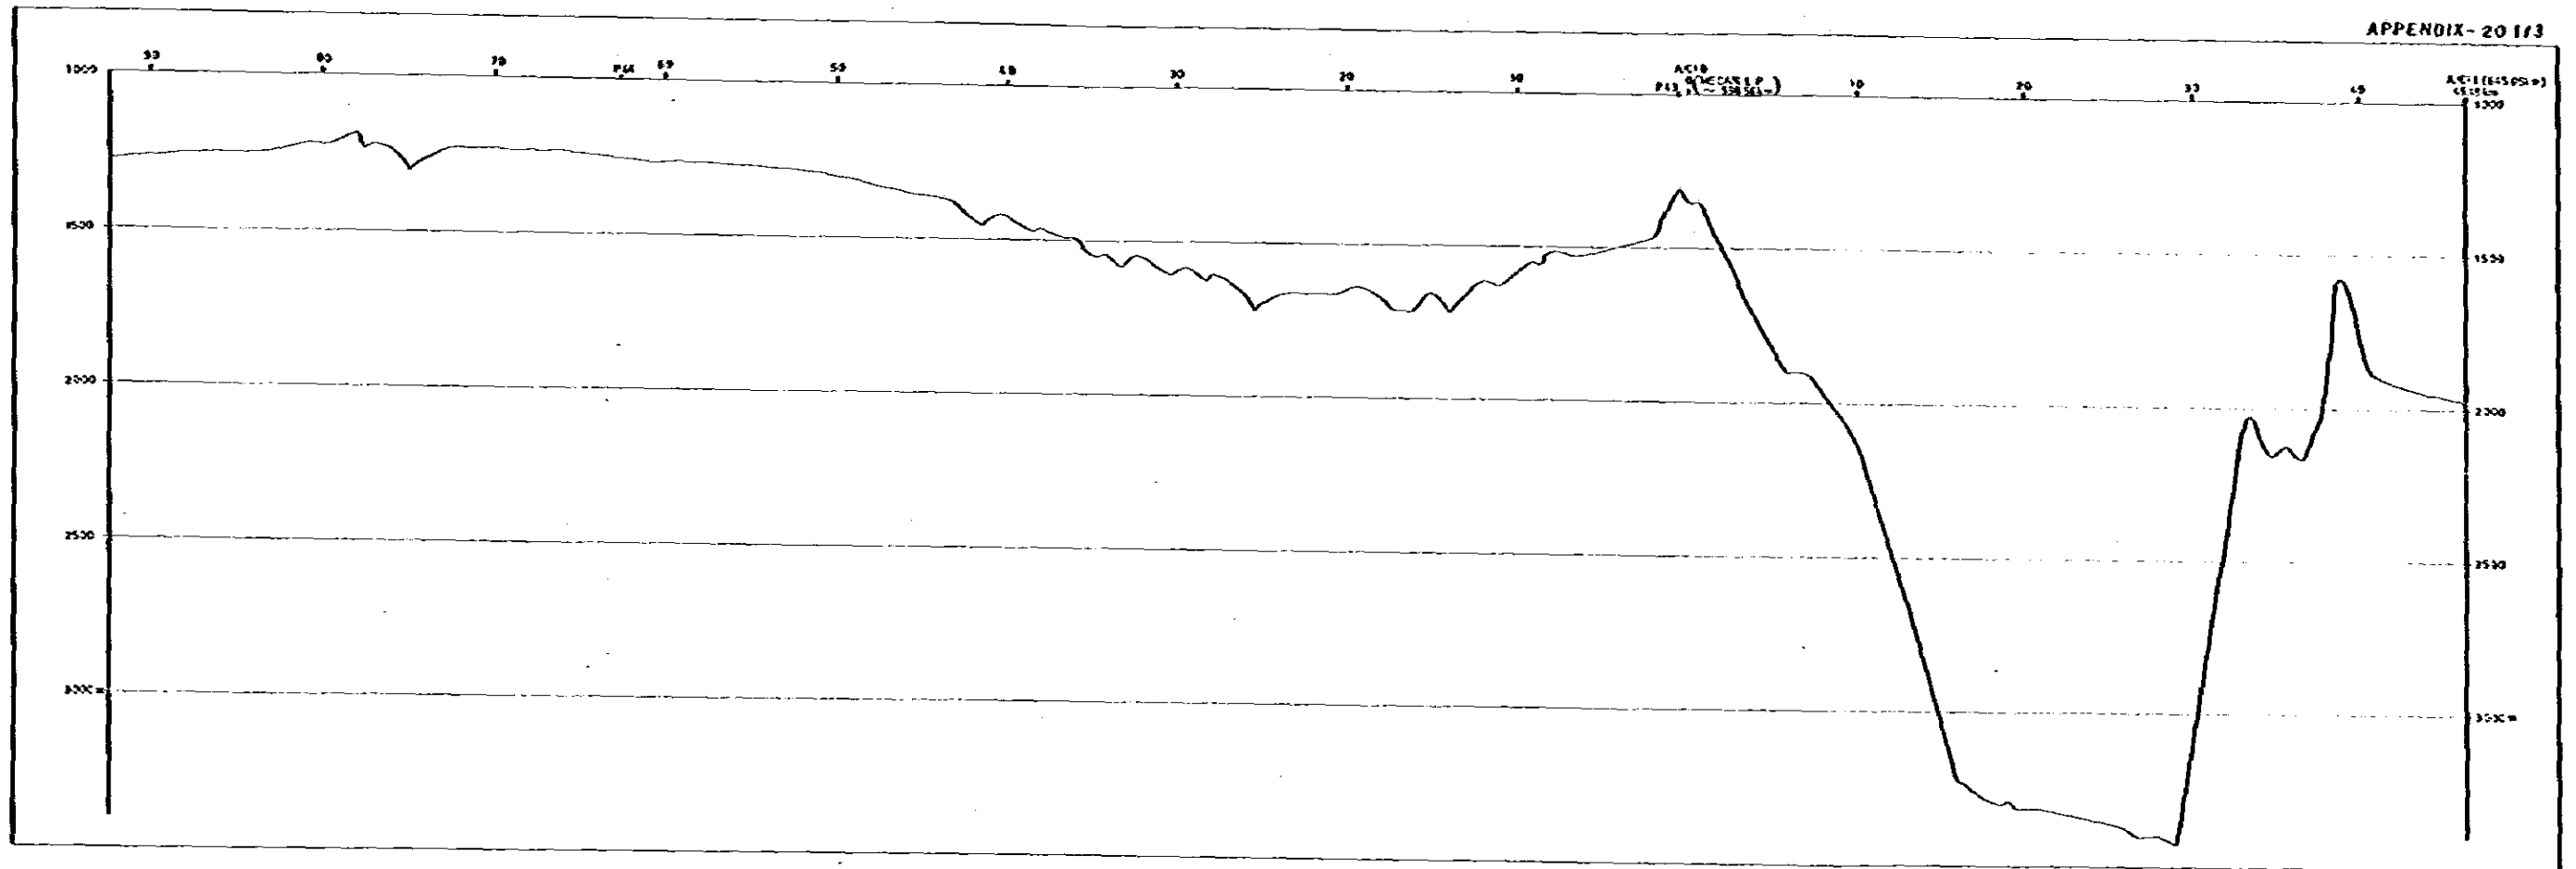
DETAILED BOTTOM PROFILE OF GREAT PASSAGE
