Appendix 25

Photograph of Seabed

## Appendix 26

### Typical Records of Side Scan Sonar

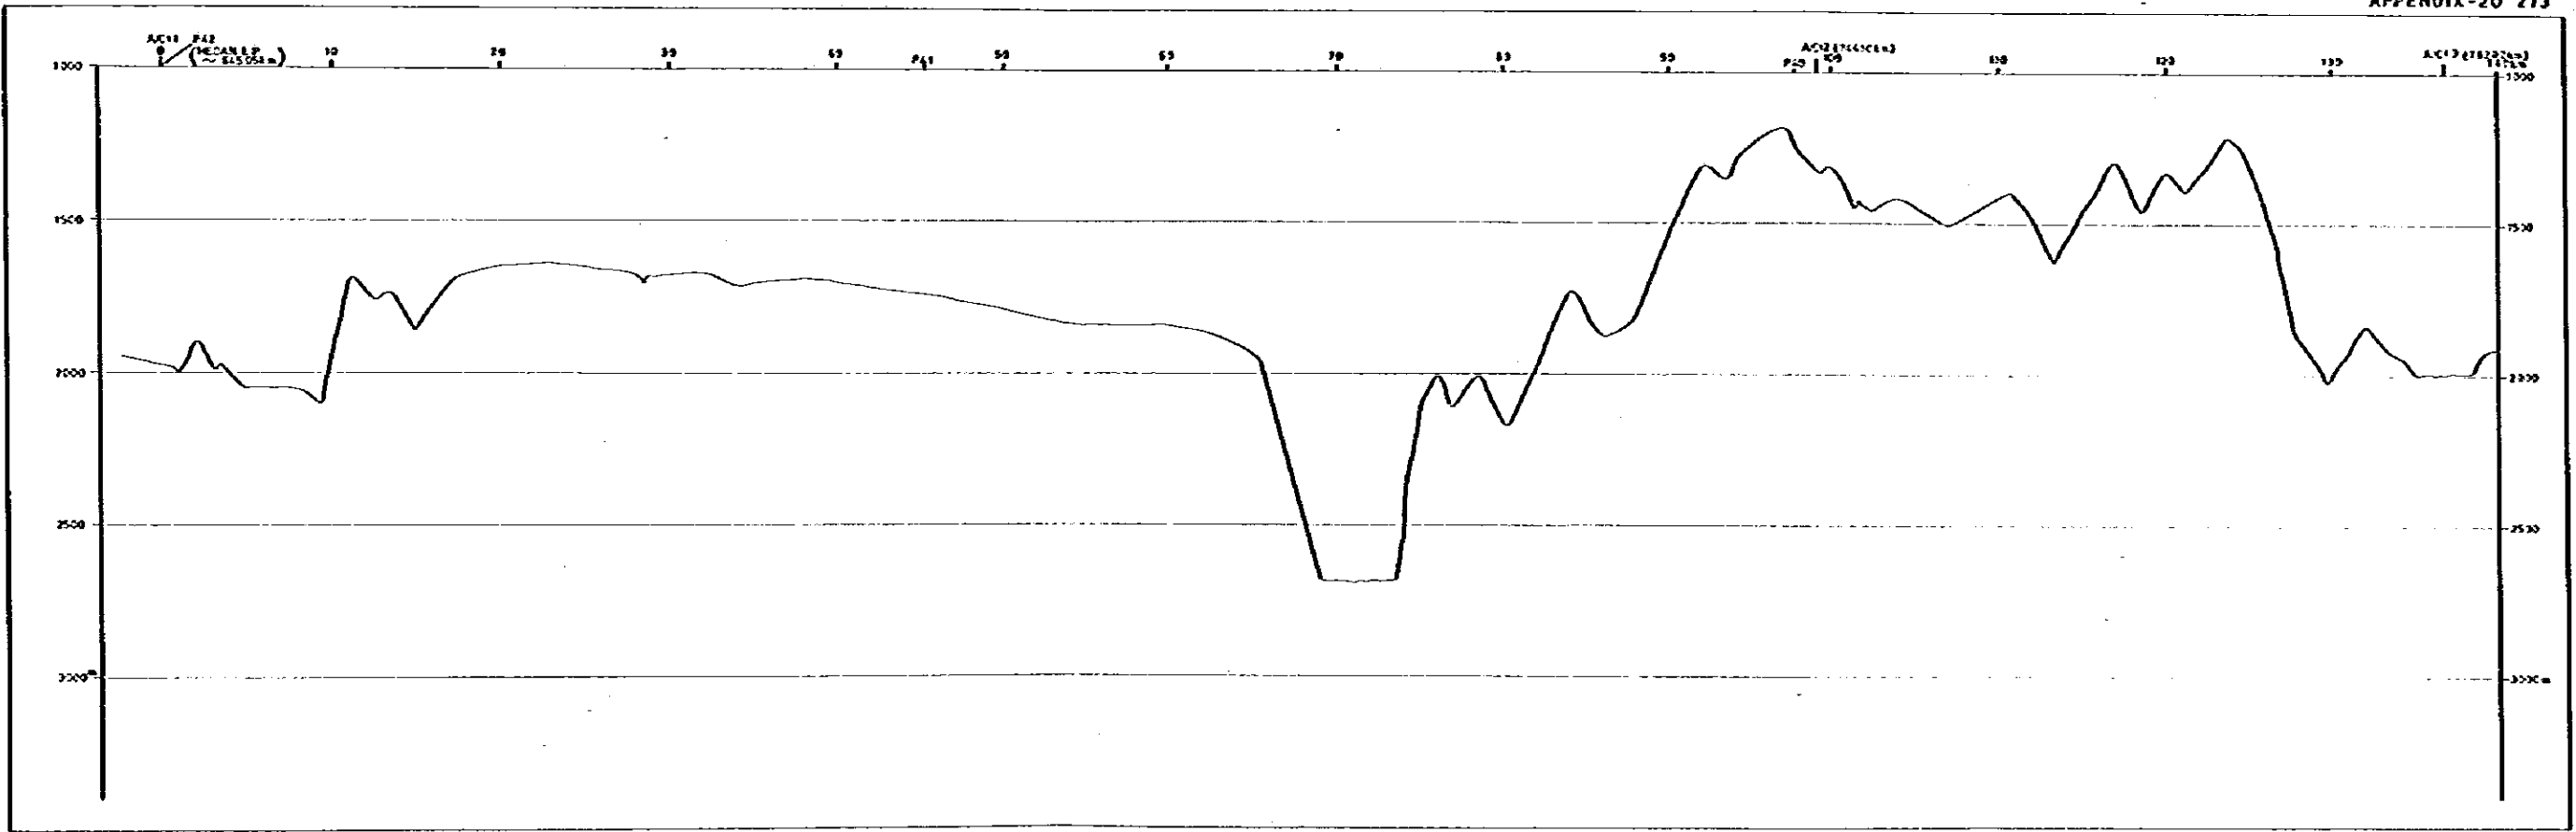
DETAILED BOTTOM PROFILE OF GREAT PASSAGE

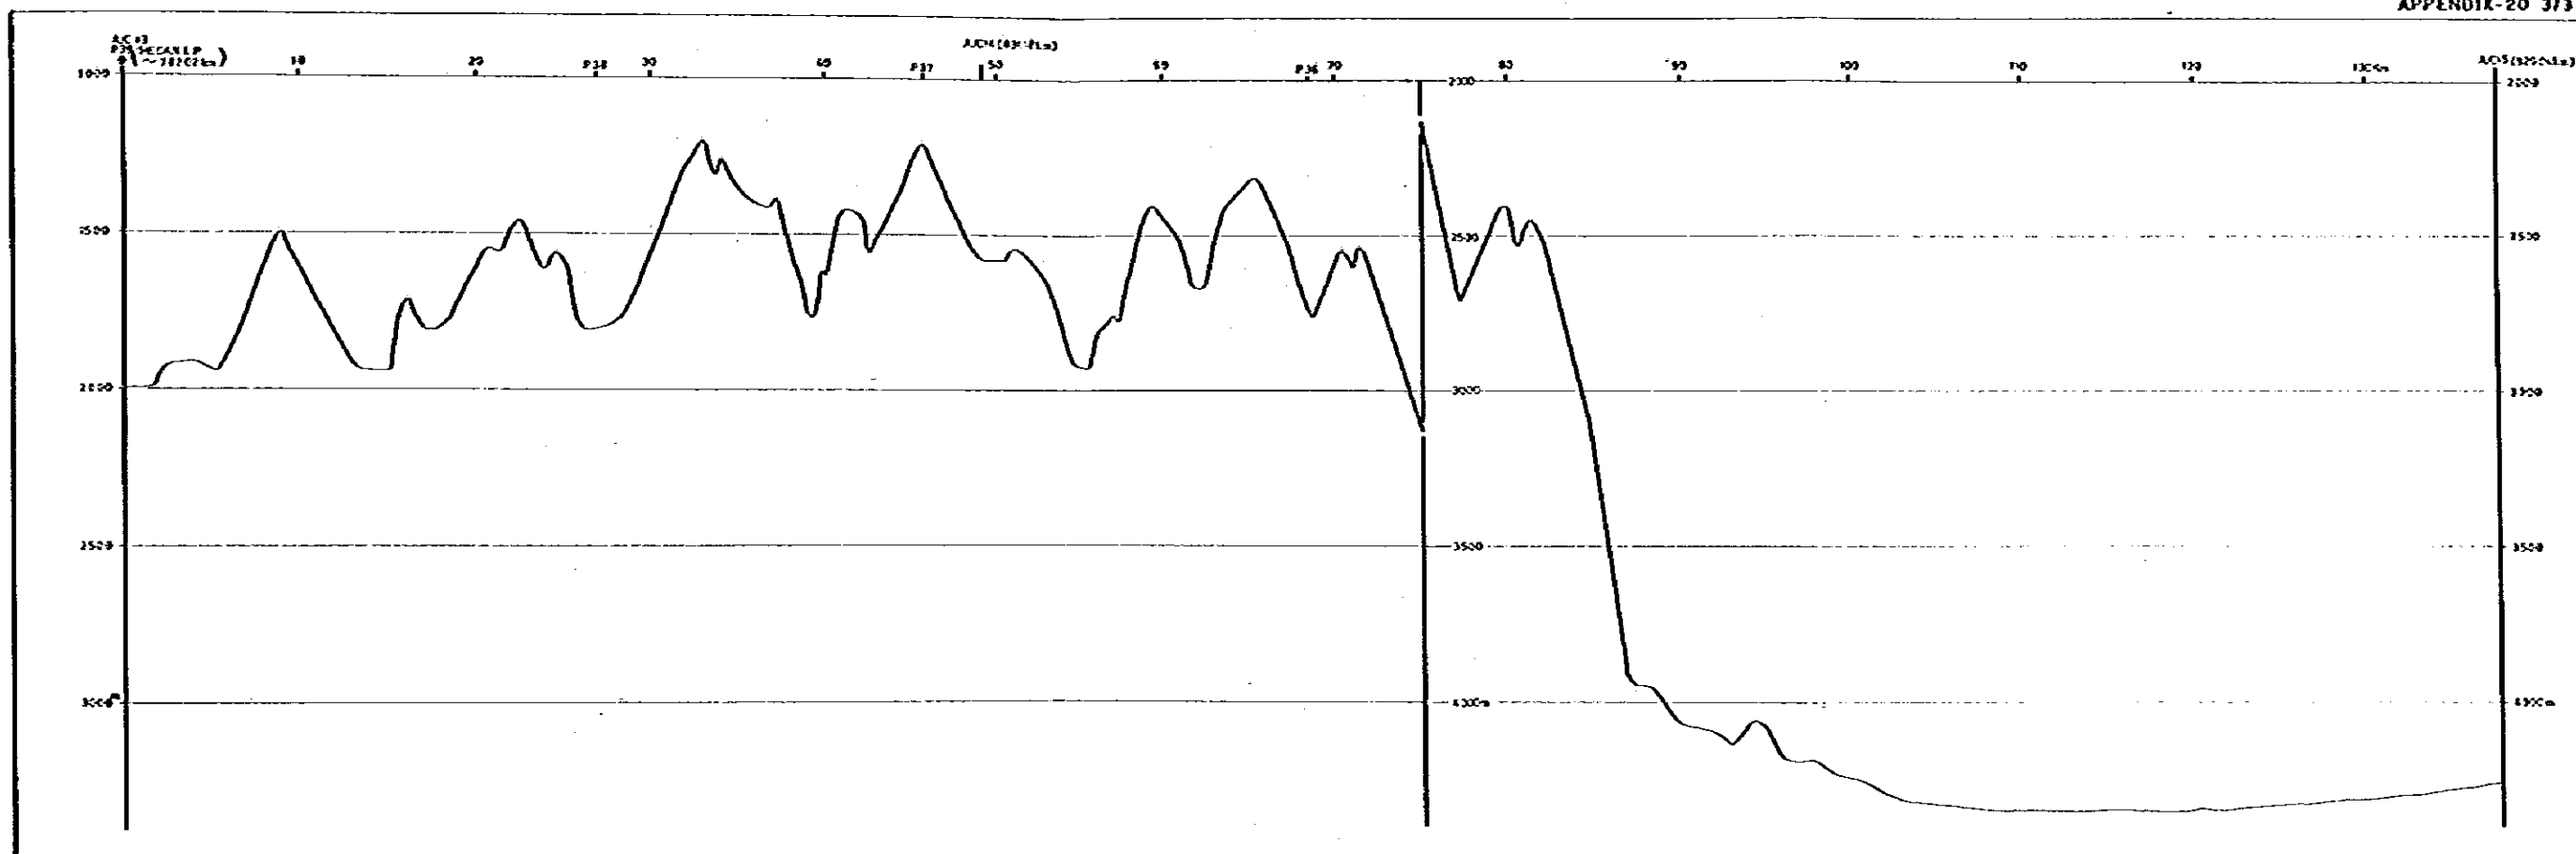
DETAILED BOTTOM PROFILE OF GREAT PASSAGE

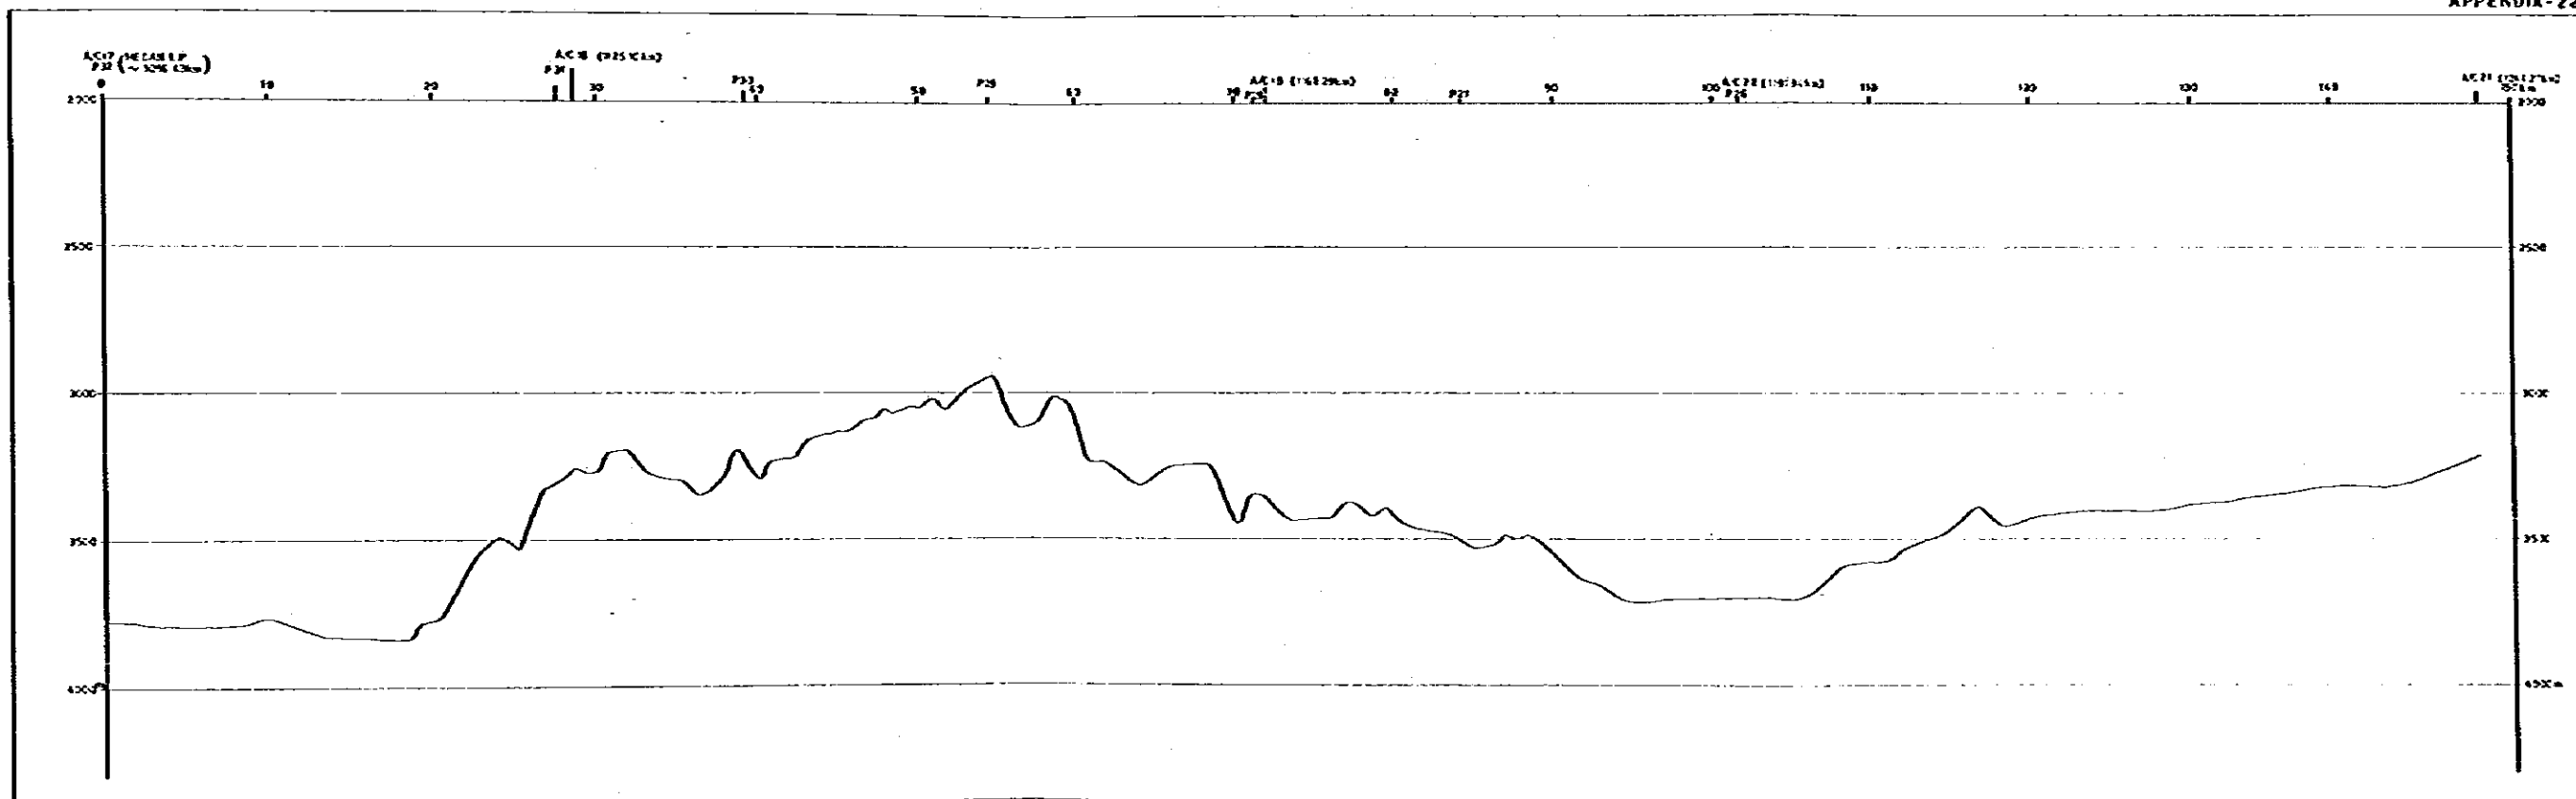
DETAILED BOTTOM PROFILE OF 90°E RIDGE

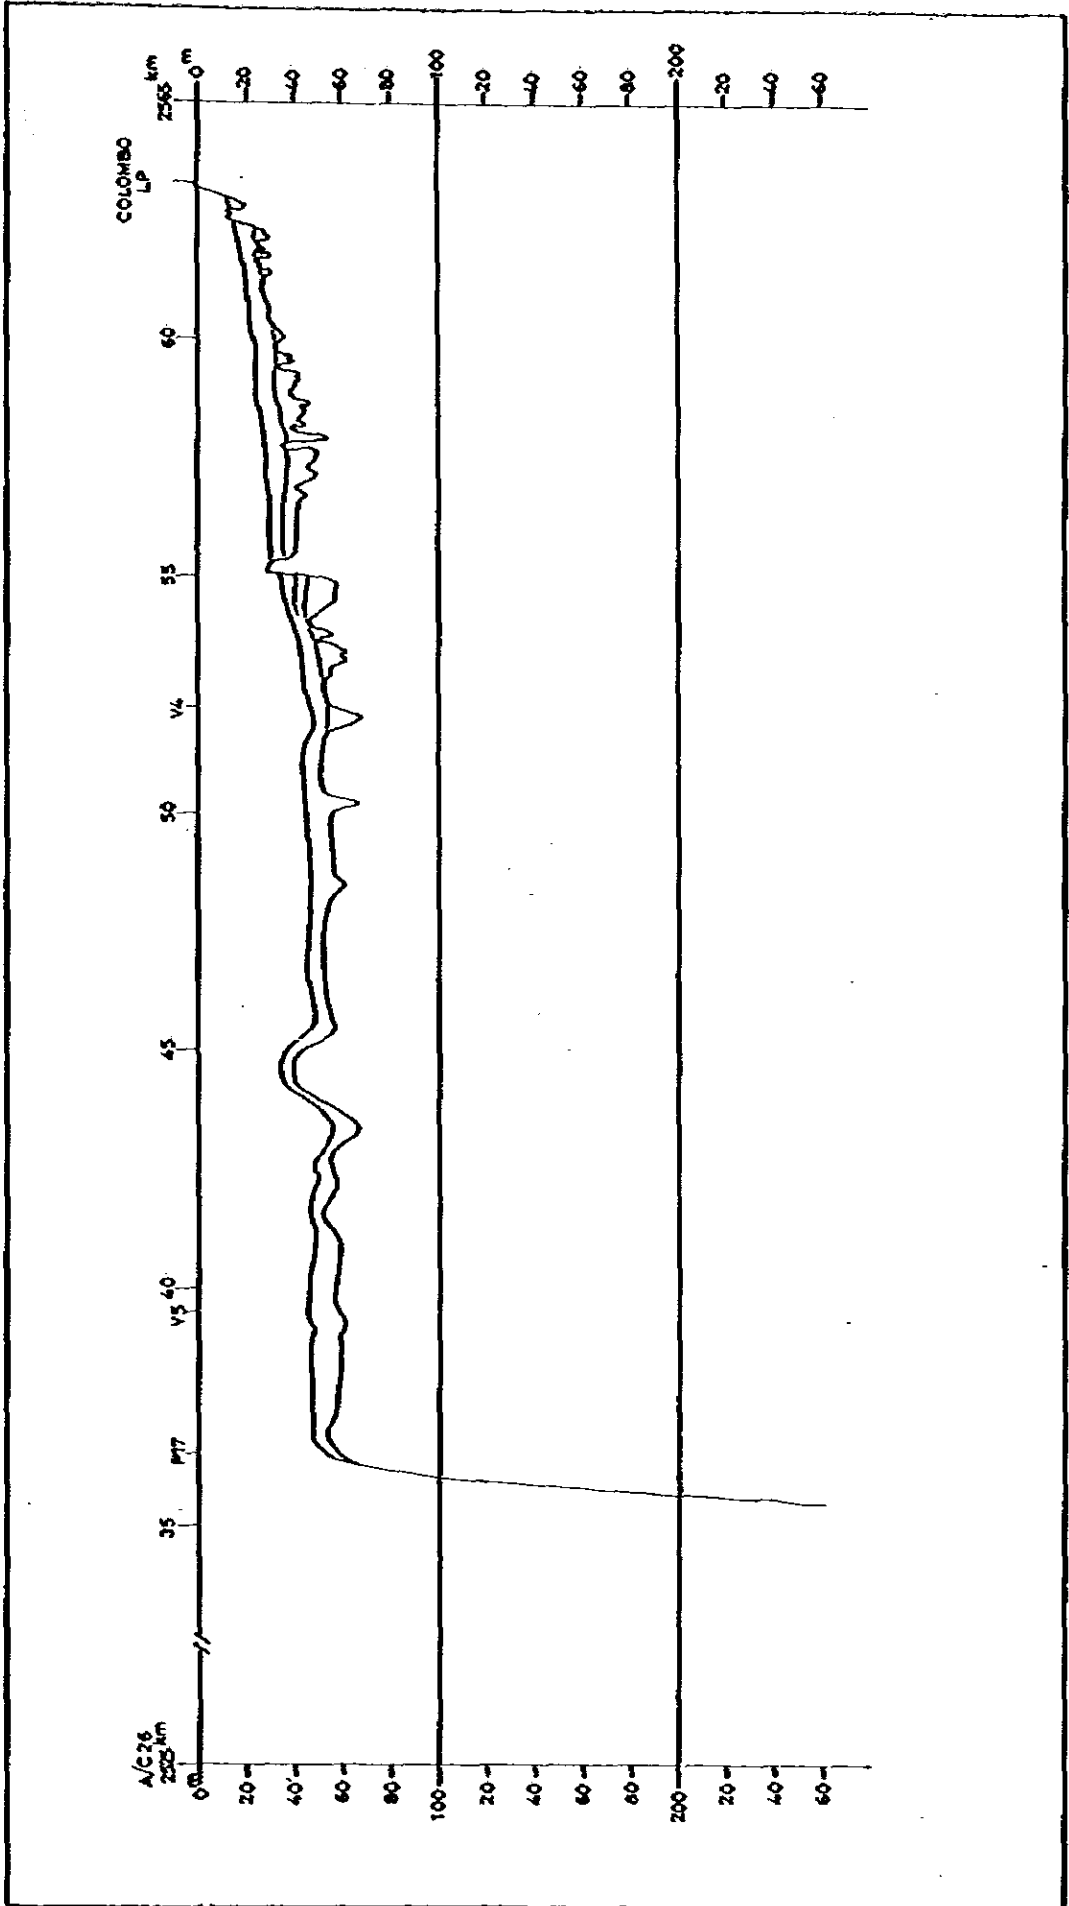
BOTTOM PROFILE AND SUB-BOTTOM LAYERS OFF COLOMBO

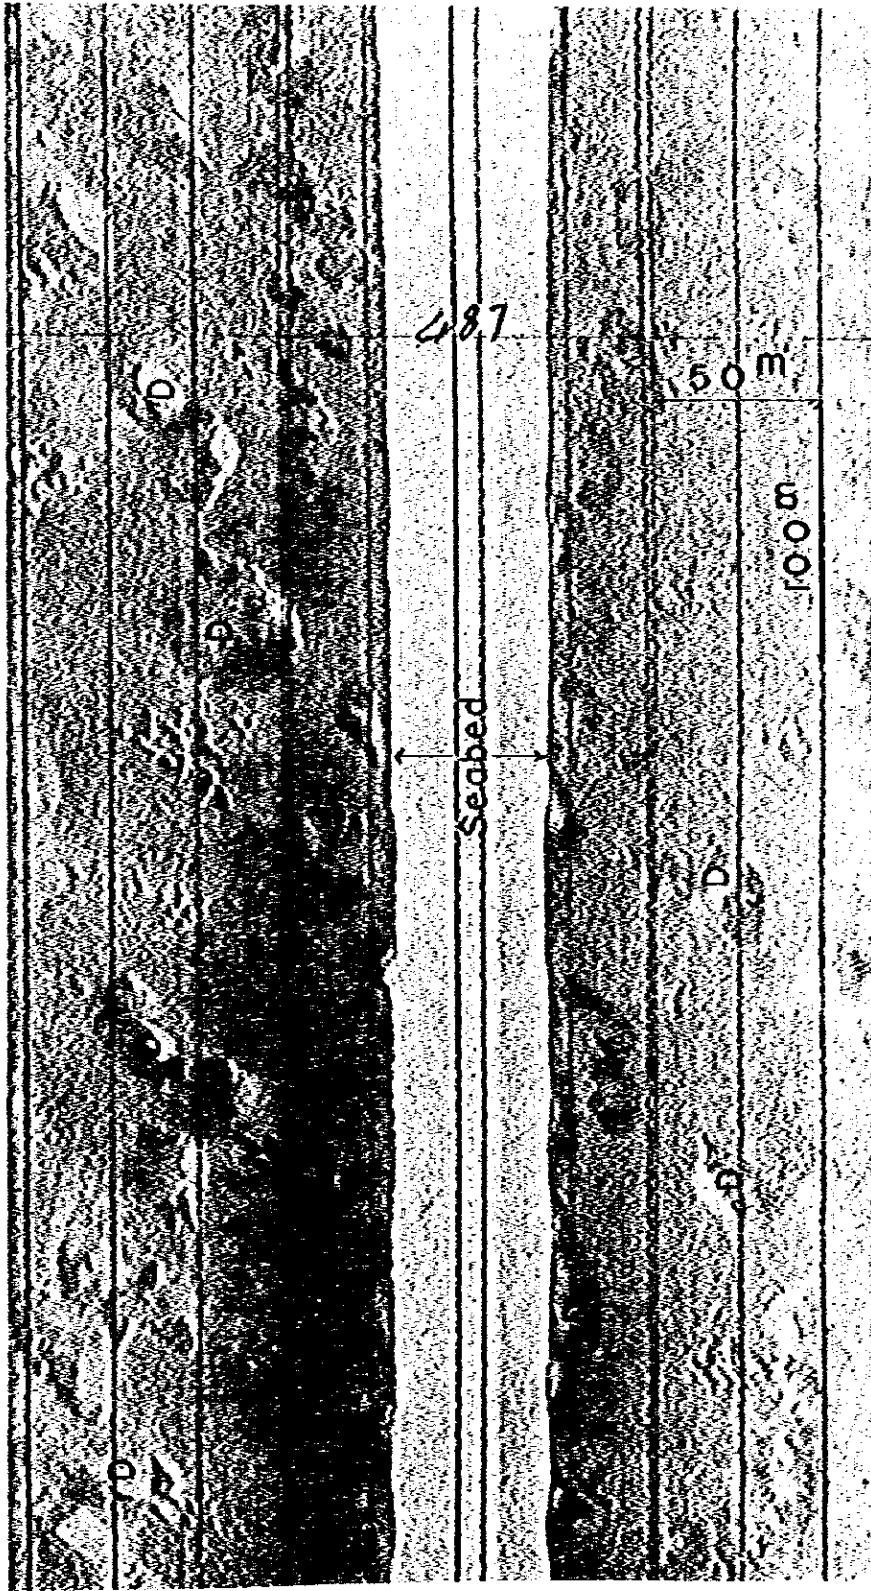
Fig. 26.1 Side Scan Sonar Record  
 Dimples on the Seabed of the Sunda Continental Shelf. D: Dimples

As a result of the investigation, there are not to be found any obstacle for laying the submarine cable. Both of these continental shelf are almost covered with the soft sediments, and are generally plain. On the Sunda Continental Shelf, we recognized the sand ripples and the dimples which are considered to be the traces of gas sprouting, and some outcrops of the rock, and also, on the Colombo Continental Shelf, some outcrops of the rock were found near inshore. These are shown in Fig. 26.1 - Fig. 26.4.

(Fig. No.)	(Location)	(Remarks)
Fig. 26.1	Sunda Continental Shelf about 70 km from A/C 5	dimples
Fig. 26.2	Sunda Continental Shelf about 60 km from A/C 6	sand ripples
Fig. 26.3	Sunda Continental Shelf about 65 km from A/C 6	rock & sand ripples
Fig. 26.4	Colombo Continental Shelf 600 - 800 m off L.P	rock

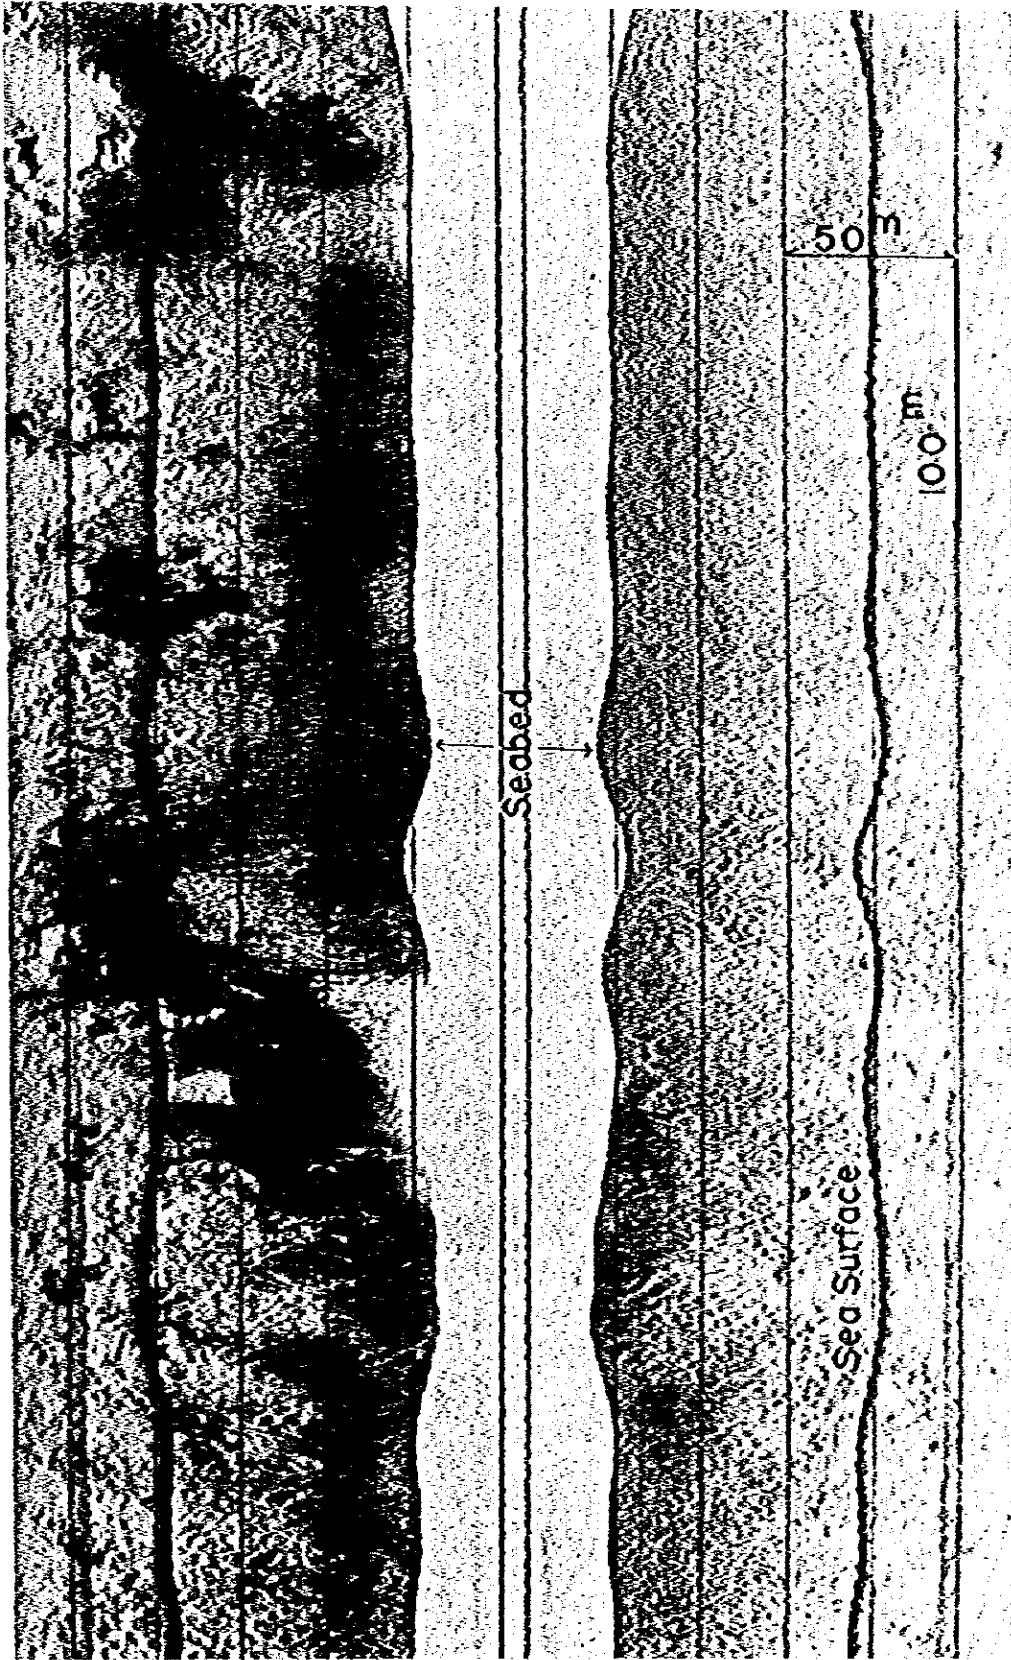
Fig. 26.2 Side Scan Sonar Record  
Sand Ripple Marks on the Sunda Continental Shelf  
Striped Patterns show the Sand Ripple Marks

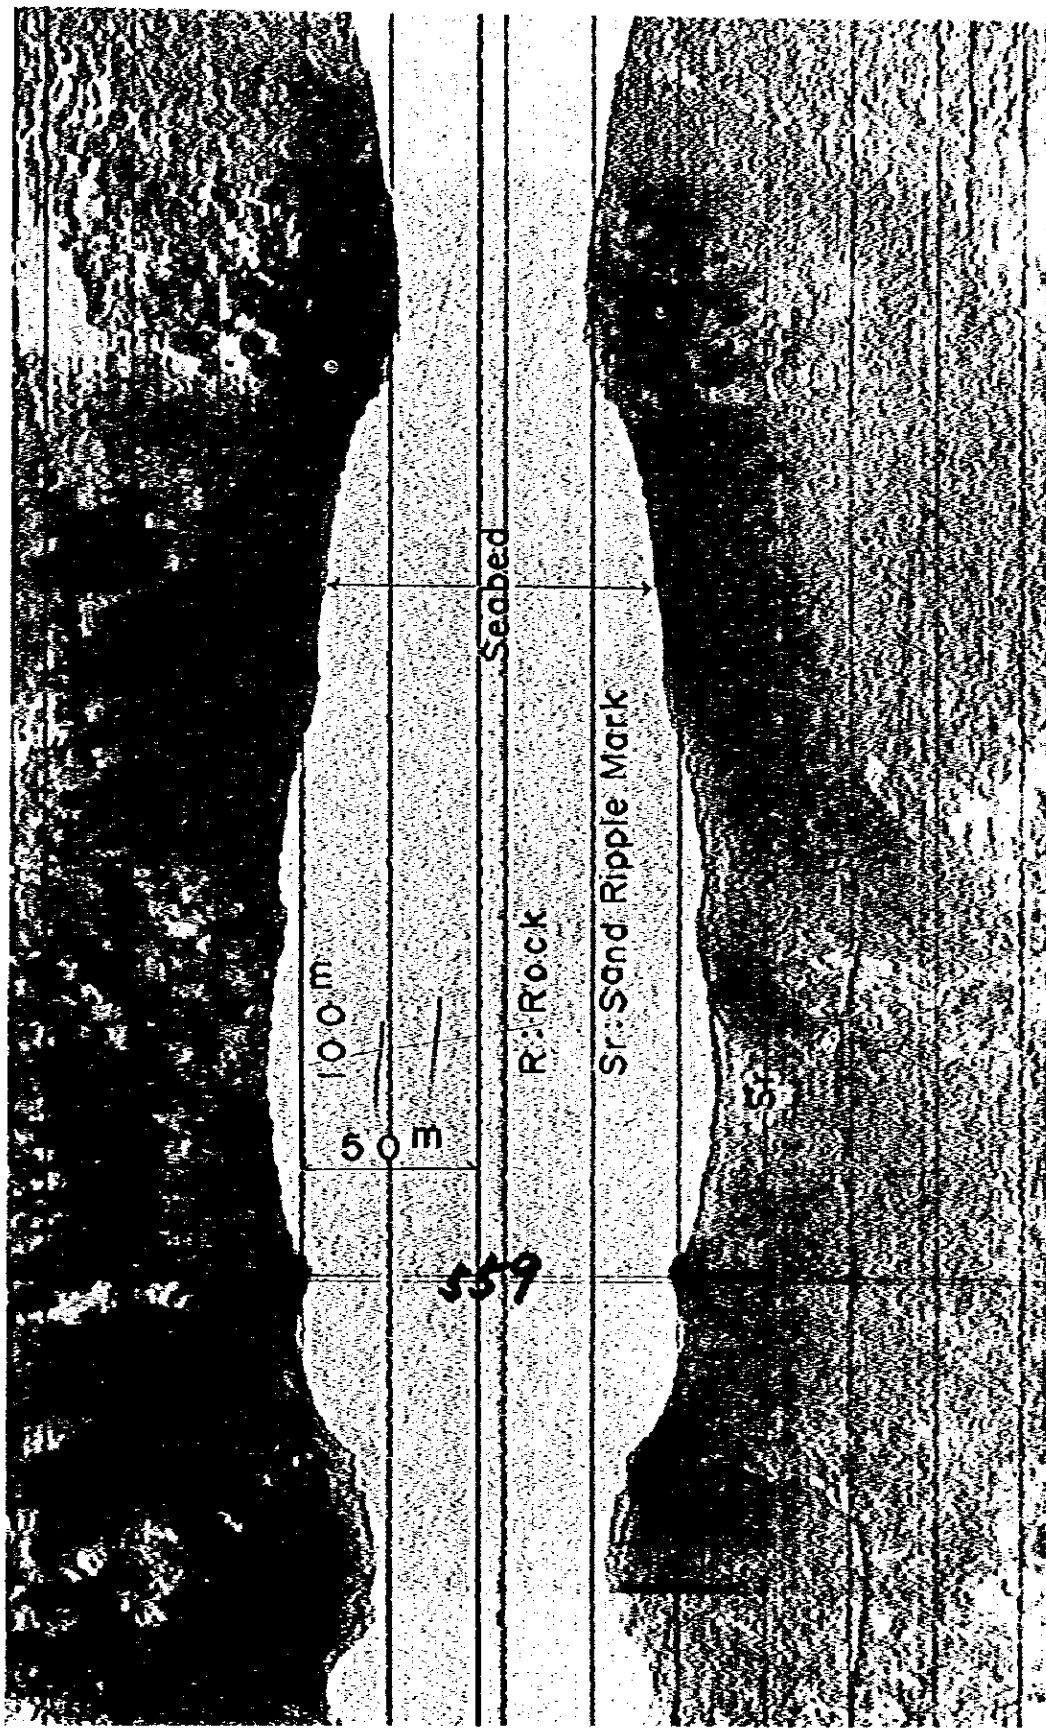
Fig. 26.3 Side Scan Sonar Record  
 Outcrops of Rock and Sand Ripple Marks on the Sunda Shelf  
 edge, Rocks consist of Sandstone and/or Mudstone.
