Figure III-2.1 FLOW SHEET OF CAUSTIC SODA AND CHLORINE DERIVATIVES PRODUCTION AT PT. ISI

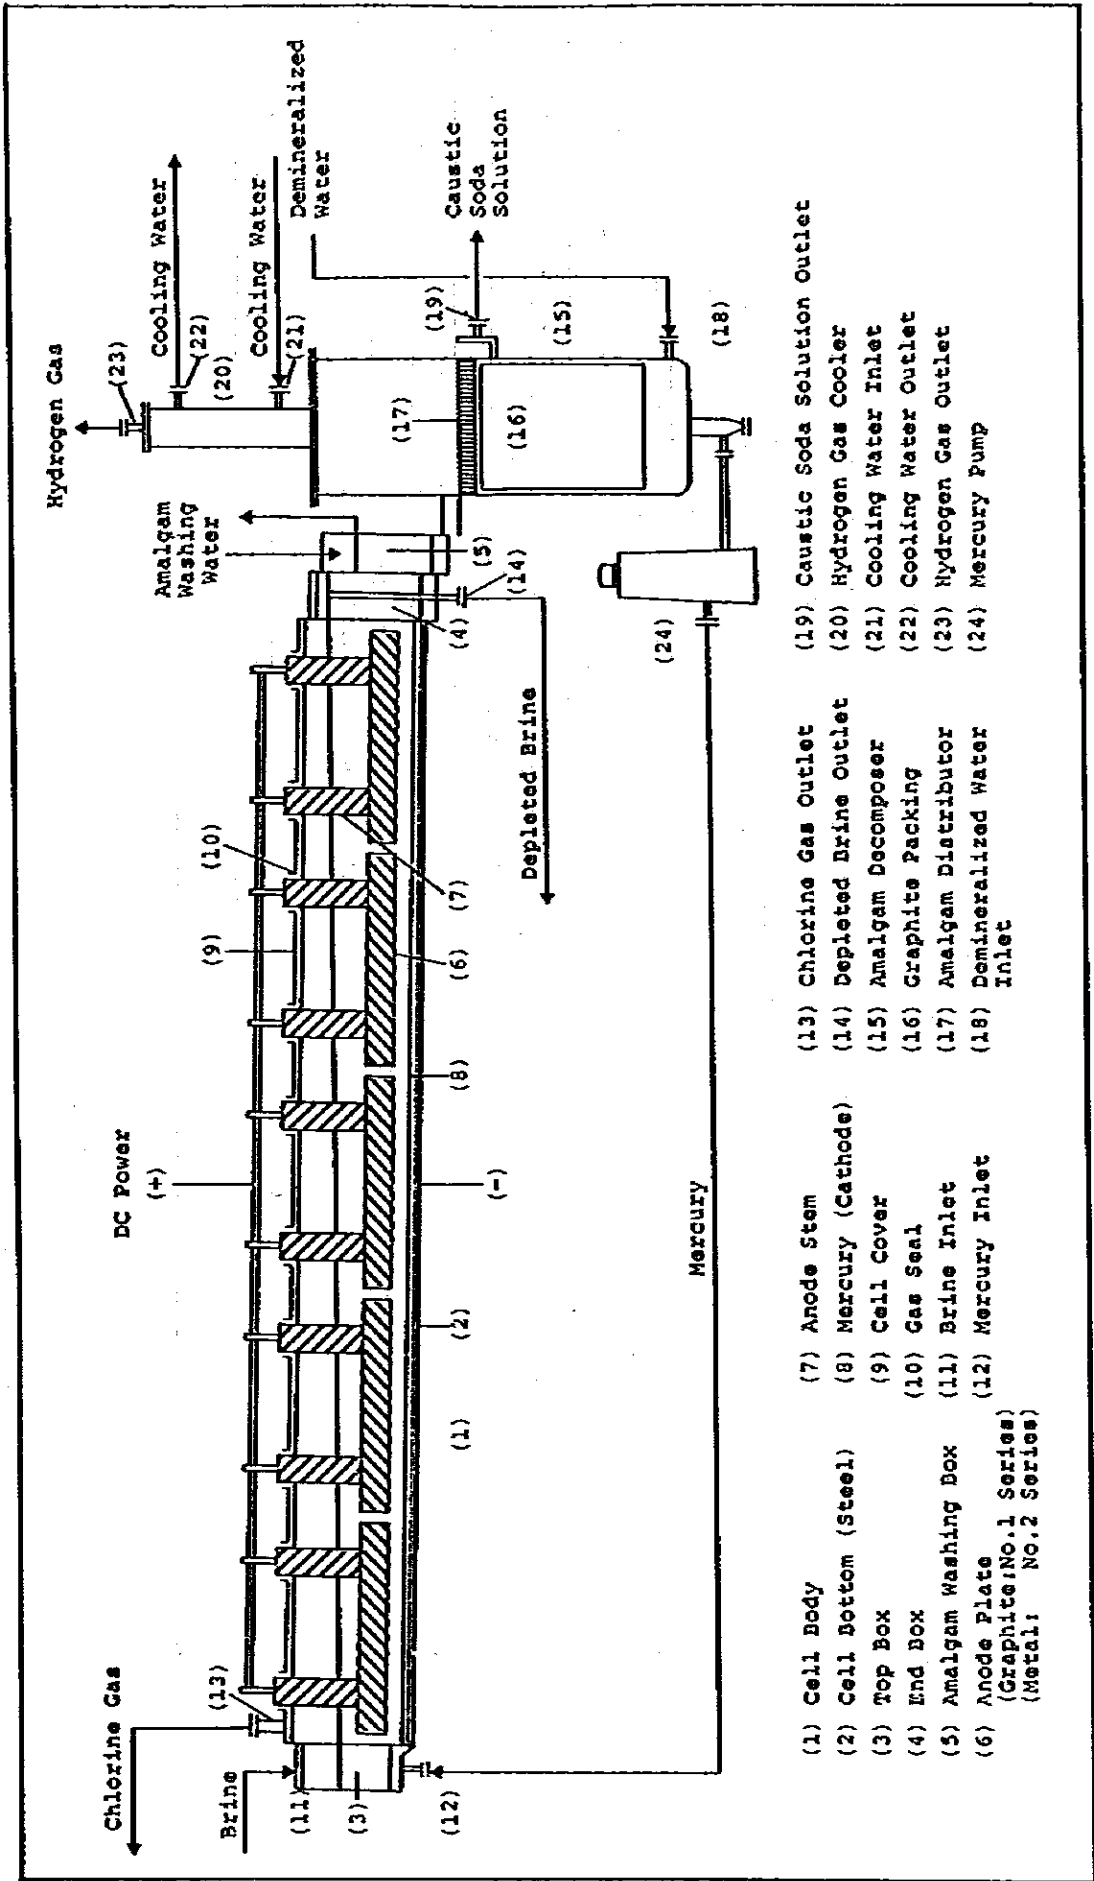
| (1) Cell Body | (7) Anode Stem | (13) Chlorine Gas Outlet | (19) Caustic Soda Solution Outlet |

(Graphite, No. 1 Series)
(Metal, No. 2 Series) | (12) Mercury Inlet | (18) Demineralized Water
Inlet | (24) Mercury Pump |

Figure III-2.2 CROSS SECTION OF MERCURY CELL (MODEL)

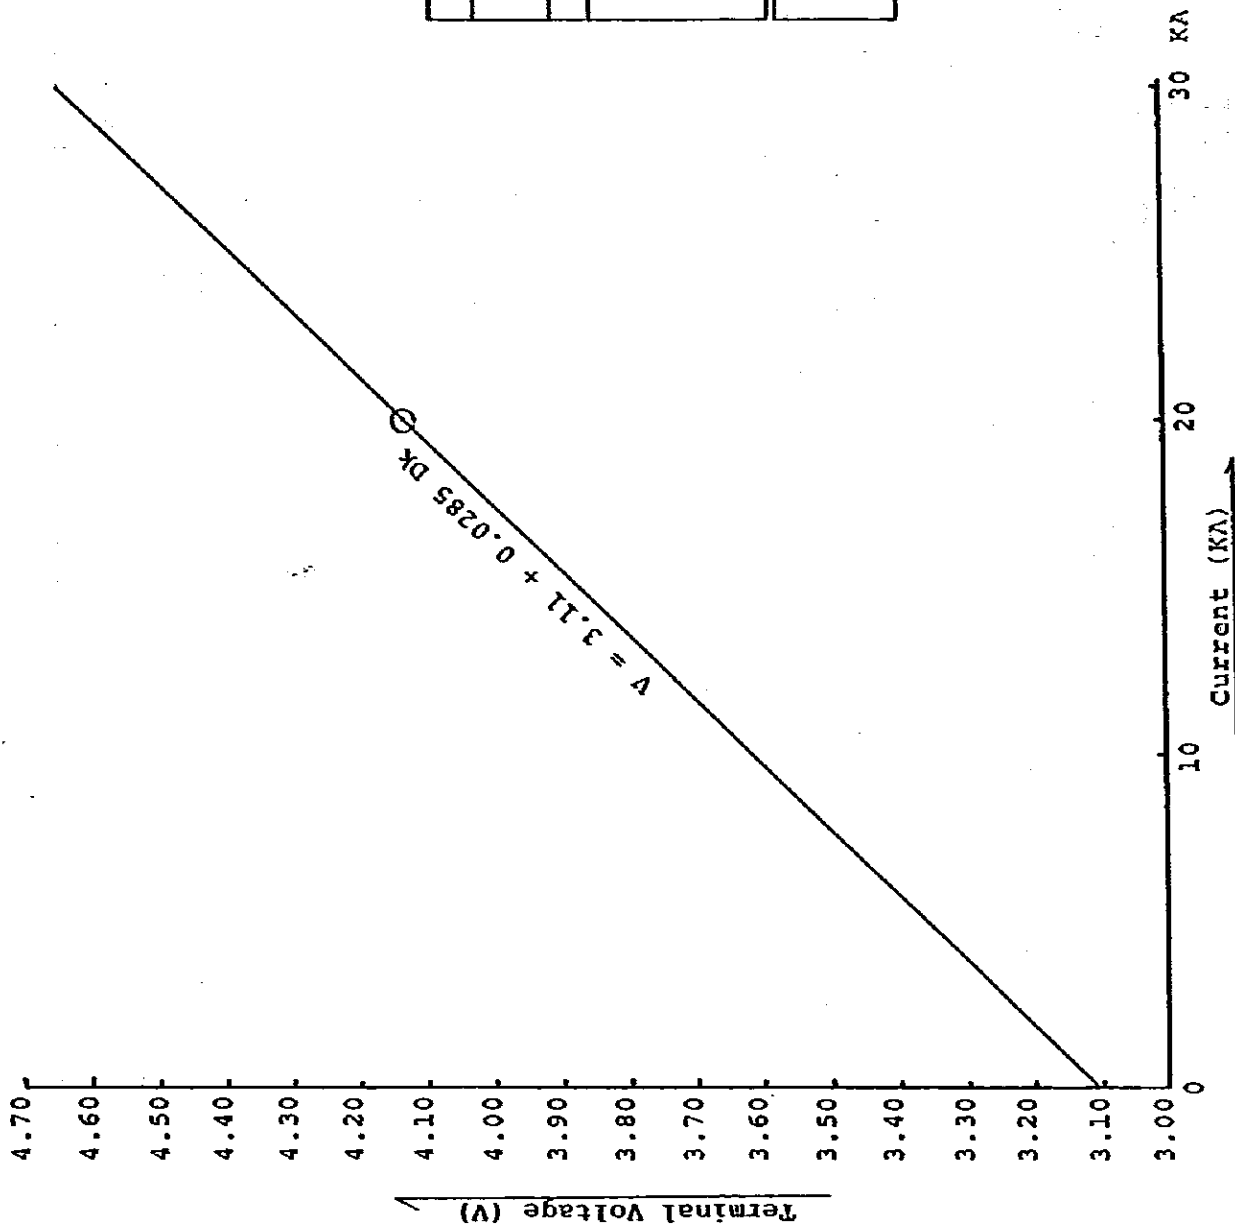
Figure III-2.4 VOLTAGE — CURRENT CURVE AT NO.1 SERIES ELECTROLYTIC CELLS

Current (KA)	20		
Cathode current density (A/dm ²)	35.71		
Date	19 May 1984		
Cell Voltage (Terminal)	Measured	n	
	\bar{X}_1	4.135	24
	\bar{X}_2	4.122	24
	\bar{X}	4.128	
Cell Temperature (°C)	\bar{X}_1	64.6	24
	\bar{X}_2	66.3	24
	\bar{X}	65.4

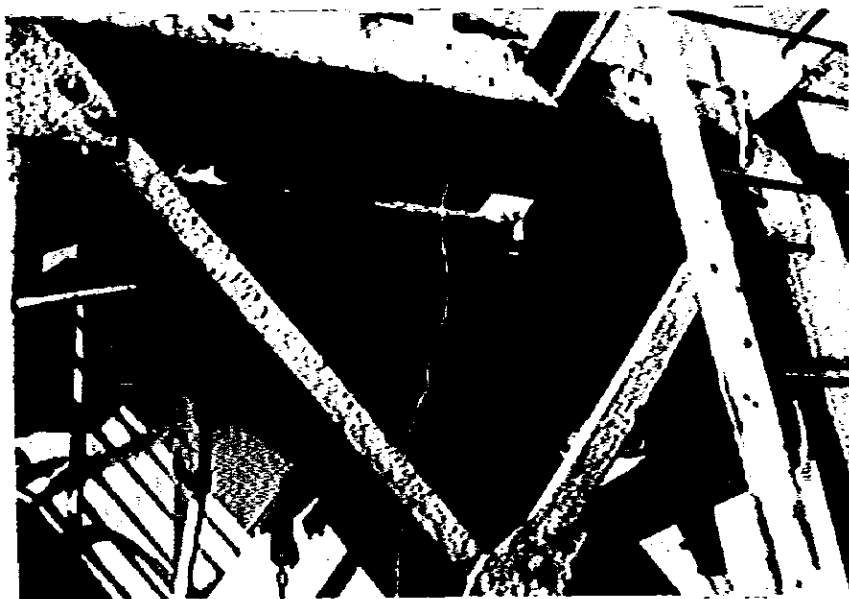
[P-4] Structure of Brine Saturator

The structure and operation stage are much corroded with the leakage of chlorine gas and hydrochloric acid gas, coupled with insufficient maintenance of painting and the like. The operation stage of a brine saturator is already in a dangerous condition, which needs immediate repairing.

The structure is entirely corroded. Especially, the operation stage of the structure for the brine saturator [P-4] is in a dangerous condition due to the poor maintenance. Chlorine gas surround the saturator, which is caused by the insufficient dechlorination of depleted brine.

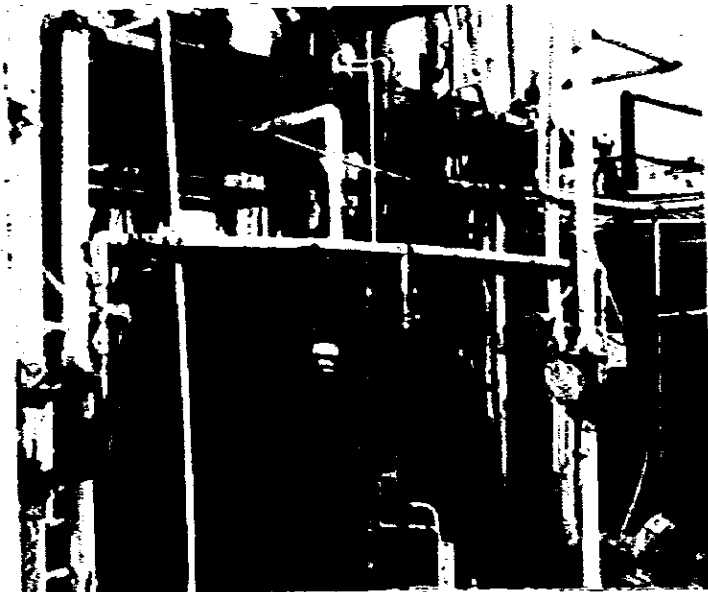
[P-6] Structure of Unit

The facilities were supplied by Asahi Glass Co., Ltd. in 1970, the designed capacity of which is 20 t/d in terms of 33% HCl, the equipments have generally advanced in superannuation, especially corrosion on the metal part of the combustion tower [P-5] and a structure [P-6] is conspicuous. The instrumentation is all unusable, and operation is being done by hand.

The diagnosis indicates that the equipments are wholly superannuated, and are thought to last only two years or so.
