**Chapter 6.**

**PRESENT TECHNICAL PROBLEMS  
AND  
COUNTERMEASURES**

**This covers the results of the investigation on the defective points and points to be improved in operation, control and equipment which was made on basis of the materials obtained and observation conducted during the factory survey. Since the contents are very detailed and there are many suggestions which can be implemented immediately, it is recommended that they are gradually to be implemented to contribute to the quality stabilization and higher earnings.**

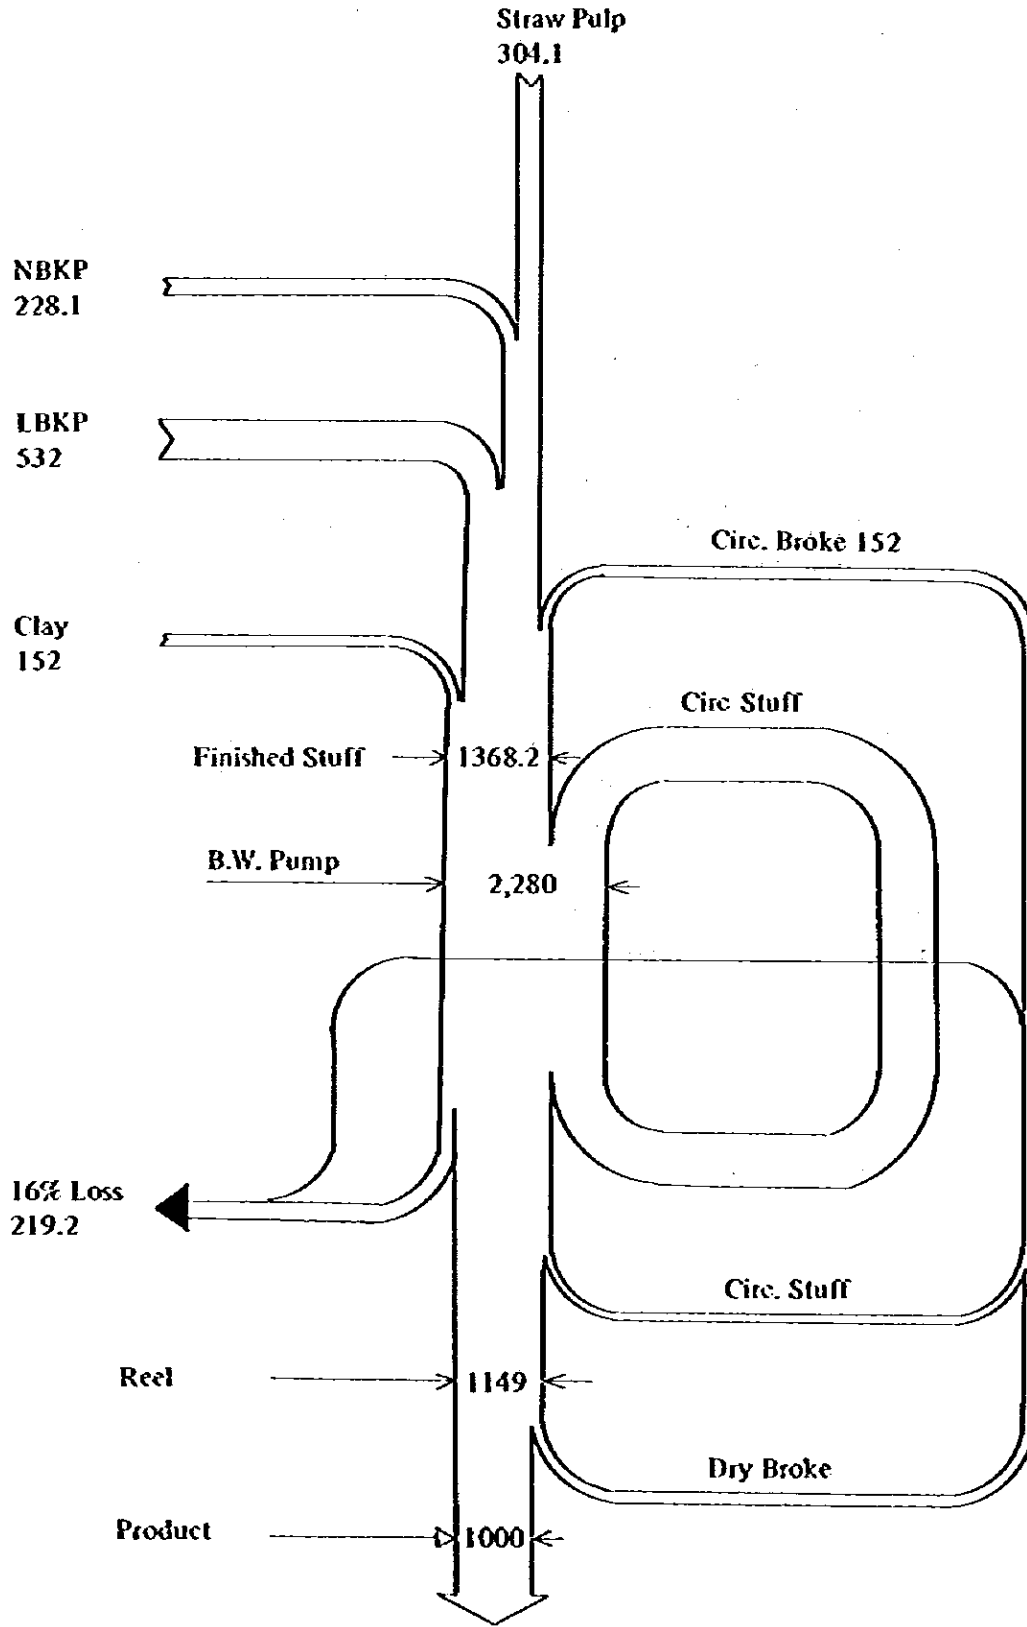
Fig. 5-6-1 Production Plan by PPM Production Plan in Mar, 1984

(1) Fig. 5-6-1 shows the mass balance concerning BANDEROL of PM I.

The figure represents values derived from the production plan of March. The figures of those virgin pulp, circulation pulp and finishing amount may change with the system of Air-Dry (AD) or Bone-Dry (BD) bases.

PM 1 – Mass Balance (For Banderol only)

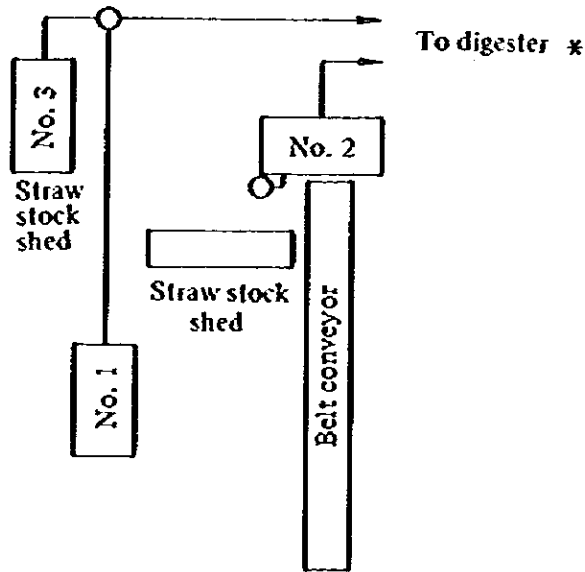
6-1-1 Machines and Equipment; Process Flow

Pneumatic conveyor  
 No. 1 cutter: Motor 30 kW  
 Diameter : 780mm  
 Width of cutting edge: 770mm  
 No. 2 cutter: Damaged  
 Air blower for straw stock  
 No. 3 cutter: Motor 45 kW  
 Diameter : 650mm  
 Width of cutting edge: 440mm  
 Unserviceable because of damaged rotor

Vertical type X 5: capacity 35m<sup>3</sup>;  
 pressure resistance 4 kg/cm<sup>2</sup>  
 Cylinder type X 1: capacity 24m<sup>3</sup>;  
 pressure resistance 12 kg/cm<sup>2</sup>

Because of having been used for a long time since inauguration of the plant in 1922, No. 1 cutter is extremely aged and does not serve with proper cutting function required, while No. 2 and No. 3 newer cutters stand unserviceable due to damages.

The straw cutter must be replaced with a new one, capable of cutting the straws into the length of about 5cm.

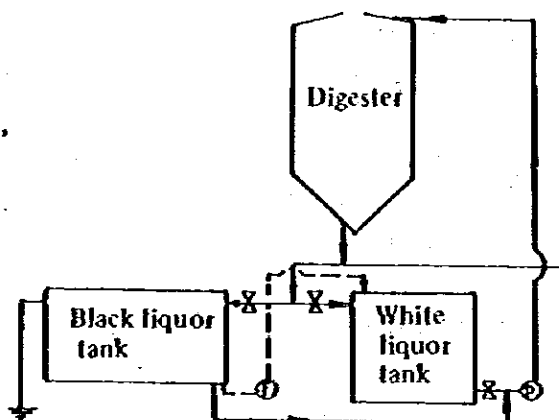
Transfer route of black liquor  
(Solid line indicates actual route,  
white dotted line indicates  
proposed route.)

Currently white liquor is fed to the digester using a liquor injection pump, and then it is returned to the white liquor tank through black liquor recovery route. It is recommended to connect the black liquor tank directly with the white liquor tank and install a pump between them to feed white liquor to its tank as shown by dotted line in the diagram.

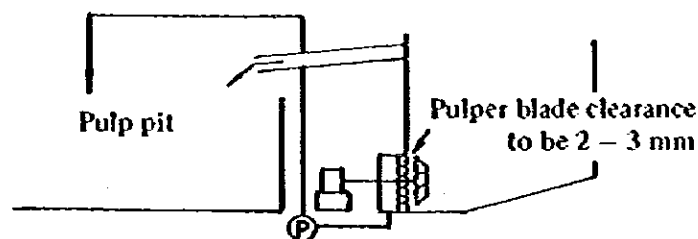
The blade clearance of the existing dissolving pulper is too wide (12mm). To prevent that un-dissolved long pulp fibers remain to be overflowed from the pulper top, the blade clearance should be adjusted to 2 – 3 mm and also pump discharging of pulp after screening should be adopted.

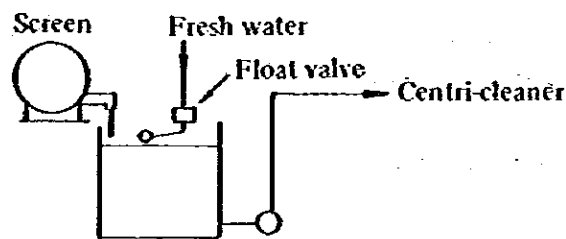
Operating consistency in centri-cleaners is too high (1.7% average) in addition to its variation in a wide range, thus the consistency remains very instable.

A water regulation valve should be installed in the level tank at the inlet of the set of the centri-cleaners, to ensure a stable level.

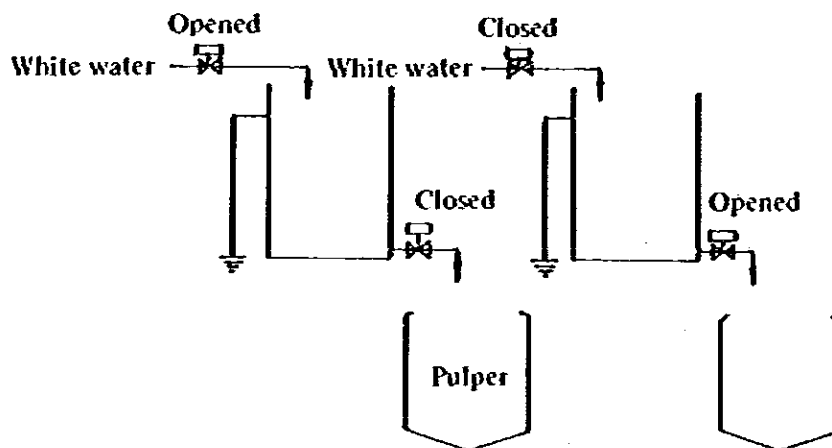
The valves should be arranged in interlocking positions as mentioned above, and repulping should be processed in the following procedures: completion of white water feed → operation of pulper → feeding of the stock → completion of repulping → completion of discharging from pulper in operation → stop of pulper

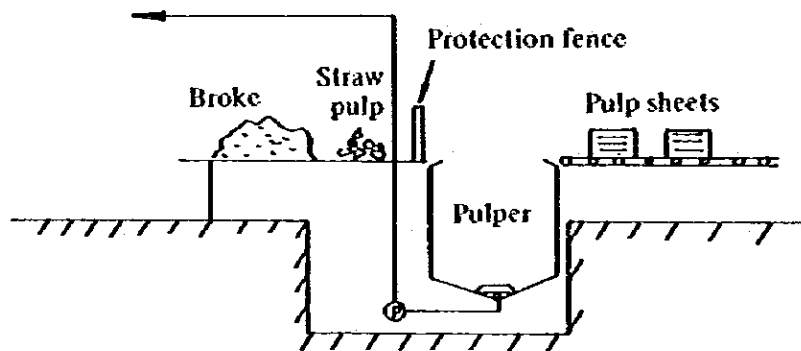
Sometimes soil has not been removed completely from portions of the pulp before such a pulp is on the belt conveyor. This soil adherence is especially observed in the feeding part of straw & broke pulp and many impurities get mixed here.

With a protection fence provided, however, it is removed when the straw and/or broke pulp are fed; this causes many times entering of impurities on the floor since pulper top comes parallel to the floor level.
