REPORT
ON
TOPOGRAPHIC MAPPING PROJECT
FOR
SATIPO AREA, DEPARTMENT OF JUNIN
THE REPUBLIC OF PERU
(Second Year Work)

Secondary Aerial Photography of the First Year
NNSS Observation
Traversing
Levelling

DECEMBER, 1983

JAPAN INTERNATIONAL COOPERATION AGENCY
(JICA)

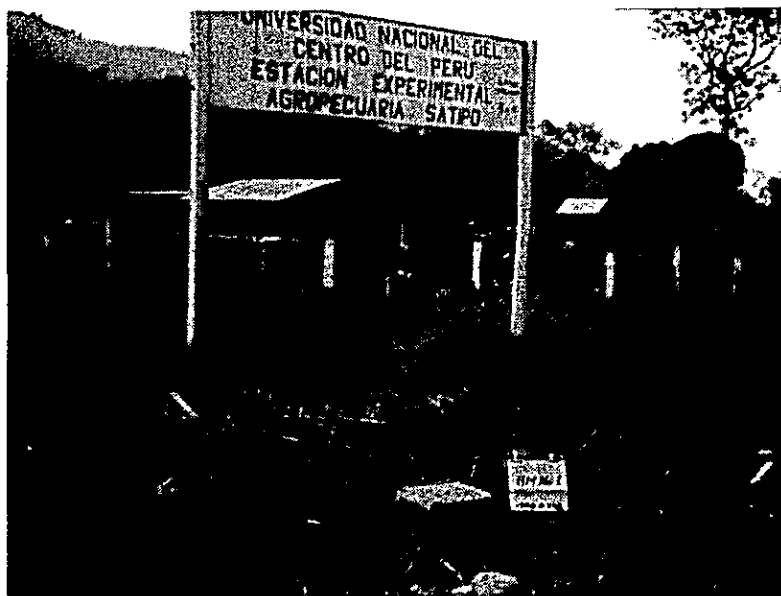
Monumenting point

- (10 NNSS points,
- 20 traversing points
- 20 bench marks

(Photo shows BM No. 1 near Satipo)
