**REPORT ON  
SEISMIC MICROZONING OF  
CHIMBOTE AREA  
PERU**

**MARCH 1971**

**OVERSEAS TECHNICAL  
COOPERATION AGENCY  
GOVERNMENT OF JAPAN**

# REPORT ON SEISMIC MICROZONING OF CHIMBOTE AREA

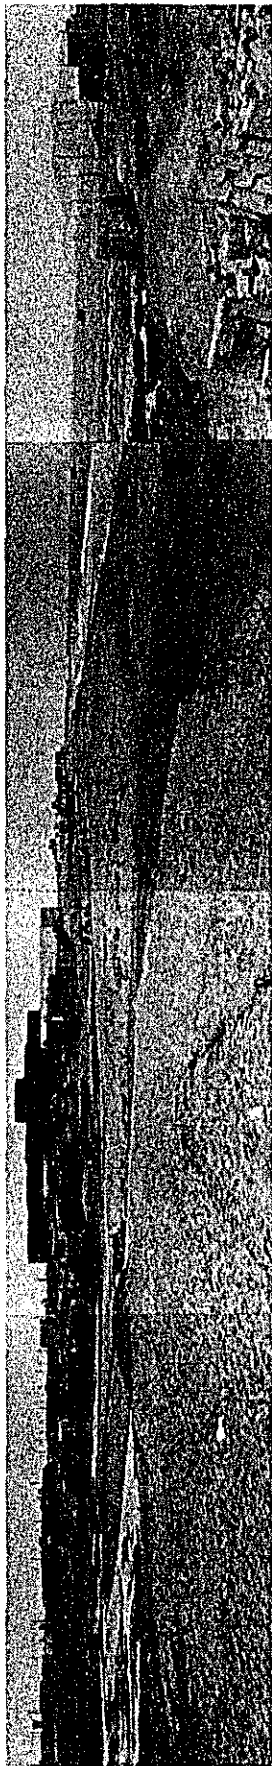
(a)

Fig. 2-5  
Beach ridge and  
lagoonal swamp  
at the estuary  
(Miramar Baja)

In and around the city of Chimbote, there are present and older beach ridges along the present coast (Fig. 2-5).

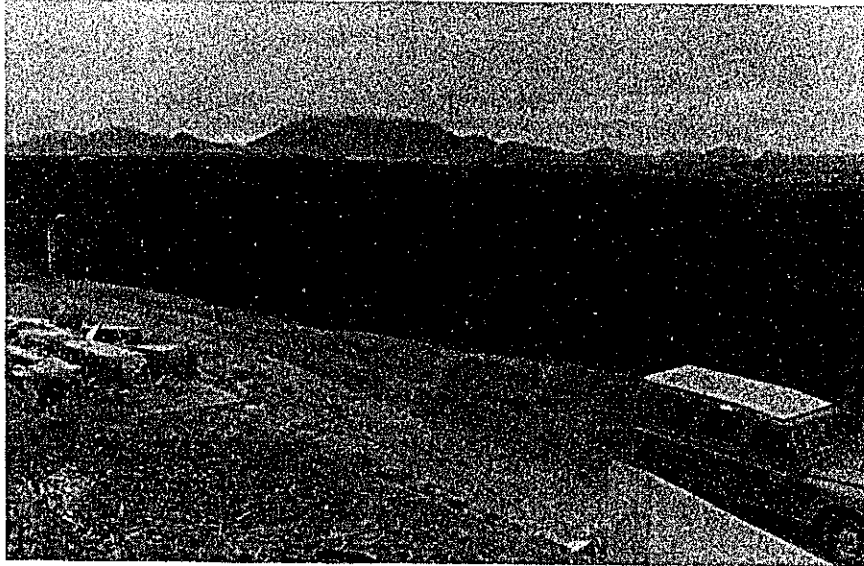
(a)

**Fig. 2-7**  
**Sheetflood deposits,**  
**west of Buenos Aires.**

A typical and largest plain extends westwards to the coast from the Pampa de la Irrigación Chimbote, on which Buenos Aires is present (Fig. 2-7). This alluvial plain is considered to have been formed by sheetflood because of absence of definite valleys on this flat plain. An alluvial plain similar to the above is one south of Chibote Hill; on which the steel plant of Chimbote stands. As shown in pre-existing boring data and as seen in the cutting in the steel plant (Fig. 2-8), the plain consists of alternation of angular debris derived from the mountains behind and sorted sand probably of reworked eolian origin. The alluvial fan north of the harbour of the steel plant consists largely of reworked eolian sand interbedded with rock debris (Fig. 2-9). Water table is fairly deep in the sheetflood plain. In Buenos Aires the water table lies 16 m below the ground surface at boring No. 5.

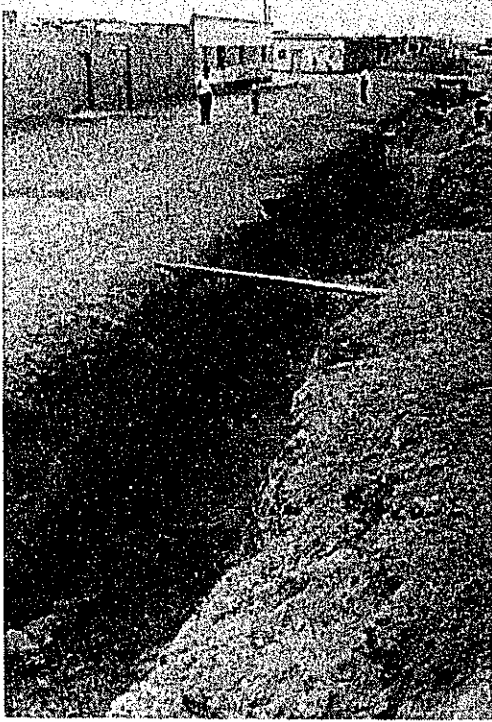
(a)

Fig. 2-10  
Soil profile along a  
trench in Jiron  
Ayacucho, Florida  
Alto. Darker layers  
are brown clay, light  
coloured layers are  
sand.

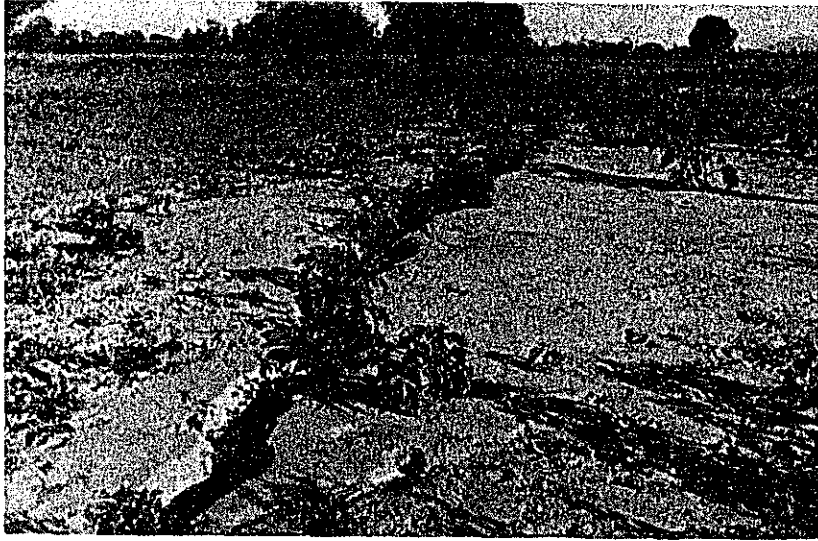
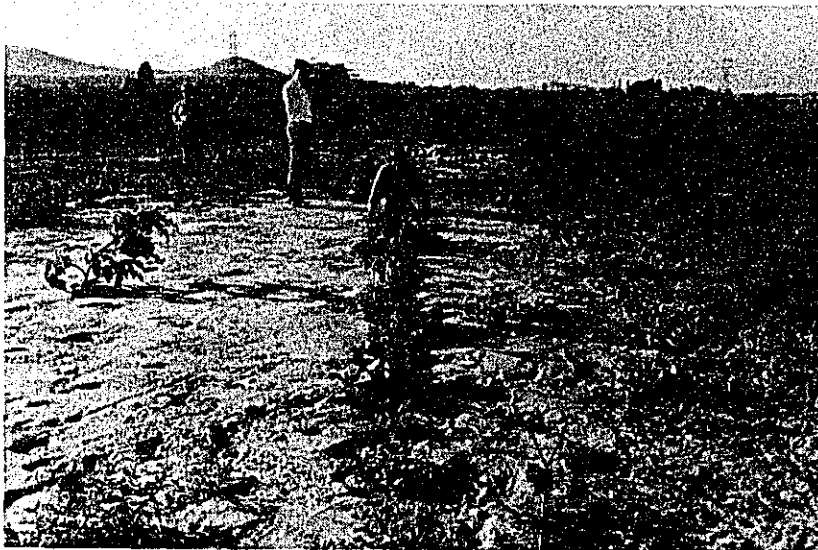
Fig. 8-2  
Sand volcanoes with  
open fissures on the  
Rio de Lacramarca  
alluvial plain (East  
of Hda. San Jose)

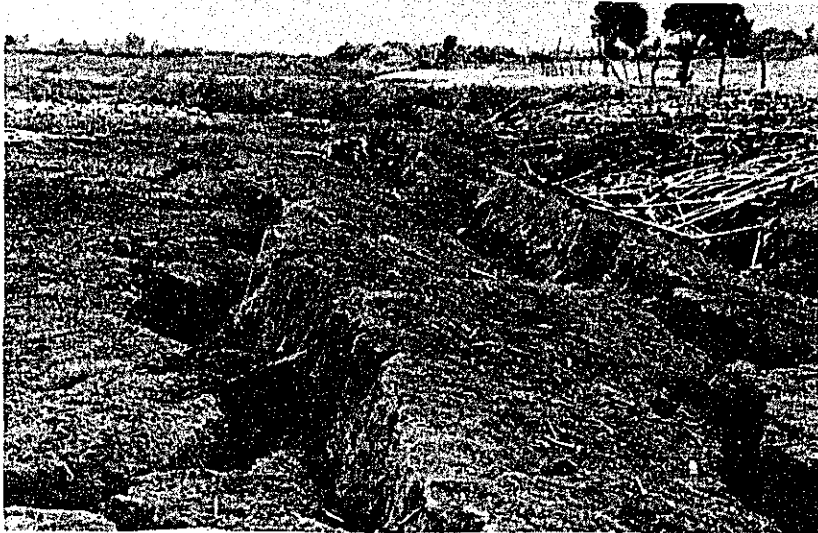
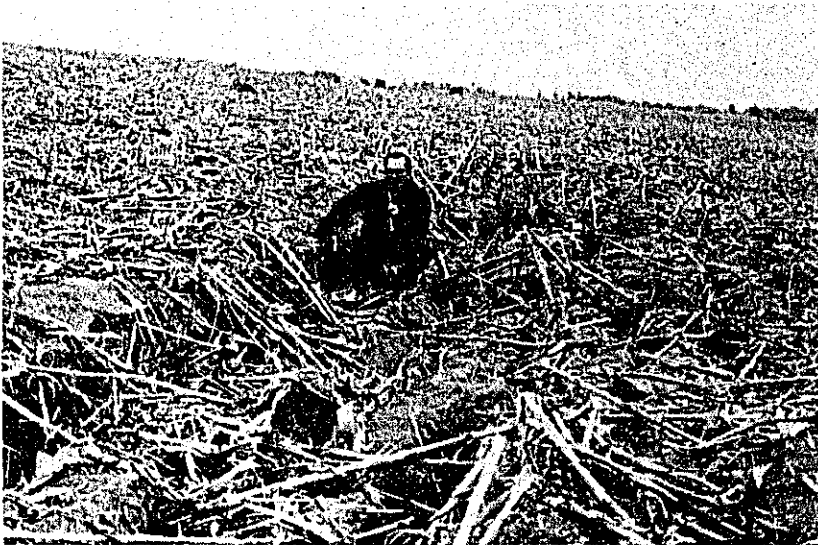
Fig. 8-5  
Ground cracks on the  
Rio de Lacramarca  
alluvial plain.  
(Hda. San Jose)

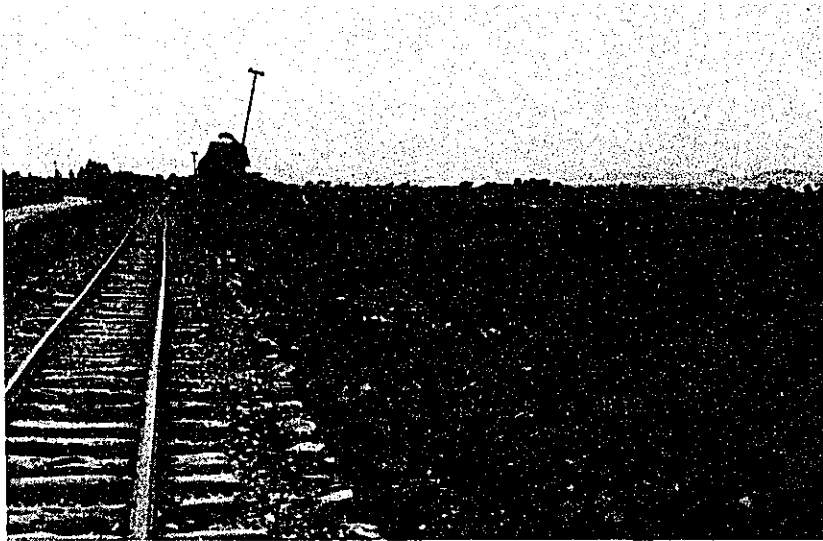
Fig. 8-6  
Damage due to sub-  
surface liquefaction on  
the Rio de Lacramarca  
alluvial plain.

a) damage to  
Chimbote-Huallanca  
railway near Hda. San Jose

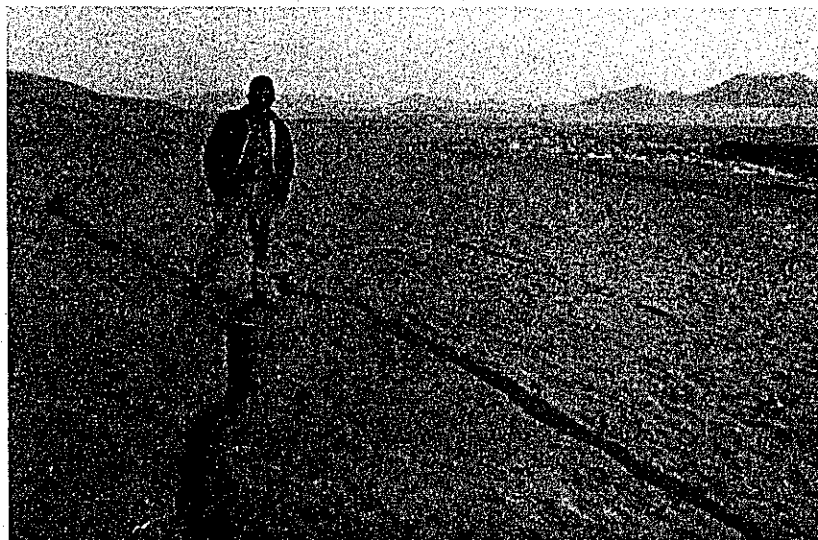
Fig. 8-9  
Cracks in the crust  
of semi-consolidated  
sand layers on the  
hill slope of San  
Pedro

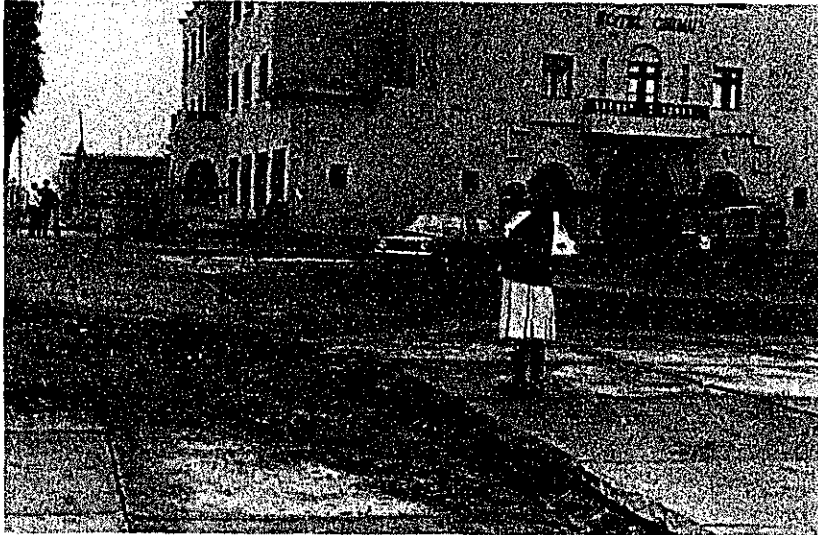
(a)

Fig. 8-11  
Differential sub-  
sidence of ground  
on beach ridge.  
(Coast near  
Hotel Chimu)

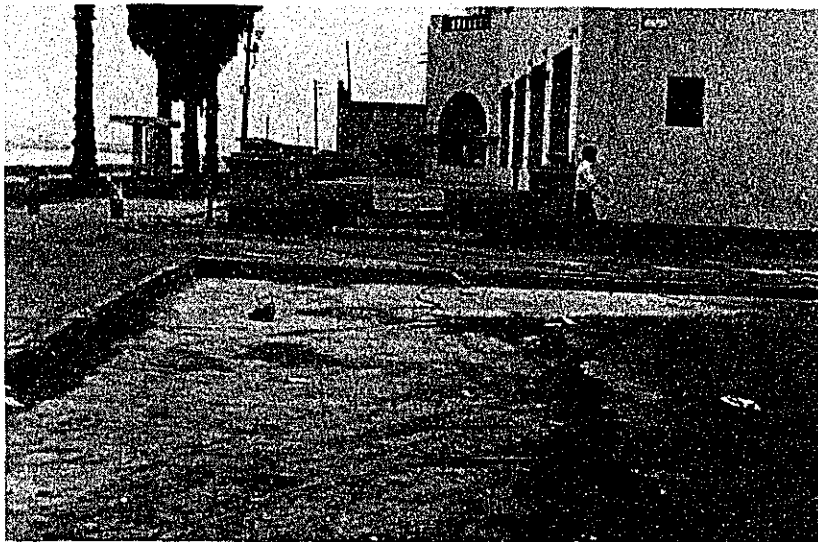
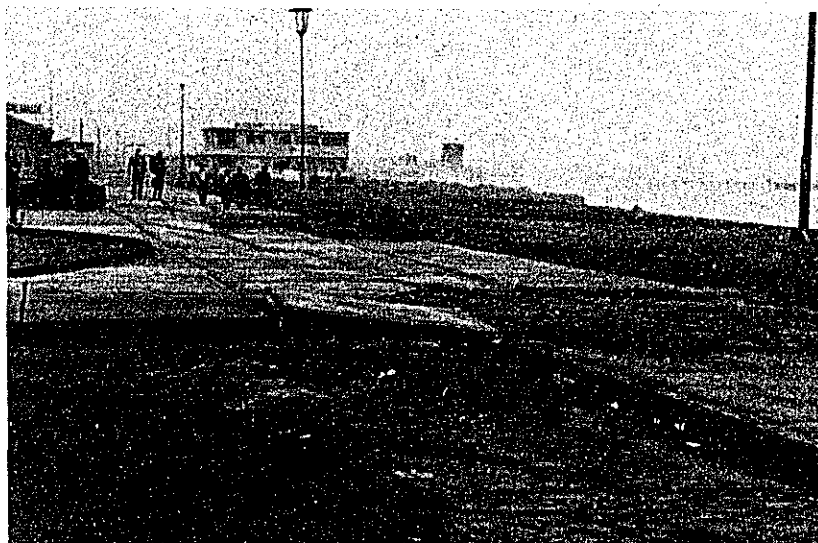
Fig. 8-12  
Differential sub-  
sidence of ground  
due to compaction.  
(Urbanizacion la  
Caleta)

Collapse of sand dune by seismic vibration and crackings associated with the subsidence of the nearby ground occurred (Figs. 8-7b, c and 8-8b), e.g. cracks observed in the sand dune area at Tres Cabezas in the southern Chimbote, where cracks appeared along the margin of a backswamp which is surrounded by sand dunes. The down-thrown side of the cracks was always on the downslope side. Houses built over these cracks were destroyed by differential settling and lateral spreading of the foundation (Fig. 8-10). At Urbanizacion la Caleta on the coast of Chimbote, a series of cracks had developed along the narrow zones on the inland side of a beach ridge. Subsidence occurred on the downslope side of the crack (Figs. 8-12c and 13a, b).

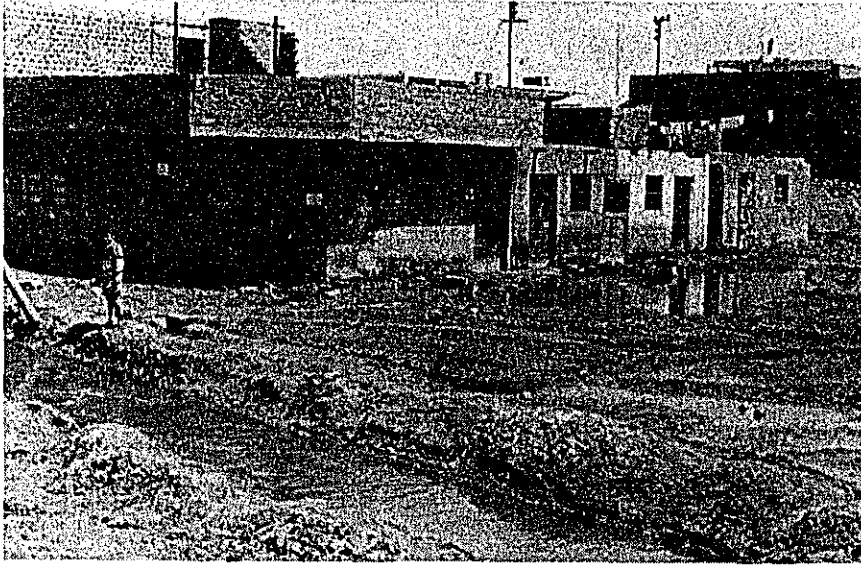
(a)

Fig. 8-15  
Flooded area  
due to ground  
settlement and  
uprise of water  
table.  
(Backswamp in  
southern Chimbote)

Subsidence of the ground and houses (e.g. in Barrio villa Maria) and a rise (ca. 1 m) of water table occurred also in the backswamp area in the southern Chimbote (Fig. 8-15). An enlargement of the water basin of the backswamp occurred not only by an increase of amount of water extruded from the backswamp, but also by ground subsidence of the backswamp area. These two phenomena are probably caused by compaction of water-saturated deposits of this area during the earthquake. Fig. 8-15c shows a drain channel which was made after the earthquake. A similar rise (ca. 1m in amount) of water level occurred also in the backswamp at the northern Chimbote. Further, a low-lying area surrounded by sand dunes at Miraflores Alto was covered by water to form a new lake (Fig. 8-16). In all cases the water level rose immediately after the earthquake, subsiding subsequently. In late August 1970, the water level was still higher than at pre-earthquake level.

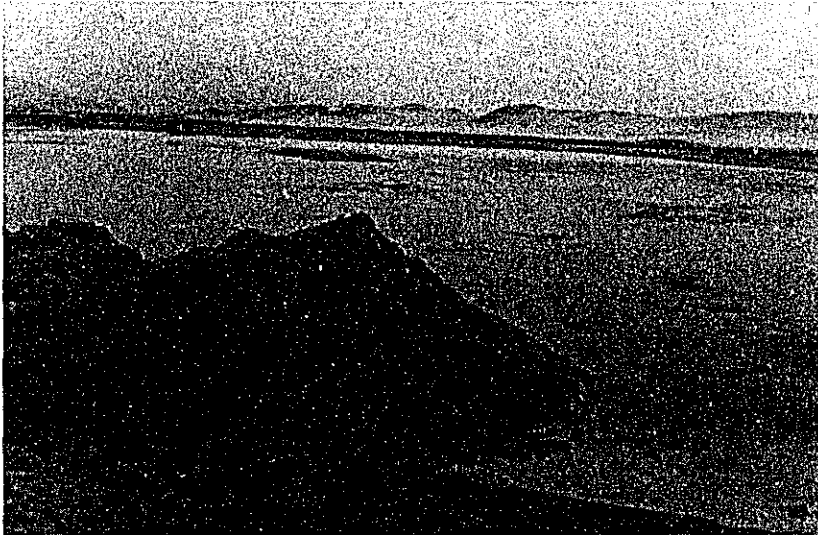
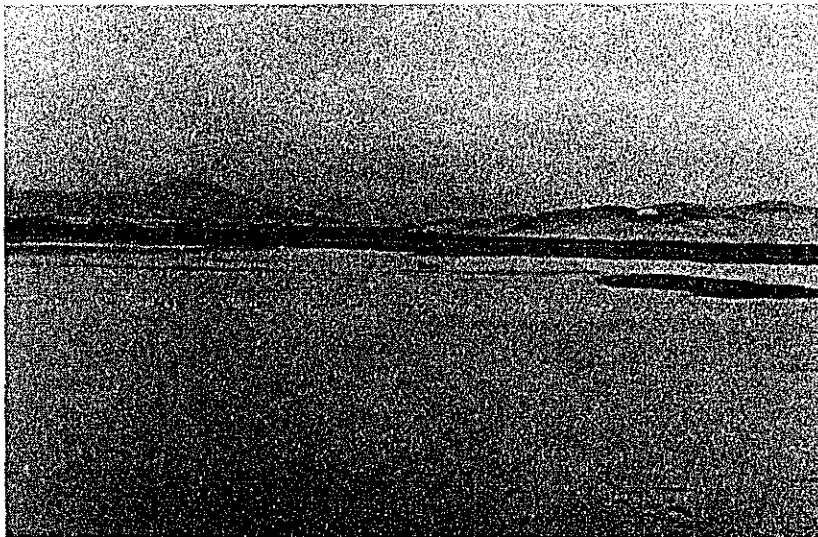
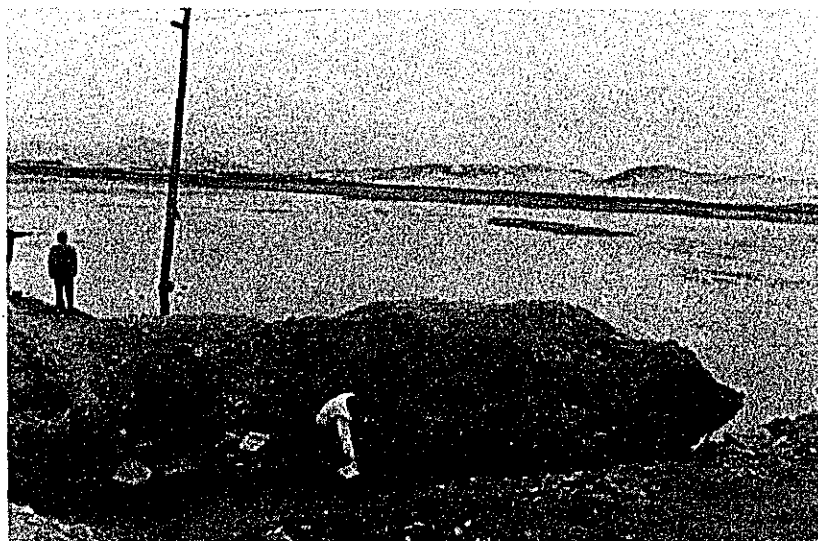
Fig. 8-16  
Flooded area due to  
ground settlement  
and rise of water  
table.  
(East of  
Miraflores Alto)

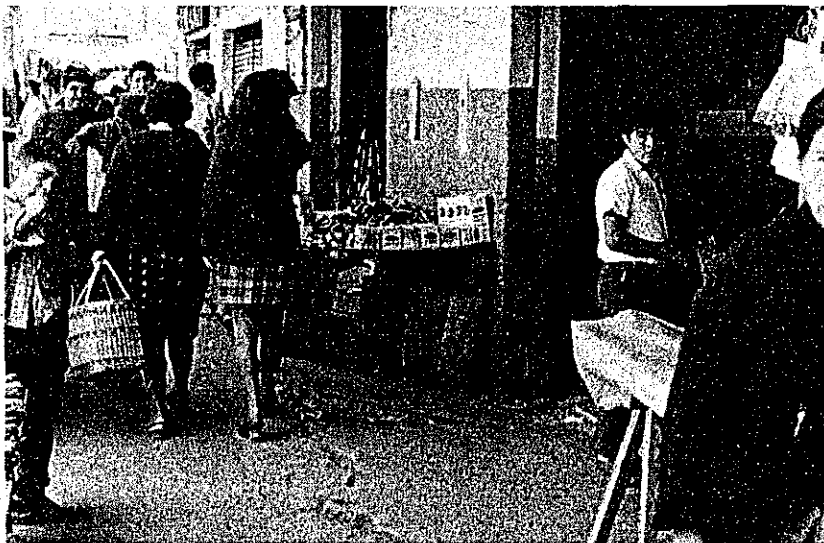
Fig. 8-17  
Damage due to  
differential sub-  
sidence of foun-  
dation of building  
(Casco Uabano)

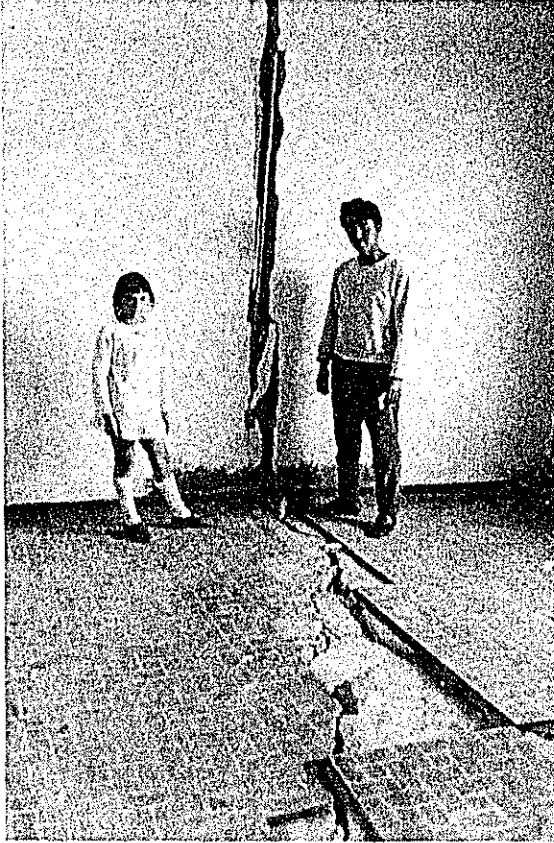
Fig. 8-18  
Damage to house  
due to differential  
subsidence.  
(Casco Uabano)

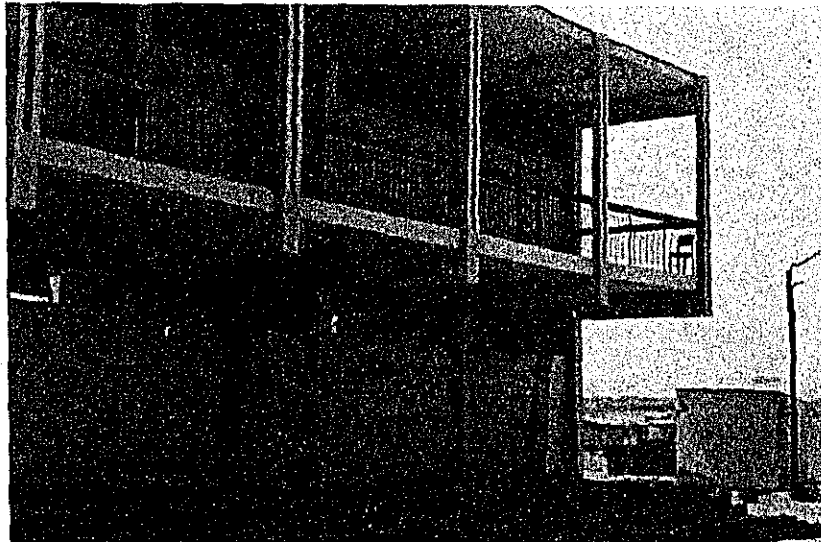
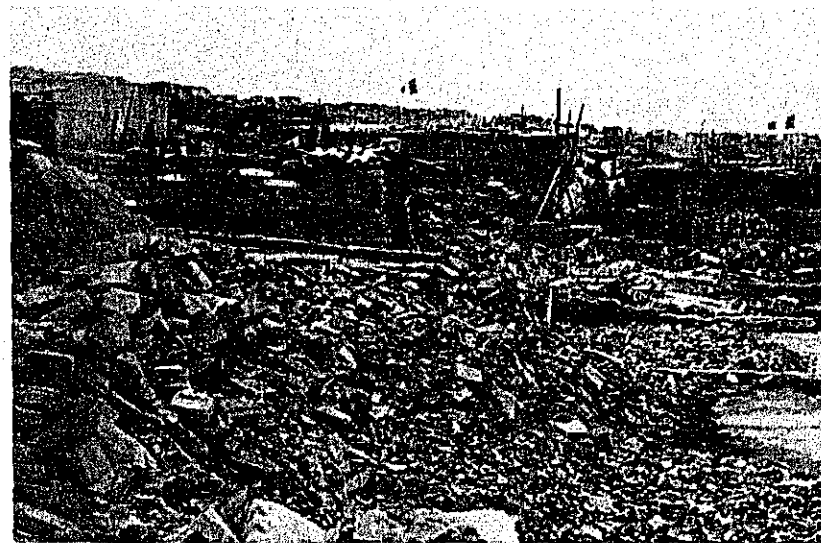
Fig. 8-19  
Damage to building  
due to earthquake  
shocks.

(a: Miraflores,  
b: School  
building of G.U.E.  
Inmaculada de la  
Merced,  
c: San Pedro)

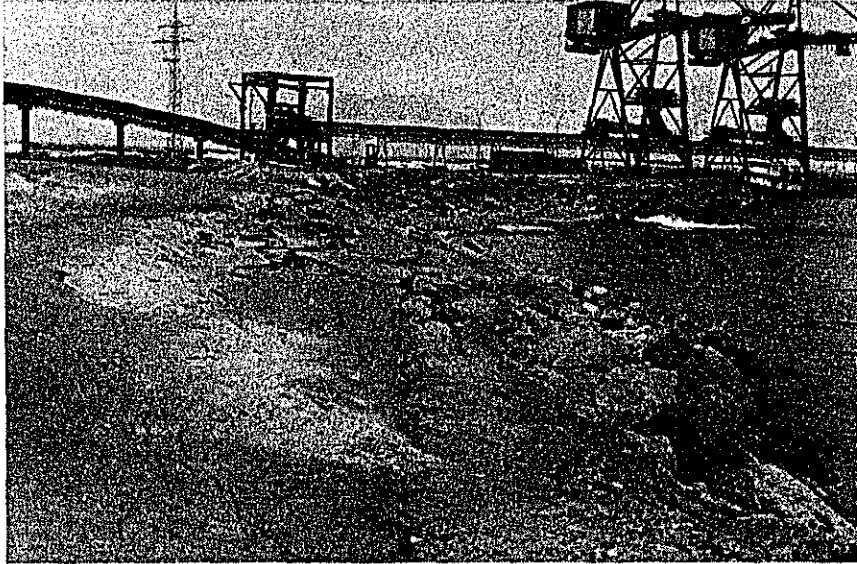
**Fig. 8-20**  
**Damage to Chimbote**  
**harbour**

**a: slumping of paved**  
**road.**

**b: ground settelement**  
**with cracks and sand**  
**volcanoes, due to**  
**liquefaction on the**  
**filled earth.**
